REGULATORY, ENVIRONMENTAL AND GEOTECHNICAL SOLUTIONS TO CONSTRUCTION OF A ROADWAY EMBANKMENT OVER A LANDFILL

Victor A. Modeer
District Engineer, District 7
IDOT, Effingham, IL 62401

Mary C. Lamic
Studies and Plans Engineer, District 8
IDOT, Collinsville, IL 62234-6198

Paper No. 10.11

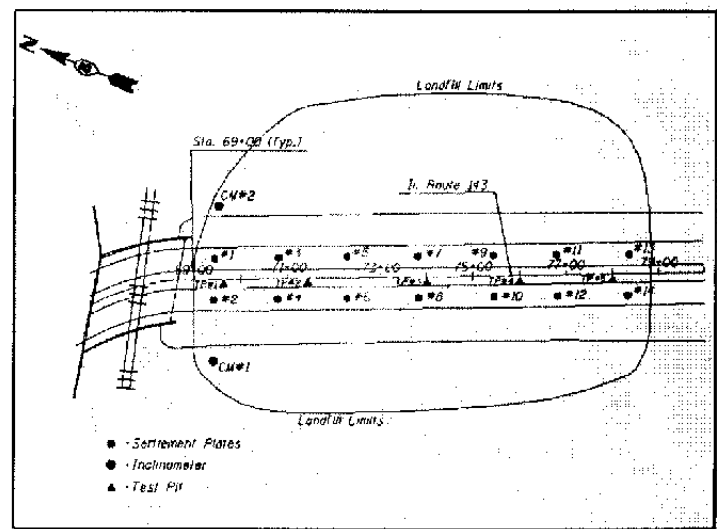
Fig. 1 -- Location Map

Borings were drilled through the landfill and five test pits were completed from January through October 1989. See Figure 1 for test pit and boring locations. The test pits were excavated with a backhoe in early February 1989 to depths ranging between 8 to 12 feet below the ground surface. During drilling and excavation the material encountered was visually classified and recorded. Samples were screened with a HNU and tested for hydrogen sulfide, methane and various other compounds using Draeger tubes.
