FAILURE OF EMBANKMENT ON SOIL-CEMENT COLUMNS FOR THI VAI PORT, VIETNAM

Nguyen Minh Hai

Bengt H. Fellenius

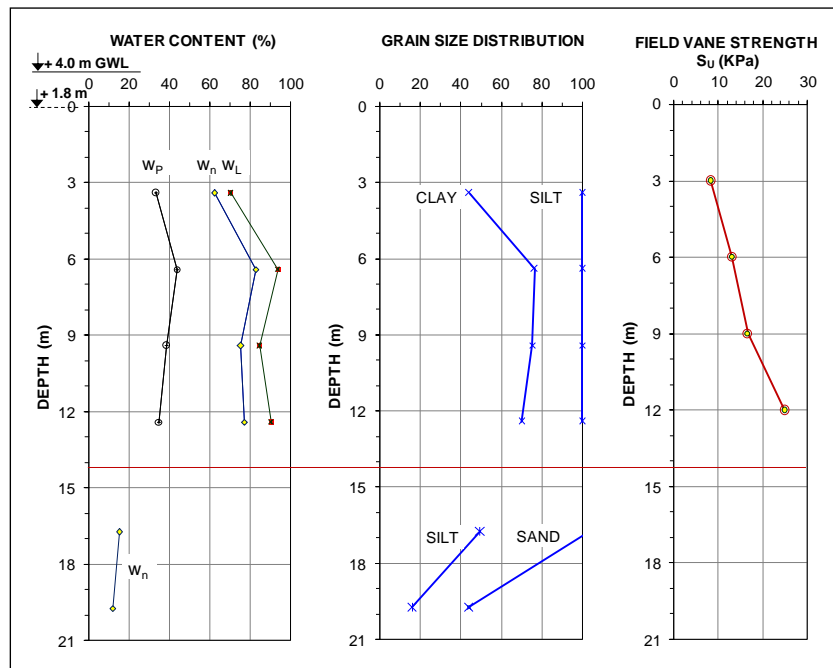
The soil profile is illustrated in Figures 4 and 5. Figure 4 shows the results of a typical CPTU sounding pushed at the site before construction start. Figure 5 shows the distribution of the basic soil parameters. The natural water content of the clay is 70 to 75 % and the total saturated density is about $1,500 \text{ kg/m}^3$. The density of the sand below the clay is estimated to $1,800 \text{ kg/m}^3$. The field vane shows the clay to be very soft above 10 m depth and soft below. The correlation

Fig. 5 Diagram of water content and Atterberg Limits, grain size distribution, and field vane strength

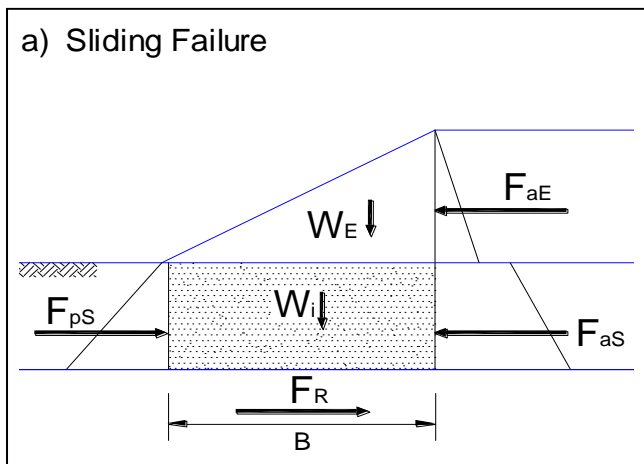
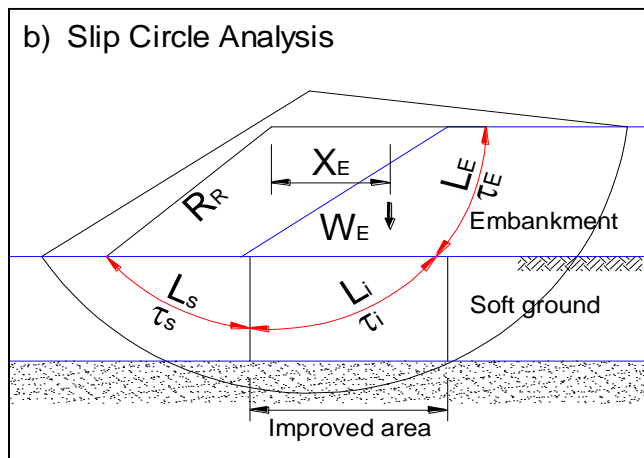
Figure 6a shows the principle of translational slope stability as applied in the design. The failure mode is based on the horizontal load equilibrium of active and passive earth pressures acting on the side boundaries of the improved area and the shear strength mobilized at the bottom of the improved area of width B . The shaded area is the soil-cement column and wick drain treated ground. The labels W_E indicates the weight of the embankment above the treated ground. The labels F_{pS} and F_{aS} stand for passive and active earth stress, respectively acting on the treated ground, and F_{aE} is the active earth stress from the embankment fill.

Fig. 6 Typical modes of stability analysis for embankment on soil-cement columns (Technical Standards and Commentaries for Port and Harbor Facilities in Japan 2002)

Figure 6b shows the principle of a rotational cylinder—slip-circle—slide failure (TSCPHF 2002) as applied in the design. The improved ground is assumed to be a composite material with an average and equal shear strength along the slip circle arc. The labels L_E , L_i , and L_s indicate length of circular arc in embankment, improved and original soft ground, respectively. The τ_E , τ_i and τ_s indicate shear strength of embankment, improved and original soft ground, respectively. W_E is the weight of the embankment and X_E is horizontal distance of embankment from center of slip circle. The R_R is the radius of the slip circle. The more shallow slip circle assumes linear increase in undrained shear strength of the soft ground with depth. The deeper slip circle assumes that the undrained shear strength is constant in the soft clay.

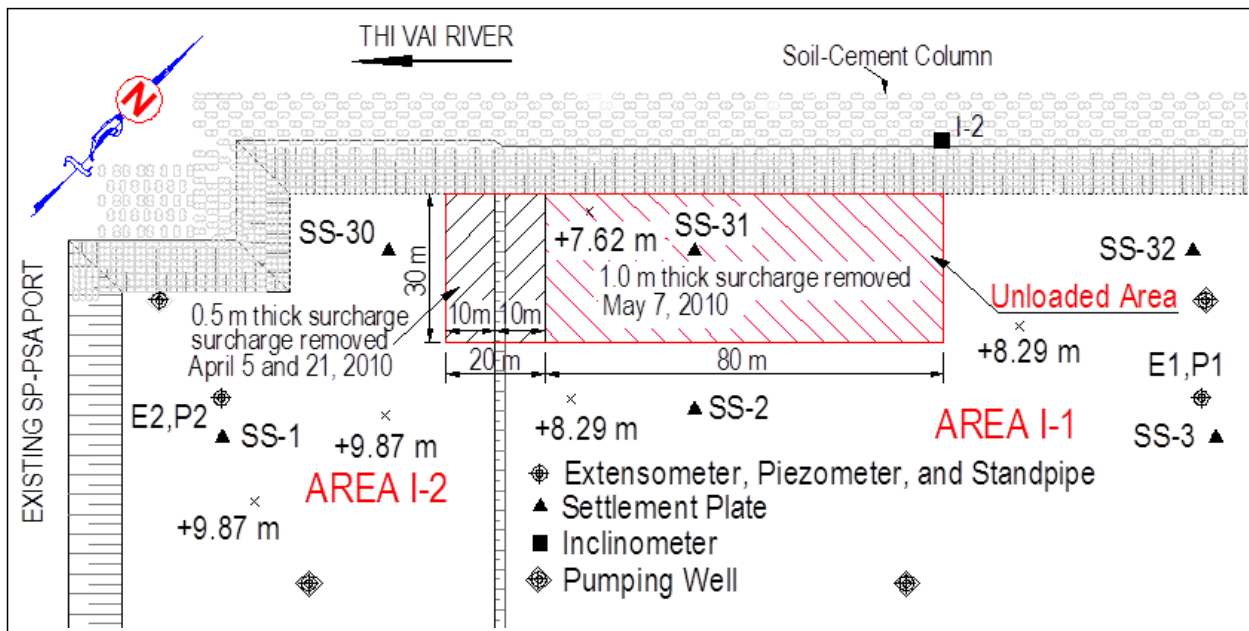
After the failure, the shear strength of the soil was investigated. The investigation included cone penetrometer soundings, CPTU, and boreholes at locations shown in Figure 9. No new FVTs were included. Surveying observations indicated that toe revetment material and surcharge fill had moved about 70 m out into the river.

Fig. 9 Locations of boreholes and CPTUs in the failure
