Stabilization of a Tailings Dam by De-Watering

SYNOPSIS The failure of the outer slope of one of the paddocks of a tailings dam, resulted in a significant decrease in the area available for tailings deposition. Overloading of the remaining five paddocks resulted. To maintain the stability of the existing dam whilst construction of new disposal facilities was in progress, three techniques were investigated; horizontal, push-in drains at the dam toe, a rock buttress around the operational paddocks, and vertical de-watering wells installed on the first terrace, or 'step-back' of the dam. De-watering wells proved most effective, and 165 wells were installed. A monitoring programme included regular determination of the water level in each well, and the installation of piezometers at selected locations around the dam. These observations were used to optimise the use of the five remaining paddocks, thus ensuring stability of the dam during the transfer of deposition operations to two new tailings dams.

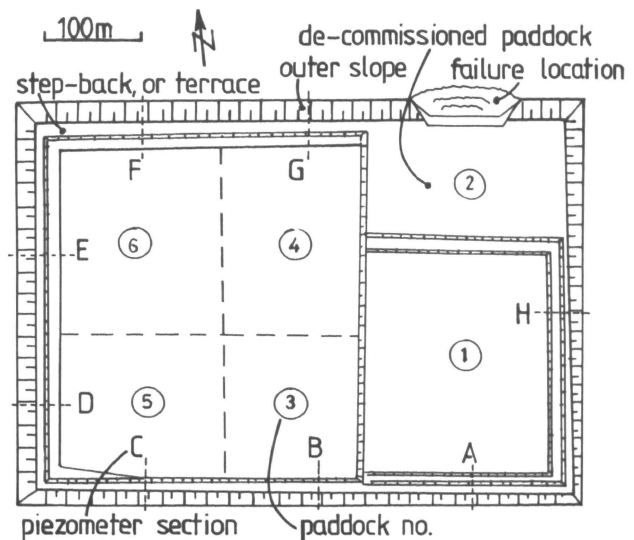
Figure 2. Plan view of tailings dam.

Recognising the sensitivity of the dam stability to an increase in pore water pressure along a potential failure surface, it was decided to install a further eight lines of standpipe piezometers around the dam perimeter, each consisting of three piezometers. The location of these sections is shown on Figure 2, which depicts the dam after decommissioning of the North-Eastern paddock. Figure 3 shows a section along one of these piezometer lines, which illustrates the location of the water pool atop the dam, and the elevated location of the phreatic surface.

Each of the randomly generated failure surfaces was analysed by the simplified Janbu method of slices, and incorporated the phreatic surface obtained from the piezometers shown in Figure 2. A statistical distribution was fitted to the variation of calculated factors of safety. The

The effectiveness of the venturi well system in drawing down the phreatic surface was initially monitored with the existing eight lines of piezometers (see Figure 2). Daily readings for a 4 month period on the section E piezometers indicated that the phreatic surface dropped at a rate of 14-40mm per day whilst no deposition was occurring, and 2-3mm per day during or shortly after a deposition cycle. As the dewatering process progressed, it became impossible to obtain readings in any of the original piezometers as they had only been drilled to 2m below the level of the phreatic surface that existed at that time. Additional monitoring of the effectiveness of the de-watering system was facilitated by the installation of an additional nine piezometers, clustered around a single well. The location chosen was the first set of venturi wells to be commissioned, along the north-west face, and sufficiently far from the corner of the dam not to be influenced by the natural preferential drawdown of the phreatic surface in this area. The primary information to be obtained from these piezometers was how the phreatic surface was drawn down midway between two wells.

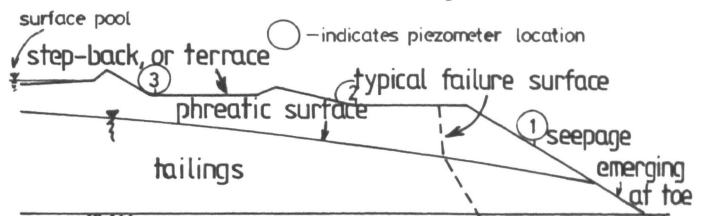
Figure 3. Typical section through tailings dam

Observation of the failed slope indicated that the plane of failure was highly unlikely to have been circular, and was most likely a wedge-type failure, with a steep back slope and the horizontal portion confined to the underlying weak clay layer, (see Figure 3). The results of a number of undrained (with pore pressure

The Morgenstern-Price (1965) approach, which utilised the simplified Janbu method of slices, was used for the backanalysis. A possible failure surface was chosen, and the factor of safety for the measured slope geometry and phreatic surface profile calculated, using the most likely value of the soil shear strength parameters. The geometry of the failure surface was varied until a minimum factor of safety was obtained, and since the friction angle of the clay had been defined with the least degree of accuracy, it was varied until a factor of safety of unity was obtained for the critical failure surface. This occurred when the friction angle of the clay was set to 10°. Although this is an extremely low friction angle, the clay had a plasticity content of 45%, and it is likely that sufficient movement had occurred to exceed the peak strength value during construction of the tailings dam.

Using these distributions, the program randomly generated a different set of material strength parameters, from within the specified distributions, for each failure surface analysed. The failure surfaces were also randomly generated, although within given limits and subject to certain biases. A wedge failure similar to that observed in the field was obtained by confining the horizontal leg of the failure surface to within the weaker black clay layer. The active and passive legs of the failure surface were biased towards forty-five degrees and zero degrees respectively. A typical failure surface generated by the program is shown in Figure 3.

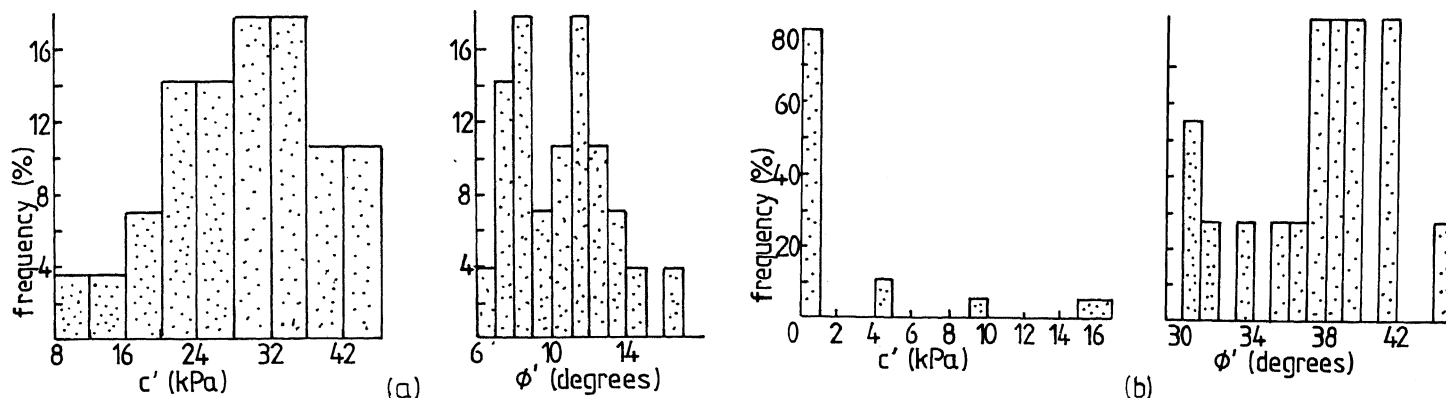
Figure 4. Triaxial test results for (a) foundation clay, and (b) tailings.

measurement) and drained shear tests on undisturbed samples of the black clay are shown in Figure 4a. A total of 28 tests were carried out. A mean cohesion value of 25 kPa was obtained, with a mean peak friction angle of 15° and a mean residual friction angle of 6°. Triaxial tests on eighteen samples of the tailings material indicated that the cohesion was negligible, with a mean friction angle of 35°, (see Figure 4b).

Studies by Schultze (1972), and Lambe (1951) of frequency distributions and correlations with soil properties have shown that many material properties are normal-like variates. This was found to be true for the distributions shown in Figure 4, with the exception of the cohesion of the tailings, for which a log-normal distribution was found to be most appropriate (with a strong bias towards very small values of cohesion).

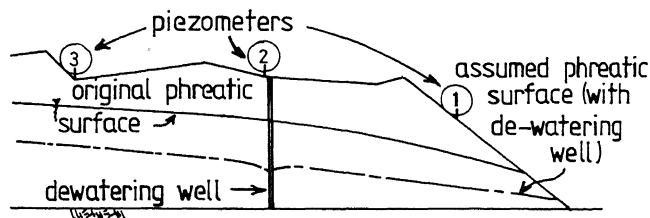
Figure 6. Section showing de-watering well, and expected phreatic surface.

The predicted improvement in stability is not as pronounced as for the rock buttress. However, as discussed in the following section, cost and other considerations outweighed these differences. Furthermore, field monitoring showed that the drawdown that was achieved was significantly better than that assumed in Figure 6.

The proposed procedure was to install cased, slotted vertical wells on the first step-back, and then draw down the phreatic surface by pumping from these wells. The envisaged effect on the phreatic surface is shown in Figure 6 below. At the time of the investigation, the technique had not been used before in South Africa for dewatering a tailings dam but it was thought that the potential benefits of using the technique made it worth pursuing.

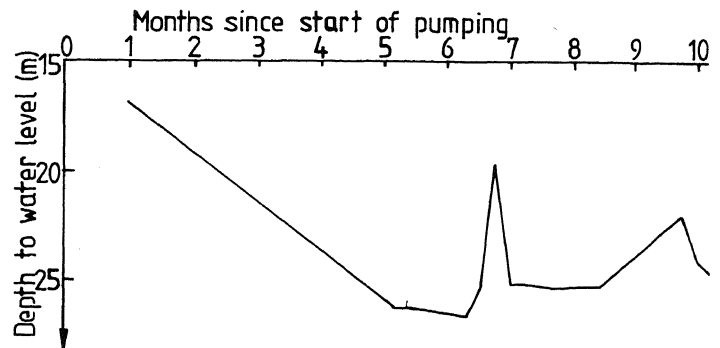
Figure 9. Water level measured in de-watering well.

Results that were obtained using these piezometers are shown in Figure 8, which shows the drawdown for the section midway between two wells that was achieved after two weeks pumping as well as after 15 months continuous pumping. After two weeks of pumping, the drawdown was still in progress, which is attributable to the fact that at the time these readings were taken, the water level in the well itself was only about 18.5m below the tailings level. The long-term steady state phreatic surface can be seen to be significantly lower than the original elevation. The drawdown that occurred in the wells surrounded by the nest of nine piezometers is shown in Figure 9 for a nine-month period. It can be seen that it

took fully four months for the water levels to be drawn down to the base of the wells, possibly because deposition continued on this paddock throughout this period. These levels then remained depressed until the pumping system was stopped for routine maintenance. This resulted in a very rapid rise in the water level, which emphasized the effective role of the pumping system in maintaining stability of the dam. As can be seen from Figure 8, the phreatic surface midway between two wells was drawn down to within about 6.5m of the underlying clay.

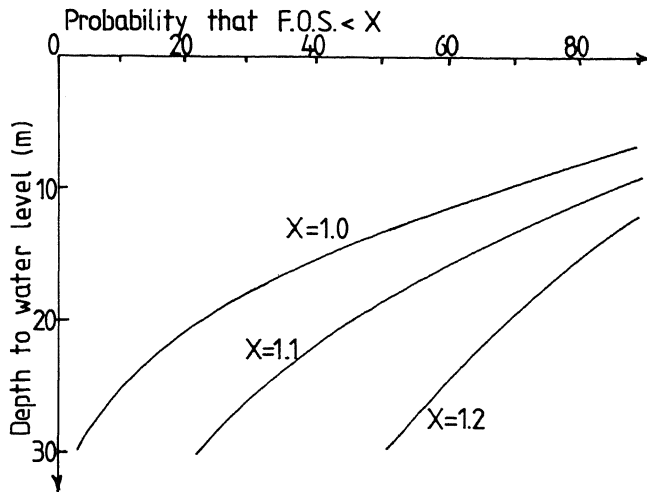
Figure 10. Typical figure used for optimisation of use of individual dam paddocks.

A second series of probabilistic analyses were carried out for the eight sections previously analysed. In these analyses the phreatic surface was decreased in increments of 1m, with the shape of the surface being based on measurements similar to those shown in Figure 8. A plot such as that shown in Figure 10 was constructed for each of these sections, showing the depth of water level (in the well nearest to the section being analysed, and accounting for the approximate 6.5m difference between the water level in the well and the phreatic surface midway between two wells) versus the probability that the factor of safety was less than a given value. A probability that

the factor of safety was less than unity of 10% was considered acceptable, although wherever possible it was attempted to reduce this probability to 5%. This level of risk was regarded acceptable, as it was a short-term risk whilst new dams were built and commissioned. Implementation of this strategy, together with regular inspections of the condition of the toe of the dam, were used to decide on which paddocks it was acceptable to deposit tailings. In addition, as strict a control as possible was exercised on water storage on top of the dam, to limit the proximity of the water pool to the crest of the dam.

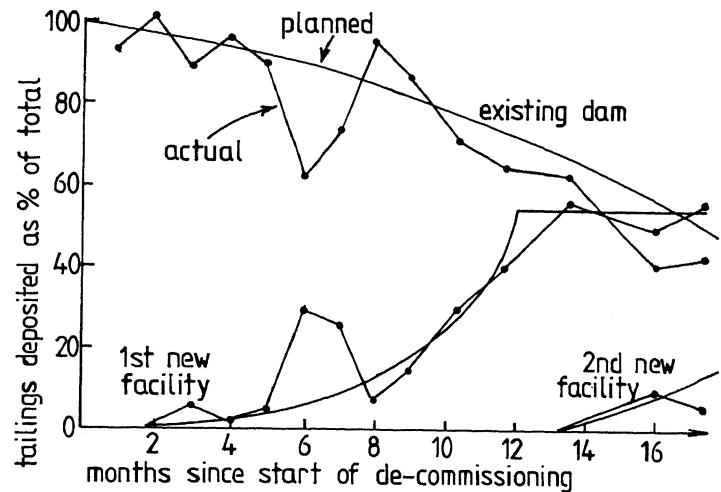
Figure 11. De-commissioning plan for old dam, showing planned and actual tonnages deposited.

Commissioning of the first of the two new tailings disposal facilities began in early 1980. However, the start up phase of a new dam is always a slow process, unless the entire perimeter is initially at the same level, and accordingly a reduction in tonnage being deposited on the old dam of only about 15% was envisaged by the end of 1980. The planned deposition volume, as well as the actual values for a nine month period, are shown in Figure 11. After about September 1980 the decrease in usage of the tailings dam went approximately according to the plan shown in Figure 11. Once the second of the new facilities had been operational for three months, usage of the old dam had dropped to about 50% of the maximum value.

The use of vertical de-watering wells, together with a management programme that controlled very closely the operation of the tailings dam, resulted in successful de-commissioning of the dam, and transfer of deposition operations to the

new disposal facilities. It was a very effective short-term solution, that ensured the mine remained in production, whilst optimising the use of an overstressed facility. The success of the operation was in large measure due to the enlightened approach of the mine management. They were prepared to allow field trials of a largely unproven technique in South Africa, and were not averse to incorporation of a fairly comprehensive monitoring programme into the de-watering operation. The benefits of the monitoring instrumentation in this job far outweighed their cost, by enabling the optimum use of the various paddocks on the dam.
