Comments Upon an Earth Dam Severely Damaged by Foundation Liquefaction

SYNOPSIS : The damage of the Draganesti earth dam on lower sector of the Olt river due to foundation liquefaction during 30 th May 1990, 0.12 g in site maximum acceleration, Vrancea earthquake is described. The dam is up to 20 m maximum height and border cross-wise and laterally the reservoir with 12.6 km length of the low head hydroelectric power station . The damage consisting of a large slide with about 60 m length at the dam downstream face and some cracks and lift-up of the reinforced concrete slabs at the corresponding upstream toe zone was placed in a zone where any special technology for increasing the relative density of the foundation loose sand layer was not applied . The natural relative density of the above mentioned layer having 1.20...7.00 m thickness was $D_r=0.15...0.30$, but it was increased up to 0.55...0.65 by vibrated-compacted gravel microcolumns technology, that was applied for over 80 % of dam foundation area. A comprehensive seismic backanalysis is performed in order to explain the damage mechanism.

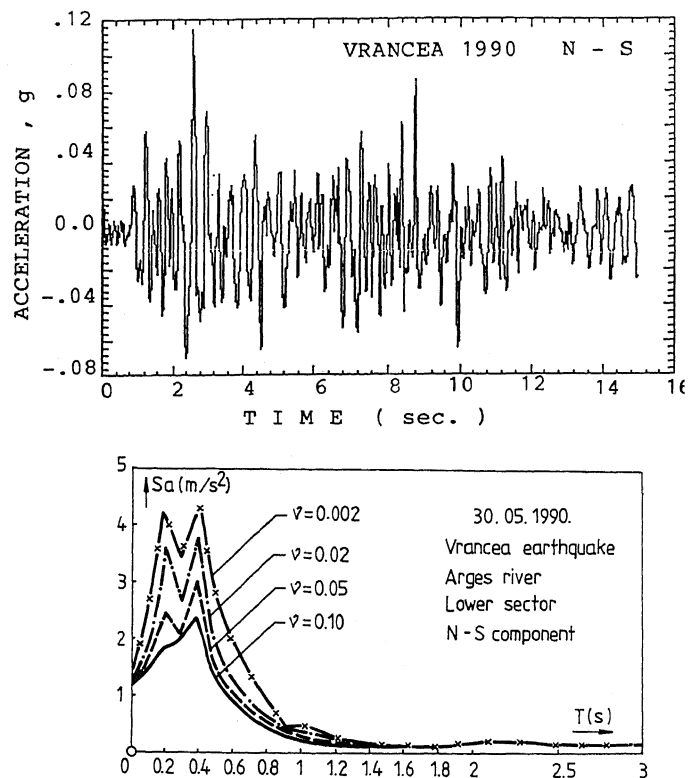
Fig. 3. Recorded accelerogram and seismic response spectrum of the 30th May 1990 Vrancea earthquake, Lower Arges river sector place.

Some recording accelerograms and seismic response spectra of the 30th May 1990, Vrancea earthquake are illustrated in Figure 3. They were recorded in the lower sector of the Arges river in a geologic profile likewise with that from Draganesti earth dam site. The peak ground acceleration of the 30th May 1990, Vrancea earthquake in Draganesti earth dam zone was appreciated to 0.12 g.
