Foundation Performance of Very Old Structures

S. C. Handa

Professor & Coordinator, Q.I.P. Centre, University of Roorkee, Roorkee, U.P., India

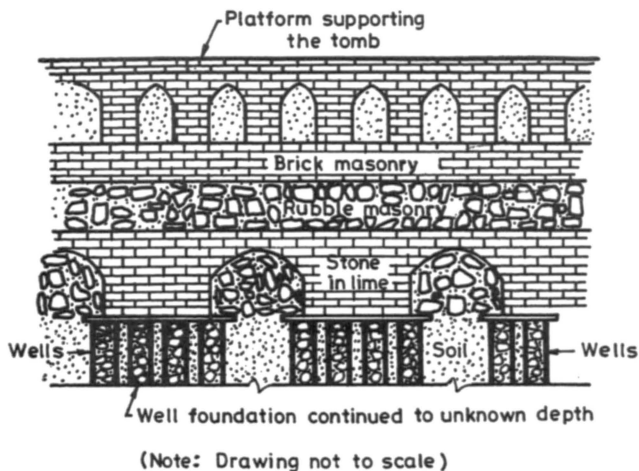
Fig.4: Imaginative view of foundations based upon available description

The drawings of the foundations must have been prepared with utmost care to carry heavy loads of the superstructure, but unfortunately they are no longer available. However, some of the details of the foundations are recorded in "Badshahnama", a contemporary text. Because of river Yamuna touching the monument on the North side and the ground being a slope of its bank and thus the deposit being of flood origin the entire structure was made to stand on a compact and solid bed of masonry. At lower level stone-in-lime masonry was used and in the upper region brick-in-lime masonry was used when possible. At the base of the foundation system a series of deep wells are provided. Their depth is not mentioned in the records but on the basis of borelog given earlier, it can fairly be guessed that they must have been taken down to rest on the layer of sandstone with fine sand starting at 62.3 feet below ground surface. The well steining consisted of stone in lime mortar while the inside of the well was filled with rubble-in-lime. A suitable number of wells were capped together to raise piers which were joined with vaults above. The masonry bed was supported above this and the arches were also included inbetween. The foundations were planned in accordance with the details of the superstructure so that massive piers and walls could rest on a suitable series of wells. Thus an effort was made to provide a platform consisting of a firm and compact base which was 43 feet above river level originally. Though the piers and walls of the superstructure rested directly on a series of capped wells, yet the whole

foundation system was so bonded together that it acted as a single compact body thereby minimizing the danger of differential settlements and hence cracking in the superstructure. An imaginative drawing of the foundation system based on the available description is shown in figure 4.

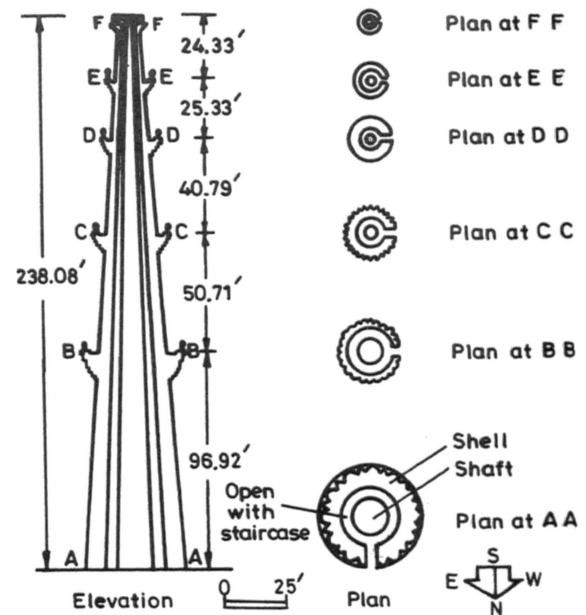
Fig.7:Sectional elevation and plans of Qutb Minar

After its completion, the first damage was done to the minar in 1368 when it was severely struck by lightning. Firoz Shah Tughlak repaired the minar and rebuilt the present top two storeys. Lightning again struck and damaged the minar during the reign of Sikandar Lodi who restored it in 1503. Later, it does not seem to have received any worthwhile attention till early nineteenth century when it was

standing in a terribly damaged condition because of weathering agents acting over a period of centuries and also as a result of severe earthquakes of 1782 and 1803. On the first of August 1803, the old cupola of the Qutb Minar fell down and the whole minar was seriously injured by this earthquake. Later, the exhaustive repair work was entrusted to Major Robert Smith who spent over two years to get the repairs completed in 1828 at a cost of Rupees 17,000 (about 1700 dollars). The repair work proved extremely beneficial as the minar thereafter successfully withstood the earthquakes of 1829 and 1905. Some repairs were carried out in 1920. Also, in early forties, it was noted that the veneer and particularly inscriptional bands had bulged out at places and a few buldges and twists had also appeared on the shaft. Major structural repairs were executed during 1944 to 1949.

In 1964 the officer-in-charge of the monument expressed concern over the development of cracks in the stones of the minar and requested for a thorough examination of the monument. A Qutb-Minar Committee was then set up by the Government to look into the various aspects of this monument, which during its investigations found that Qutb Minar not only had cracks in its super structure but was also leaning towards South-West direction by 2 feet 1 inch at the top. The foundation investigations were carried out and the foundation was strengthened by cement grouting in 1972. The superstructure repairs were also carried out in the first storey and are planned to be done throughout the height of the minar.
