Thissavros Hydropower Plant Managing Geotechnical Problems in the Construction

THISSAVROS HYDROPOWER PLANT MANAGING GEOTECHNICAL PROBLEMS IN THE CONSTRUCTION

ABSTRACT

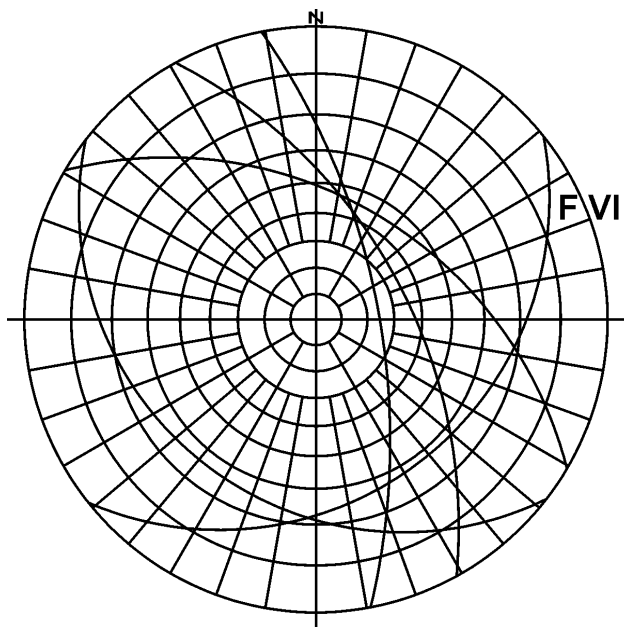
Foliation at the dam site trends almost perpendicularly to the valley and dips downstream at 40° to 60°. Additionally, there are two principal sets of subvertical joints, directed roughly parallel and perpendicular to the valley walls, respectively. Although some faults and shears traverse the rock, surface excavation in sound rock normally met with favorable conditions. However, excavations also revealed elements of critical significance for the performance of the slopes at the dam site. These were low angle thrust faults, dipping 15° to 35°, found to continue extensively over the site and the slopes. Thick clay gouge developed along these faults acted as hydrogeological barriers in the rock mass, locally resulting in adverse hydraulic thrusts in the slopes. Owing to low shear strength on these faults, combined with the groundwater loads, major stability problems developed during the early construction phase of the project. Principal faults and shears are traced in Fig. 1; Fig. 2. illustrates the orientation of the various fault systems in the rock mass.

Figure 2. Stereogram of faults at the dam site

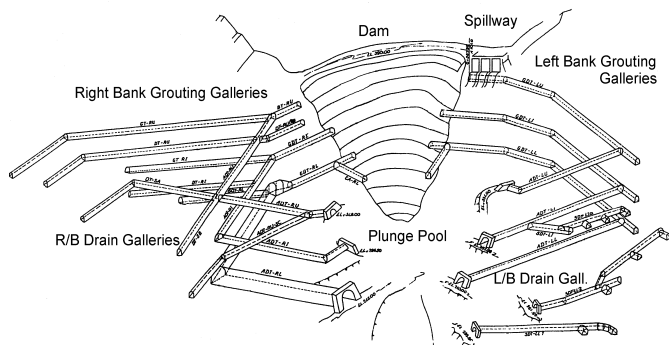
To achieve efficient drainage of the slide mass, to intercept seepage percolating through the grout curtain and to prevent build-up of undesirable groundwater loads against the steep slope along the right bank downstream of the dam, a system of galleries is provided (see Fig. 5). Two parallel galleries at the upper level partially traverse the slide mass of Segment A above Fault F VI. One drainage gallery at the intermediate level also intersects Fault F VI. At the lower level, one gallery serves the combined purpose of grouting and drainage. Seepage water in the drain holes is captured by slotted PVC screens, wrapped with geotextile to prevent erosion of fines. The screens can be pulled for maintenance. Standard spacing of drain holes is at 6 m centers.

Figure 5. Schematic view of arrangement of grouting and drainage galleries

At each of the three levels of grouting galleries, a branch parallel to the flank of the slide mass serves as drainage gallery (at about elevations 350, 290 and 240 m, see Fig. 5). The hydro-geologically complex and compartmentalized nature required an additional branch at the intermediate level and two further separate galleries at about el. 260 m and 240 m.

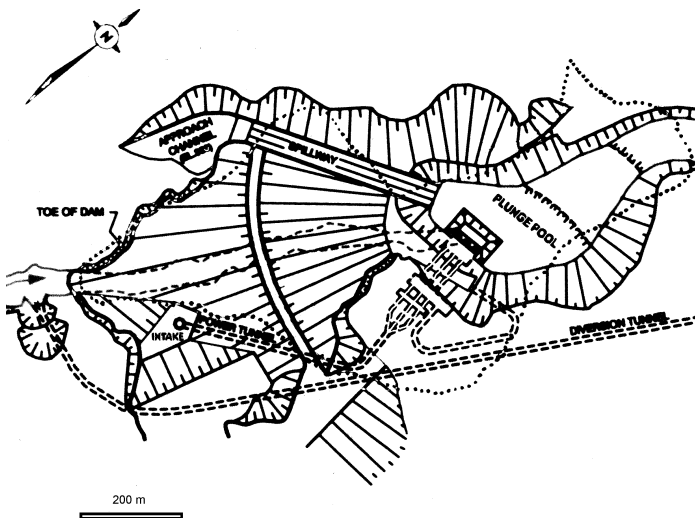
Preliminary concepts had envisaged extensive removal of the slide material, using it for the construction of a gently sloping earth dam and creating at the same time space to place the spillway on the right bank. For tender design the type and layout of the dam were adjusted to take into account the hydraulic requirements for the evacuation of the large design flood under the constraints imposed by the stability problems on the valley flanks (see Fig. 7). Therefore, a rockfill dam was adopted with a central, upstream inclined clay core. A two-layer filter is arranged on the downstream side and in the upper reach on the upstream side. The upstream shell has an overall mean inclination of 1V in 2.25 H, the downstream shell slopes 1V in 1.5H between the road berms (1V in 2H as a mean, in the major

Figure 7. Tender design. Dotted line marks toe of preliminary design earthfill dam

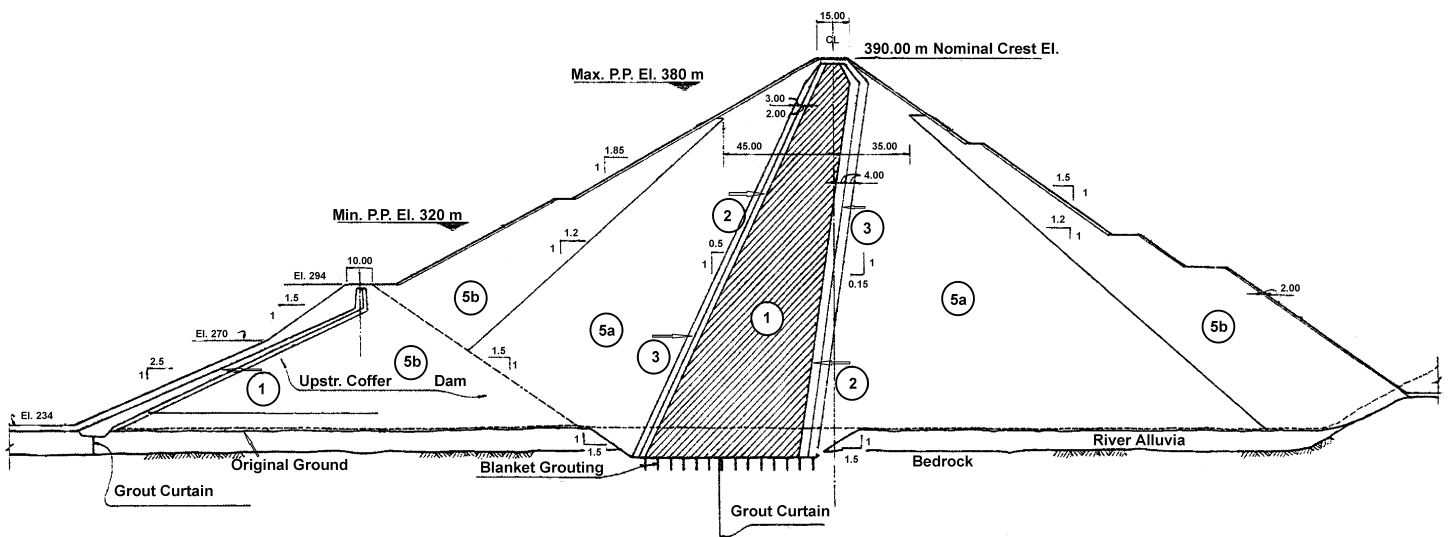
The embankment was completed in 1994. Total settlements of the fill recorded until end of construction have been extremely small, ranging from about 1.2 to 1.5%. Horizontal displacements of about 30 cm were estimated from one inclinometer. In the end-of-construction analysis, linear-elastic and non-linear-elastic FEM modeling gave the best agreement with the recorded embankment strains, introducing a mean modulus of 60 to 80 MPa for the shells.

Figure 8. Typical section of rockfill dam. Description of zones see Table 2

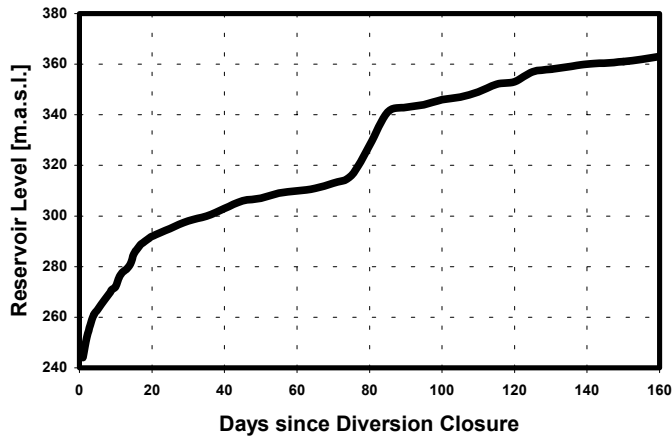
The diversion tunnel was closed on 16 September 1996. To the end of September the lake level rose to El. 290 m and thereafter continued slowly to el. 312 in November. With an exceptional storm, the filling rate at the end of November increased drastically to rise at an average of 1 m/day and temporarily peaking at 6.0 m in one day (see Fig. 10). A delay in the commissioning of the power plant eventually resulted in minor

releases before the work at the plunge pool was completed. Emergency plans to regulate the water level in the plunge pool for such scenario were in place and adverse effects on the left bank slope stability were prevented. Despite the unprecedented, fast rate of reservoir filling, the well compacted embankment performed fully satisfactorily.

Figure 10. Reservoir filling
