RECENT DAMAGING EARTHQUAKES IN JAPAN, 2003-2008

Robert Kayen, Ph.D. P.E.

ABSTRACT

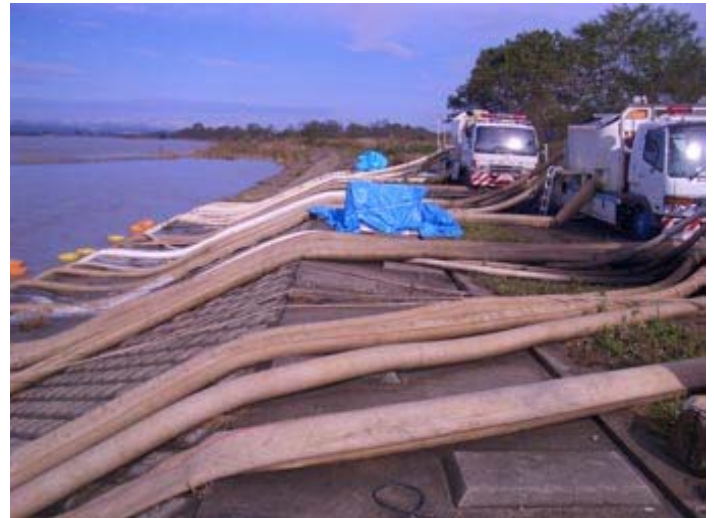
Nagaoka City receives its water from the Shinano River, upstream of the city. Water level in the river is raised by lowering gates across the river, and water is diverted into a pipe that carries the water to a treatment plant downstream of the gates. The earthquake disrupted power to the gates and also caused some damage to the wire rope machinery used to raise the gates, so the gates could not be lowered and the treatment plant received no water. As a result, the plant had to resort to emergency drafting from the Shinano River (Figure 34).

Figure 34: Emergency drafting of water from Shinano River for Nagaoka City Water Treatment Plant (photo: C. Scawthorn).
