Distress in Hirakud Dam, Orissa, India – Possible Causes and Remedial Measures

B. Ramachandran
Madras, India

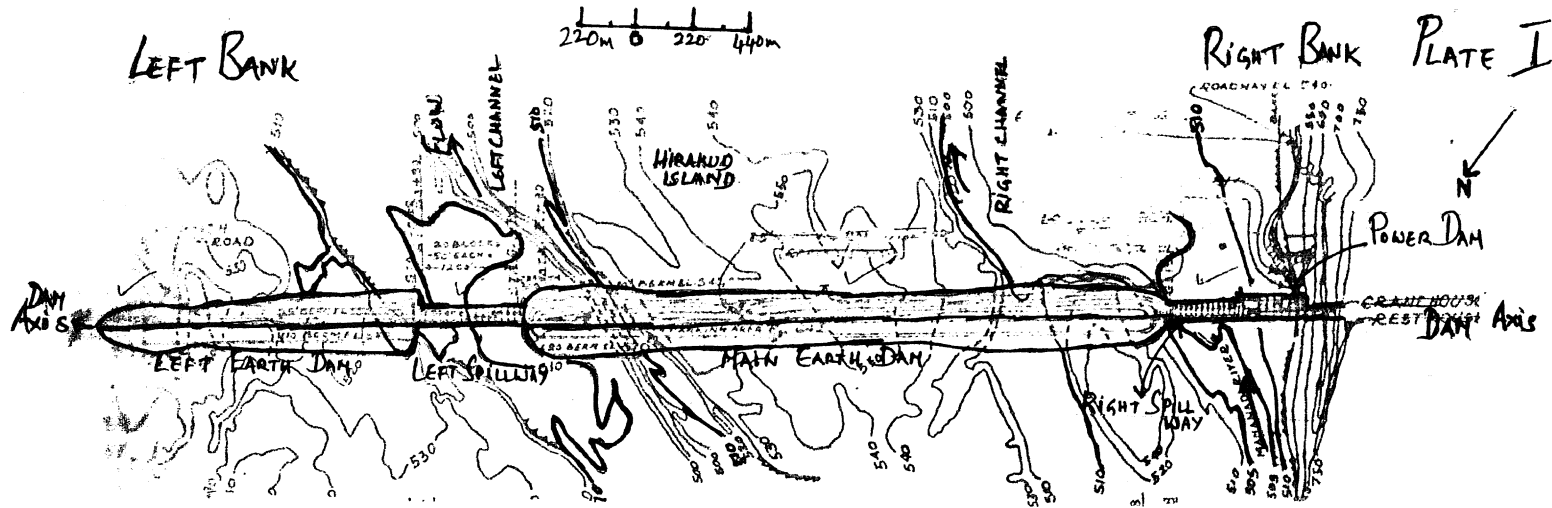
CRACKS ON D/S FACE OF THE DAM - RIGHT BANK

SYNOPSIS: Distress has been observed in the above dam, on its right spillway immediately after its completion in 1957. The distress has been intensified in the eighties with development of thin horizontal cracks in the undersluice barrels, gate gallery and adjoining areas at a level 18m above bed. These have all been chiselled, opened up and epoxy grouted; besides with water proof cement. But parallel cracks opened up soon after. Studies in detail carried out by various government organisations point out that rapid placement of concrete in '55-'56 leading to thermal stress is the main cause. Though some attribute it to alkali aggregate reaction because of strained quartz in the aggregates. Further studies and remedial measures are under way.

Summing up, rapid placement of concrete without precooling and other construction control appears to be primary cause for the distress noticed; More so, because the cracks are horizontal and are confined to certain levels, where rapid placement has taken place. The theory of strained quartz causing alkali aggregate reaction is not universally accepted; Besides there are no evidences of extensive use of river gravels containing chert, chalcedony etc.

Remedial Measures : Ever since the development of cracks were observed, the project authorities have been opening them with chisels and jackhammers, and grouting them at pressures of 1 to 3 kg/sq.cm. with Cement and Epoxy resin. The grout appears to cover only 3 m from the crack surface. Guniting of some parts with waterproof cement has also been performed.

The latest measures consist of provision of steel sheets by international groups, the steel sheets, placed upstream of the dam extending from the river bed to the maximum water level in the non overflow and overflow sections. Steel sheets are expected to prevent further attack of the concrete and its deterioration subsequently.
