Geotechnical Damage Due to Bihar Earthquake of August 1988

SYNOPSIS: The Bihar-Nepal earthquake of August 21, 1988 (magnitude 6.6) caused significant loss of life and property. Besides the epicentral area, two distant places (Munger in India and Bhaktapur in Nepal) suffered significantly. This was also the case in the 1934 earthquake (magnitude 8.4) and is due to peculiar geology of the area. Geotechnical damage in the affected area includes liquefaction, cracking and subsidence of embankments, and cracks in bridge abutments and wing walls. Besides, in the hilly regions of Sikkim, landslides and rockfalls disrupted road network significantly. Extensive damage took place in the eastern Nepal also. This paper describes the geotechnical damage to the Indian areas only.

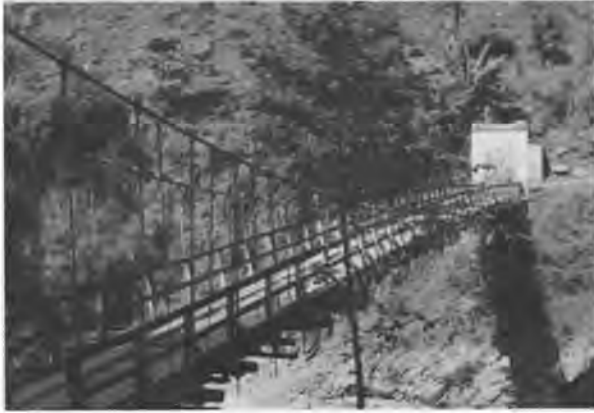
decking, which is situated very near to the proposed bridge site, also did not receive any damage (Fig. 14).

FIG. 14 Old Suspension Bridge Near Tashiding Bridge, Sikkim (no damage).
