Structural Damage in a Populated Area due to an Active Fault

SYNOPSIS: The city of Patras was struck in August 1989 by a shallow earthquake of $M_s = 4.8$ which caused a surface rupture and serious structural damage to several buildings located in a narrow elongated zone. A detailed investigation programme was carried out including geological mapping, drilling of boreholes, in situ and laboratory testing and monitoring of horizontal and vertical movements. It was found that the surface rupture, about 1500 m long, was closely related with the reactivation of a preexisting normal fault. The structural damage of buildings was found to be limited mainly in a narrow zone 50 m wide along the fault and connected with its movements and the seismic intensity.

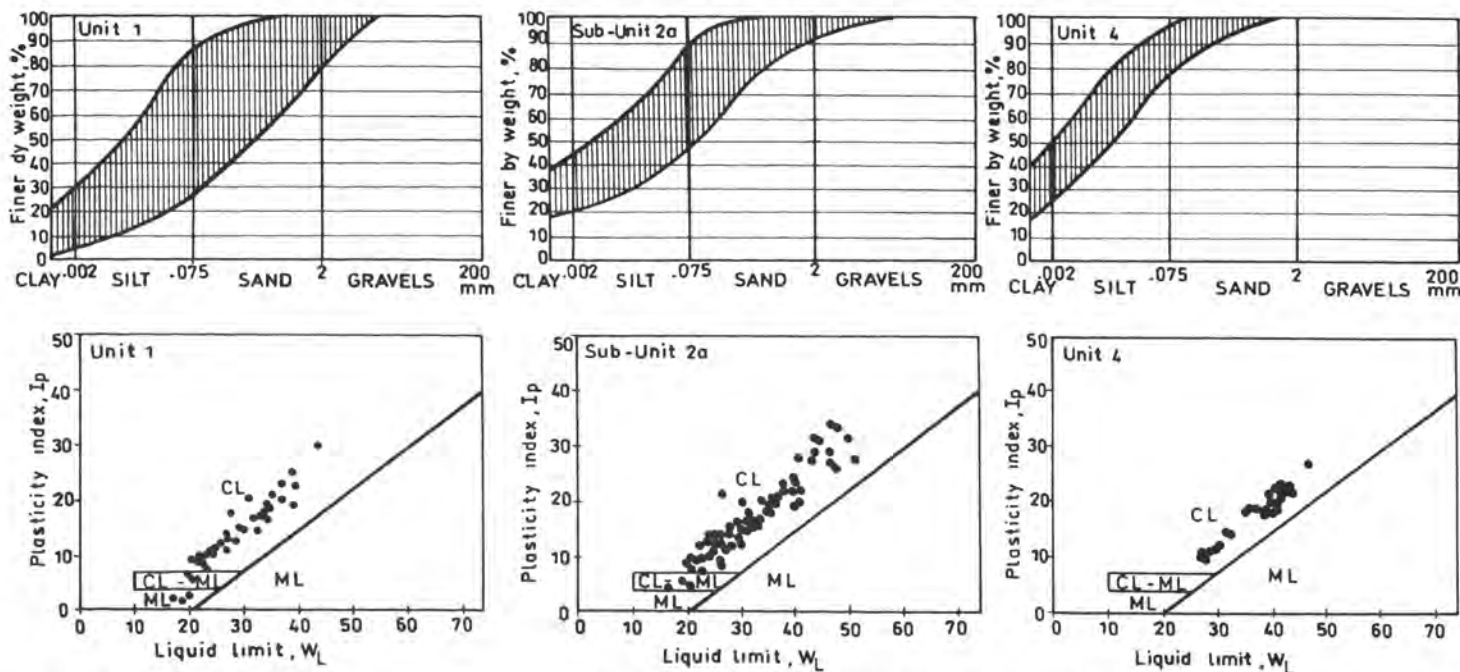
Sub-unit 2a: brownish-red to brownish-grey, medium to very stiff, sandy clays, with some gravels and pockets of sand and silt. These deposits are mainly classified as clays of low to high plasticity, CL or CH ($W_L=16.4 - 51.6$ and $I_p=4.4 - 34.0$) and silty clays or clayey silts (CL, ML). In Figure 3 the envelope of grain size distribution curves and the plasticity chart are given. The mean value of their unconfined compressive strength, q_u , is 200 kPa, while that of $N_{SPT}=36$ blows/30 cm penetration.

Sub-unit 2c: grey to brownish-grey clays with thin intercalations of sands and silts, of a total thickness up to 17 m. They are classified as clays of low plasticity, CL, ($W_L=17.3 - 43.8$, $I_p=5.3 - 27.5$) and as clayey silts (CL-ML). The mean value of the unconfined compressive strength is 136 kPa and that of $N_{SPT}=59$ blows/30 cm penetration.

Fig. 3. Grain size distribution curves and plasticity charts of the geotechnical units

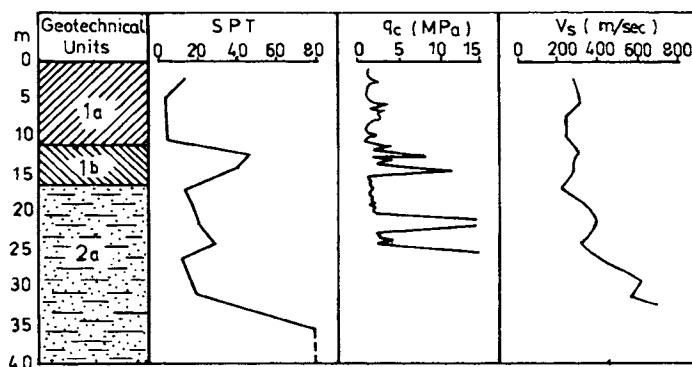
The geological section shown in Figure 4 illustrates the sequence of the geotechnical units described above and the normal fault which has caused the relative displacement of the layers (the thrust is up to about 10 metres) and the recent surface rupture. A typical geotechnical profile which includes only the upper units 1a, 1b and 2a, is shown in Figure 5. In this the results of SPT, CPT and Cross-Hole testing up to a depth of about 40 m are shown.

Fig. 5. Typical geotechnical profile of the upper geotechnical units
