## Change of Waterline and Water Depth at Izmit Bay Due to 1999 Kocaeli Earthquake in Turkey

# CHANGE OF WATERLINE AND WATER DEPTH AT IZMIT BAY DUE TO 1999 KOCAELI EARTHQUAKE IN TURKEY

## ABSTRACT

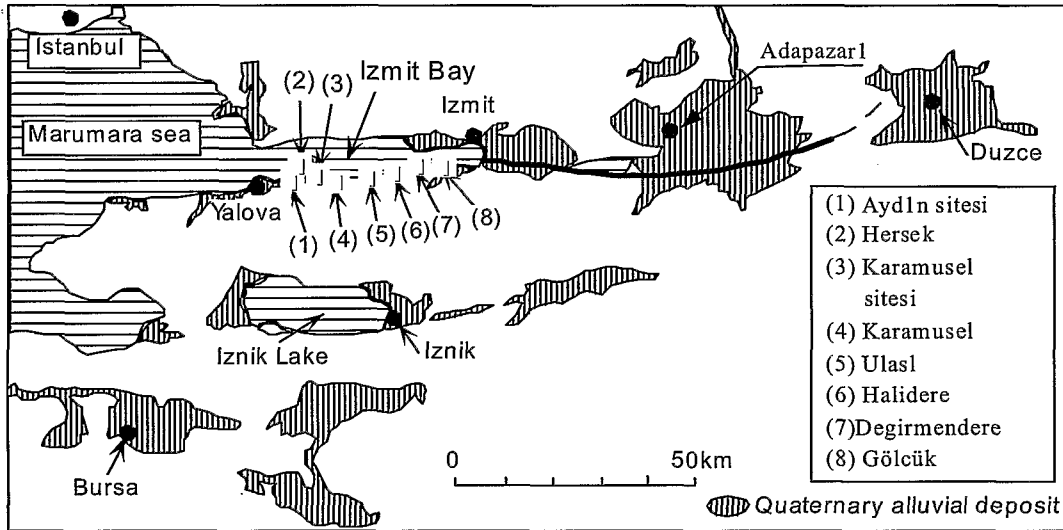
Fig. 1. Location of the sites and fault line in the severely shaken area at the time of the Kocaeli Earthquake

It is known that the rupture of the fault in the 1999 Kocaeli Earthquake was right-lateral type and ran along an east-west alignment as shown in Figure 1. It appeared on the surface about 30km west of Duzce City and disappeared into the sea in the south of Izmit City. It ran along the coastline and reached to the northward of Yalova City. On the Kocaeli Earthquake, severe geotechnical damages were frequently observed in the southern coast part of the Izmit Bay. They were ground subsidence and loss of coastal land in addition to the structural damage caused by inertia force. This section describes the typical and characteristic damages, which occurred at the cities along the southern coast of Izmit Bay during 1999 Kocaeli Earthquake, from west to east one by one.

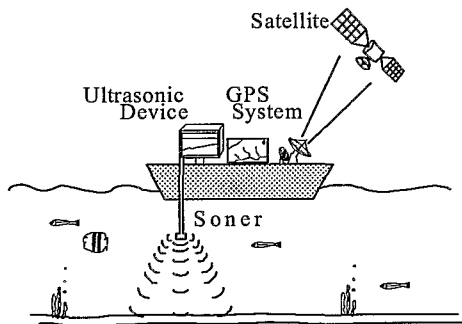
Following the earthquake, depth of the seabed water was measured along a cross section perpendicular to the coastline by means of an ultrasonic device illustrated in Figure 3. Location of the measurement is shown in Figure 2. Exact distance from the shore was monitored by means of Global Positioning System (GPS). The outcome of the measurement is

Fig. 3. Image of water depth measurement device
