LIQUEFACTION AND GROUND FAILURES DURING THE 1998 ADANA (TURKEY) EARTHQUAKE AND LAB MODEL SIMULATIONS

Korhan Adalier

ABSTRACT

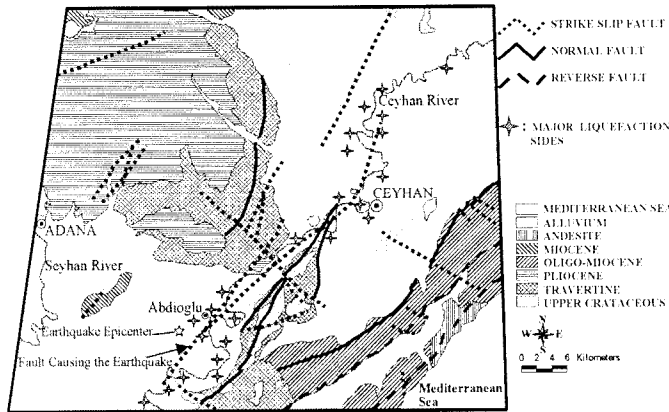
The earthquake epicenter was located on thick Quaternary alluvial soils covering most of the area where the earthquake was strongly felt (Fig. 1). In the areas along the Ceyhan River, where widespread liquefaction was observed, the ground was typically formed by young alluvial soils of mainly silty clay, overlying silty fine sands with occasional gravel. According to the Turkish Geological Survey, the thickness of the sediments in this area varies from 50 to 250 m with shear wave velocities typically ranging from 100 to 300 m/s.

Fig. 1 Main geological and tectonic elements of the earthquake region (modified after ERD 1998) along with the major liquefaction sites observed after 1998 Adana earthquake.

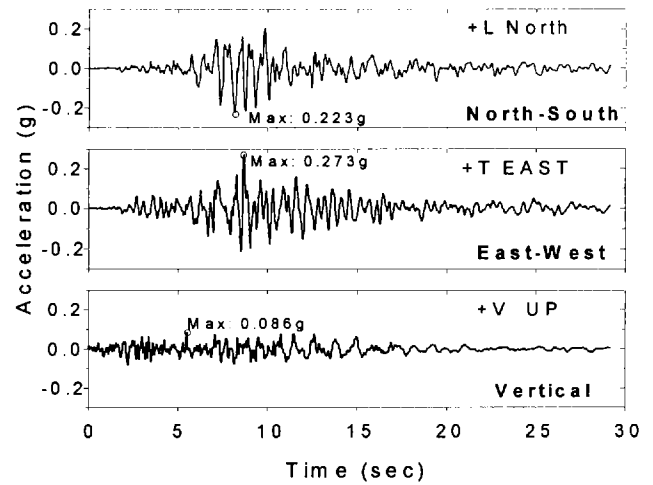
Fig. 2 Acceleration time histories recorded at Ceyhan Station.
