The Behavior of Retaining Walls Under 1999 Chi-Chi Earthquake

THE BEHAVIOR OF RETAINING WALLS UNDER 1999 CHI-CHI EARTHQUAKE

Yung-Show Fang, Tsang-Jiang Chen, Yu-Chih Yang and Cheng-Chieh Tang
National Chiao Tung University
Hsinchu, Taiwan, ROC, 30010

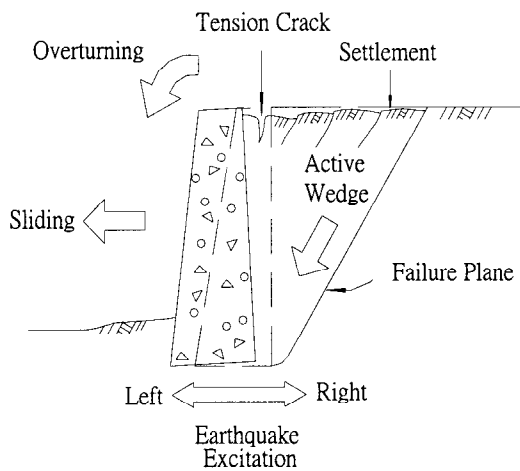
Fig. 2. Sliding and overturning of wall due to earthquake.

The behavior of a retaining wall under horizontal acceleration a_h can be explained with the help of Fig. 2. As the ground shakes from left to right, the dynamic earth pressure and inertia force of the wall would act from right to left. If the resistance at the base of the wall is not sufficient to defy the thrust, active wall movement would occur. However, if the direction of ground shaking is reversed, the wall is thrown from left to right. Due to the existence of the backfill, passive earth pressure would act between the wall and the soil, and only partial active wall-movement could be recovered. If the wall moves outward a small amount due to each cycle of a_h , with increasing effective cycles, the wall would gradually move away from the backfill. As indicated in Fig. 2, with the outward movement of the wall, the soil wedge behind the wall would slide down along the failure plane, causing settlement and tension cracks on the backfill. In the following sections, typical modes of wall failure due to the Chi-Chi earthquake are introduced. Locations of the sites investigated and seismographs are indicated in Fig. 1.

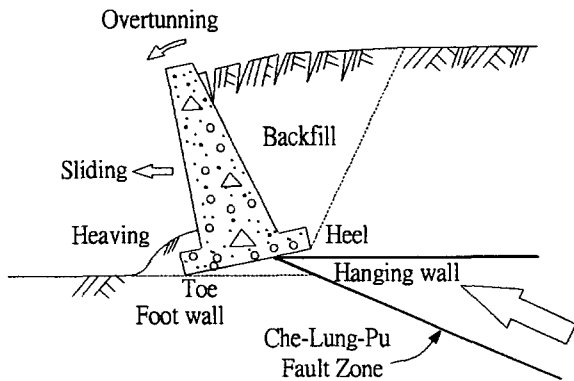
Fig. 10. Fault rupture and wall movement.

top of an active fault is illustrated in Fig. 10. During the earthquake, the vertical displacement of the hanging-wall uplifts the heel, causing the wall to overturn. Horizontal displacement of the hanging-wall pushes the wall to slide, and the soil in front of the toe to heave. Sliding and overturning of the wall would induce settlement and crack on the backfill.

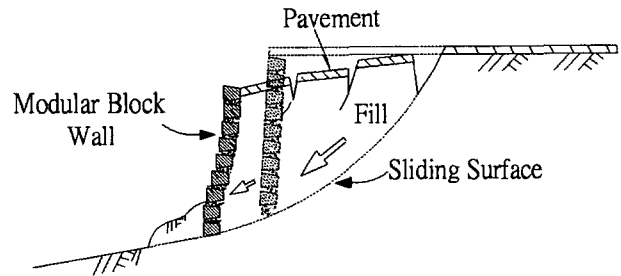
Fig. 12. Modular block wall and sliding surface.

Fig. 12 illustrates the downhill sliding of a modular-block retaining wall. The wall built on a slope lost its overall stability and failed during the earthquake. Fig. 13 shows the failure of a modular-block wall located at the parking lot of the Lalu Resort (Site 5). The 2.0 m-high wall was built on a slope. The wall slid down along the slope and a rotational sliding surface formed in the soils behind the wall. Fig. 14
