Study of Liquefaction Damages of Quay-Walls and Breakwaters During Kobe Earthquake

STUDY OF LIQUEFACTION DAMAGES OF QUAY-WALLS AND BREAKWATERS DURING KOBE EARTHQUAKE

Yasuo Tanaka
RCUSS, Kobe
University, Kobe,
Japan 657-8501

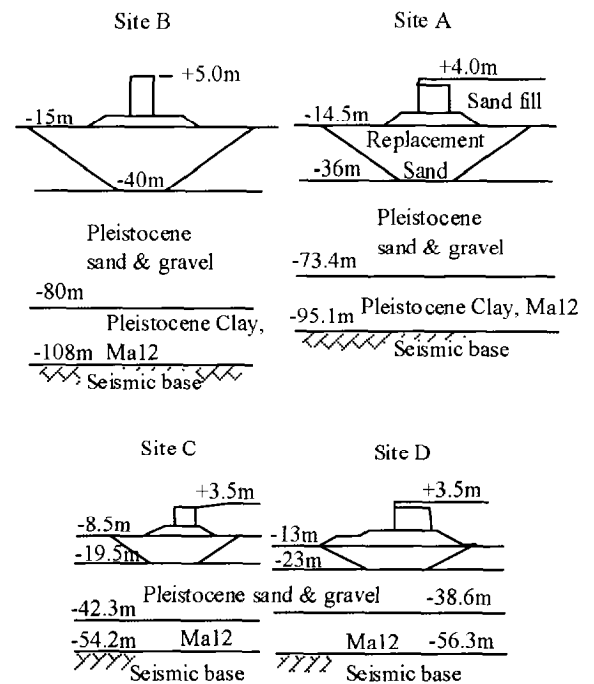
Fig. 13 Modeling of geotechnical conditions at four sites of liquefaction analysis.

Fig.13 shows the geotechnical conditions of seabed at the four locations. Based on these geotechnical profiles, the finite element mesh was constructed for the liquefaction analysis by using a computer program of FLIP as developed by Iai (1992). A typical FEM mesh for liquefaction analysis is shown in Fig. 14. At the base of Ma12 clay, the acceleration record that was measured at Kobe Port Island at the bottom of same stratum was applied. Only adjustment was to change the maximum acceleration according to the value obtained from the attenuation equation (1) as discussed earlier. Table 2 lists the computed results and the actual measurements of both
