A Field Study and Dynamic Finite Element Analysis of Railway Retaining Structures Damaged by the Hyogoken-Nambu Earthquake (1995)

A FIELD STUDY AND DYNAMIC FINITE ELEMENT ANALYSIS OF RAILWAY RETAINING STRUCTURES DAMAGED BY THE HYGOKEN-NAMBU EARTHQUAKE (1995)

The seismic damage to embankments and retaining walls caused by the Hyogoken-nambu Earthquake (1995) was reviewed, rather focusing on railway structures. Nearly eight kilometers of damaged retaining structures were divided into five structural types, such as gravity-type walls, leaning-type walls, embankments, geo-textile-reinforced earth walls, and reinforced concrete walls, and into three categories of the damage, such as collapse, tilt, and crack. It was observed that the damage to gravity-type and leaning-type walls was greater than that to embankments, geo-textile-reinforced earth walls, and reinforced concrete walls, when they are lower than five meters. But some leaning-type walls higher than seven meters remained un-collapsed. In a smaller limited section, damage analyses of stone masonry walls of gravity type were carried out including undamaged ones. The percentage of heavy damage to stone masonry walls with slopes

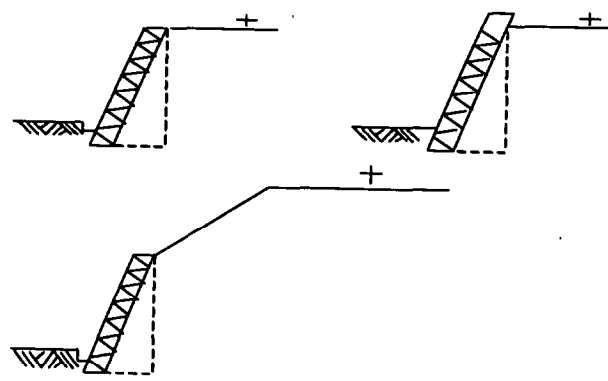
Fig.5. Three structures compared: stone masonry wall (above left), stone masonry wall with protruded crown (above right), and stone masonry wall with slope (below)

In a smaller limited section, all stone masonry retaining structures including non-damaged ones were analyzed, and the damage ratio was calculated. The retaining structures in this section were composed from stone masonry wall, stone masonry wall with protruded crown, and stone masonry wall with slope as shown in Fig. 5. Figure 6 shows that the damage ratio of stone masonry wall with slope is twice greater than that without slope. The ratio of collapse in stone masonry wall with protruded crown is nearly twice greater than stone masonry wall. But even if tilted structures are included to the collapsed, the damage ratio with protruded crown does not change so much. From this figure, it is suggested that in the

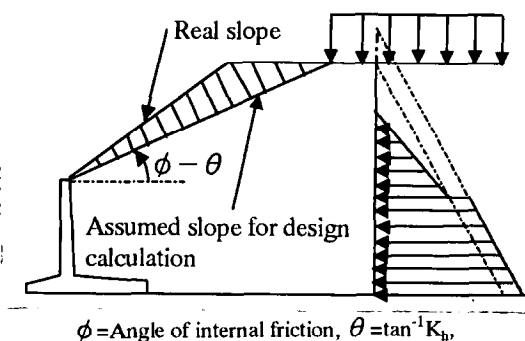
Fig. 7. Assumption of slope for applied aseismic design of retaining wall with slope

applied aseismic design of retaining walls with slope, seismic active earth pressure can be estimated to be too small. Figure 7 shows the assumed slope for calculating seismic earth pressure in the applied seismic design. The shaded triangular soil mass over the assumed slope is considered to slide during earthquake, and neglected in the calculation of seismic earth pressure. This underestimation of seismic earth pressure may contribute to the large ratio of collapse. Moreover, some other factors such as slope protection works might accelerate the damage.

Aseismic design codes for railway structures were revised in 1999, and the concept of sliding soil mass in the calculation of seismic active earth pressure to retaining walls with slope was abandoned. The necessity of this revision coincides with the findings presented in this paper.

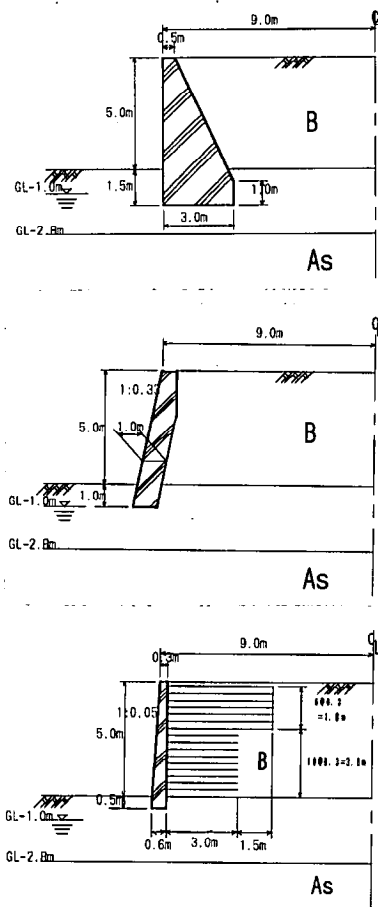
Fig.9. Modeled sections of retaining walls: gravity-type wall (top), leaning-type wall (middle), geo-textile reinforced earth wall (bottom)

Time history response analyses were conducted for a gravity-type wall, a leaning-type wall, and a GRW, each of which has five meters in height, as shown in Fig.9 (Kasai *et al* 1998).

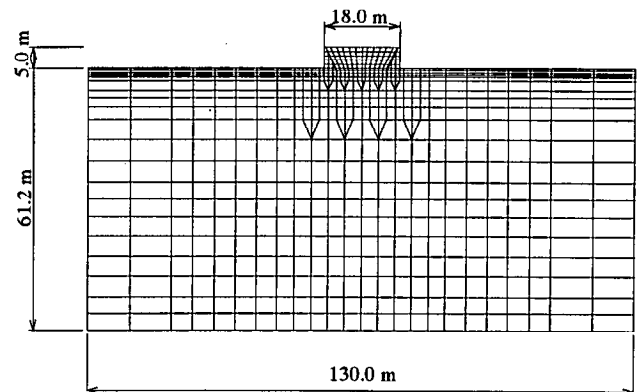
Fig. 10. Finite element model (gravity-type wall)

The two-dimensional finite element model has depth of 61.2 meters and extends 56 meters from the wall location to both boundaries as shown in Fig. 10. The lower boundary faces bedrock. Non-linearity of ground stiffness, de-lamination or sliding at the contact face between backfill and wall is considered in the calculation. Soil properties were obtained at the damaged site of the gravity-type wall. As the aim of the analyses is to find some difference in seismic response among these three retaining structures, the same soil properties are used for analyses. The shear wave velocity is 150 meters per second in the backfill, and 100-540 meters per second in bearing layer increasing from surface to bedrock. Backfill soil and the top five-meters layer of the ground follow the elasto-plastic Mohr-Coulomb's criterion. The angle of internal friction for the cohesionless backfill and the top layer are 42.0 and 35.8 degrees respectively. The soils below this layer and concrete walls are modeled as linear materials. Geo-textile material is modeled as non-symmetrical bi-linear spring that resists tension force only.

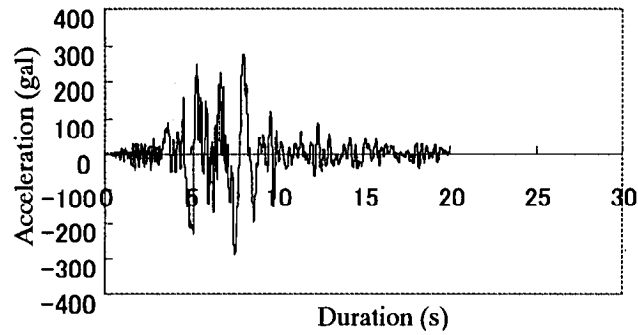
Fig.11. Waveform in acceleration

In order to obtain an input waveform, a pre-calculation was performed. The waveform of earthquake ground motion detected at the location of Kobe University on bedrock surface during the 1995 Hyogoken-Nambu earthquake was applied on the bottom viscous boundary with half space, and a quasi-linear analysis was conducted. The resulting waveform at the upper side of the boundary is used for the present finite element analysis. Figure 11 is the waveform thus obtained.

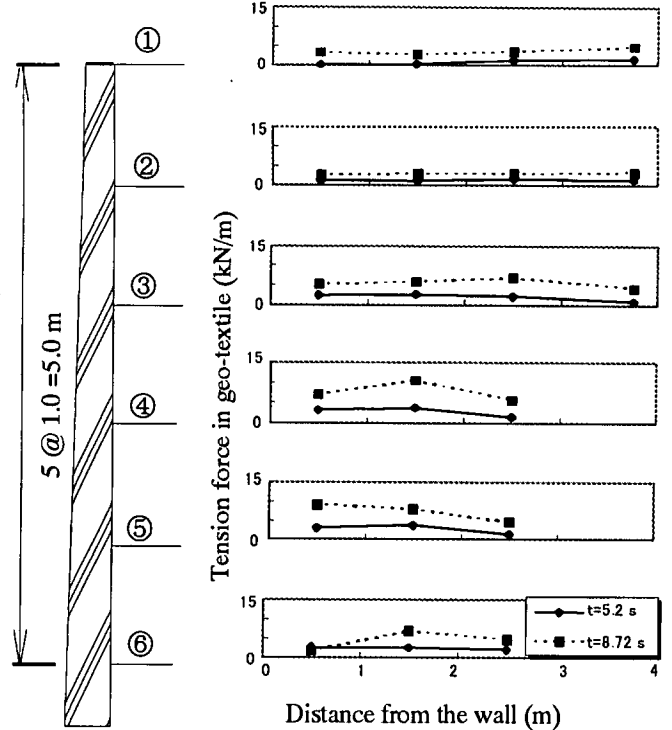
Fig.17. Distribution of tension force in the geo-textile

whether the wall is moving right or left. Therefore, the tension force is not directly caused by the horizontal movement of the wall, but by the settlement of backfill. This tension force suppresses sliding of the wall. Figure 17 shows the distribution of tension force when the whole structure is moving from the left to the right.
