The Loma Prieta Earthquake: Implications of Structural Damage

S.A. Mahin

Professor of Civil Engineering, University of California, Berkeley

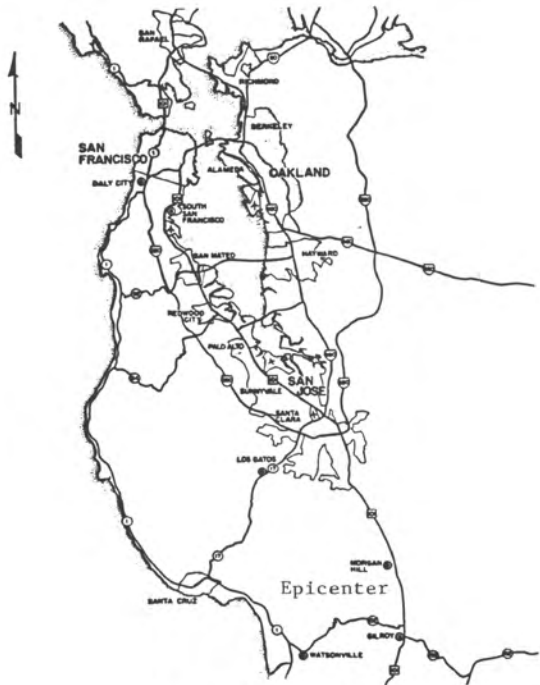
Fig. 1 Area Map

Particularly severe damages were observed the epicentral region. The older downtown regions of Santa Cruz, Watsonville and Los Gatos (Fig. 1) were hard hit as were individual homes in the Santa Cruz mountain. Today, several square blocks in Watsonville and Santa Cruz have been demolished and stand vacant as silent reminders of the devastation caused by this earthquake. Highway and building structures were also damaged in localized regions throughout the greater San Francisco Bay Area. Significant damages were also observed in lifeline facilities (water pipelines and treatment plants in particular), telecommunication facilities, and in the architectural and mechanical components and contents of buildings. The total cost of the physical damages to structures is estimated by FEMA to be in excess of \$ 6.7 billion. However, the total cost of the earthquake considering the loss in

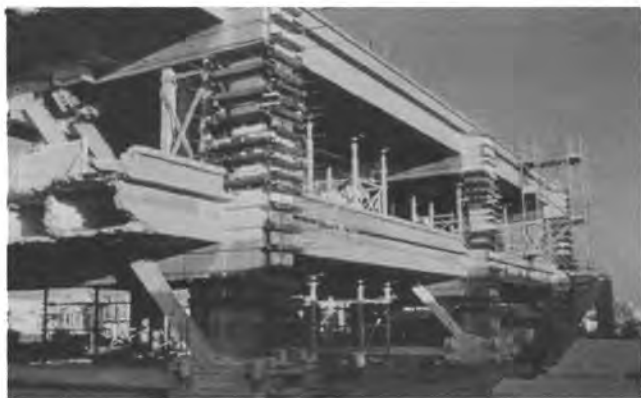
Fig. 26 Cypress Street Test Structure

The need for rapid retrofit of the damaged double deck freeways in San Francisco led to a series of field tests on undamaged portions of the Cypress Street Viaduct. These tests consisted of forced vibration studies to determine the dynamic characteristics of the structure and static lateral load tests in the transverse direction to determine force and deformation capacities. Tests were performed on a relatively unmodified segment of the structure, as well as on the same segment after it was retrofit. The three bents used in the tests are shown in Fig. 26. The results of these tests have been reported by Moehle and Mahin (1990).

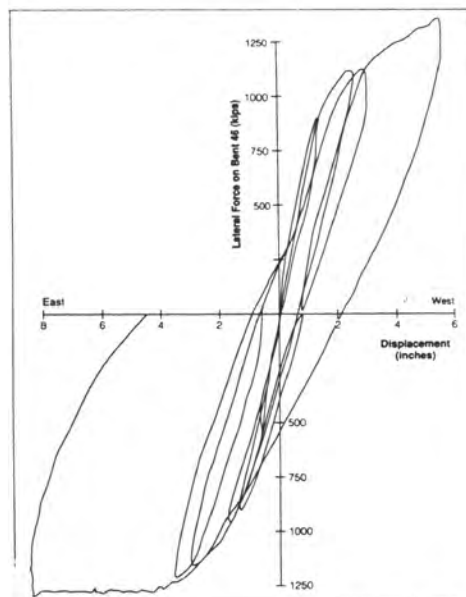
Fig. 27 Hysteretic Plots for Retrofit Viaduct
