1991 - Second International Conference on
Recent Advances in Geotechnical Earthquake
Engineering & Soil Dynamics

Liquefaction of Soils in the 1989 Loma Prieta Earthquake

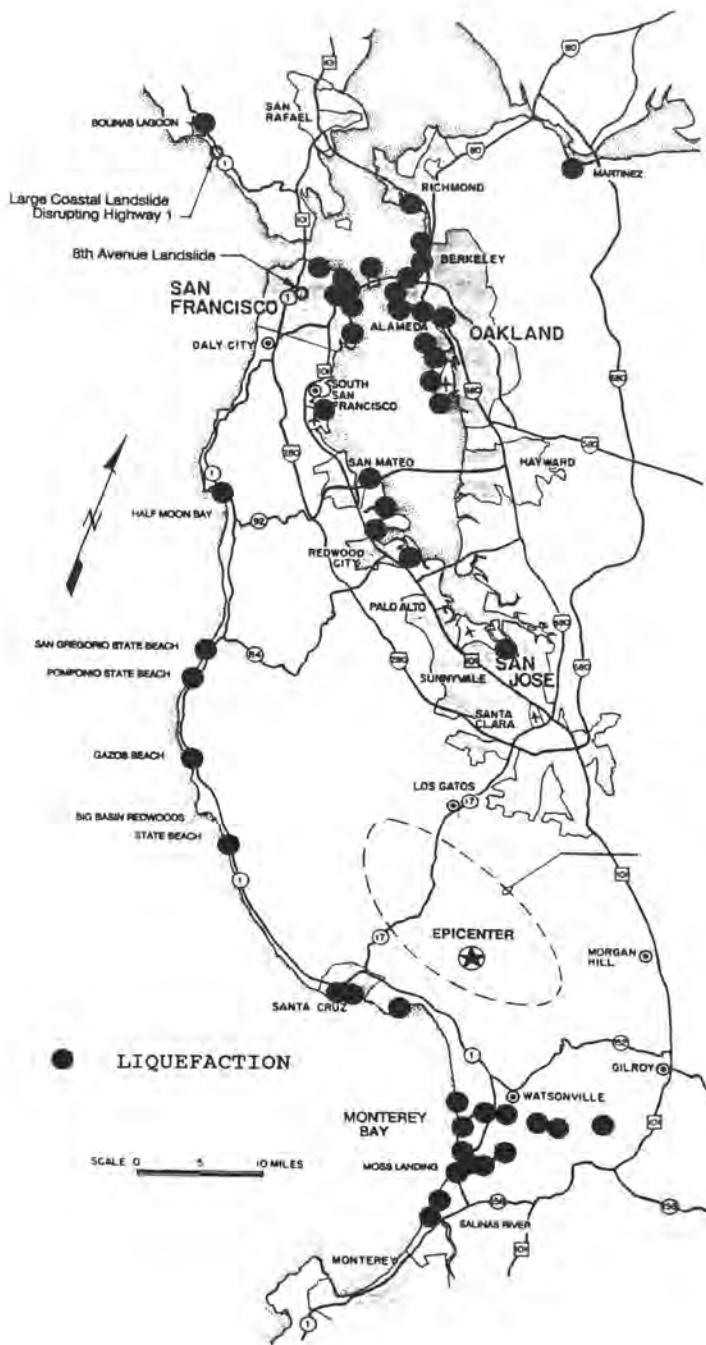
Fig. 1 Map of Affected Region Showing Sites of Soil Liquefaction

Soil liquefaction affected a widespread area during the Loma Prieta Earthquake, as shown in Figure 1. In addition to the well-publicized liquefaction-induced damage which occurred in the Marina District in northern San Francisco, considerable damage associated with liquefaction also occurred in areas of eastern San Francisco, on Treasure Island at the center of San Francisco Bay, and along the east San Francisco Bay shore in Oakland, Emeryville, and Alameda, as well as farther south along the Pacific coast in the Santa Cruz and central Monterey Bay regions. The two most northern sites found to show evidence of liquefaction were: (a) a sand soil adjacent to a pile supporting a pier on the south shore of Suisun Bay at Martinez, and (b) a series of sand boils observed and photographed in a lagoon at Bolinas, on the Marin Peninsula, with associated lateral spreading of the adjacent beach.

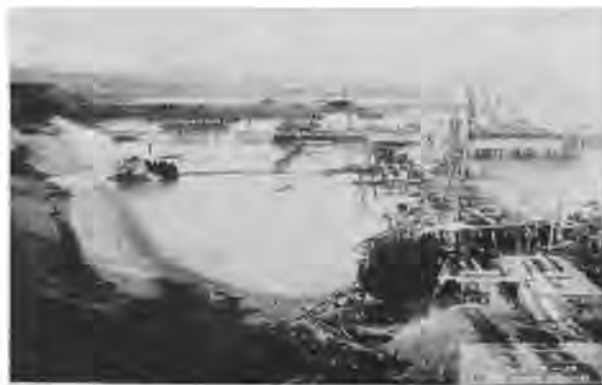
Fig. 2 View of the Marina District Looking West from Fort Mason in January of 1910. [Photo courtesy of the San Francisco Maritime Nat'l. Historic Park]

fill process typically results in a loose saturated fill which is vulnerable to potential soil liquefaction during earthquake shaking, and the Marina District was no exception to this. Figure 2 is a photograph of the Marina District viewed from Fort Mason, immediately to the east. Taken in January of 1910, this photograph shows conditions as they existed at an early stage of the hydraulic fill placement. Note the seawall at the right of the photograph, and the small barge and floating pipeline in the bay depositing hydraulic fill.

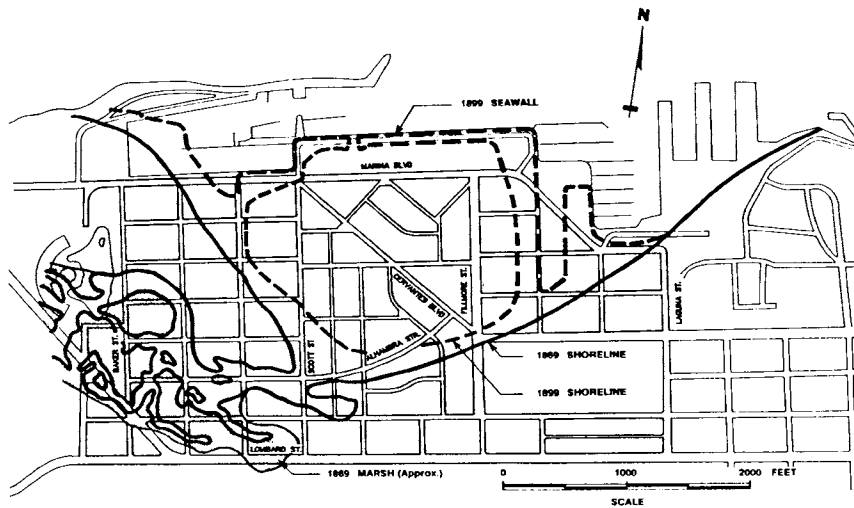
Fig. 3 Map of the Marina District in San Francisco Showing the Approximate Locations of the Earlier Coastlines and Marshes

Figure 3 is a map of the Marina District as it existed at the time of the Loma Prieta Earthquake of October 17, 1989. Super-imposed on this is the old 1869 shoreline and the associated marshy deposits occurring at the south-west limit of the small embayment which existed at that time. Much of the existing Marina District consists of landfill placed since 1869, both to reclaim the marshes and to infill the small baylet. This fill, which was placed in two general stages or periods, is composed primarily of uncompacted fine sands and silty sands. It was primarily within these loose, saturated cohesionless soils that widespread liquefaction occurred.

The first stage of fill placement occurred between about 1870 and the end of the 19th century, and consisted primarily of placement of loosely dumped fill around the perimeter of the small Marina bay and in the perimeter marshes. Most of this fill was dune sand taken from onshore dune deposits occurring adjacent to the southeast edge of the Marina District. A seawall was also constructed to provide a protected harbor. The heavy dashed line in Figure 3 shows the resulting coastline and seawall as they existed at the end of the 19th century.

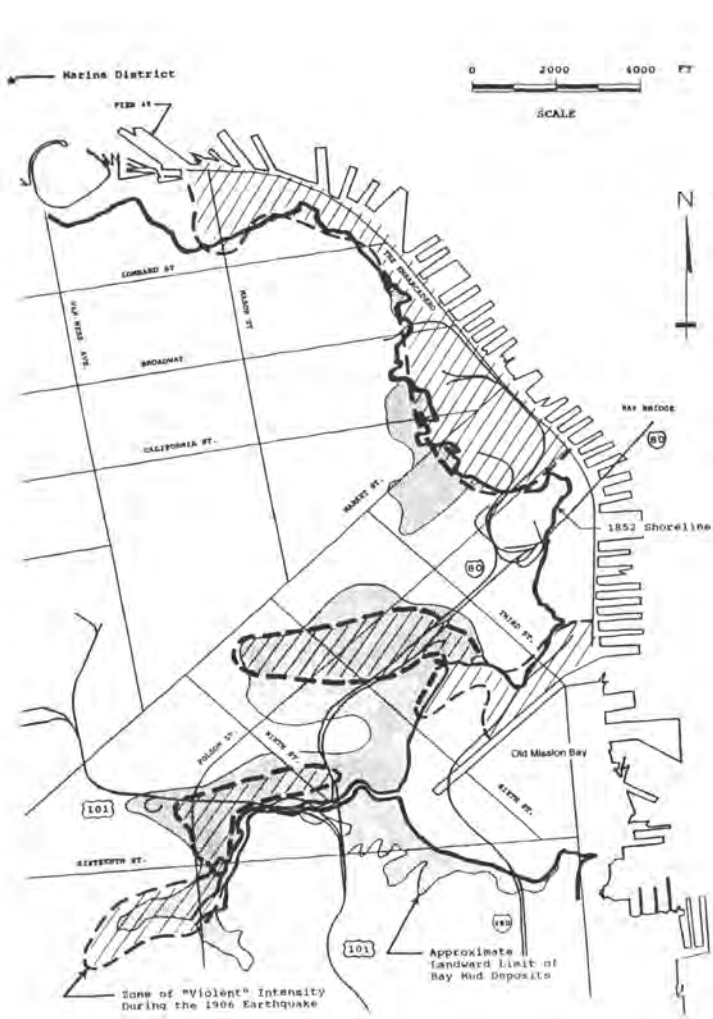
Fig. 7 Map of Eastern San Francisco Showing the Region Most Intensively Damaged During the 1906 Earthquake (Before the Post-Earthquake Fire), and the Historic Coastline and Marshes of 1852

Figure 7 presents a map of eastern San Francisco, showing the old historic shoreline (the heavy solid line) and the bay marshes (dark zones) which extended well inland prior to extensive fill placement during the latter half of the last century. Superimposed on this map are three zones outlined with dashed lines and shaded with cross-hatching; these were the regions of heaviest (pre-fire) damage intensity during the 1906 San Francisco Earthquake. This heavy damage intensity in 1906 was the result of both: (a) site effects on strong shaking, as a result of the soft clays underlying the surface fills, and (b) massive and widespread soil liquefaction inducing bearing failures, differential settlements and lateral spreading.

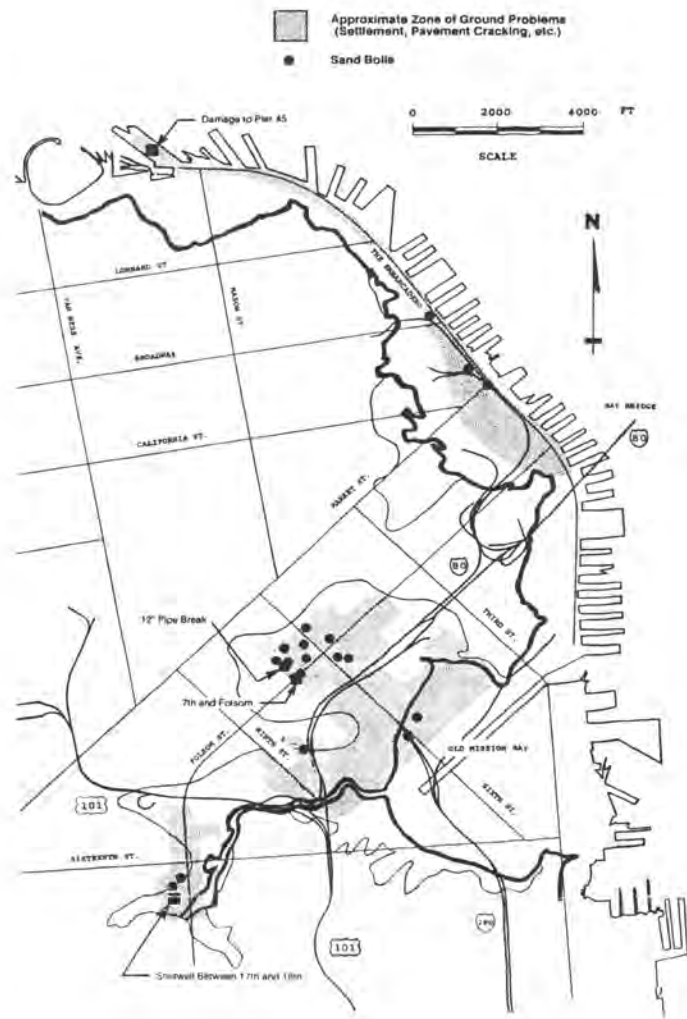
Fig. 8 Apparent Extent of Soil Liquefaction in San Francisco's Embarcadero and Old Mission Bay Regions on October 17, 1989

Despite the relatively moderate levels and short duration of shaking produced in these regions by the Loma Prieta Earthquake of October 17, 1989, soil liquefaction occurred again throughout much of these same areas, as shown in Figure 8. Much of this liquefaction was of moderate severity, representing ground softening and minor settlements producing cracking of pavements and utility breaks, but a number of buildings were also destroyed or damaged beyond repair as a direct result of liquefaction in these areas. In one 15-block area surrounding 6th and Folsom Streets, more than 50% of the structures were either significantly damaged or condemned, representing an overall level of damage not unlike that of the central Marina District.

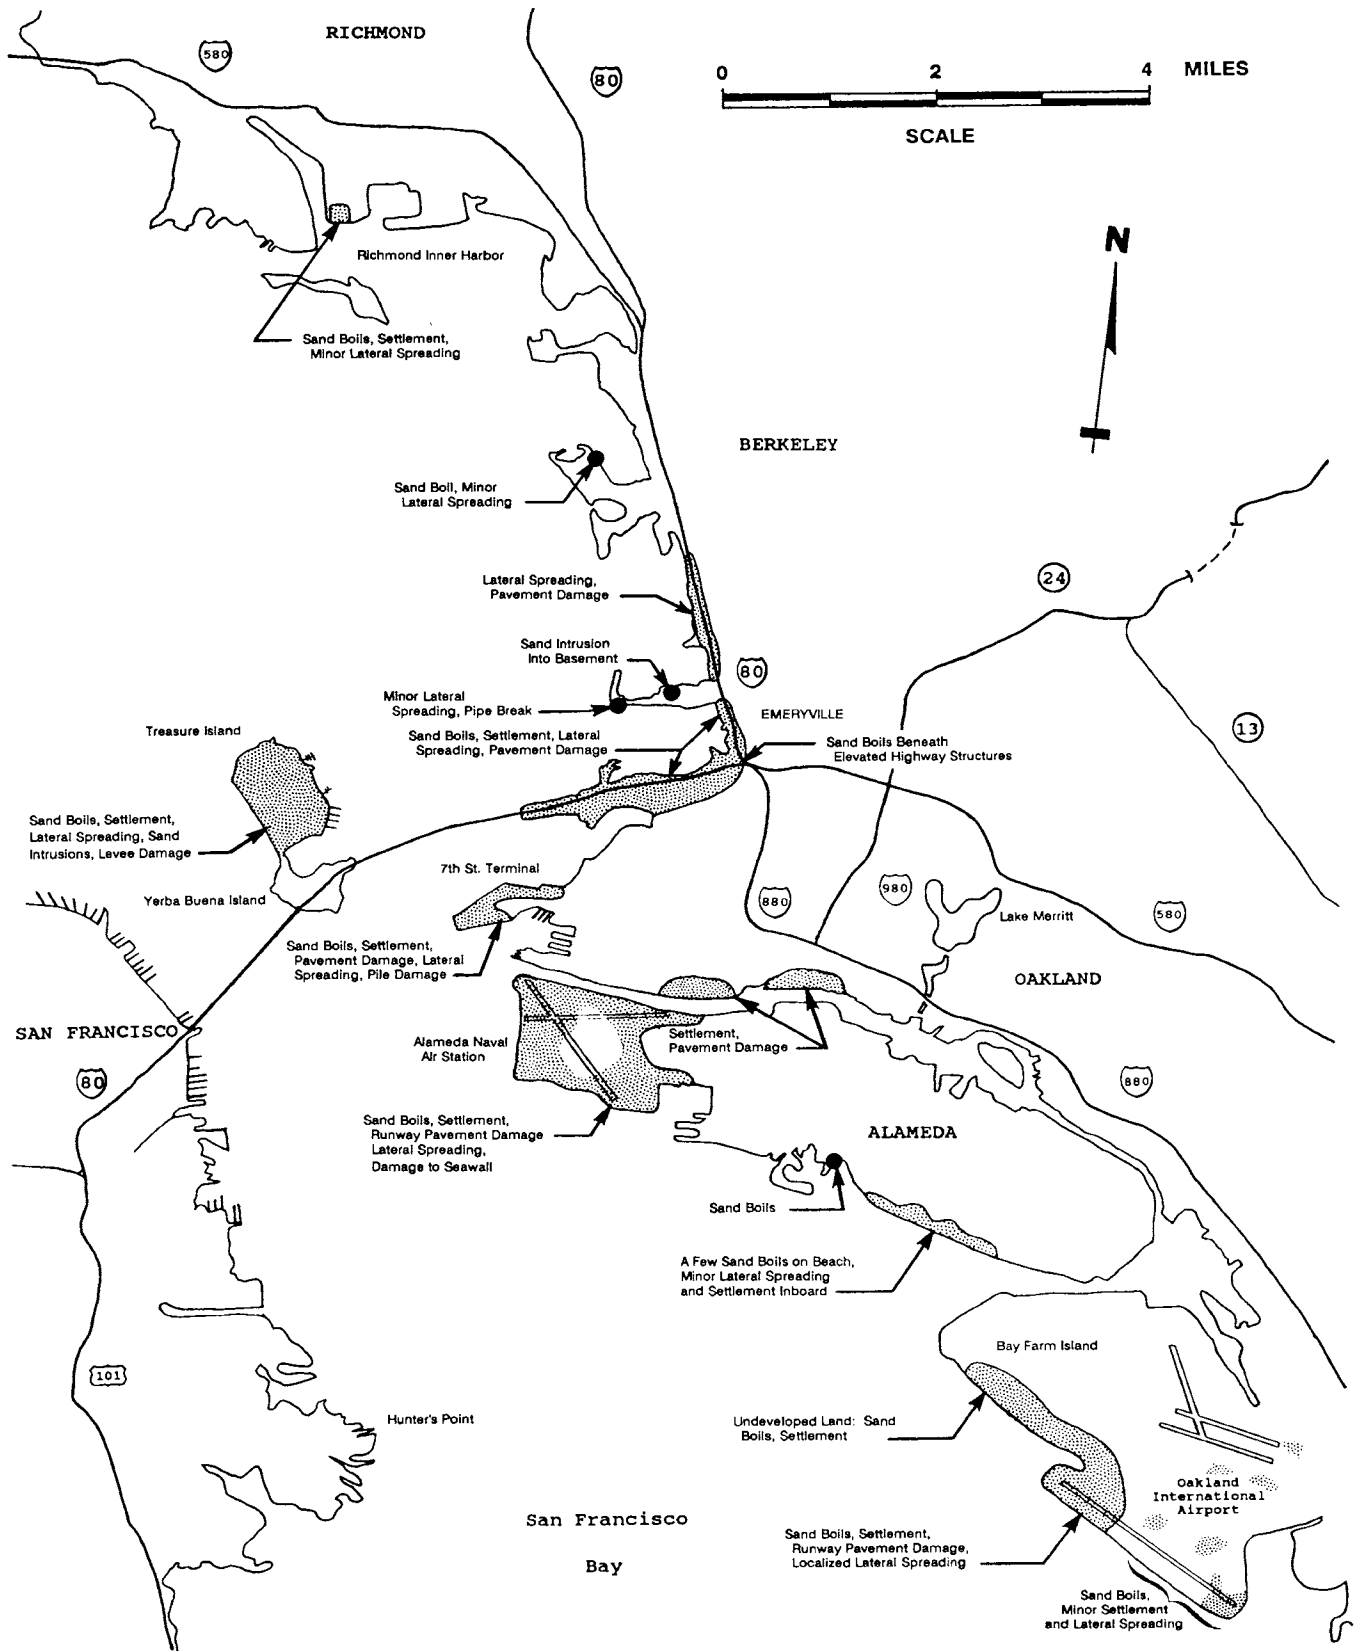
Fig. 12 Map of Eastern and Central San Francisco Bay Area Showing Sites Damaged by Soil Liquefaction

The central and east San Francisco Bayshore areas also suffered considerable damage due to liquefaction, as shown in Figure 12. Widespread liquefaction occurred over most of Treasure Island, a man-made island constructed by placing sandy hydraulic fill within rock containment dikes at the center of San Francisco Bay. In addition to producing numerous sand boils and large ponds, and damaging both structures and utilities, this liquefaction caused lateral movements and settlements of many of the levees surrounding this island. Among the most potentially ominous liquefaction-related features observed in the Loma Prieta Earthquake, these movements were indicative of the onset of liquefaction around most of the island perimeter. Studies are currently underway to evaluate the depths to which this liquefaction occurred, and the likelihood of more extensive liquefaction in stronger or more near-field future events producing full failure of the perimeter containment dikes.

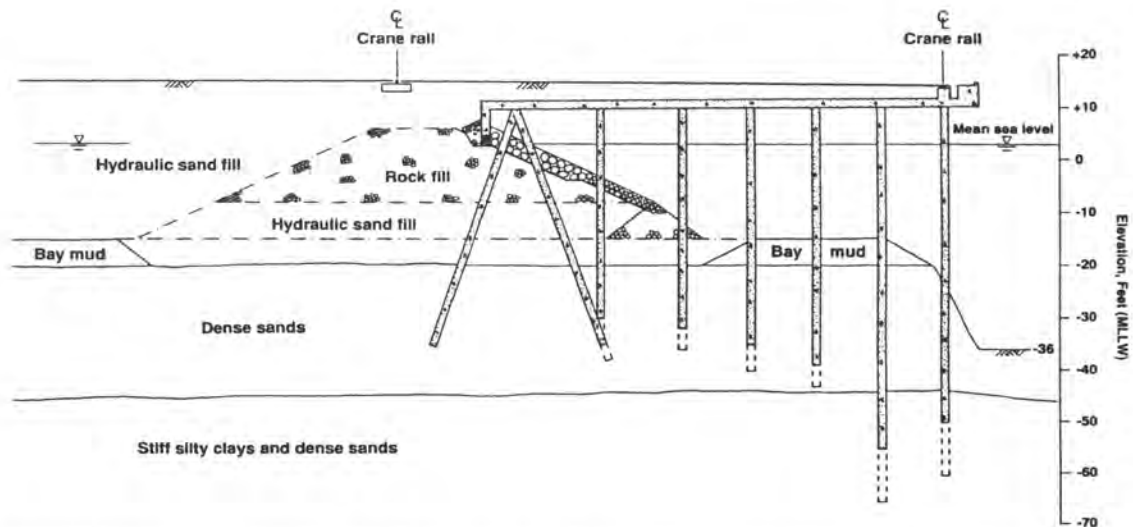
Fig. 13 Cross-Section Through the Edge of the Fill, Dike and Wharf at the North Side of the 7th Street Terminal, Port of Oakland [Benuska et al., 1990]

Immediately south of the Bay Bridge, extensive damage due to liquefaction occurred at the main Port of Oakland container cargo docks at the 7th Street, Matson, APL and Howard Terminals. Settlements and lateral spreading (accompanied by sand boils) damaged pavements and rendered many of these facilities at least temporarily inoperational as a number of massive cranes were unable to traverse railroad tracks rendered uneven by ground displacements. Figure 13 shows a cross section through the edge of a typical wharf at the 7th Street Terminal. The liquefaction-damaged harbor terminals in Oakland all consisted of hydraulic sand fill, placed behind containment dikes, and underlain by deep bay alluvium deposits. The section shown in Figure 13 is fairly typical of these.

Most of the concrete wharves at the edges of the terminal fills were supported primarily on vertical concrete piles, but the inboard two rows of piles at the 7th Street terminal were battered to provide lateral load resistance as shown in Figure 13. These battered piles were massively damaged at their tips, as shown for example in Figure 14, illustrating the problems inherent in the use of battered piles to withstand seismic forces in an otherwise compliant soil system. Most of the terminal wharves at the affected Port facilities had at least one row of battered piles, and these consistently behaved poorly. The damaged piles (both battered and vertical) from the wharves supported on a combination of battered and vertical piles are currently being replaced by vertical piles only.

Several of the newer wharves are supported by vertical piles only (with no battered piles). This provides a more ductile and compliant system, and these wharves do not appear to have been damaged. As wharves combining battered and vertical pile support represent a common design, both on the west U.S. coast and world-wide, there is an important lesson here.

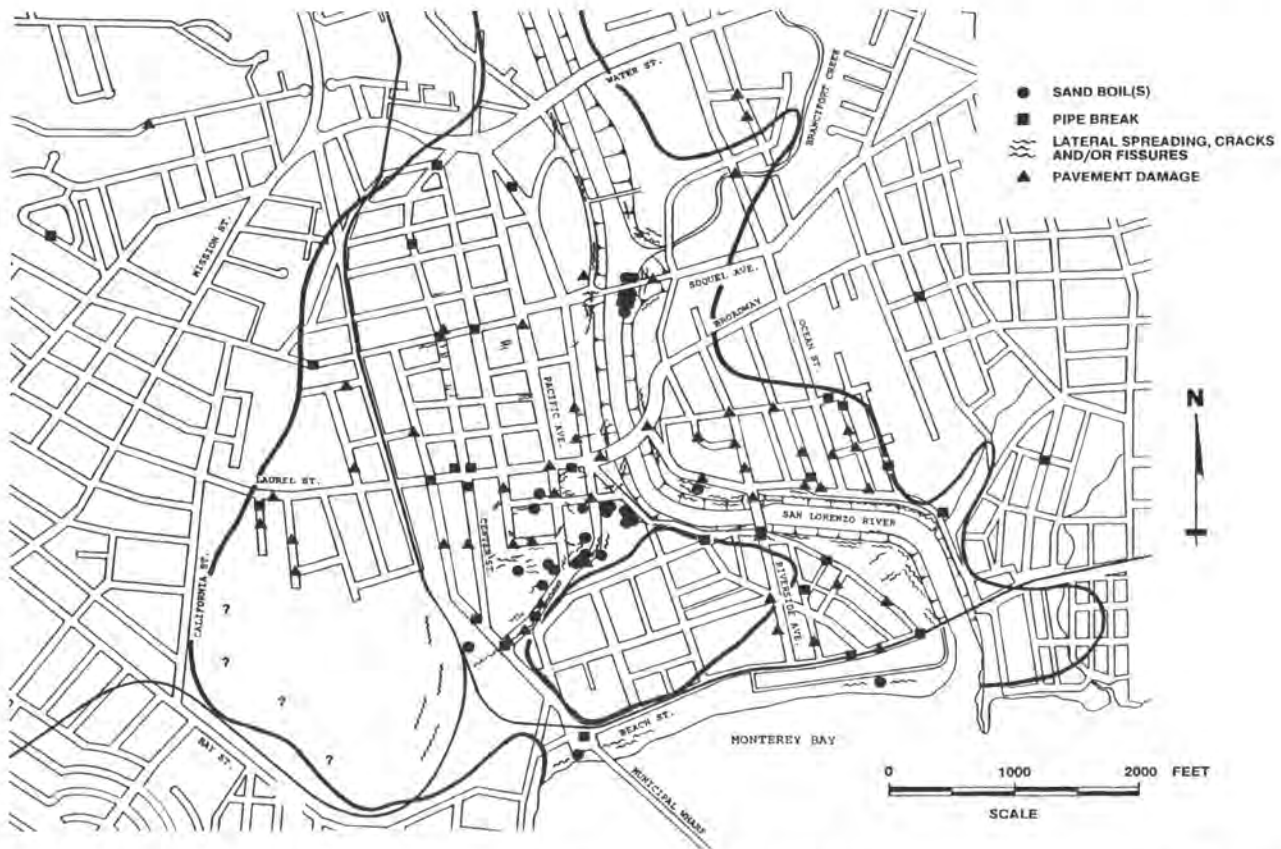
Fig. 17 Map of Central Santa Cruz Showing Major Liquefaction-Related Features After the Loma Prieta Earthquake of October 17, 1989

Considerable liquefaction (sand boils, settlement, cracking and buckling of pavements, lateral spreading, etc.) occurred in the City of Santa Cruz over an area roughly one kilometer wide and extending at least 1.5 kilometers inland at the mouth of the San Lorenzo River as shown in Figure 17. Considerable structural damage also occurred in this area, including the collapse of a major shopping mall. Additional lateral spreading and sand boils occurred, but caused little damage, immediately south at the edge of the Santa Cruz small craft harbor. The heavy solid line in Figure 17 outlines the zone predicted to be susceptible to soil liquefaction during moderate to strong levels of seismic shaking, based on studies (City of Santa Cruz, 1976) performed using SPT-based procedures (Seed and Idriss, 1971) to evaluate in-situ liquefaction resistance. As shown in Figure 17, these procedures well-defined the zone of liquefaction hazard.

A second and much smaller region, several hundred yards to the southeast of the zone shown in Figure 17, was also identified in the 1976 studies as vulnerable to liquefaction. This region, adjacent to the central yacht harbor, also suffered liquefaction during the Loma Prieta event.
