Lifeline and Geotechnical Aspects of the 1989 Loma Prieta Earthquake

SYNOPSIS: This paper provides an overview of areas in San Francisco which were affected by soil liquefaction and significant ground deformation as a result of the Loma Prieta earthquake. The distribution of pipeline system damage is examined, and comparisons are made between 1989 and 1906 patterns of water supply damage. Special attention is given to the Marina to illustrate how the natural site conditions and artificial fills contributed to soil liquefaction and buried pipeline damage of both the water and gas distribution networks. Finally, the liquefaction potentials of natural beach and sand bar deposits, land-tipped fill, and hydraulic fill are evaluated and compared.

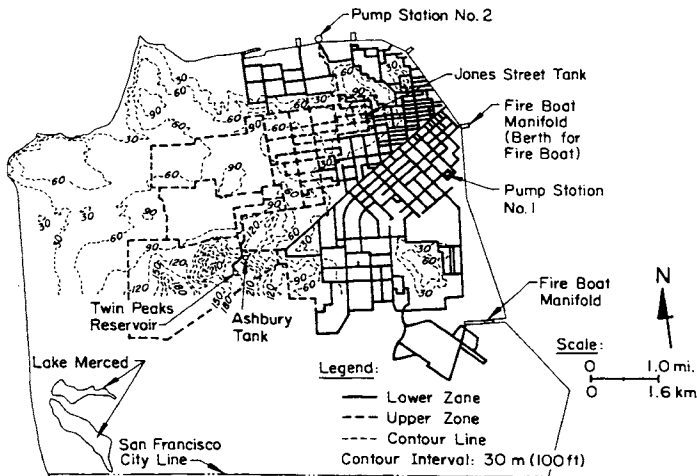
Figure 7. Plan View of AWSS

The AWSS is shown in Figure 7. It is separated into an upper and lower zone, each of which operates nominally at a pressure of about 1 MPa. There are approximately 200 km of buried pipe, with nominal diameters ranging from 250 - 500 mm. Nearly 160 km of the system is cast iron, to which about 40 km of ductile iron pipe have been added during the past several decades. The AWSS has no building connections or service lines; only fire hydrants can draw from the system.

Damage of the AWSS occurred as a broken 300-mm diameter main on 7th St., four broken hydrants, and two leaking joints. The approximate locations of these damaged components are illustrated in the figure. Hydrants were the most vulnerable parts of the system, with damage being concentrated at elbows. Typical construction involves a 200-mm diameter cast iron elbow affixed to a concrete thrust pad beneath the street surface hydrant. Damage at hydrant elbows occurred as 45° fractures centered on the elbows.

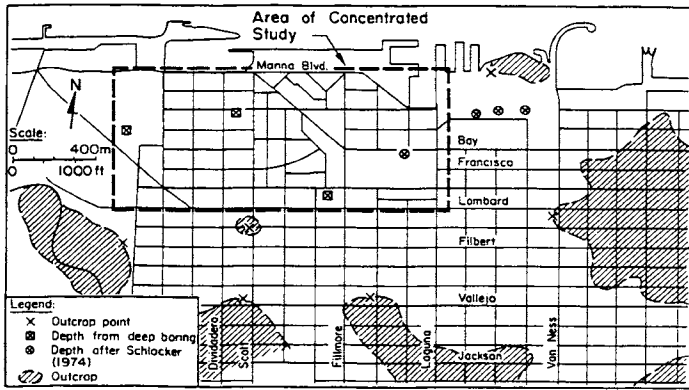
Figure 11. Plan View of Marina and Surrounding Neighborhoods

Figure 11 shows a plan view of the northern part of San Francisco which surrounds the Marina district. An area of concentrated study is illustrated, within which the most severe effects of the earthquake were experienced. The figure shows outcrops and soundings to bedrock mapped by Schlocker (1974). Only data which were confirmed as pertaining to Franciscan bedrock are shown. In addition, the locations of several other borings to bedrock are indicated.

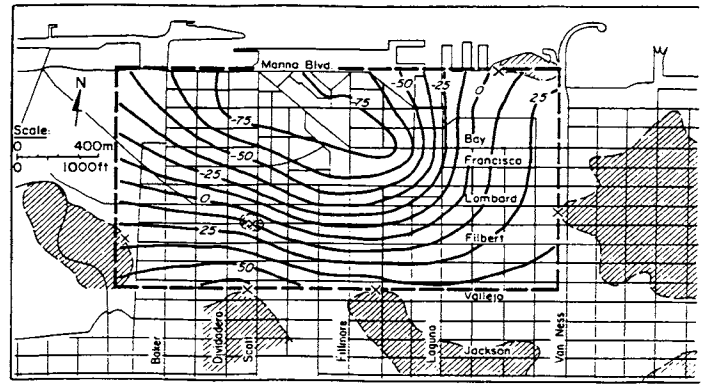
Figure 12. Bedrock Contours Beneath the Marina

On the basis of the boreholes and outcrops illustrated in Figure 11, contours of bedrock elevation were plotted and are displayed in Figure 12. The contours were developed with the computer program "Surfer" (Golden Software, Inc., 1985) using a procedure referred to as kriging, in which the contours are developed with minimal estimation variance from a statistical evaluation of the input data (e.g., Ripley, 1981). All elevations are referenced to the San Francisco zero datum.

Figure 12 indicates that the Marina is underlain by an oblong bedrock basin, with its long axis oriented in a northwest direction. This direction appears to be structurally controlled, being subparallel to anticlinal and synclinal axes mapped by Schlocker and coworkers in San Francisco (1974). The long axis also is subparallel to a zone of sheared rocks trending northwest beneath the Marina (Schlocker, 1974). The basin is over 75 m deep below Marina Blvd. adjacent to Marina Green and the yacht harbor.

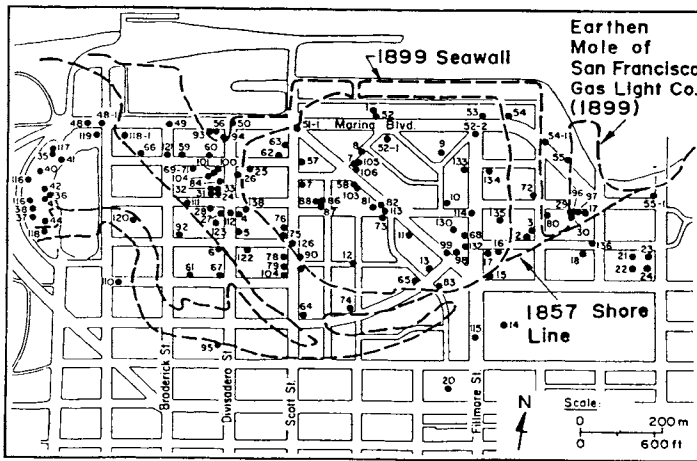
Figure 13. Soil Borings in the Marina

Figure 13 shows a plan view of selected soil borings performed for engineering projects in the Marina that preceded the Loma Prieta earthquake,

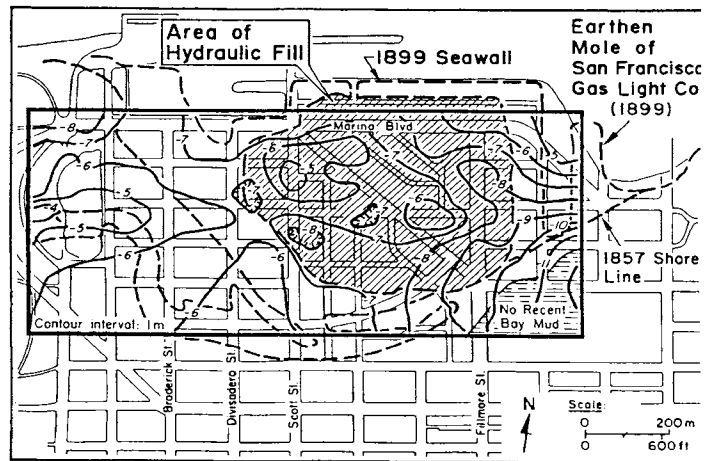
Figure 14. Contours of Equal Elevation for Top of Recent Bay Mud in the Marina

Figure 14 shows that the top of mud, which forms

the underlying surface of the fills, is irregular. This irregularity is especially noticeable beneath the hydraulic fill, and takes the form of a hummocky surface with mounds and depressions. Such an irregular surface is consistent with the method of filling whereby sands were pumped into various portions of the lagoon, causing local bearing failures, with associated mounding of displaced fine grained sediments.

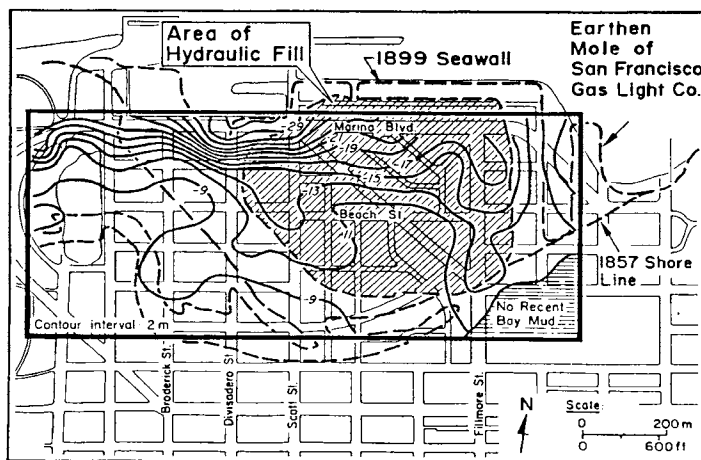
Figure 15. Contours of Equal Elevation for Bottom of Recent Bay Mud in the Marina

Figure 15 shows that the Recent Bay Mud thickens rapidly towards the bay, with its steepest bottom surface from Broderick to Scott Sts. between Marina Blvd. and Jefferson. Slopes of the bottom surface in this region are locally as steep as 10°. The configuration of contours apparently is related to surface drainage features established before the deposition of mud at the end of the Pleistocene.

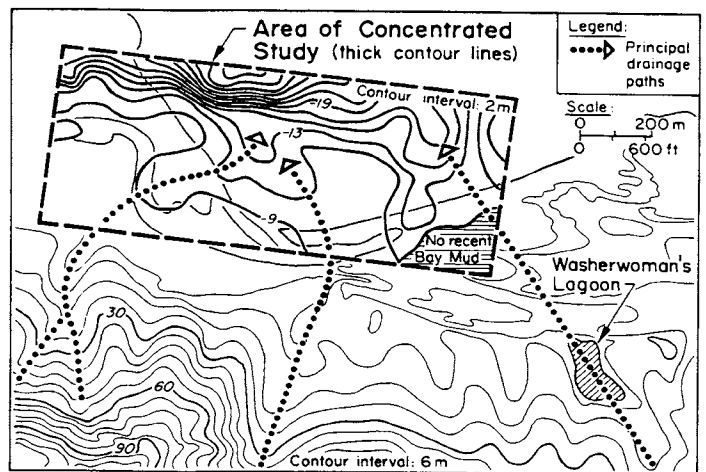
Figure 16. Erosional Surface Beneath Recent Bay Mud in Relation to San Francisco Topography

Figure 16 shows the contours of the bottom of Recent Bay Mud superimposed to scale on a contour map of northern San Francisco. The San Francisco contours are based on one of the original coastal surveys of this area (U.S. Coast Survey, 1857). The basal contours of the mud are consistent with drainage features converging on the Marina from higher elevations to the south. A prominent drainage line crosses the old Washerwoman's Lagoon and intersects the eastern sector of the erosional surface beneath the mud. Similar to the long axis of the bedrock basin, this drainage line is oriented in a northwest direction, sub-parallel to major structural features which have been mapped in San Francisco.
