Lessons Learned from Liquefaction and Lifeline Performance During San Francisco Earthquakes

T. D. O'Rourke
Cornell University, Ithaca, New York

J. W. Pease
Cornell University, Ithaca, New York

Paper No. SOA12

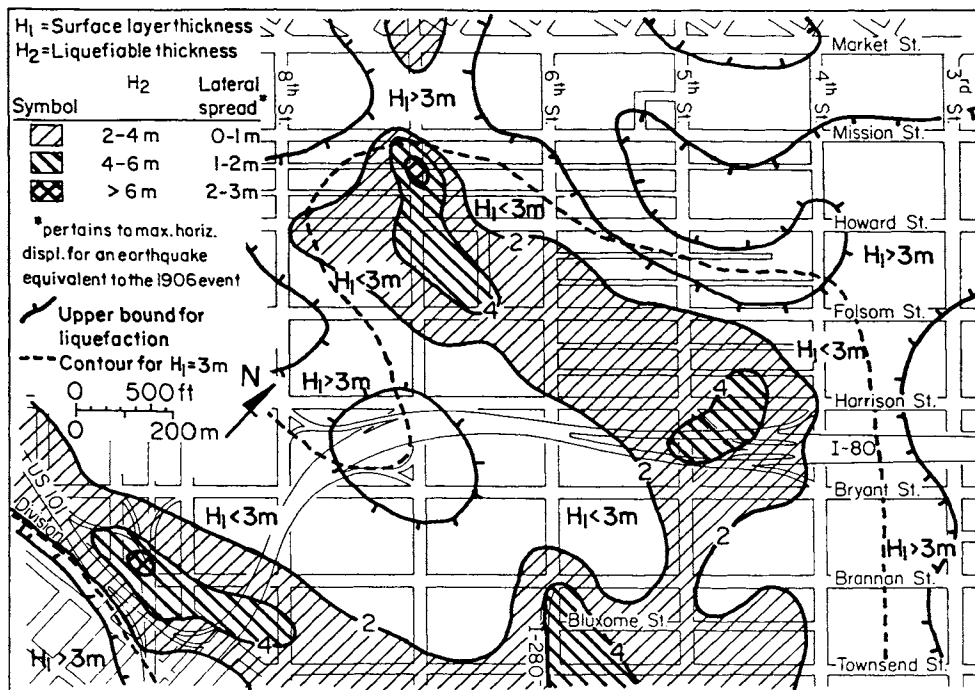
Shaded areas in Figure 28 and 29 denote regions with greater than 2 m of liquefiable soils, which are associated with high levels of lateral displacement in the 1906 earthquake. As indicated by the key in each figure, liquefiable thickness provides a means to predict magnitude of permanent lateral displacement. Manifestation of other liquefaction features including subsidence, sand boils, ground deformations, and pavement offsets are also likely to be found in these areas in proportion to the severity of permanent lateral deformation, and are also therefore related to liquefiable thickness.

The maximum lateral extent for the occurrence of liquefaction in Figure 28 and 29 is indicated by a hatchured line referred to as the upper bound contour. Areas potentially subject to liquefaction, on the hatchured side of the contour, represent areas where the base of fill occurs within 2 m above mapped

Figure 29. Liquefaction Hazard Map of the South of Market, Showing Zones of Highest Potential Damage and Lateral Movement for an Earthquake of Similar Magnitude to the 1906 San Francisco Earthquake [Note: A dashed contour ($H_1 = 3$ m) indicates the regions where surface layer thickness is less than 3 m, where liquefaction damage is more likely to be observed during lower magnitude earthquakes, such as the 1989 Loma Prieta earthquake.]
