Geotechnical Aspect of Damage In Adapazari City During the 1999 Kocaeli, Turkey, Earthquake

GEOTECHNICAL ASPECT OF DAMAGE IN ADAPAZARI CITY DURING THE 1999 KOCAELI, TUEKEY, EARTHQUAKE

This report summarizes detailed investigation on the structural damage and its geotechnical condition in the Adapazarı City, Turkey, during the 1999 Kocaeli earthquake by the reconnaissance team of the Japanese Geotechnical Society. Damages to individual buildings were investigated along several streets in the downtown area. A little rough investigation was made almost all downtown area, in which damages were classified by its cause, i.e., inertia force or soil liquefaction. These investigations as well as hearing investigation and areal investigation by means of helicopters made clear the area where there was an island a few hundred years ago by which the name of Adapazarı i.e., ada (island) + pazarı (market), came from. In addition, the damage in the Adapazarı City is shown to be strongly affected by the ground condition because damage caused by liquefaction was observed only outside the old island and areas where significant structural damage was observed were concentrated near the boundary betwe

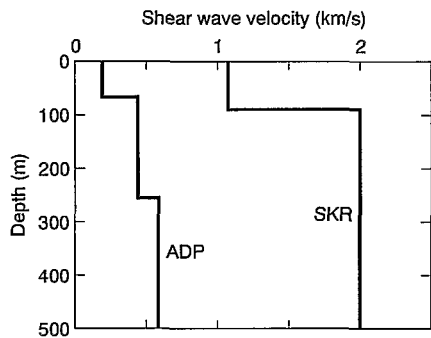
Fig. 3. S-wave velocity identified from microtremor measurement

earthquake, Kudo et al. (1999) conducted microtremour measurement in order to obtain the shear wave velocity structure at the strong motion observation site as well as a downtown site. The result is shown in Fig. 3. There is a discontinuity of the shear wave velocity at about 250 m deep at the downtown site, which may be consistent with the hearing investigation. They, however, pointed that the shear wave velocity at the downtown is quite different with that at the strong motion observation site even at very deep depth; shear wave velocity at the ground surface of the strong motion observation site is larger than 1km/s whereas that in very deep point is still about 500 m/s at the downtown site. This indicates that evaluation of the ground shaking in the downtown area from the earthquake record is difficult because there is no common base layer.

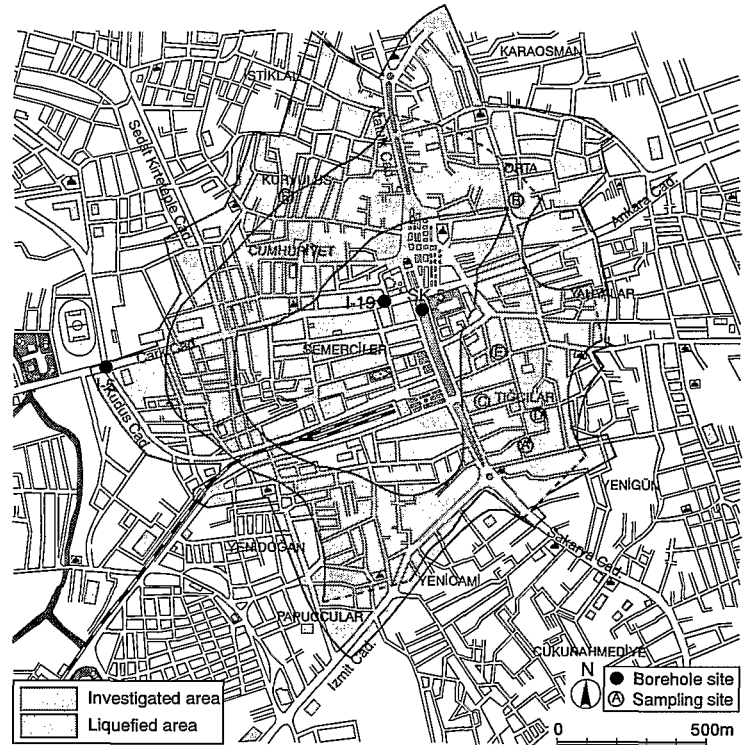
Figure 4 shows the map in the downtown of the Adapazarı City, in which various informations obtained by the reconnaissance are overdrawn. The dark gray shading indicates the liquefied area, which will be discussed later. Several borehole data are obtained out of this area, some of which is shown in Fig. 5. The I-5 point is located west of the map along the Cark Cadesi in

Fig. 4. Map of Downtown Adapazarı. Investigated area, site of borehole investigation, sand sampling, and liquefied area are shown

Since data in the liquefied area was not obtained, sand samples were taken at the liquefied area. Fig. 6 shows grain size distribution of the samples. Sites where samples were taken are shown in Fig. 4 as notation A to F with circle. Among these samples, A to E are samples taken from sand boils, therefore

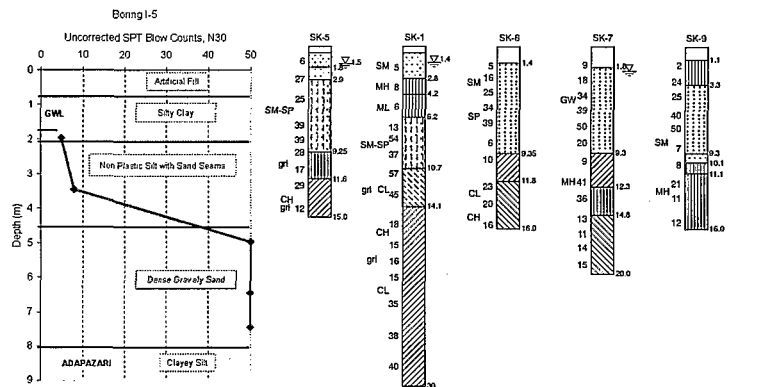
Fig. 5. Drilling log

Fig. 4 (Erken, 1999). Water table is about 1.8 m below the ground surface. There exist fill with 1 m thickness and silty clay layer with 1 m thickness. Non-plastic silt with 2 m thick that includes lens shaped sand exists beneath them. Then there exists dense gravelly sand with more than 50 SPT-N value. The right hand drilling logs in Fig. 5 are obtained close to the station (the name SK-5 is used to indicate the location in Fig. 4) (Onalp, 1999). Although they are located close by, the data fairly scatters. The surface layers are made of silt and sand, but SPT-N values are considerably large, which may be the reason why liquefaction did not occur at this site.

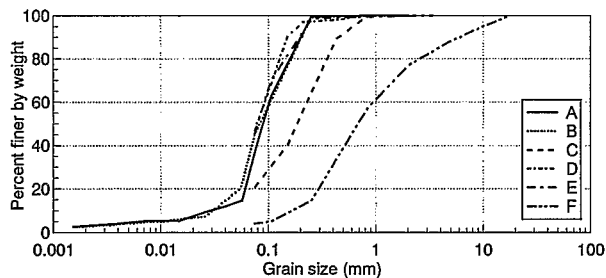
Fig. 6. Percent finer by weight

liquefied material. The sample at point F is excavated sand at the water supply construction site, therefore may not be related to liquefaction. Grain size distributions are nearly identical in the liquefied site except B. The average grain size D_{50} is fairly small to be a little less than 0.1mm; the sand is classified to be fine sand close to silt. The grain sizes are concentrated around D_{50} , therefore it is easy to liquefy. The D_{50} at B is about 0.2 mm which is about two times larger than the other sand, but it is also easily liquefiable sand.

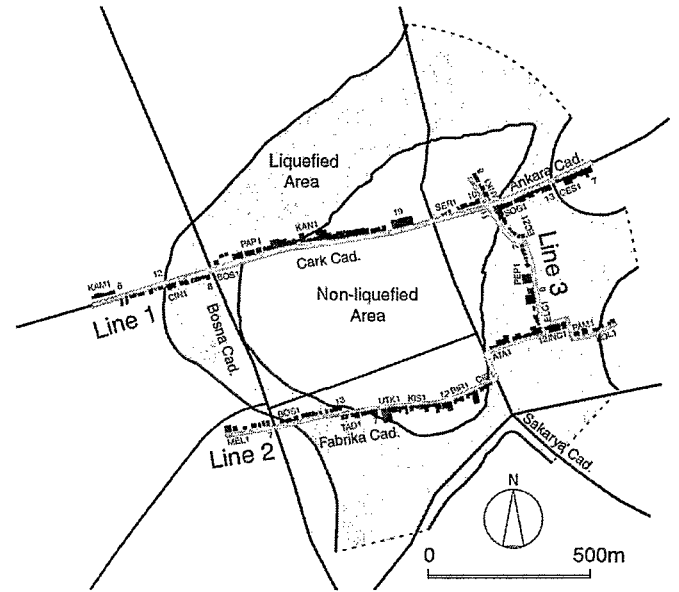
Fig. 11. Map showing lines for detailed investigation such as Cark, Fabrika and Izmit Cadesi. These areas can also be said to be located adjacent to the liquefied area. Irregular ground configuration between liquefied and non-liquefied sites may be the reason of the localization of severe inertia type damage.

Investigation of all buildings was conducted along three lines shown in Fig. 11. Structural dimensions such as size of plan and number of stories, settlement, tilt and damage level were measured and evaluated. 192 building were investigated in total. Elevations of investigated buildings are schematically drawn in Fig. 11. Since one side of the road was generally investigated, the buildings are drawn on the side where original building exists.
