# The Northridge Earthquake of 1994: Ground Motions and Geotechnical Aspects

Paper No. 14.01

**Abstract:** Following the January 1994 Northridge Earthquake in Southern California, the authors traveled to Los Angeles and surveyed the earthquake damage region. Subsequently, seismologic, geologic and ground motion data were compiled and evaluated. This paper presents our observations and evaluation of: geologic and soil effects; soil-structure interaction; liquefaction; slope failures and rock slides; and ground deformations.

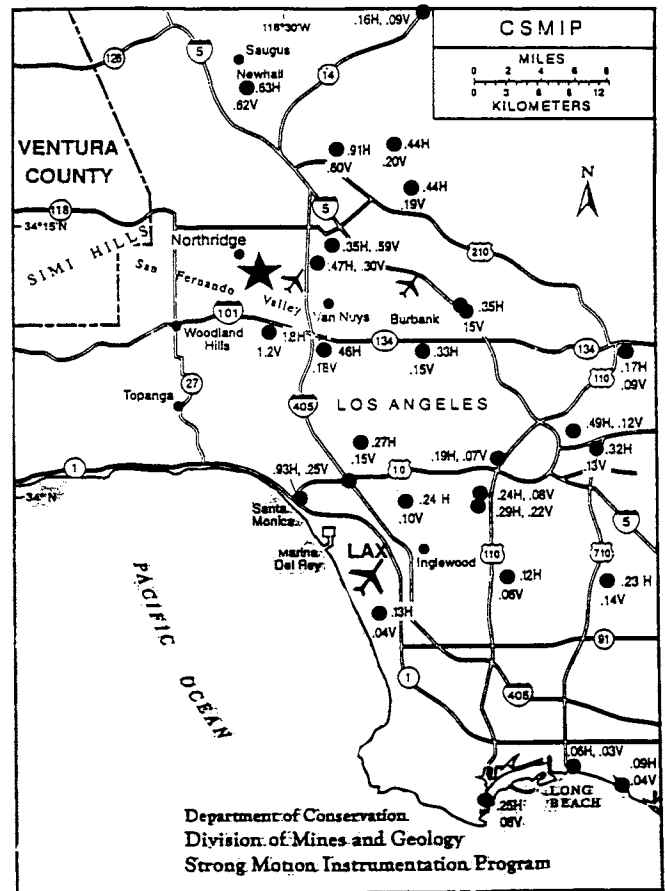
Fig. 1 Map of peak accelerations from CSMIP.

- Along and near Highway I-10, the peak ground accelerations (PGA's) vary from 0.93g at the City Hall near the Santa Monica Beach (24 km from the

epicenter) to 0.27g at the Century City-LACC site (20 km from the epicenter), with the Hollywood Storage building site reaching an intermediate 0.41g value (23 km from the epicenter). Since these sites are at similar distances, and in the same general direction from the fault, soil “amplification” effects appear to be the most likely reason for the large differences in the recorded accelerations.

- In the Long Beach area, nearly 60 km from the epicenter, several records exhibit PGA’s in the range of 0.06g to 0.09g. Yet, nearby, at the base of Vincent Thomas Bridge, the recorded peak acceleration was 0.25g. For the reasons stated above, soil “amplification” is again a very likely culprit.
- In the San Fernando Valley, and in its northern extension, peak accelerations vary widely, almost regardless of epicentral distance. Examples: Olive View Hospital 0.91g (distance = 15 km), Arleta Nordhoff Ave. Fire Station 0.39g (distance = 9 km), Newhall 0.63g (distance = 19 km), Sepulveda VA Hospital 0.94g (distance = 8 km). Soil amplification effects may have played a role in such differences, although, so close to the source other seismological factors, including azimuthal orientation and “directivity” effects, may have contributed as well.

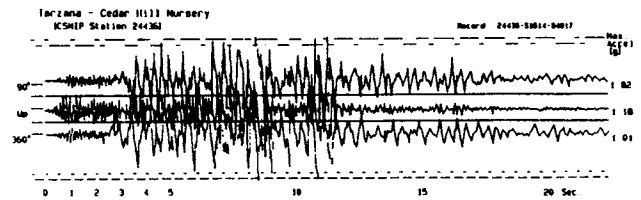
The second is at the Tarzana Cedar Hill Nursery located about 7 km from the epicenter. The ground motion record at this site displays an unusually large number of pulses with peak acceleration values of 1.82g and 1.01g in the two horizontal directions, and 1.18g in the vertical direction. Fig. 2 shows the traces of the ground motions recorded in Tarzana. Similar “anomalously” high ground motions (PGA  $\approx$  0.60g) were also recorded in Tarzana during the 1987 Whittier earthquake (epicentral distance  $\approx$  40 km). Tarzana is located at the northern foothills of the Santa Monica mountains. Very localized soil and, especially, topographic effects may have contributed to these high motions.

Fig. 2 Ground motion record from the recording station in Tarzana (3 components).

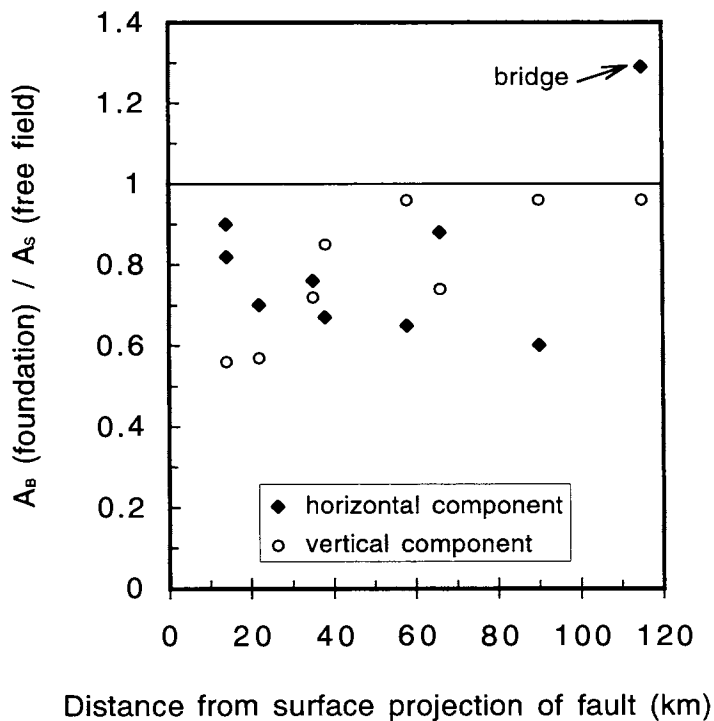
Another phenomenon of geotechnical interest that appears to have played a role in the seismic performance of bridges and buildings is called *soil-structure interaction*. In simple words, the term describes the unavoidable interplay between a structure (building, bridge pier, bridge abutment) and its supporting soil. One is transmitting forces to the other, while their motions must be compatible. Unfortunately, it is very difficult to actually “observe” this interplay in the field after an earthquake. There have, however, been several instrumental manifestations of the phenomenon. For instance, in nearly all cases where accelerations were recorded in both the parking lot (“free field”) and the base of a structure, the measured peak accelerations were different. In buildings, the peak base motion was usually only about 80% of the “free-field” peak. Examples: Hollywood Storage building: 0.29g at the base versus 0.41g at the free field; Los Angeles University Hospital: 0.37g at the base versus 0.49g at the free field; and so on. Fig. 3 summarizes a compilation of all such data, in the form of the ratio of peak accelerations recorded at the foundation and the free field,  $A_B/A_S$ . Notice that for all buildings this ratio was less than 1.

Fig. 3 An indication of the effect of soil-structure interaction is that the ratio of peak acceleration,  $A_B$ , recorded on the base of buildings (foundation) was almost always smaller than the peak ground acceleration,  $A_S$ , at the nearby parking lot (free field).

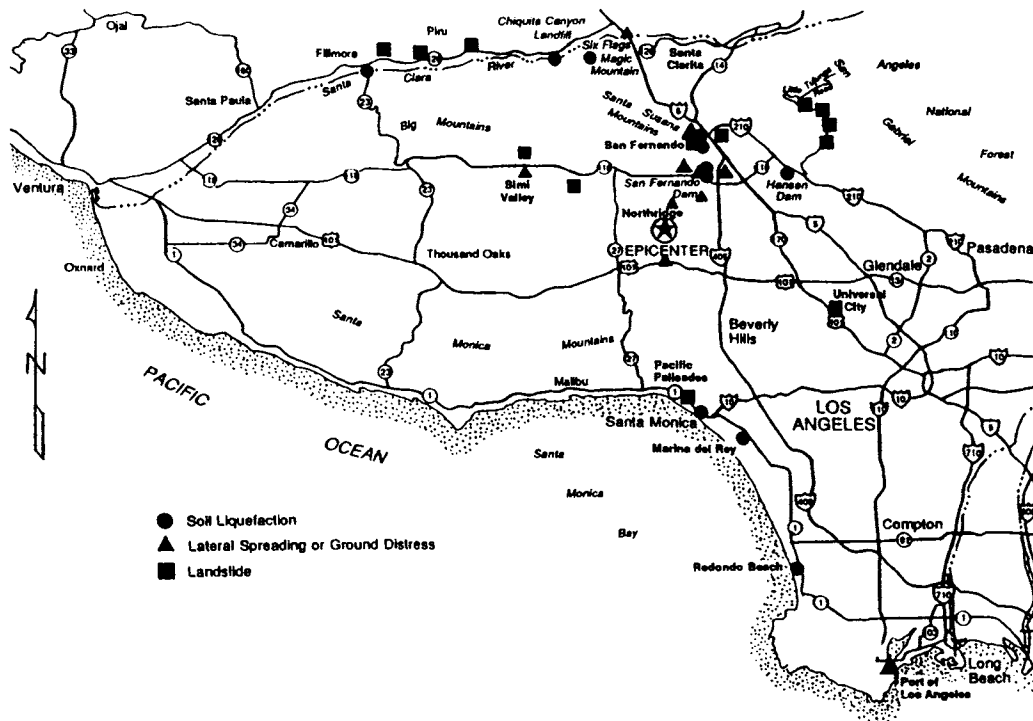
Manifestations of geotechnical failures and damage could be observed at many different locations as far away as 50 km from the general epicentral region. Fig. 4 shows the approximate locations of sites where liquefaction and landslides were observed. Evidence of liquefaction has been observed in the Simi Valley, 15 km northwest of the epicenter. Also, soil liquefaction near the toe region of a section of Highway 126 near the town of Piru may have contributed to its failure. In the parking lot of the Santa Monica Pier, liquefaction of the underlying sands had caused extensive cracking of the pavement and ejection of sand, as shown in Fig. 5.

Fig. 4 Map of the earthquake affected region with locations of geotechnical observations. (from EERC Report, 1994)
