Damage to Agricultural Facilities Caused by the 1993 Kushiro-oki and Hokkaido Nansei-Oki Earthquakes

Paper No. 9.15

S. Tani

SYOPSIS Two large earthquakes struck Japan during only a 6 month period in 1993: Kushiro-oki on January 15 and Hokkaido Nansei-oki on July 12. Both caused a lot of damage to facilities, including installations such as farm roads, reclaimed farmland, channels, head works, drainage pump stations, pipelines and fill dams. In this paper, we present an outline of the damage to agricultural facilities and its features.

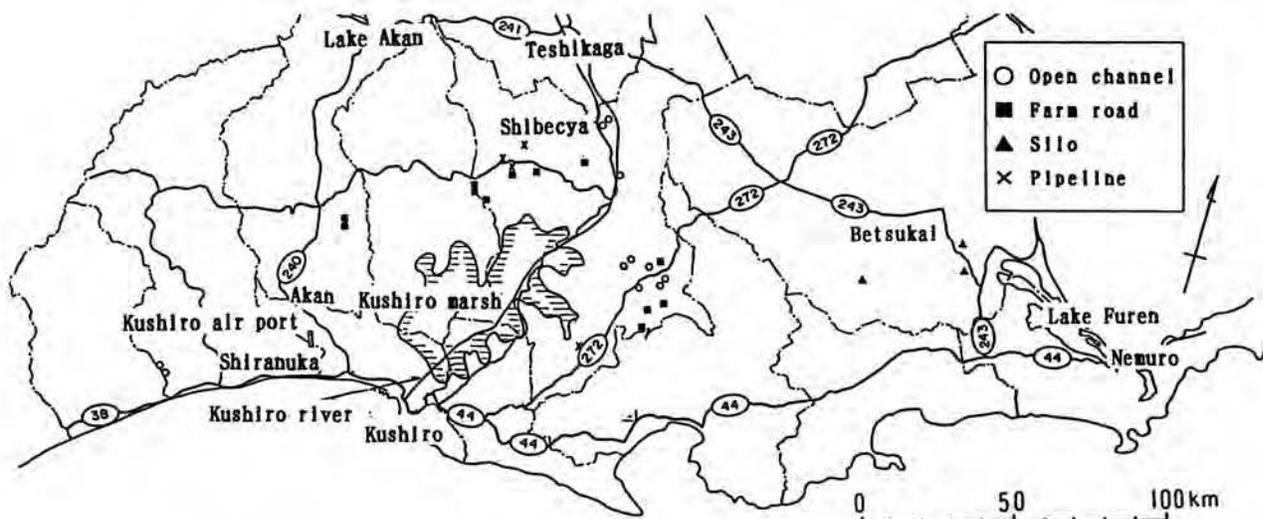
Fig.2. Map of Damaged Agricultural Facilities caused by the 1993 Kushiro-Oki Earthquake.

The damaged sites of agricultural facilities are shown in Fig. 2

(1) Farm roads: The main farm roads were damaged at 7 places, 5 of which were relatively lightly damaged including faulting resulting in 3- 5 cm differences in surface level and pavement cracks. The remaining 2 places in Isobunnai (town of Shibechea) were greatly damaged. The total length of damaged road was 180 m, faulting emerged, and the ground caved in 2 m at the maximum. Most of the damage on farm roads occurred in the boundary area between the cut and the bank over a ravine. Judging from the surrounding topography, the thicker the layer of soft ground, the greater the damage was.

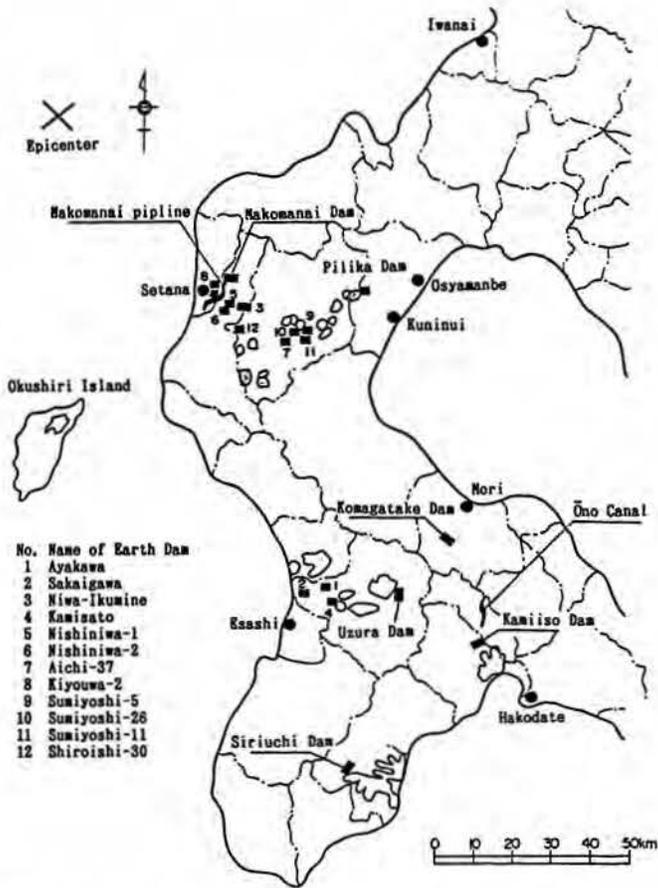
Fig. 4. Map of The North Hokkaido Showing Dam Sites.

The major damaged places and dam sites are shown in Fig. 4

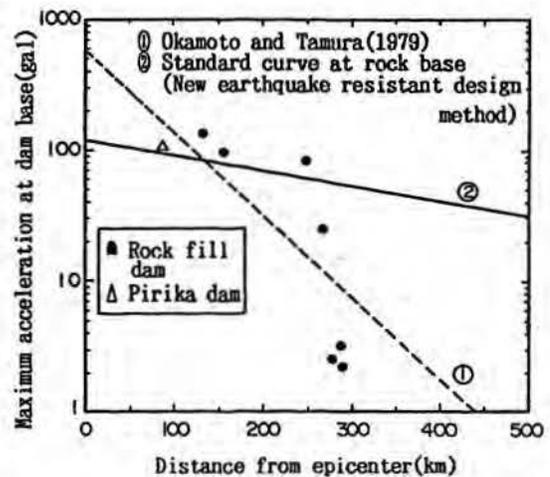
Fig. 6. Maximum Acceleration Records at Dam Base.

occurred on the natural slope around the reservoir. Fig. 6 shows the relationship between the distance from the epicenter and the maximum input acceleration, based upon the data obtained at the fill dams in the vicinity. The result in Fig. 6 adheres closely to the relationship suggested by Okamoto and Tamura. Judging from the data, the maximum acceleration at Makomanai Dam is estimated at about 180~250 gal.

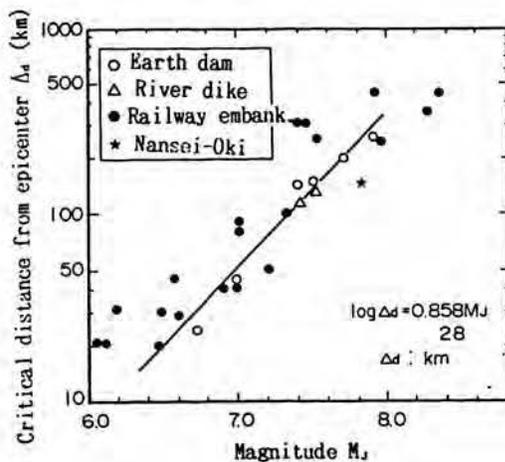
Fig. 9. Relationship between Magnitude and Critical Distance from Epicenter.

Fig. 9 shows the relationship between magnitude and critical distance, the greatest distance from the epicenter when any earth dams are damaged by the earthquake. The line in the figure was drawn based upon the data of earthquakes in the past and the area below the straight line shows affected areas. * indicates the data of Hokkaido Nannsei-Oki earthquake, which appears to relate closely with tendencies of past earthquake result data.
