Geotechnical Aspects of Recent Japan Earthquakes

Susumu Yasuda
Tokyo Denki University, Japan

Tomohiro Tanaka
Tokyo Denki University, Japan

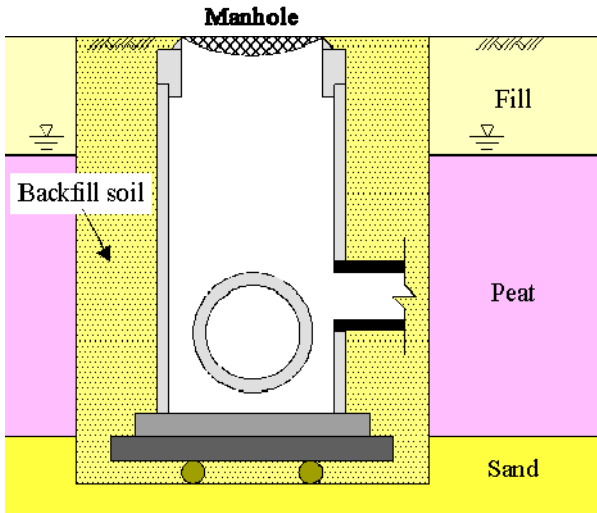
Fig. 3. Schematic diagram of the cross section of a sewage manhole

of the ditch or holes, and iii) the ditch or hole is filled with sand which is compacted as show in Fig.3. Soil fill in the damaged sites were sand with fines to sand with gravel. Water levels in the soil fill at the damaged sites were extremely shallow, such as GL.- 0.2 m to GL.- 1.1 m. The density of the soil fill at the damaged sites was very low, with degree of compaction D_c of 74% to 81% or relative density D_r of 38 % to 41%. Therefore, it is certain that the soil fill liquefied and caused the uplift of manholes. Water tables at the undamaged sites were slightly deeper than those at the damaged sites. This may be the reason why manholes were not uplifted at these

In the restoration work, the manholes that uplifted more than about 5 cm and the pipes that uplifted more than 1/4 of the diameter of the pipes had to be replaced in Nagaoka City.

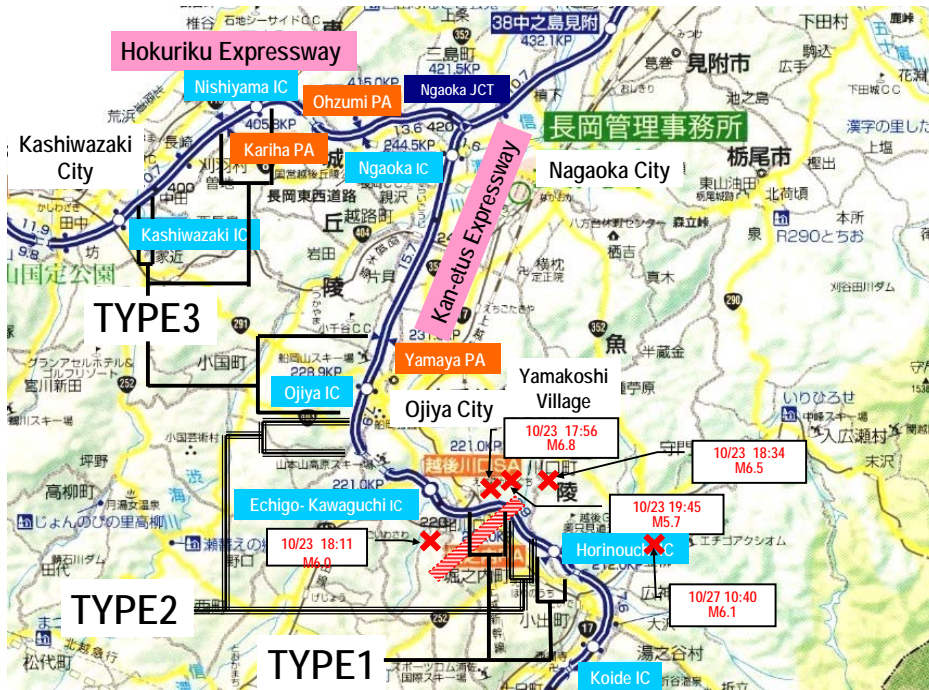
Fig. 4. Route map of Kan-etsu and Hokuriku Expressways and zones damaged during the Niigatoken-chuetsu and Niigatoken-chuetsu-oki earthquakes (Yasuda and Fujioka, 2009)

- between Horinouchi IC and Echigokawaguchi IC (8.8 km), and between Yamamotoyama Tunnel and Yamaya PA (5.5 km) of Kan-etsu Expressway as shown in Fig.4, and

b) between Ohzumi PA and Nagaoka JCT (6.0 km) of Hokuriku Expressway.

Sections where these types of failures occurred are shown in Fig.4.

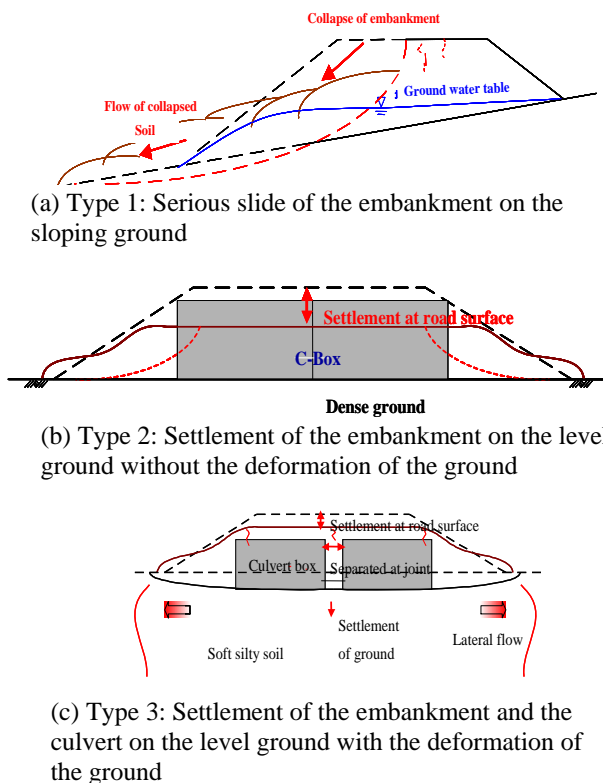
Fig. 5. Classification of the damage to the embankment of Kan-etsu Expressway according to the mechanism of failure (Yasuda and Fujioka, 2009)

(1) Type 1: Serious slide of the embankment on the sloping ground as schematically shown in Fig.5 (a);

(2) Type 2: Settlement of the embankment on the level ground without obvious deformation of the ground as schematically shown in Fig.5 (b);

(3) Type3: Settlement of the embankment and the culvert on level ground with deformation of the ground, as schematically shown in Fig.5 (c).

Type 1 failure was serious slides of the embankment on the sloping ground. Type 2 failure was settlement of the embankment on level ground without the deformation of the ground. Type 3 failure was settlement of the embankment on level ground with deformation of the ground. In Types 2 and 3, settlement of the embankment seemed to have been induced due to the reduction of shear modulus of the fill materials. A reduction of the shear modulus of soils in the foundation ground also seemed to influence Type 3 failure.

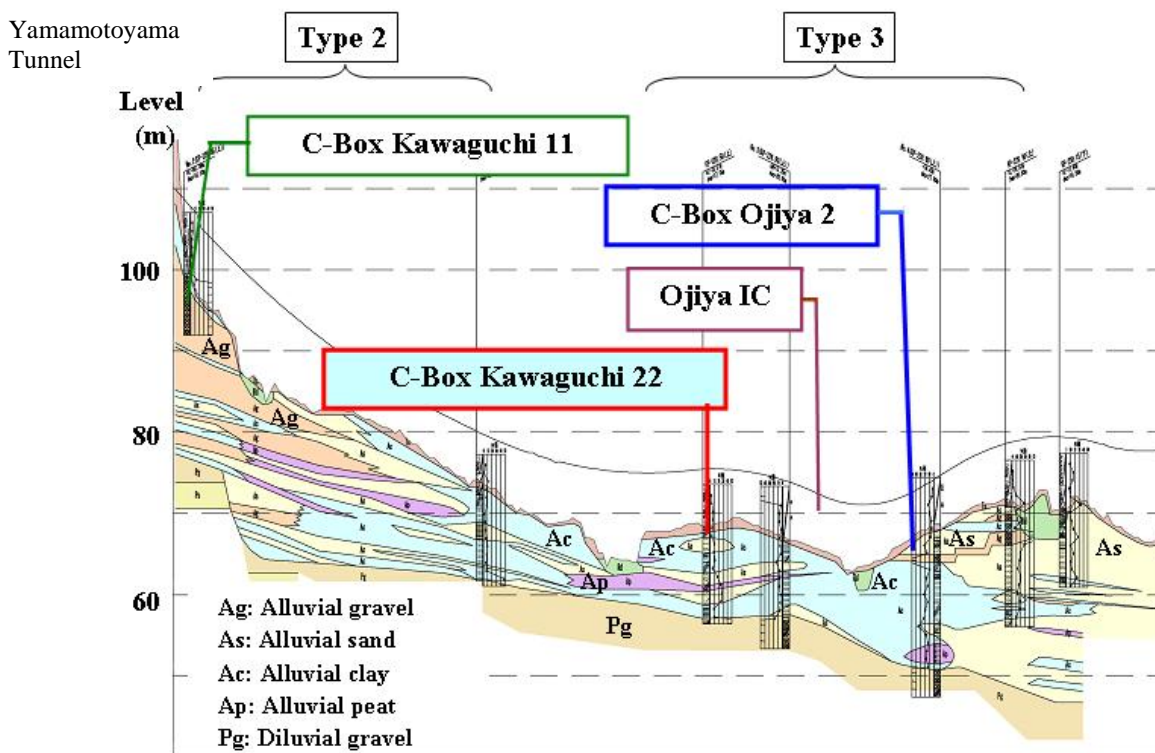
Fig. 6. Soil cross section between Yamamotoyama Tunnel and Yamaya PA (Yasuda and Fujioka, 2009)

Figure 6 shows the soil cross section from Yamamotoyama Tunnel to Yamaya PA. The surface soil is gravel near Yamamotoyama Tunnel, then, gradually changes to soft clayey soil or loose sandy soil towards Yamaya PA. Type 2 and Type 3 failures occurred near Yamamotoyama Tunnel and around Ojiya IC, respectively. Large differential settlement of 70 cm occurred between the embankment and the culvert box at C-Box Kawaguchi 11, as shown in Photo 4. The subsurface soil of the foundation ground is dense gravel with the an SPT N -value of more than 50. The height of the embankment is about 10 m. Fill materials are sandy silt with gravel, gravel with cobbles and clayey silt with gravel. The fines content of these soils was 50 to 60%. The measured water level was about 3 m higher than the bottom of the embankment. However, it is not clear whether the water was perched.

The differential settlements between embankments and culverts, and the settlements of culverts themselves between Yamamotoyama Tunnel and Yamaya PA, were measured. The differential settlement was about 50 to 70 cm near Yamamotoyama Tunnel and the settlements of culverts were about 10 to 20 cm. On the contrary, culverts near Ojiya IC

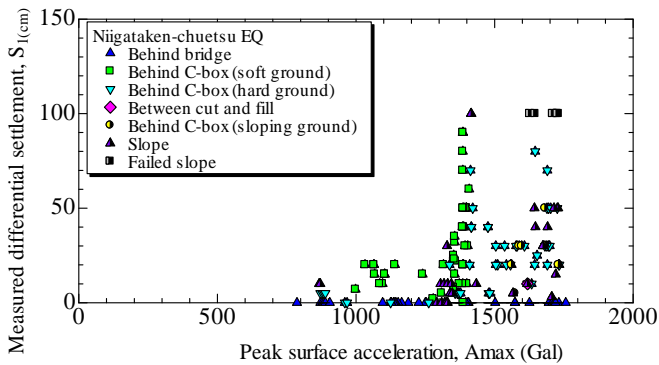
Fig. 7. Relationship between differential settlement and maximum surface acceleration (Yasuda and Fujioka, 2009)

and differential settlements between fill and cut zones were measured. The relationships between these differential settlements and peak surface accelerations are plotted in Fig.7. The peak surface acceleration was estimated based on the relationship between the epicentral distance and the peak surface accelerations recorded by K-net. Differential settlements increased with the peak acceleration as shown in Fig.7.

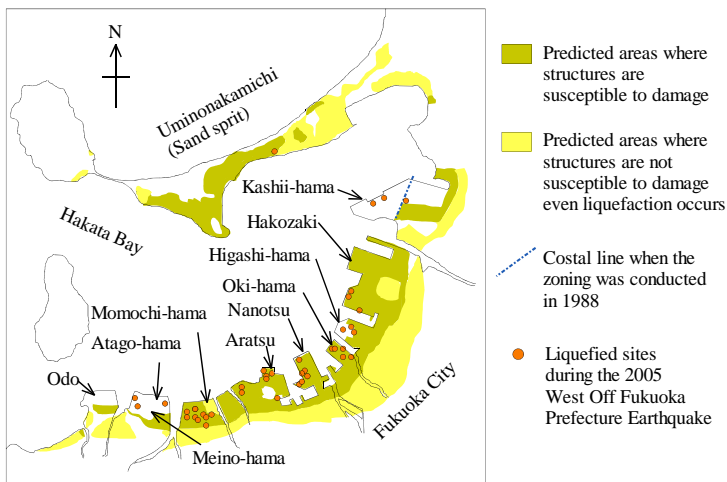
Fig.9. Hazard map for liquefaction and liquefied sites during the Fukuokaken-seiho-oki earthquake

Close circles plotted on Fig.9 show liquefied sites (Yasuda and Tanoue, 2006). Almost all sites are located in reclaimed lands along Hakata Bay. No liquefaction occurred in alluvial low land. One site in Uminonakamichi sand sprit liquefied. However the liquefied site was a newly filled land on a pond. Therefore, it can be said liquefaction occurred in only artificially reclaimed lands.

Among the reclaimed lands, Oki-hama, Nanotsu, Higashi-hama Aratsu and Hakozaki, Momochi-hama were constructed before 1990. These reclaimed lands were filled mainly with sandy soil. Other reclaimed lands, Meino-hama, Odo, Atago-hama, Kashii-hama and Island City were newly filled with clayey soil. Therefore, only few or no boiled sands were observed in the latter newly reclaimed lands. On the contrary, in the former reclaimed, liquefaction occurred at comparatively many sites. In Oki-hama, a quay wall tilted as shown in Photo 9. Horizontal displacement of the quay wall was about 2 m. The ground behind the quay wall flow toward bay and subsided. Flowed zone extended about 10 m behind the quay wall. Several quay walls tilted a little in Nanotsu, Higashi-hama and Aratsu. Two small tanks settled about 20

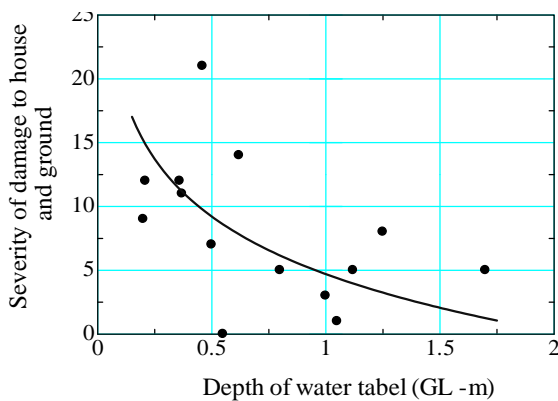
Fig.16. Relationship between grade of severity and depth of ground water table

Among the first group, about 20 houses settled due to liquefaction in Hashiba district as shown in Photo 14. The author and his colleagues conducted detailed survey on the damage to houses and grounds. Then, severity of the damage to houses and grounds were graded. Figure 16 shows the relationship between the grade of severity of the damage and depth of ground water table. Severity of damage decreased

with the increase of the depth of water table. If the ground water table was deeper than about 1.5 m, no severe damage was observed. Photo 15 shows boiled sand and settled an electric light pole in Matsunami district. Huge amount of water and sand erupted in Matsunami district due to liquefaction. However, only few houses which were located on sloping grounds were damaged. Measured ground water tables at several sites were about GL-2 m to -3 m. Therefore it can be judged that no severe damage to houses occurred because surface unliquefiable layer was thicker than about 1.5 m, though liquefaction induces in the layers below ground water table. This phenomenon is similar as the previous experience during the 2000 Tottoriken-seibu-oki earthquake (Yasuda, et al., 2004).

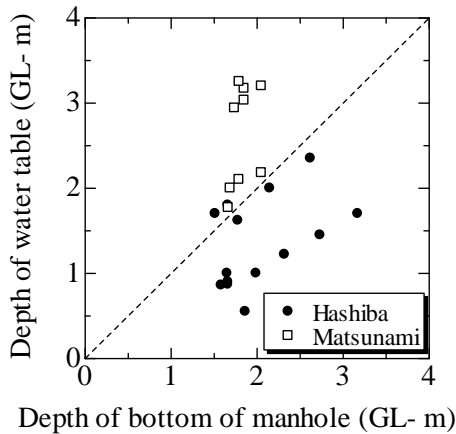
Fig.17. Relationships between the depth of the bottom of sewage manholes and the depth of ground water table in Hashiba and Matsunami districts

In the liquefied areas, uplifted manholes were few though surrounding grounds liquefied. Relationships between the depth of the bottom of sewage manholes and the depth of ground water table in Hashiba and Matsunami districts are plotted on Fig.17. The depths of the bottoms of the manholes were almost same or shallower compare with the depths of ground water tables. This may be the reason why sewage manholes were not uplifted.

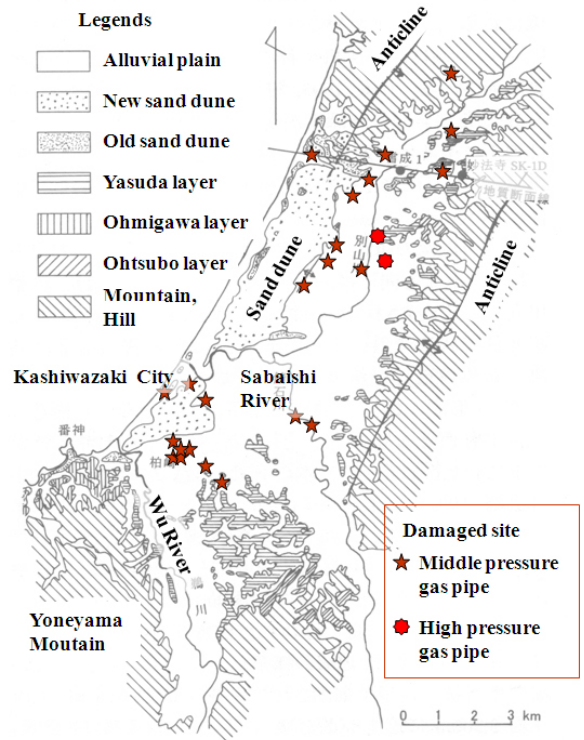
Fig.18. Topographical map and damaged sites to high and middle pressure gas pipes

Moreover it was remarkable that high and middle pressure gas pipes which are strong steel pipes with diameters of 50 cm to 300 cm, were damaged at 28 sites as show in Fig.18. Main type of the damages was buckling of pipes occurred at the boundary between a wide valley plain and surrounding hills or sand dunes. In and around Kashiwazaki City, the wide valley plain with about 15 km long and 3 to 5 km wide is formed. Figure 19 shows a soil cross section along 17-17' line. Soft clayey alluvial layers, Ac in Fig.19, are deposited in the valley plain. Maximum depth of the alluvial layers is about 50 m as shown in Fig.19. However the thickness of the soft clayey layers is quite irregular inside the plain. About 20,000 years ago during ice age, several valleys existed and formed very

of the plain are surrounded by hills and mountains. As mentioned above, the surface soil in the valley plain is very soft. Moreover, epicenter of the earthquake is fairly close. Then it is estimated that very large compressive strain induced at the boundary between the valley plain and surrounding hills or sand dunes and caused the buckling of the middle and high pressure gas pipes. Photo 18 shows topographical condition of a damaged site.

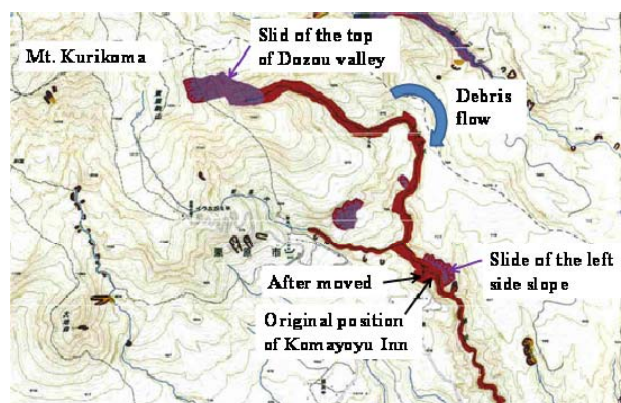
Fig.21. Komayoyu Inn, slide at two sites and debris flow

Remarkable damage due to the combination of slide and debris flow occurred on the southeast slope of Mt. Kurikoma which is volcano. There was a hot spring inn named "Komanoyu" on the right side terrace of Dozou Valley as schematically shown in Fig,21 and photo 20. A slope at left side of the Dozou Valley slid due to the earthquake and blocked the flow of Dozou Valley. At the time Komanoyu Inn had no damage. Due to the earthquake, a slope at the top of Dozouzawa Valley slid also as shown in Photo 21 and caused debris flow by including snow and river water. The volume,
