Behavior and Damage of Dams Under the 1993 Big Earthquakes in Japan

Paper No. 6.23

SYNOPSIS By analyses of the acceleration records at dams during the two big earthquakes which hit in Hokkaido of Japan in 1993, the maximum acceleration at damsite rock, the maximum acceleration amplification ratios at crest and the natural periods of dam bodies were evaluated and were compared the results with empirical equations. Damage to the dams was described, and the mechanism of the deformations was examined.

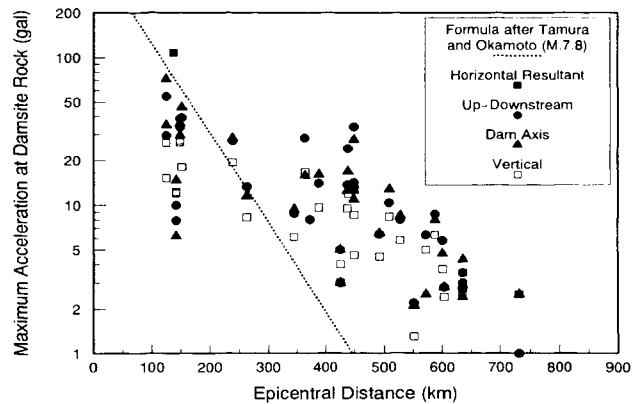
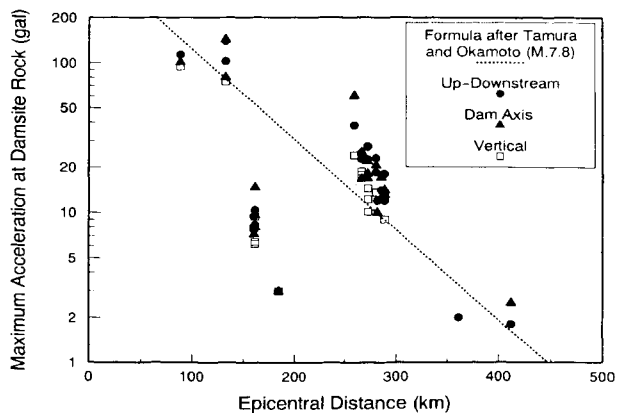
Fig. 1 Attenuation of the Maximum Dam Site Rock Acceleration with Epicentral Distance

Figures 1 (a) and (b) show the attenuation of the maximum acceleration at damsite rock with the epicentral distance during the two earthquakes. In those figures, a dotted line represents attenuation of the maximum acceleration calculated by the formula of Tamura and Okamoto (1979) expressed as:

where, a_{max} is the maximum rock acceleration in gal, Δ is the epicentral distance in km, and M is the magnitude of earthquakes. This attenuation formula was based on seismic records observed in underground rock within an epicentral distance of 280 kilometers. The actual records for the 1993 Kushiro Oki Earthquake tend to be smaller than those estimated by the attenuation formula for dams less than 300 kilometers from the epicenter and larger for dams further than 300 kilometers from the epicenter. In the case of the 1993 Hokkaido Nansei Oki Earthquake, up to an epicentral distance

of about 400 kilometers, the actual attenuation is modeled accurately by the attenuation formula of Tamura and Okamoto.

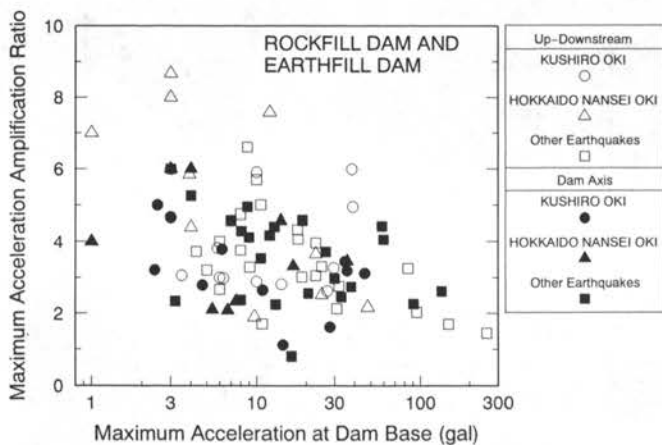
Fig. 2 Acceleration Amplification Ratio at the Crest with the Maximum Acceleration at the Base for Embankment Dams

Figure 2 shows the relationship between the maximum acceleration amplification ratio at a dam crest and the maximum acceleration at a base observed at embankment dams. The figure also shows cases of other earthquakes. For all earthquakes, the amplification ratios range from 2 to 8, and decrease as the maximum base accelerations increase. This is thought to be because of the increase of damping as the maximum base accelerations increase, and also because an earthquake event with a maximum base acceleration larger than 100 *gals* has a short epicentral distance and tends to cause earthquake motion with a higher frequency than that of the dam body. The amplification ratios for the up-downstream component tend to be larger than for the dam axis component.

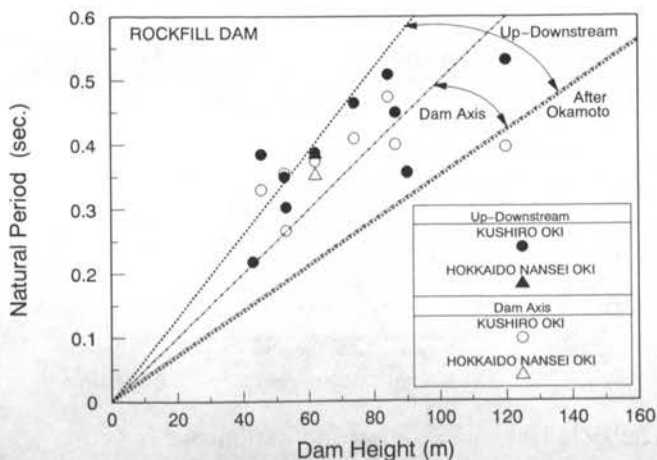
Fig. 3 Natural Period of the Rockfill Dam with Dam Height

and dam height. The natural period increases linearly with the dam height, and most of the plots are within the range of the empirical equation of Okamoto (1984) based on earthquake observations and vibration tests. The natural period in the dam axis component tends to be smaller and to deviate further from the range of the empirical equation than in the up-downstream component. This is thought to be because the shape and binding of the canyon affect the vibration in the direction of the dam axis.
