Corrosion of Galvanized Fasteners used in Cold-Formed Steel Framing

RESEARCH REPORT RP04-4

FINAL REPORT

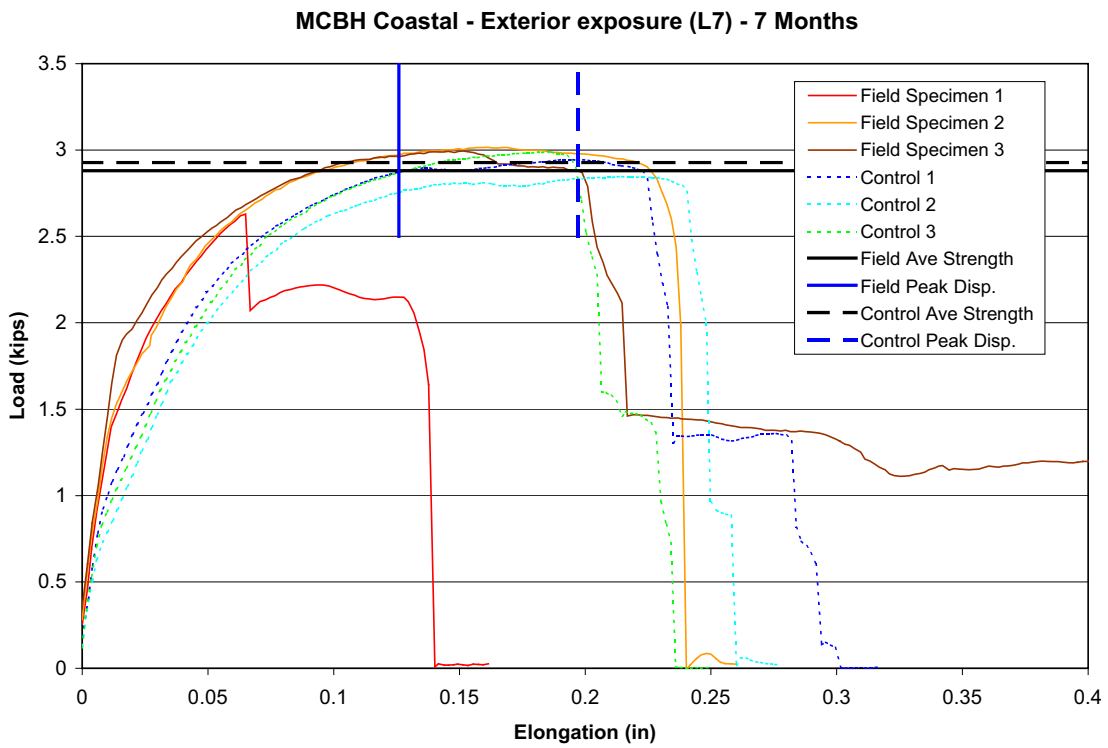
Figure 6.3: MCBH Coastal – 7 Months Exterior Exposure

Figure 6.4: MCBH Coastal – 7 Months Exterior Exposure – Test Results

However, the displacement ratio shows a significant decrease in ductility for the MCBH Coastal specimens that were subjected to exterior exposure, and a modest decrease for the other connection sets (Figure 6.16). The average peak elongation of the field test specimens after 7 months exposure is 74% of that observed in the control connections. This reduction in average elongation is often the result of a single connection, which failed at a significantly lower deformation than the control specimens.

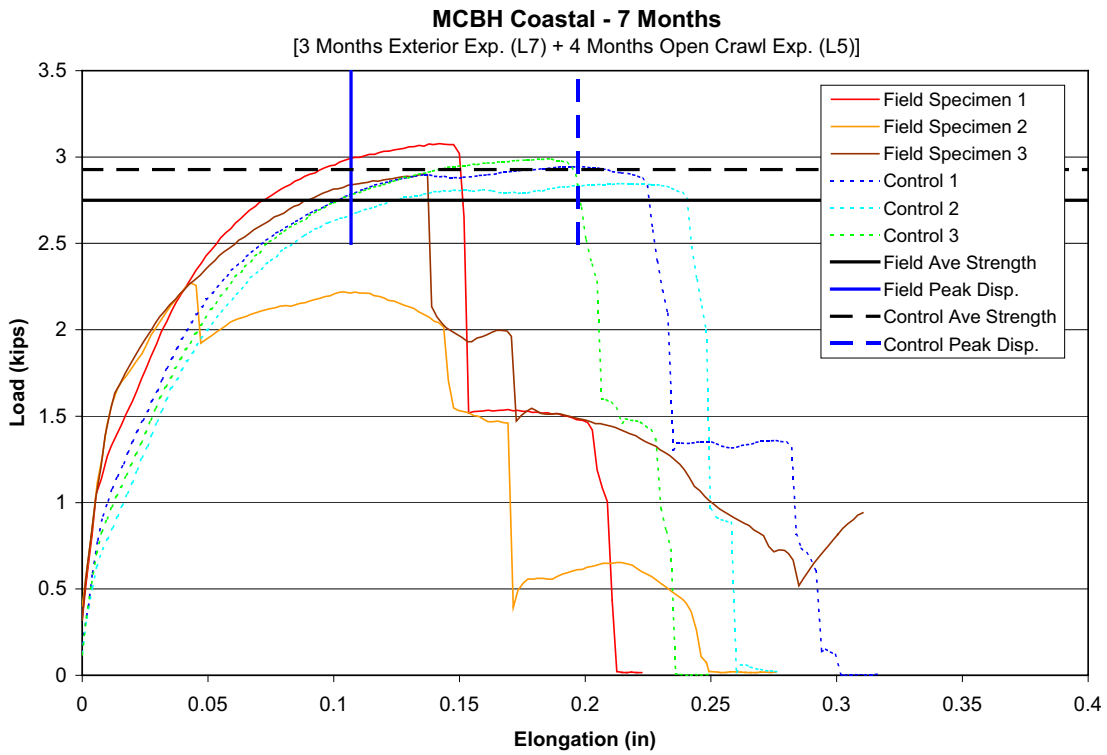
Figure 6.5: MCBH Coastal – 3 Months Exterior Exposure + 4 Months Open Crawl Exposure

Figure 6.6: MCBH Coastal – 3 Months Ext. Exp. + 4 Months Open Crawl Exp. – Test Results

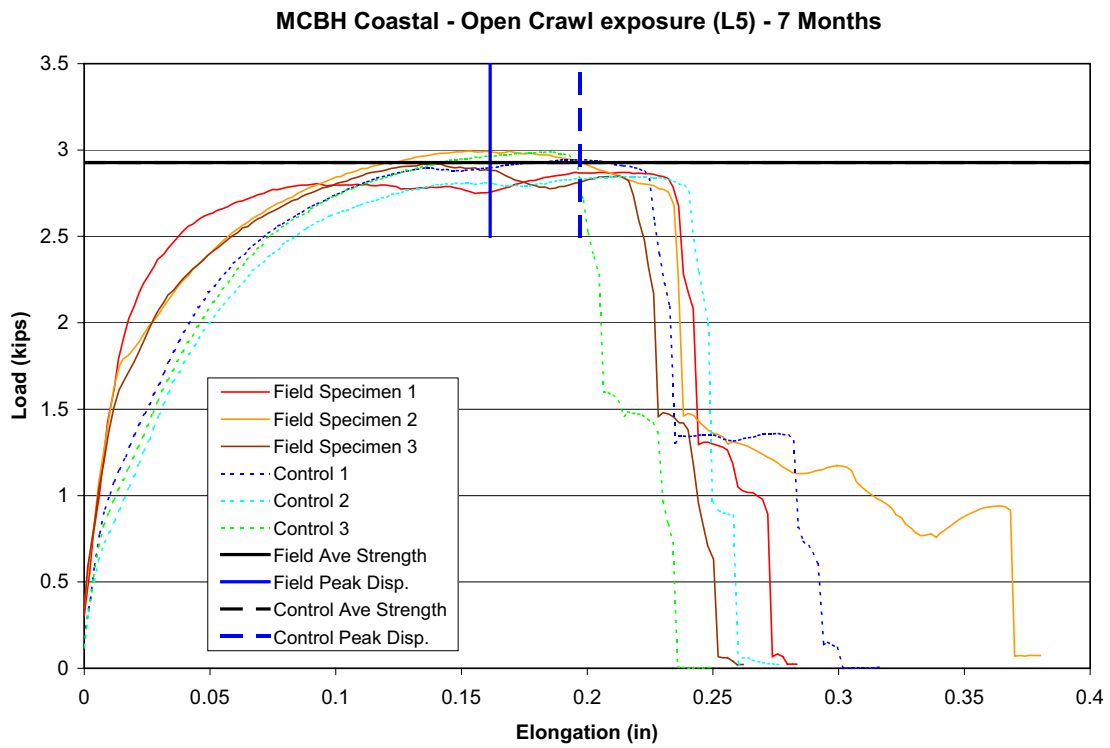
Figure 6.7: MCBH Coastal – 7 Months Open Crawl Exposure

Figure 6.8: MCBH Coastal – 7 Months Open Crawl Exposure – Test Results

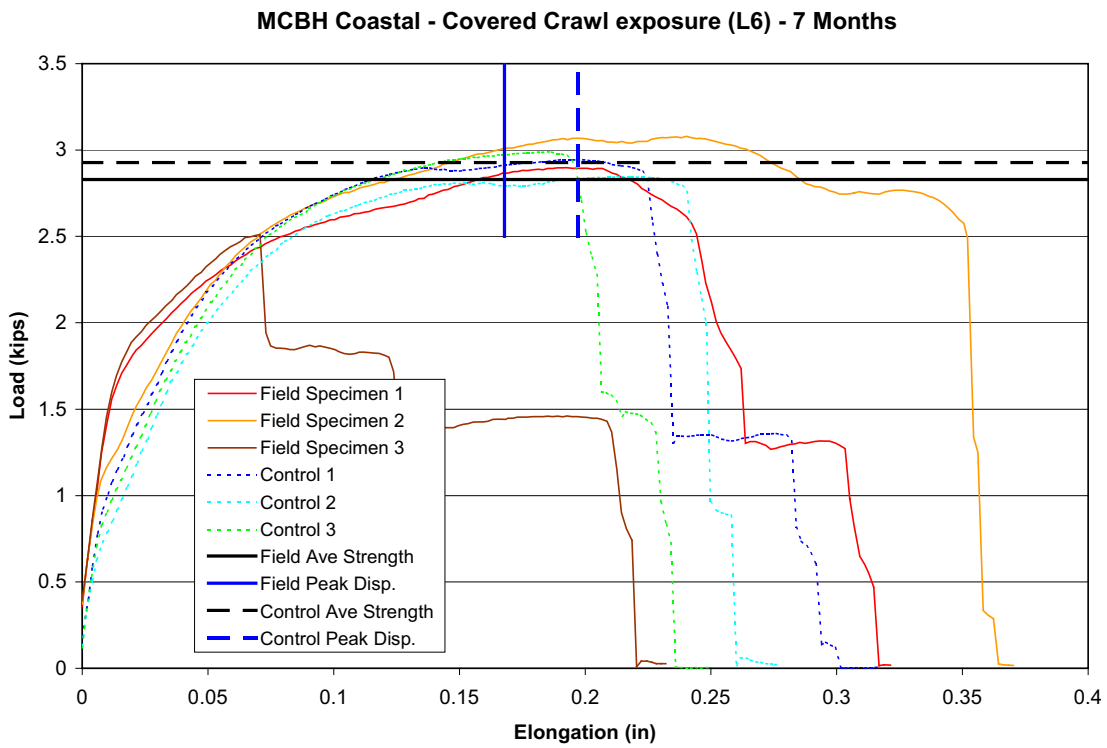
Figure 6.9: MCBH Coastal – 7 Months Covered Crawl Exposure

Figure 6.10: MCBH Coastal – 7 Months Covered Crawl Exposure – Test Results

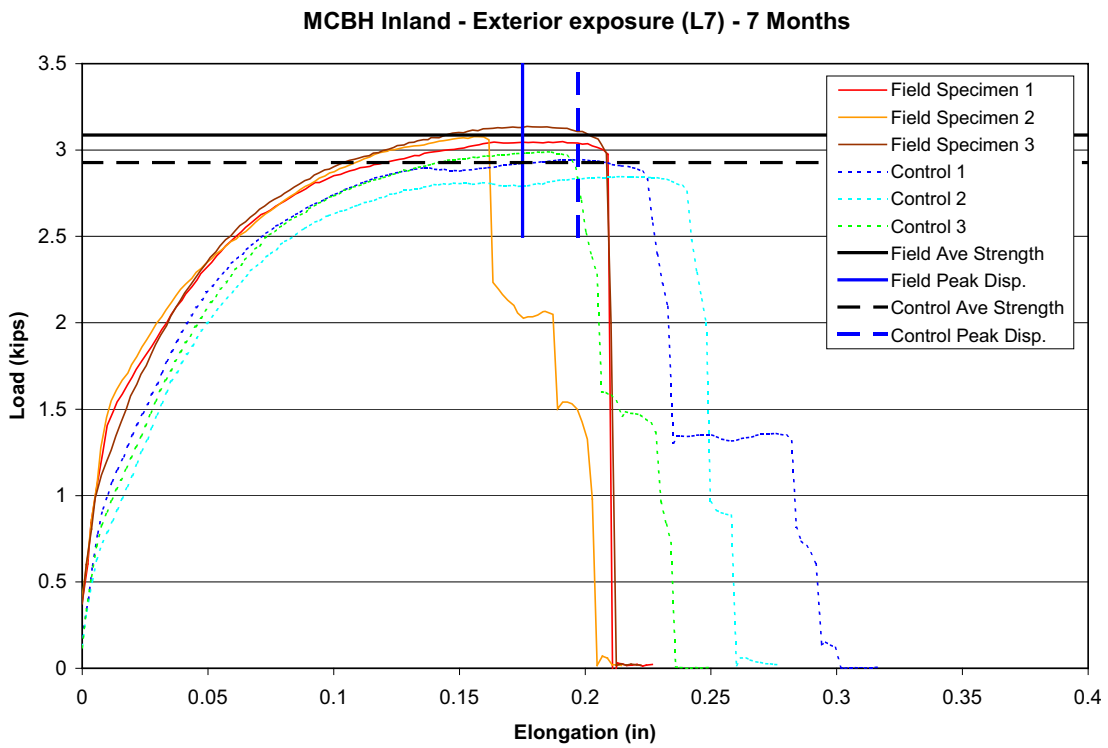
Figure 6.11: MCBH Inland – 7 Months Exterior Exposure

Figure 6.12: MCBH Inland – 7 Months Exterior Exposure – Test Results

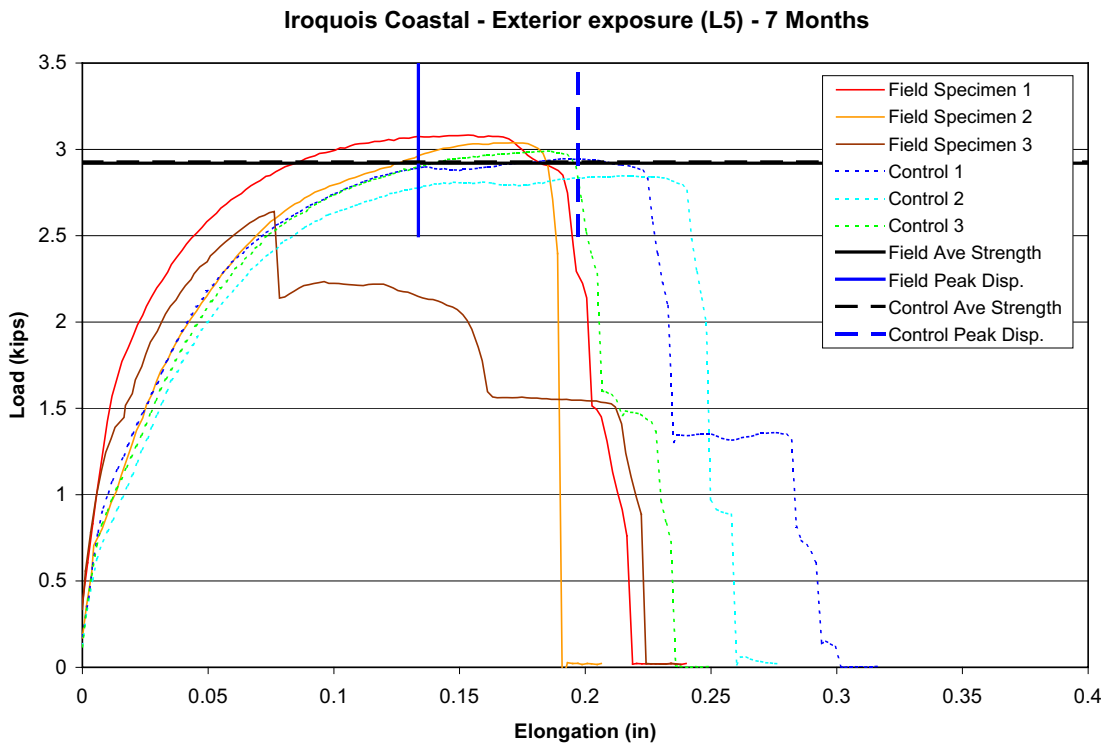
Figure 6.13: Iroquois Coastal – 7 Months Exterior Exposure

Figure 6.14: Iroquois Coastal – 7 Months Exterior Exposure – Test Results

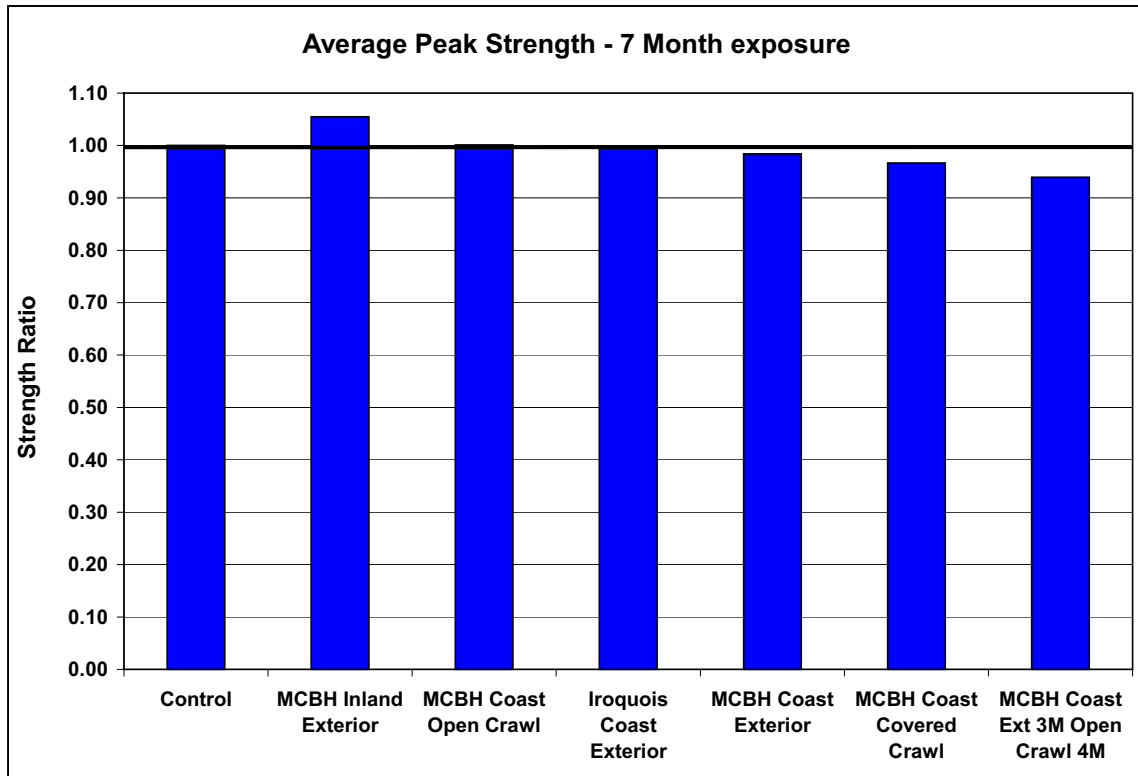
Figure 6.15: Average Strength Ratio for field specimens after 7 month exposure

The strength ratios in Table 6-1 are plotted in Figure 6.15, and show that there has been no change in the average failure strength of the lap connections recovered from the field after 7 months exposure. The average strength ratio is 0.99 for all 6 connection sets tested.

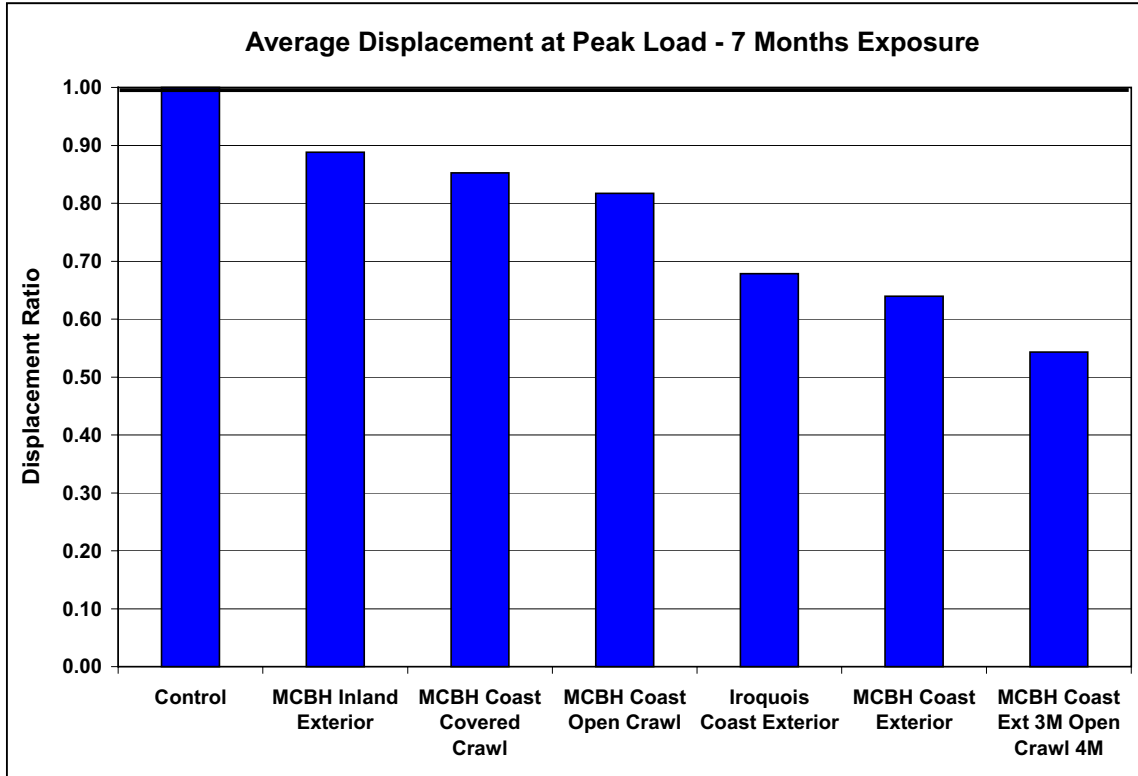
Figure 6.16: Average Displacement at Peak Load for field specimens exposed for 7 months.

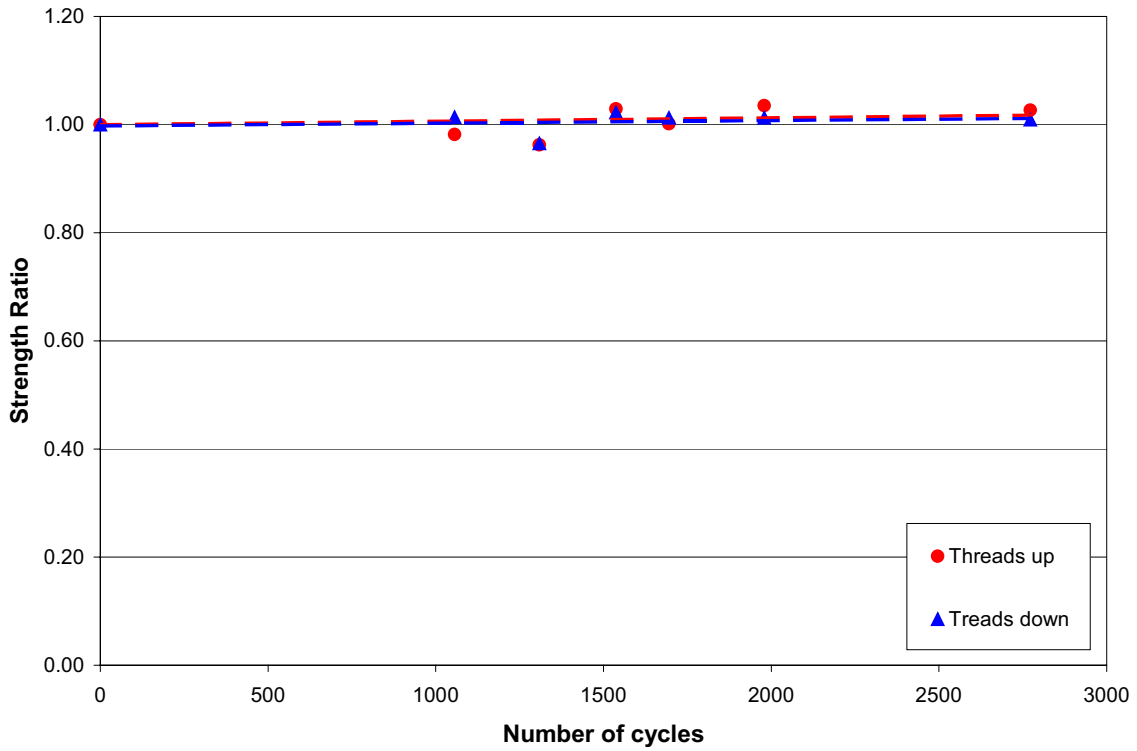
After 2772 cycles in the corrosion chamber, the galvanized screws showed significant surface corrosion (Figure 6.32). Nevertheless, the average connection strength had not decreased, regardless of whether the threads were oriented up or down in the corrosion chamber (Figure 6.35). However, the average specimen elongation at the peak load had decreased to around 80% of that for the control specimen (Figure 6.36). This decrease was larger for the connections stored with threads up. It appears that the connection ductility is affected by this level of corrosion, though the strength is not. Figure 6.37 to Figure 6.40 show microscopic images of the screw threads for control and 1537 cycle test specimens before and after testing. Although the surface corrosion appears significant, it has not yet penetrated the shaft of the screw, and hence has not affected the screw failure strength (Figure 6.40).

Figure 6.35: Strength Ratio versus Number of Cycles in corrosion chamber

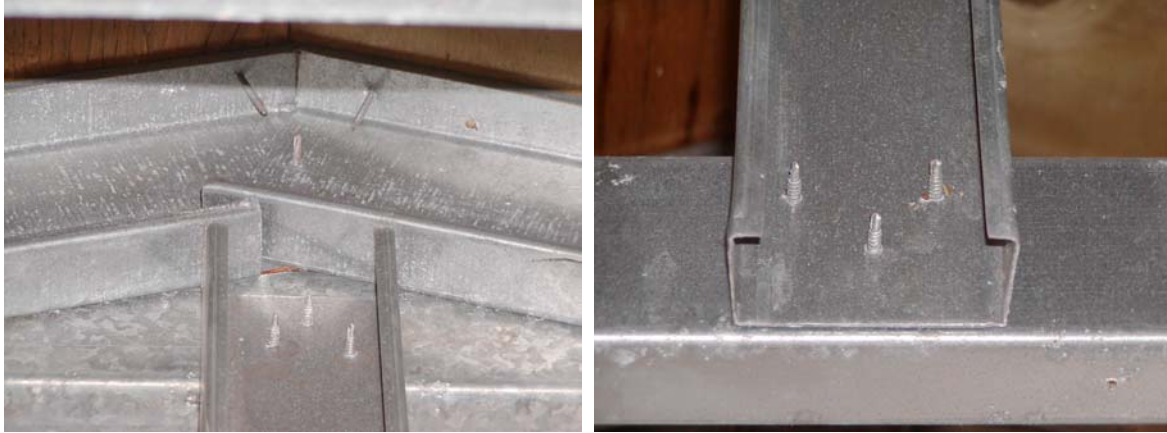
Initiation of corrosion was evident at the cut edges of the CFS framing and on some of the fasteners in the vented attics of the two Iroquois sites as shown in Figure 7.2. The fasteners in the vented attic at the Wheeler site showed no corrosion as seen in Figure 7.3.

Figure 7.3: Attic framing at Wheeler site after 20 months exposure.

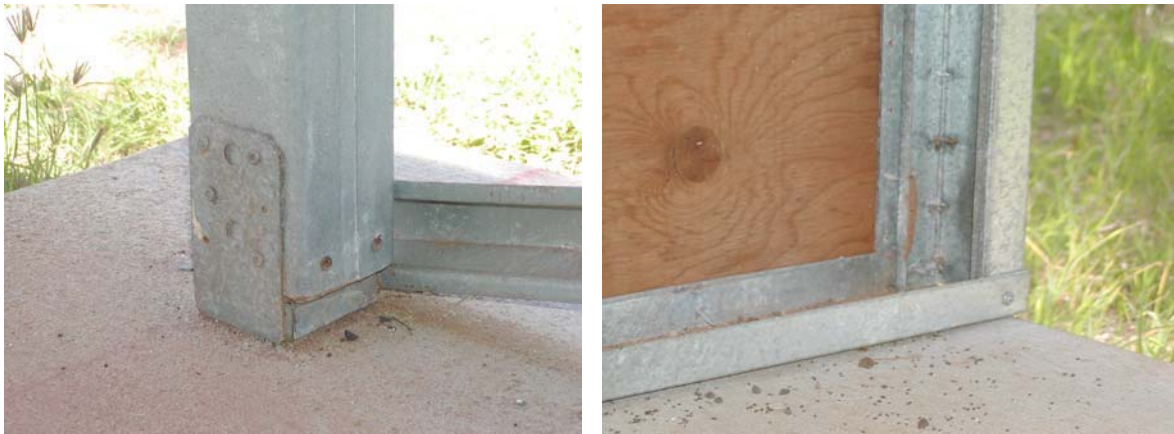
Almost no signs of corrosion were noted in the crawl space framing of these three sites after 20 months of exposure. Initiation of corrosion was evident on a few of the fasteners with full exposure to the elements as shown in the post base connection in Figure 7.4. The floor joists showed no evidence of corrosion whether exposed (Figure 7.5) or covered with plywood sheathing.

Figure 7.4: Crawl space post and cripple wall framing at Iroquois Coastal after 20 months.

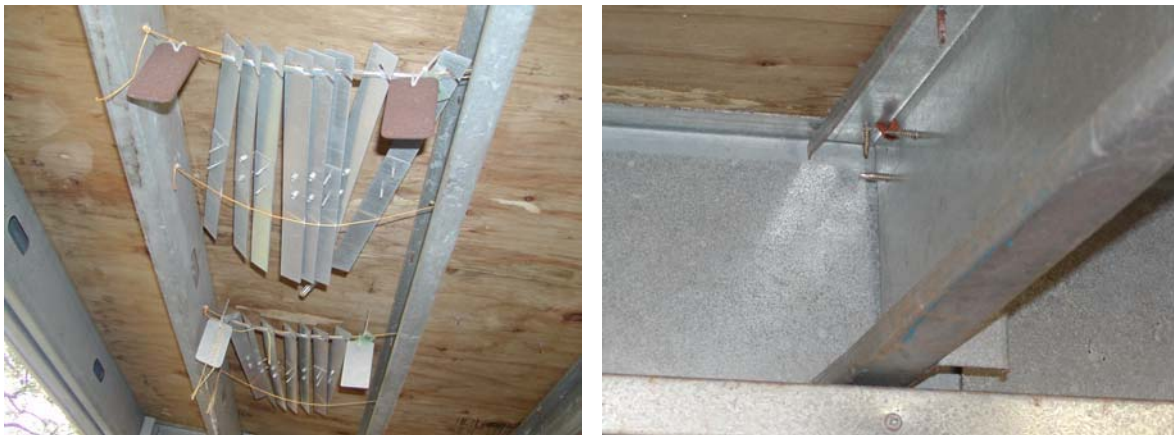
Figure 7.5: Exposed floor joists at Iroquois Coastal after 20 months exposure.

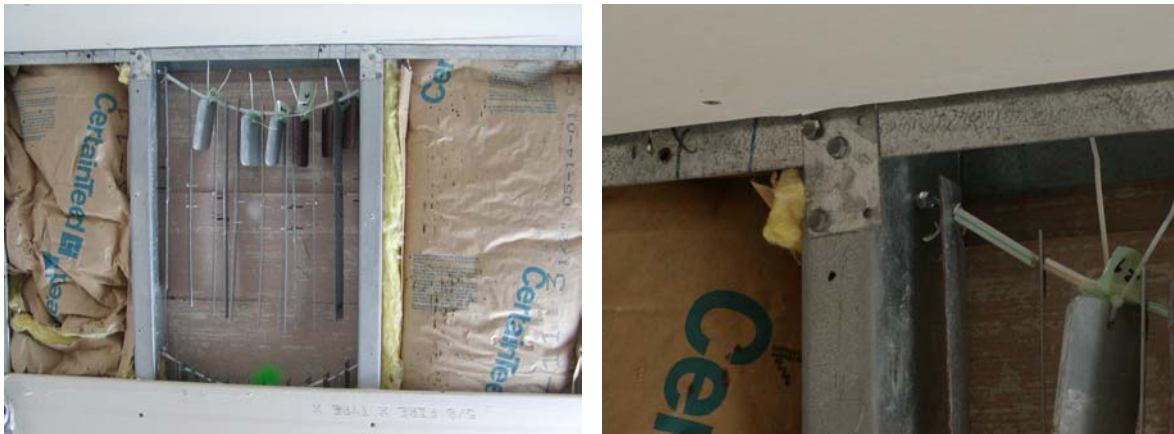
After 28 months of exposure, no evidence of corrosion was noted on the framing members or fasteners in the wall framing with lap siding but no vapor barrier (Figure 7.7).

Figure 7.7: Wall framing without vapor barrier at MCBH Inland after 28 months.

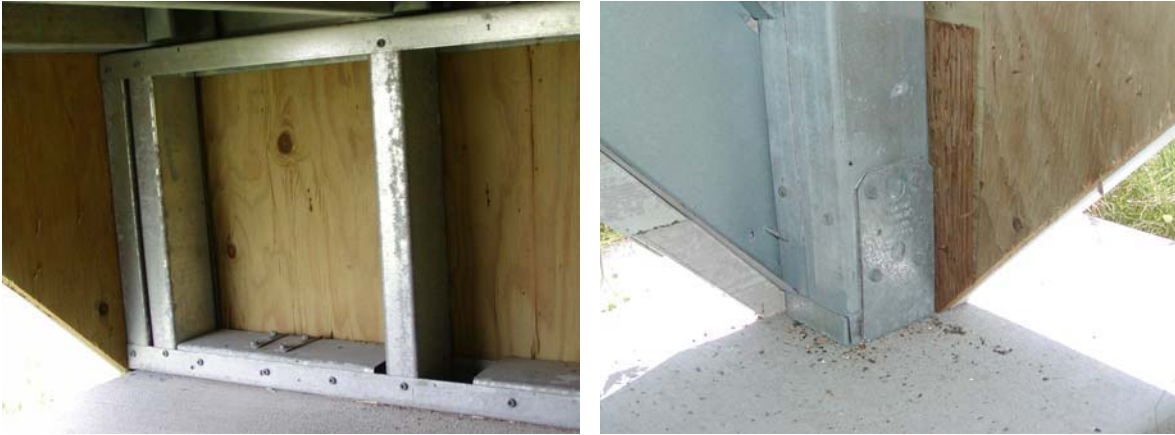
Figure 7.10, Figure 7.11 and Figure 7.12 show a progression of the corrosion on the cripple wall and post supports in the crawl space of the MCBH Inland enclosure. After 5 months there were signs of tarnishing of the zinc galvanizing, but no evidence of ferrous oxide on the fastener heads or threads. By 16 months, the galvanizing was fully tarnished and ferrous oxide was evident on some of the fastener heads and threads. By 28 months, there was more significant corrosion on the same fasteners and initiation of corrosion at other fasteners elsewhere in the crawl space support framing.

Figure 7.10: Crawl space cripple wall and post at MCBH Inland after 5 months exposure.

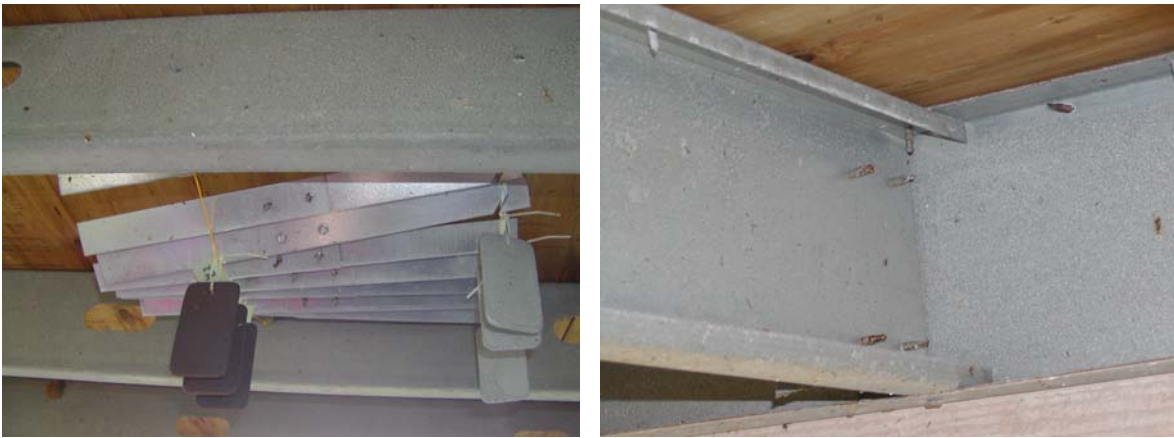
Figure 7.13 and Figure 7.14 show the exposed floor joist framing in the crawl space of the MCBH Inland enclosure. After 16 months, there was some tarnishing of the joists, but no evidence of ferrous oxide on the fasteners. By 28 months, the joists were fully tarnished and minor ferrous oxide was noted on some of the fastener threads. For the floor joists enclosed by plywood sheathing, there were no signs of corrosion after 28 months of exposure (Figure 7.15).

Figure 7.14: Crawl space floor joists at MCBH Inland after 28 months exposure.

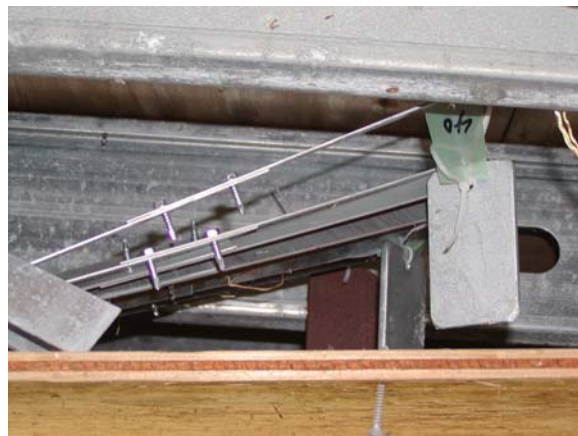
Figure 7.15: Floor joist with plywood sheathing after 28 months exposure.

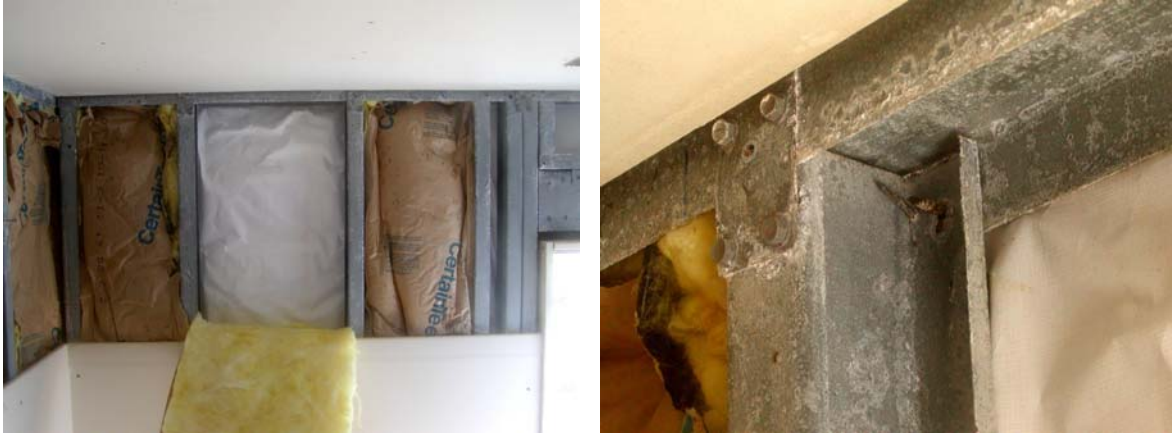
Figure 7.17: Wall framing with lap siding and vapor barrier, MCBH Coastal after 21 months.

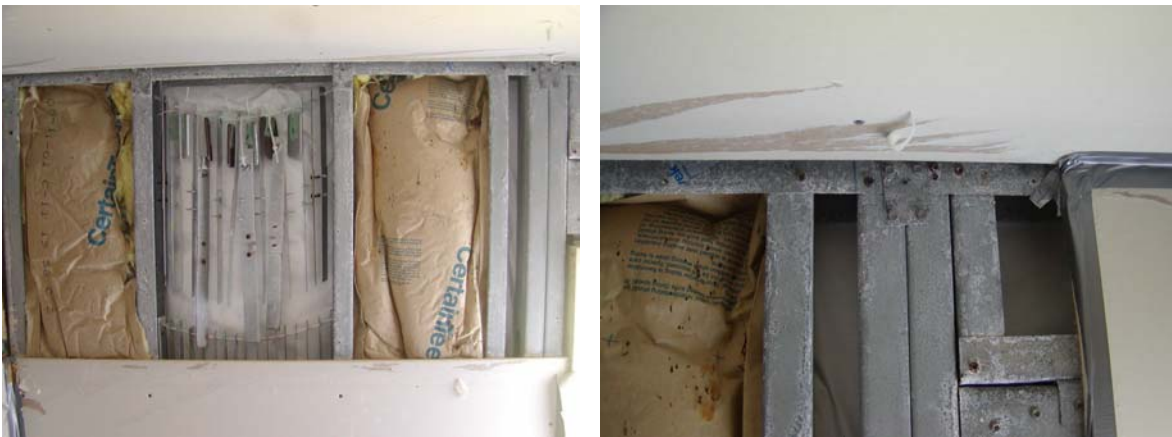
Figure 7.18: Wall framing with lap siding and vapor barrier, MCBH Coastal after 28 months.

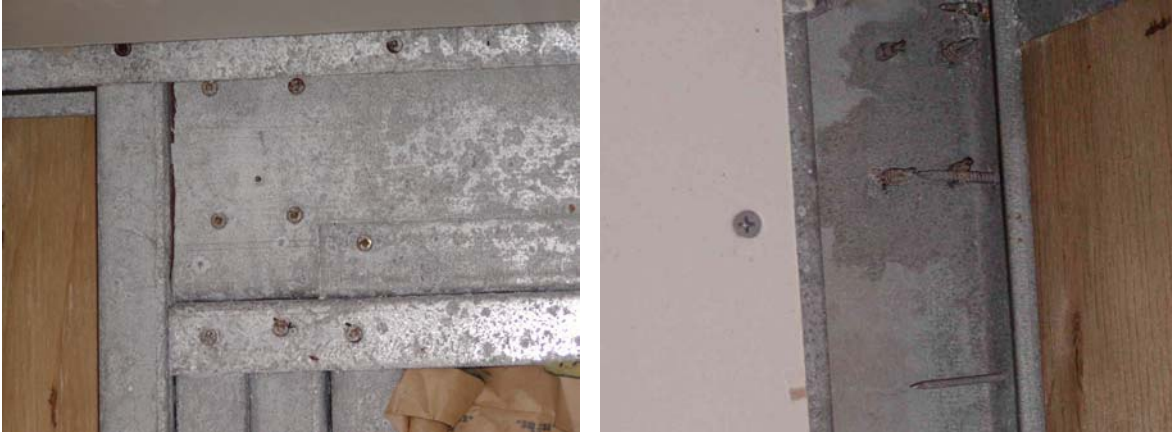
After 16 months of exposure, there was some evidence of ferrous oxide on the cut ends of CFS sections and on the heads and threads of the framing fasteners at the top of the wall with plywood siding but without a vapor barrier (Figure 7.22). There were many framing fasteners, and virtually all ETF pin fasteners, that showed no signs of corrosion. There were also many

Figure 7.22: Wall framing with plywood sheathing, MCBH Coastal after 16 months.

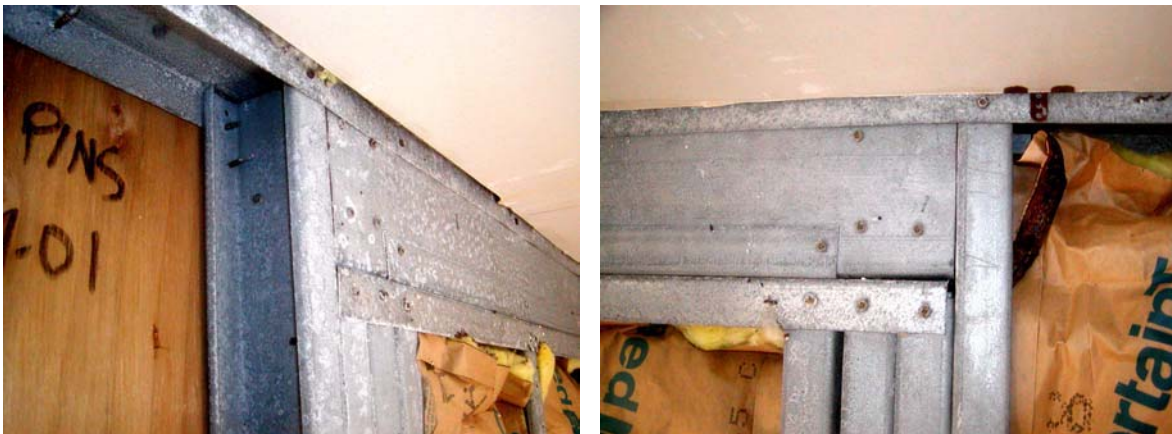
areas of the CFS that were untarnished. There was some progression of the corrosion after 21 months (Figure 7.23) and 28 months (Figure 7.24), including on the ETF pin fasteners used to secure the plywood sheathing, particularly at the top of the wall. In general the observed condition was similar to or better than the wall with lap siding and vapor barrier.

Figure 7.23: Wall framing with plywood sheathing, MCBH Coastal after 21 months.

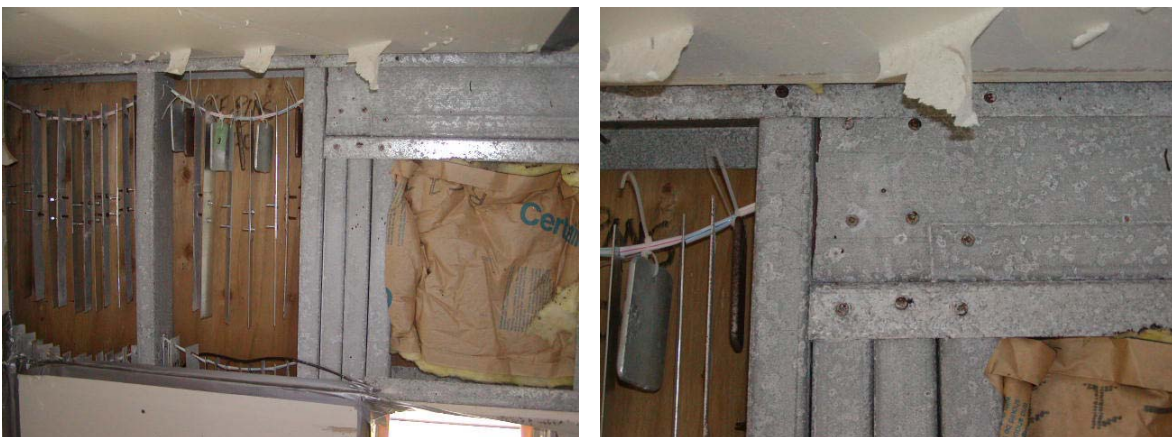
Figure 7.24: Wall framing with plywood sheathing, MCBH Coastal after 28 months.

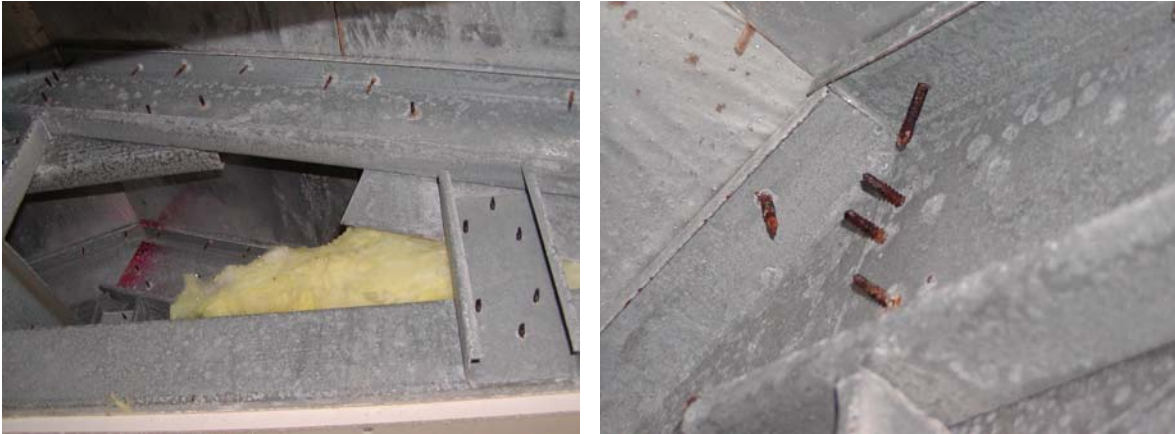
After 16 months there was already significant ferrous oxide on virtually all of the fasteners in the vented attic (Figure 7.25). This condition worsened at 21 months (Figure 7.26) and 28 months (Figure 7.27), by which time there was also significant ferrous oxide at cut ends of the CFS framing members (Figure 7.27).

Figure 7.25: Vented attic framing at MCBH Coastal after 16 months.

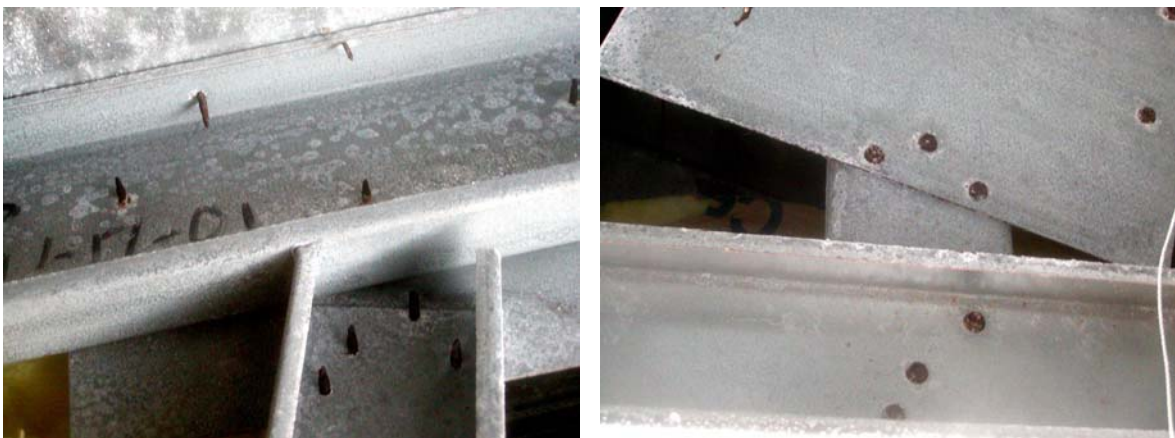
Figure 7.26: Vented attic framing at MCBH Coastal after 21 months.

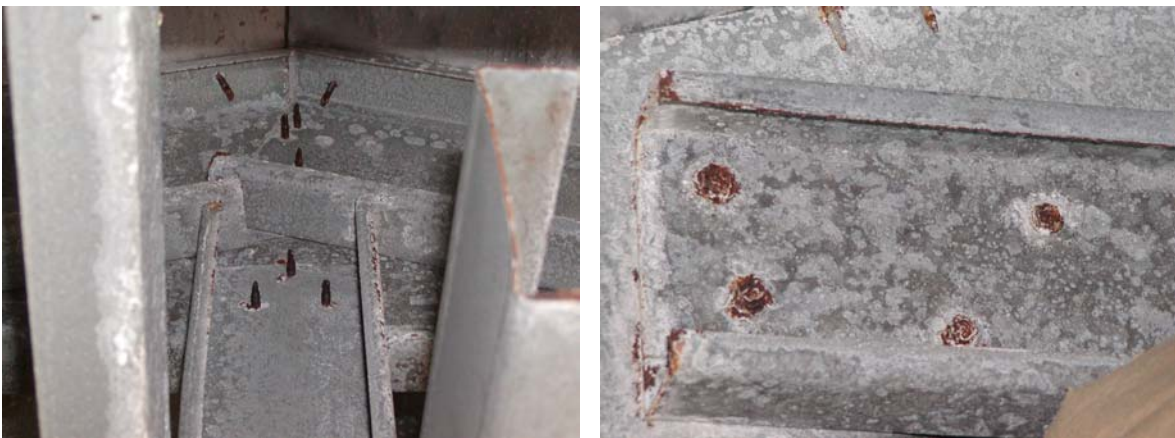
Figure 7.27: Vented attic framing at MCBH Coastal after 28 months.

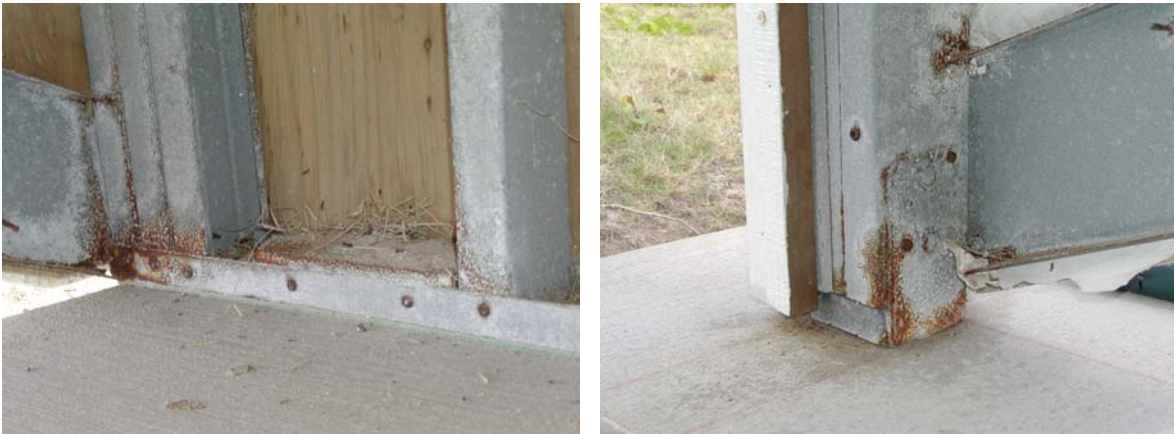
Figure 7.28, Figure 7.29, Figure 7.30 and Figure 7.31 show a progression of the corrosion on the cripple wall and post supports in the crawl space of the MCBH Coastal enclosure. After 5 months there were signs of tarnishing of the zinc galvanizing, and ferrous oxide on some of the fastener heads or threads, and cut ends of the CFS members (Figure 7.28). By 16 months, the zinc coating on portions of the CFS framing had corroded completely and ferrous oxide was forming on end regions of the CFS members and galvanized anchor hardware. There was also significant ferrous oxide on the exposed fastener heads (Figure 7.29). At the 21 month inspection it was clear that this corrosion had progressed rapidly (Figure 7.30) and after 28 months there was clear indication that the corrosion had compromised the integrity of the CFS studs, post and post base hardware (Figure 7.31). The corrosion appeared to concentrate in regions exposed directly to through flow of chloride laden air from the nearby coastline.

Figure 7.29: Crawl space cripple wall and post, MCBH Coastal after 16 months.

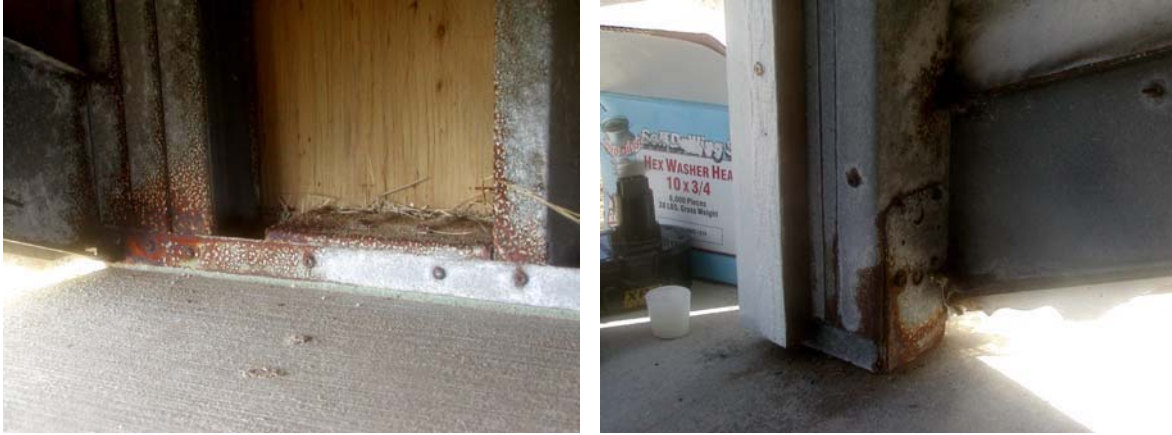
Figure 7.30: Crawl space cripple wall and post, MCBH Coastal after 21 months.

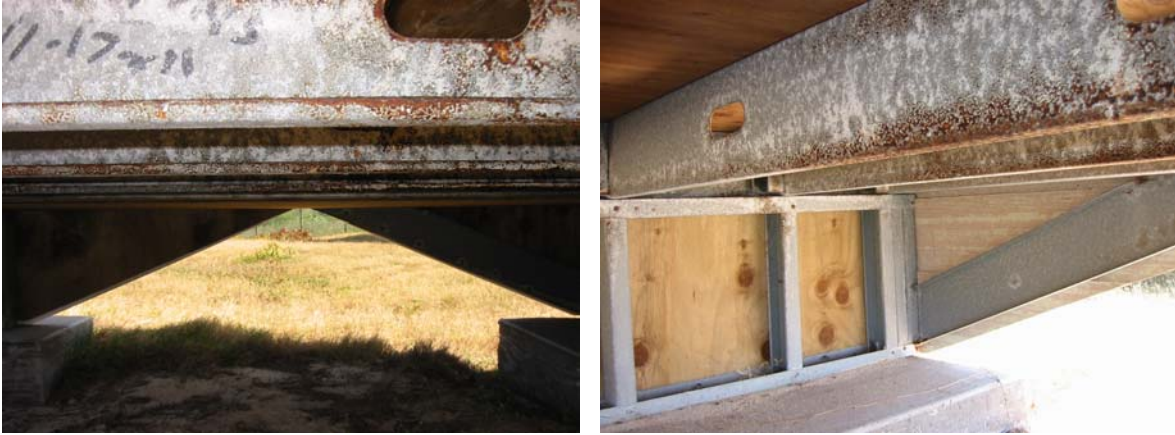
Figure 7.32 through Figure 7.38 show the exposed floor joist framing in the crawl space of the MCBH Coastal enclosure. After 5 months, the surface of the joists was tarnished and there was evidence of ferrous oxide on cut edges and some of the exposed fasteners (Figure 7.32). After 10 months exposure, this corrosion had progressed significantly with considerable ferrous oxide at the joist bottom flange and at cut ends and punchouts. There were also signs of ferrous oxide on most of the exposed fasteners (Figure 7.33).

Figure 7.33: Crawl space exposed floor joists, MCBH Coastal after 10 months.
