**Corrosion of Galvanized
Fasteners used in Cold-
Formed Steel Framing**

RESEARCH REPORT RP04-4

2004

FINAL REPORT

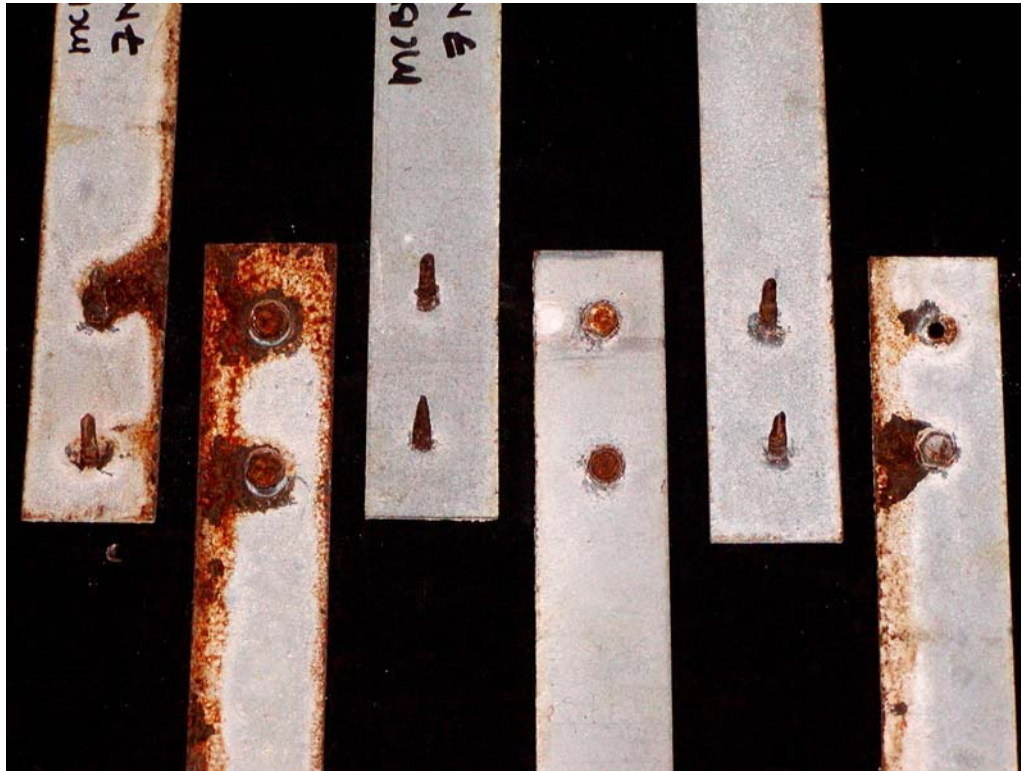
Figure 6.3: MCBH Coastal – 7 Months Exterior Exposure

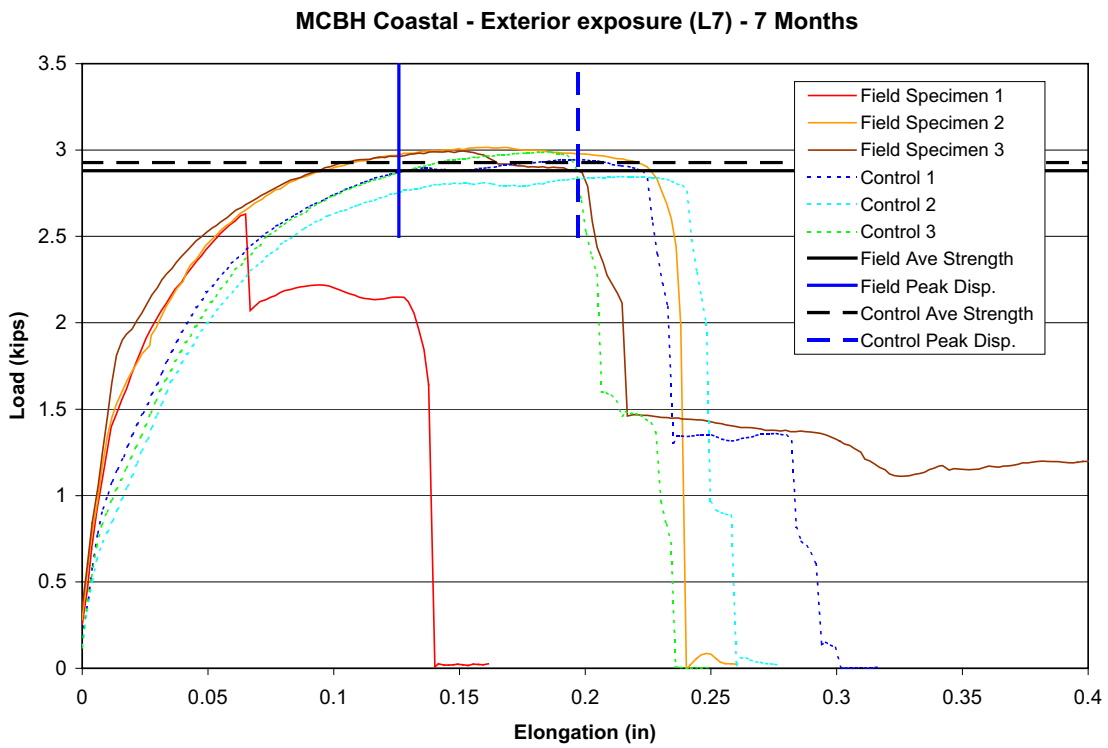
Figure 6.4: MCBH Coastal – 7 Months Exterior Exposure – Test Results

However, the displacement ratio shows a significant decrease in ductility for the MCBH Coastal specimens that were subjected to exterior exposure, and a modest decrease for the other connection sets (Figure 6.16). The average peak elongation of the field test specimens after 7 months exposure is 74% of that observed in the control connections. This reduction in average elongation is often the result of a single connection, which failed at a significantly lower deformation than the control specimens.

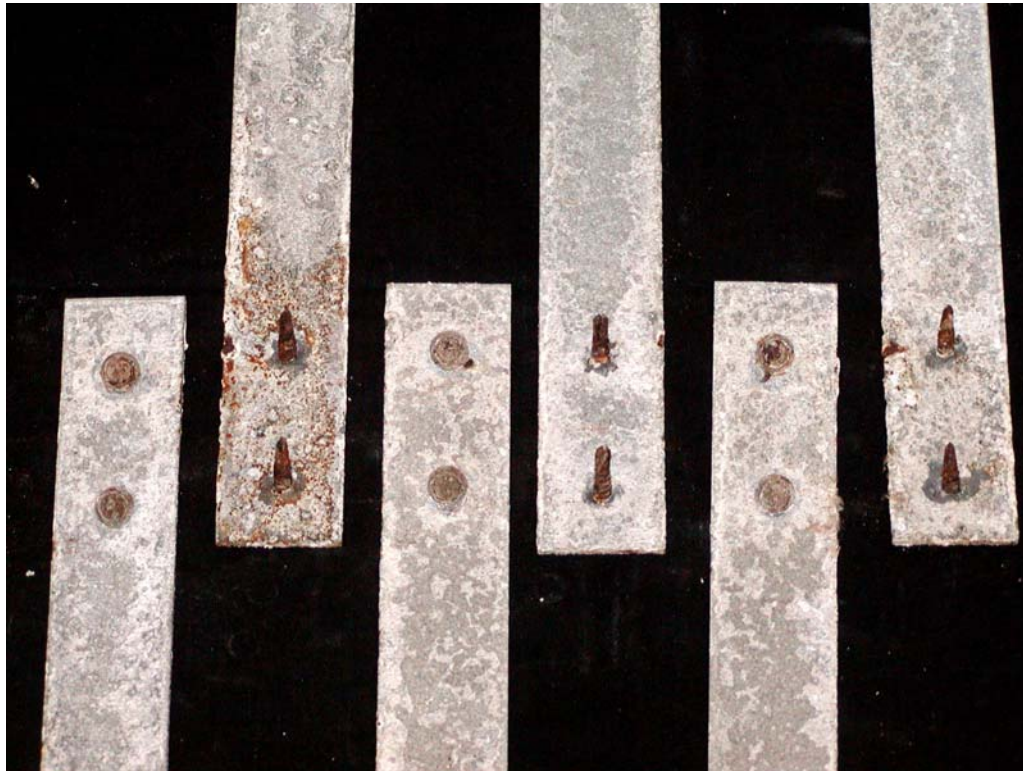
Figure 6.7: MCBH Coastal – 7 Months Open Crawl Exposure

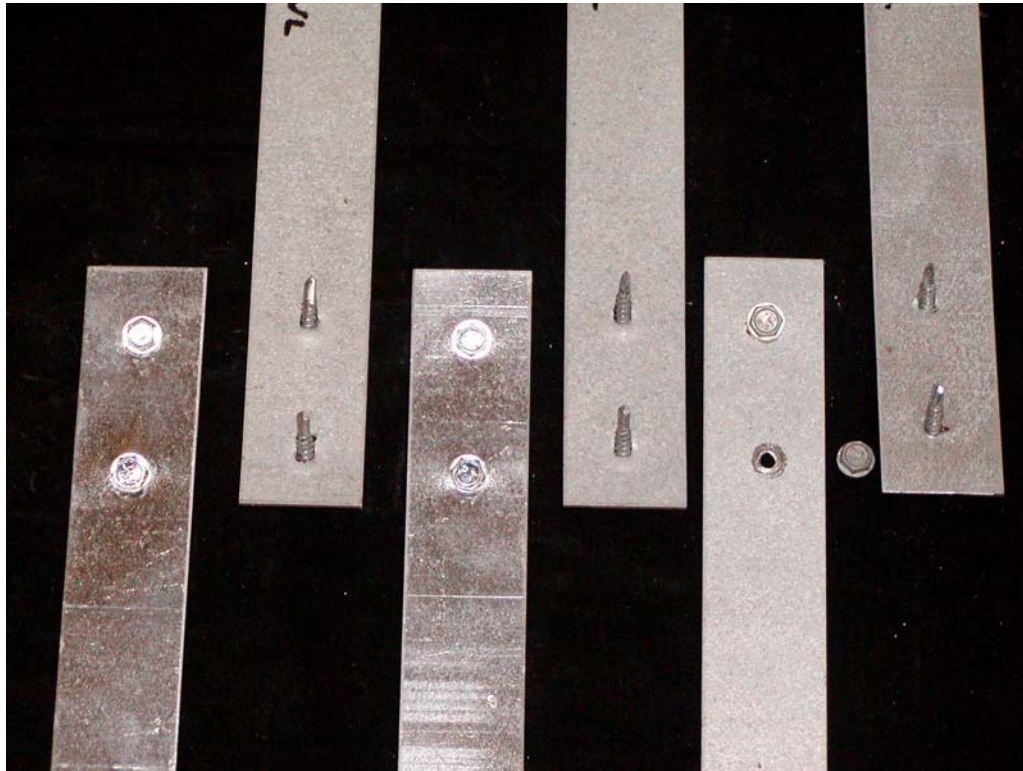
Figure 6.9: MCBH Coastal – 7 Months Covered Crawl Exposure

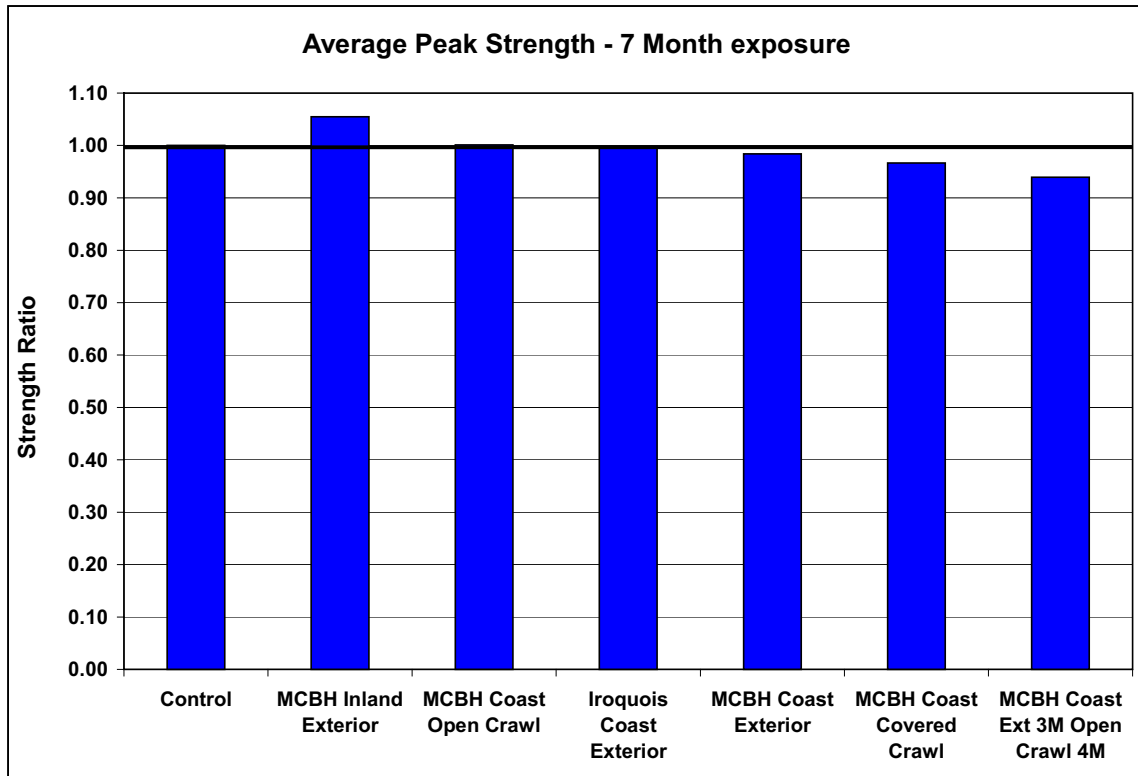
Figure 6.15: Average Strength Ratio for field specimens after 7 month exposure

The strength ratios in Table 6-1 are plotted in Figure 6.15, and show that there has been no change in the average failure strength of the lap connections recovered from the field after 7 months exposure. The average strength ratio is 0.99 for all 6 connection sets tested.

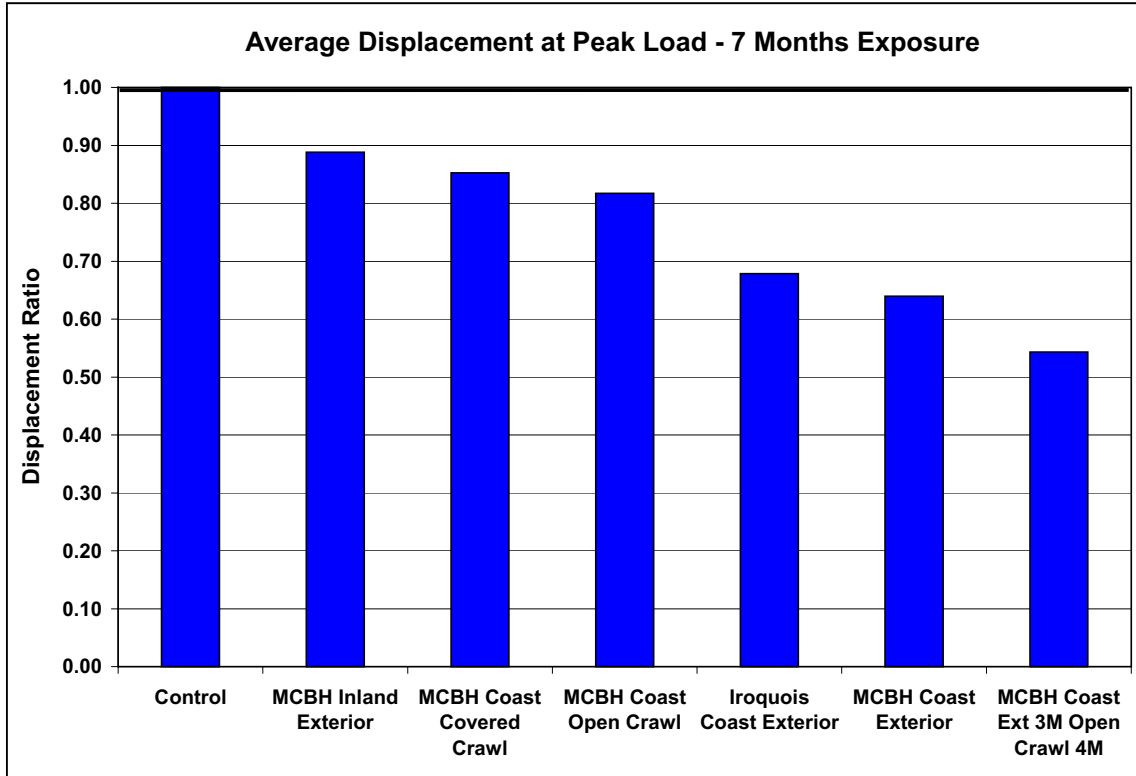
Figure 6.16: Average Displacement at Peak Load for field specimens exposed for 7 months.

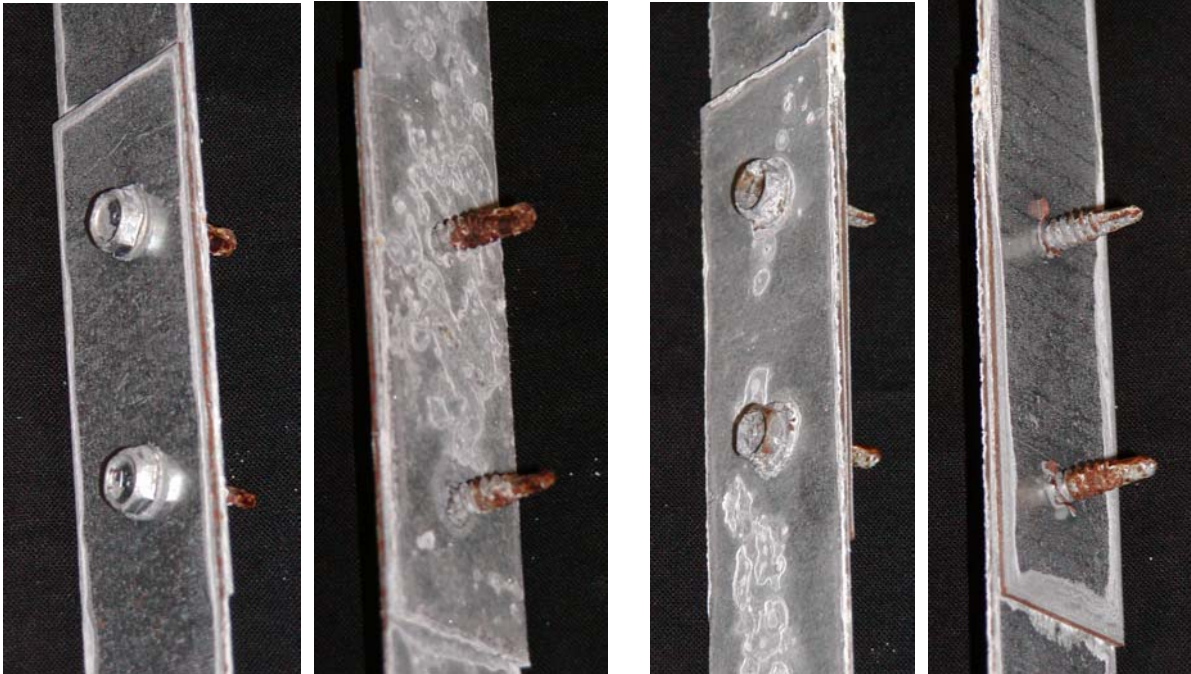
Figure 6.20: Test connections after 1309 cycles – Threads up (left) and down (right)

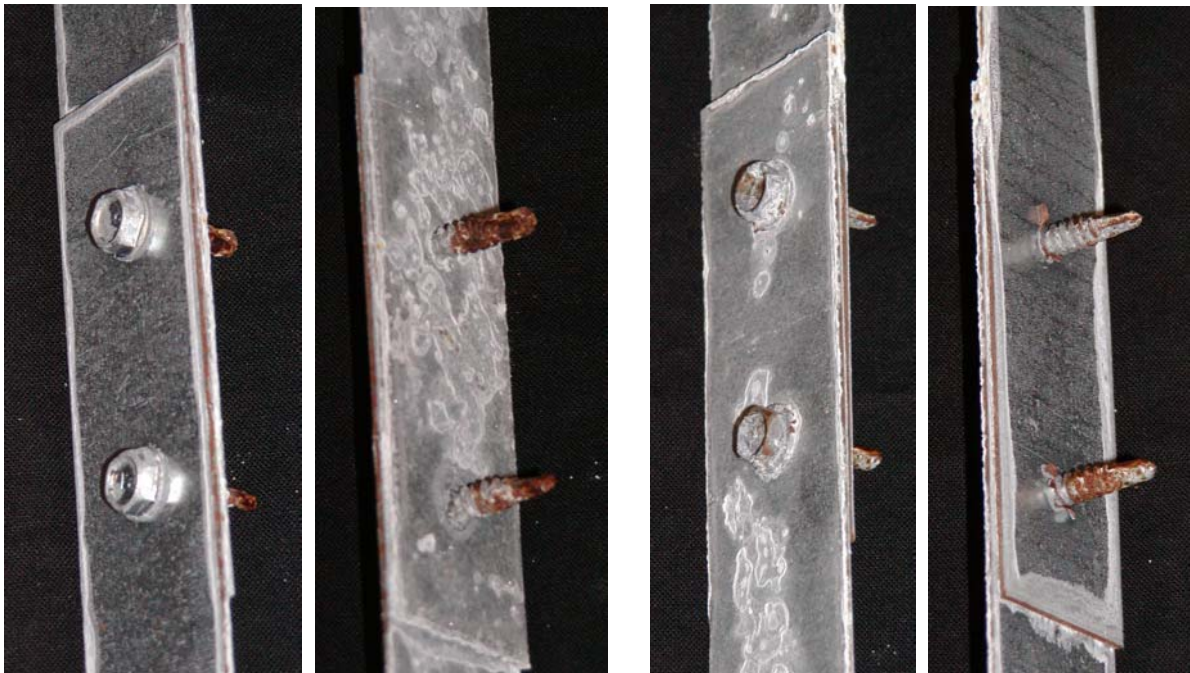
Figure 6.23: Test connections after 1537 cycles – Threads up (left) and down (right)

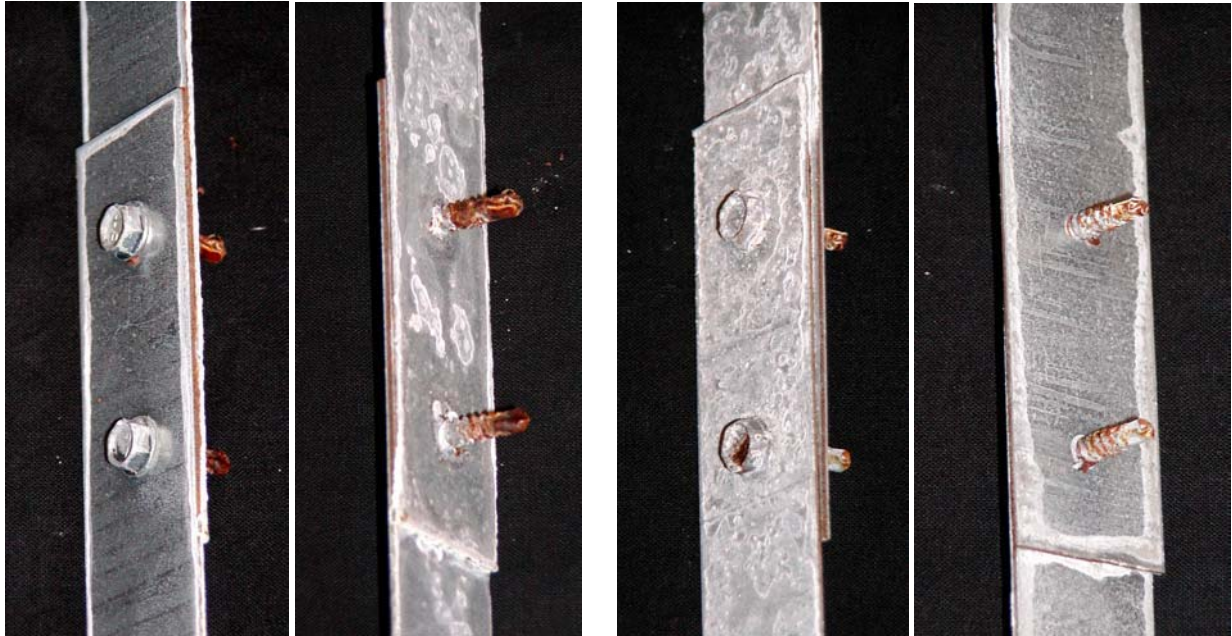
Figure 6.26: Test connections after 1695 cycles – Threads up (left) and down (right)

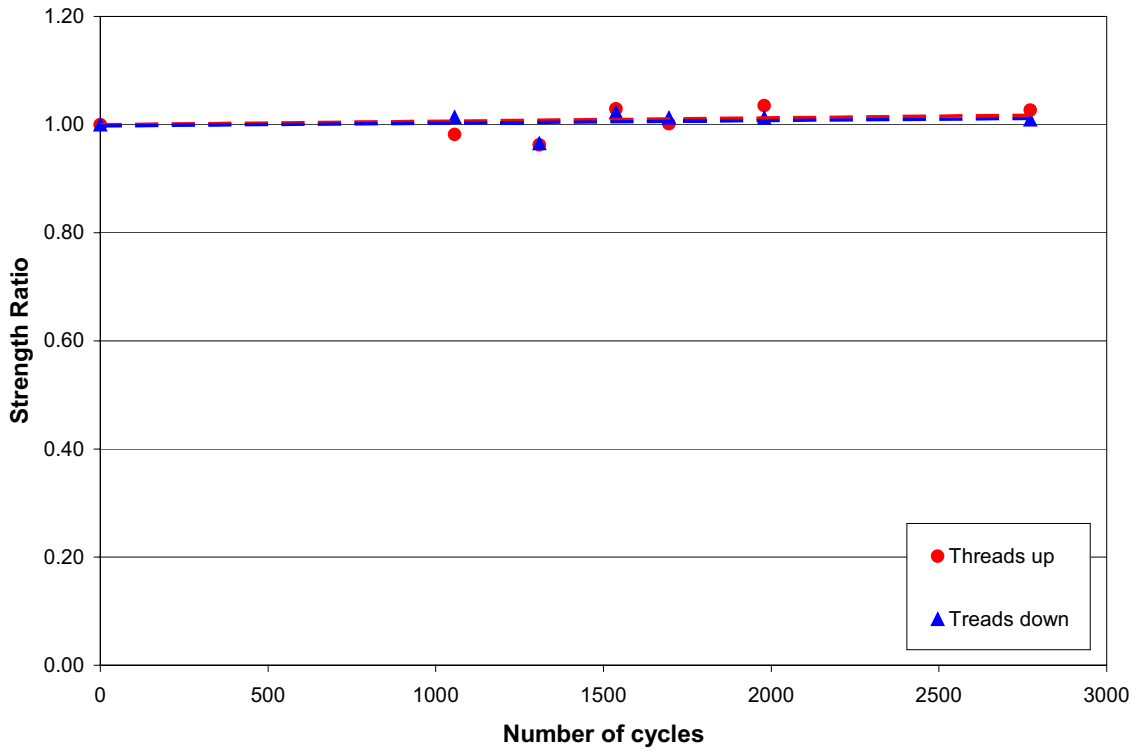
After 2772 cycles in the corrosion chamber, the galvanized screws showed significant surface corrosion (Figure 6.32). Nevertheless, the average connection strength had not decreased, regardless of whether the threads were oriented up or down in the corrosion chamber (Figure 6.35). However, the average specimen elongation at the peak load had decreased to around 80% of that for the control specimen (Figure 6.36). This decrease was larger for the connections stored with threads up. It appears that the connection ductility is affected by this level of corrosion, though the strength is not. Figure 6.37 to Figure 6.40 show microscopic images of the screw threads for control and 1537 cycle test specimens before and after testing. Although the surface corrosion appears significant, it has not yet penetrated the shaft of the screw, and hence has not affected the screw failure strength (Figure 6.40).

Figure 6.35: Strength Ratio versus Number of Cycles in corrosion chamber

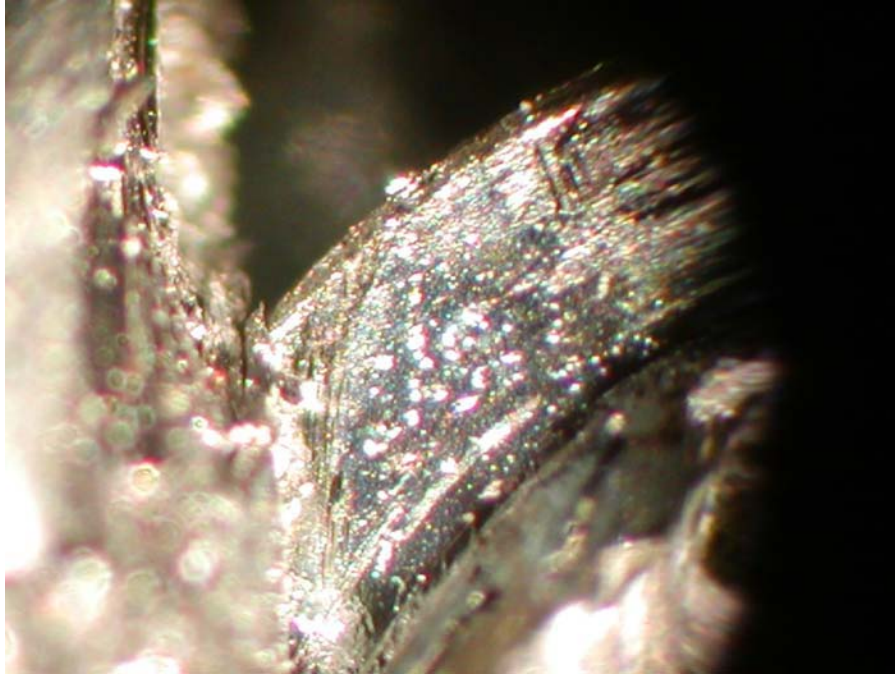
Figure 6.39: Close-up of screw threads after control specimen failure.

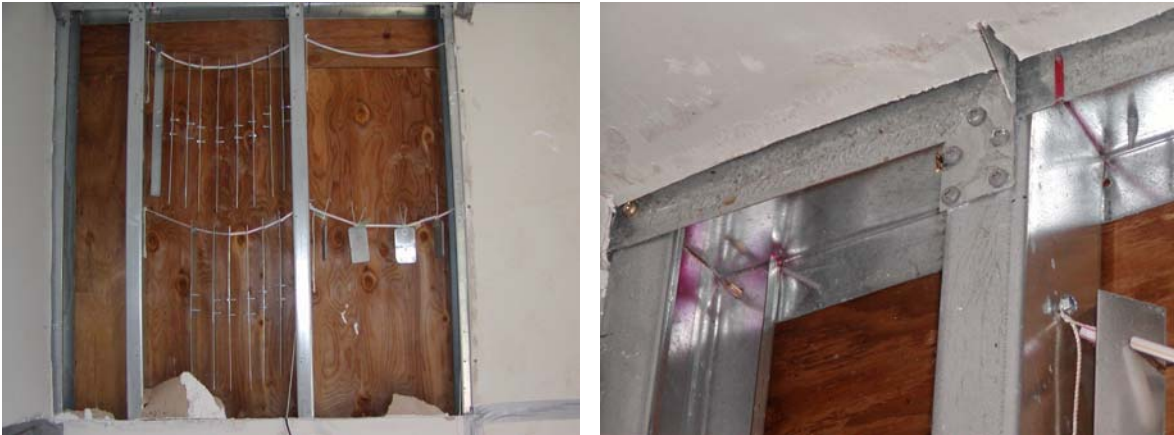
Figure 7.1: Interior wall framing and fasteners at Iroquois Coastal site after 20 months exposure

As seen in Figure 7.1, there were no signs of corrosion on the CFS framing or fasteners in the enclosed wall framing for these three sites.

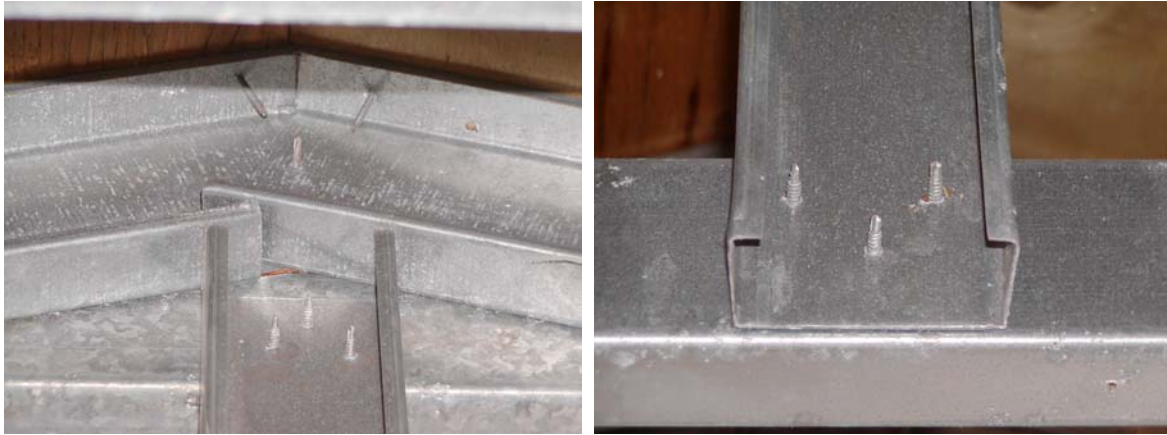
Figure 7.3: Attic framing at Wheeler site after 20 months exposure.

Initiation of corrosion was evident at the cut edges of the CFS framing and on some of the fasteners in the vented attics of the two Iroquois sites as shown in Figure 7.2. The fasteners in the vented attic at the Wheeler site showed no corrosion as seen in Figure 7.3.

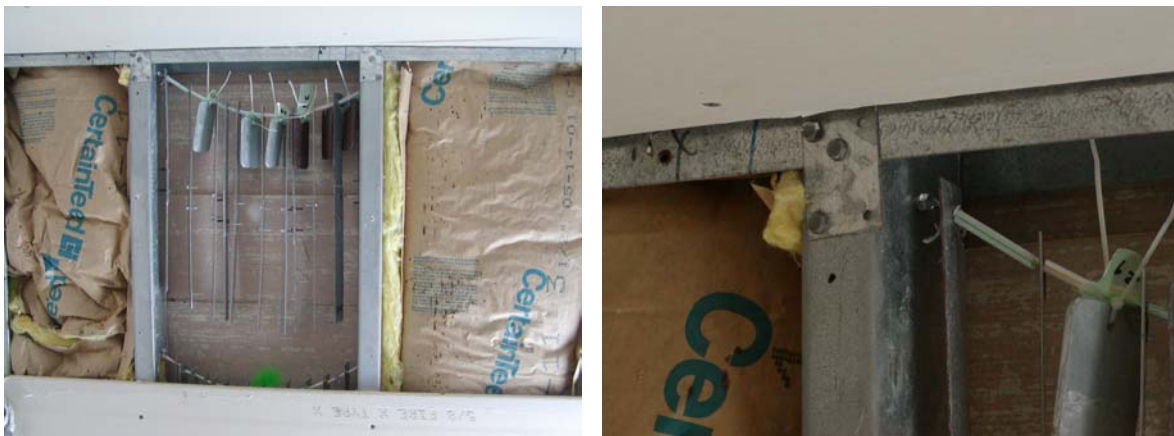
Figure 7.7: Wall framing without vapor barrier at MCBH Inland after 28 months.

After 28 months of exposure, no evidence of corrosion was noted on the framing members or fasteners in the wall framing with lap siding but no vapor barrier (Figure 7.7).

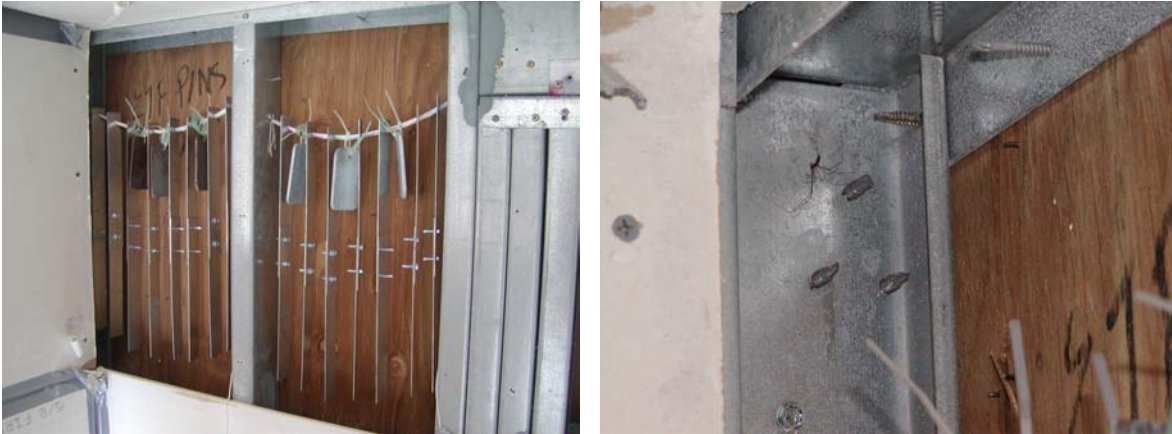
Figure 7.8: Wall framing with plywood sheathing at MCBH Inland after 28 months.

After 28 months of exposure, no evidence of corrosion was noted on the framing members or fasteners in the wall framing with plywood sheathing and no vapor barrier (Figure 7.8).

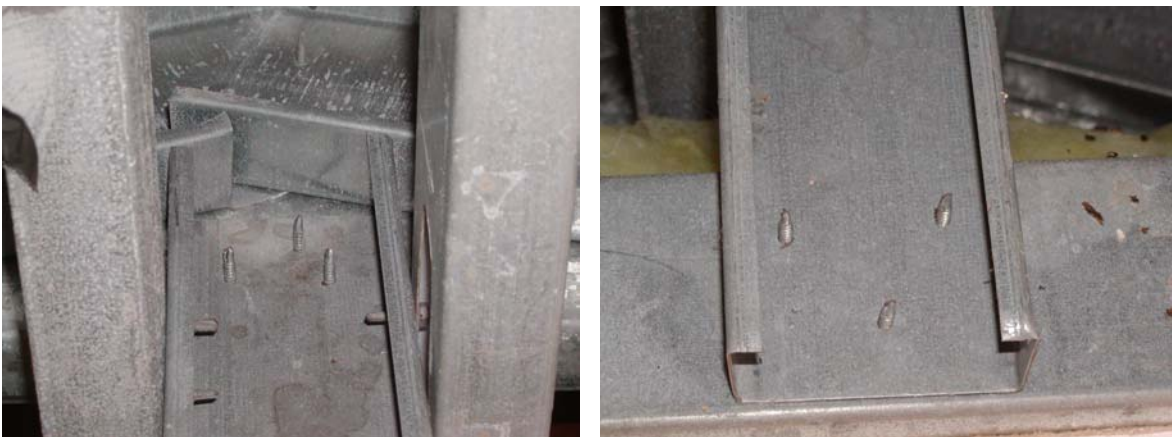
Figure 7.9: Vented attic framing at MCBH Inland after 28 months exposure.

Portions of the CFS framing in the vented attic showed signs of tarnishing due to zinc coating corrosion, but all fasteners were free of ferrous oxide (Figure 7.9).

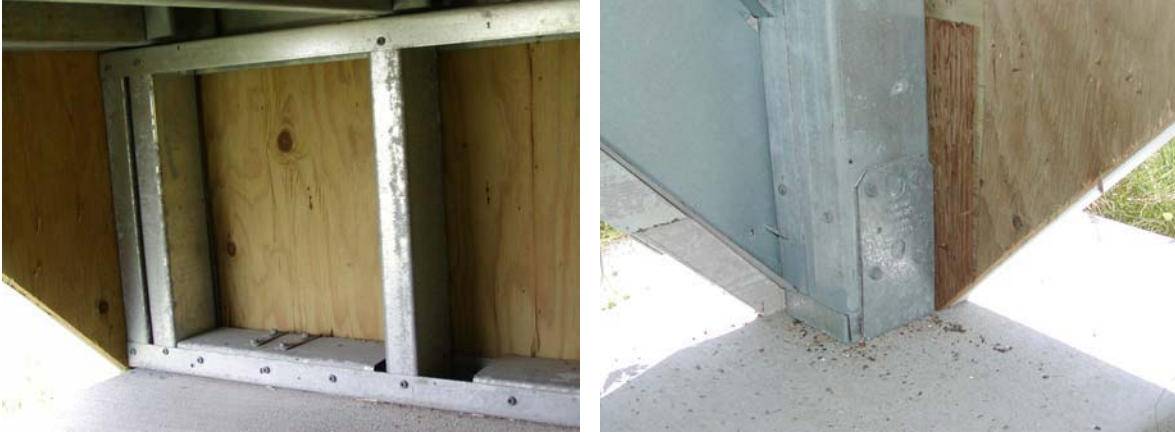
Figure 7.10: Crawl space cripple wall and post at MCBH Inland after 5 months exposure.

Figure 7.10, Figure 7.11 and Figure 7.12 show a progression of the corrosion on the cripple wall and post supports in the crawl space of the MCBH Inland enclosure. After 5 months there were signs of tarnishing of the zinc galvanizing, but no evidence of ferrous oxide on the fastener heads or threads. By 16 months, the galvanizing was fully tarnished and ferrous oxide was evident on some of the fastener heads and threads. By 28 months, there was more significant corrosion on the same fasteners and initiation of corrosion at other fasteners elsewhere in the crawl space support framing.

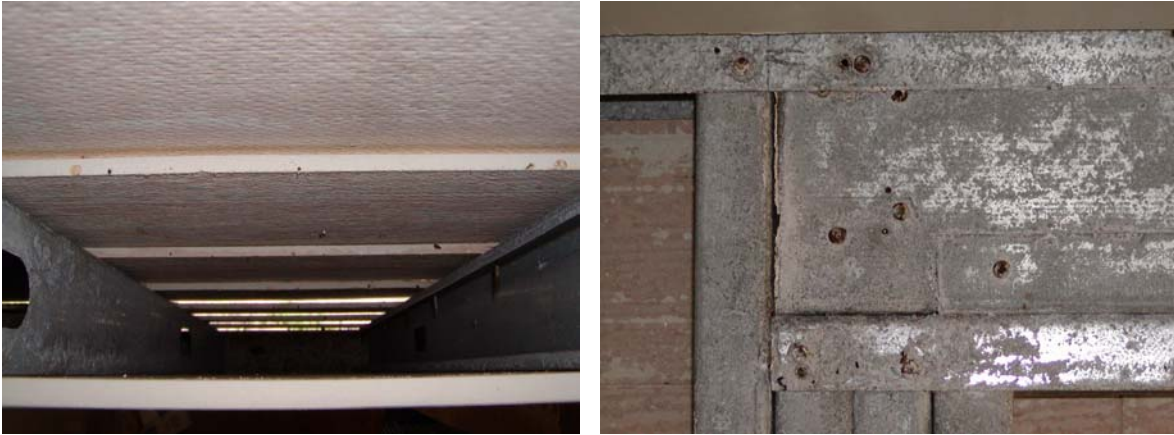
Figure 7.19: Wall framing with lap siding without vapor barrier, MCBH Coastal after 16 months.

After 16 months of exposure, there was evidence of ferrous oxide on the cut ends of CFS sections and on both heads and threads of the framing fasteners in the wall with lap siding but without a vapor barrier (Figure 7.19). This corrosion was particularly severe at the top plate and top section of the studs, but was evident throughout the height of the studs. This condition worsened after 21 months (Figure 7.20) and 28 months (Figure 7.21). In addition to any exterior air entering through the vented attic to the top of the wall, there was now easy access for exterior air through the lap siding itself (Figure 7.19). The corrosion in this wall was considerably worse than that in either the lap siding wall with vapor barrier or the plywood sheathed wall without vapor barrier.

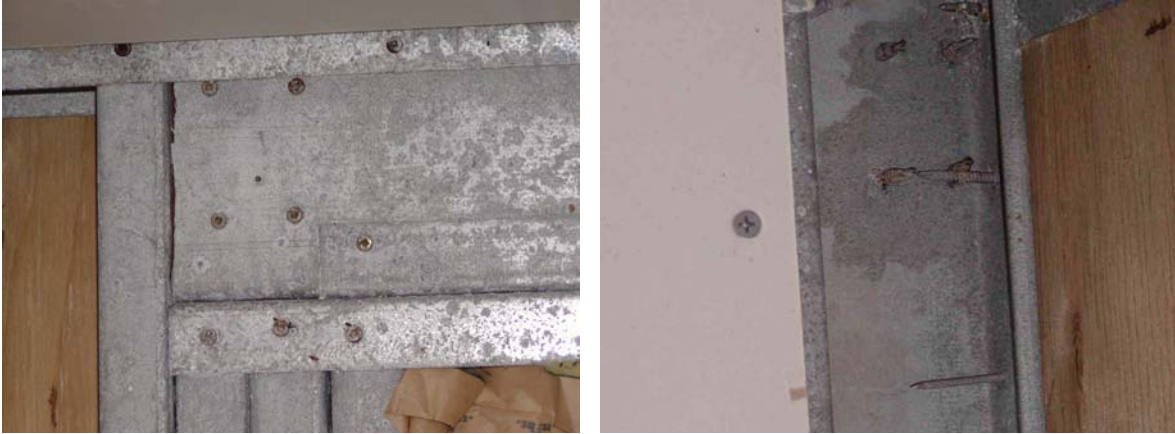
Figure 7.22: Wall framing with plywood sheathing, MCBH Coastal after 16 months.

After 16 months of exposure, there was some evidence of ferrous oxide on the cut ends of CFS sections and on the heads and threads of the framing fasteners at the top of the wall with plywood siding but without a vapor barrier (Figure 7.22). There were many framing fasteners, and virtually all ETF pin fasteners, that showed no signs of corrosion. There were also many

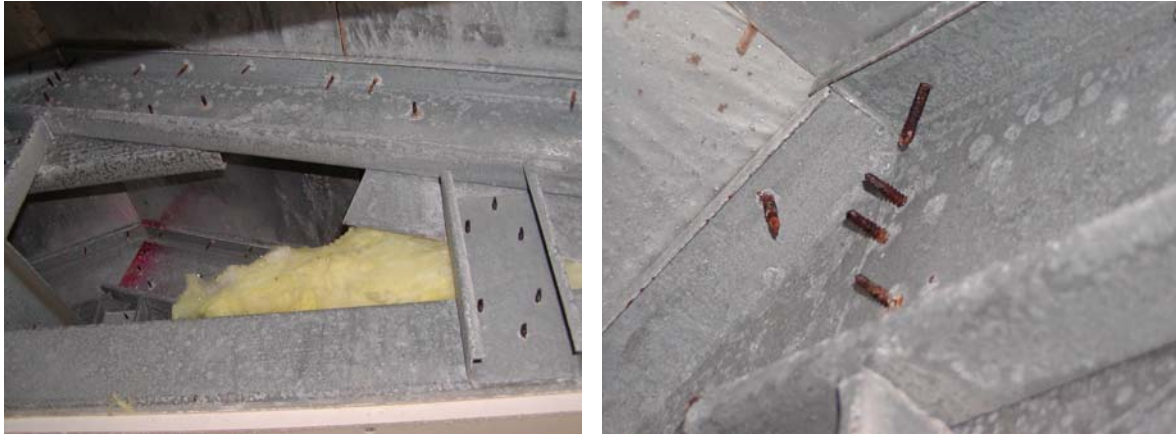
Figure 7.25: Vented attic framing at MCBH Coastal after 16 months.

After 16 months there was already significant ferrous oxide on virtually all of the fasteners in the vented attic (Figure 7.25). This condition worsened at 21 months (Figure 7.26) and 28 months (Figure 7.27), by which time there was also significant ferrous oxide at cut ends of the CFS framing members (Figure 7.27).

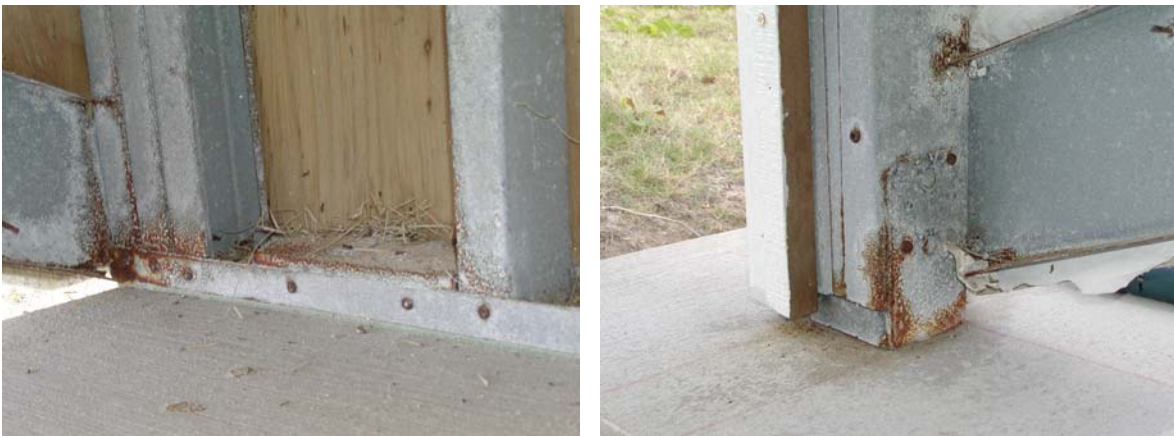
Figure 7.29: Crawl space cripple wall and post, MCBH Coastal after 16 months.

Figure 7.28, Figure 7.29, Figure 7.30 and Figure 7.31 show a progression of the corrosion on the cripple wall and post supports in the crawl space of the MCBH Coastal enclosure. After 5 months there were signs of tarnishing of the zinc galvanizing, and ferrous oxide on some of the fastener heads or threads, and cut ends of the CFS members (Figure 7.28). By 16 months, the zinc coating on portions of the CFS framing had corroded completely and ferrous oxide was forming on end regions of the CFS members and galvanized anchor hardware. There was also significant ferrous oxide on the exposed fastener heads (Figure 7.29). At the 21 month inspection it was clear that this corrosion had progressed rapidly (Figure 7.30) and after 28 months there was clear indication that the corrosion had compromised the integrity of the CFS studs, post and post base hardware (Figure 7.31). The corrosion appeared to concentrate in regions exposed directly to through flow of chloride laden air from the nearby coastline.

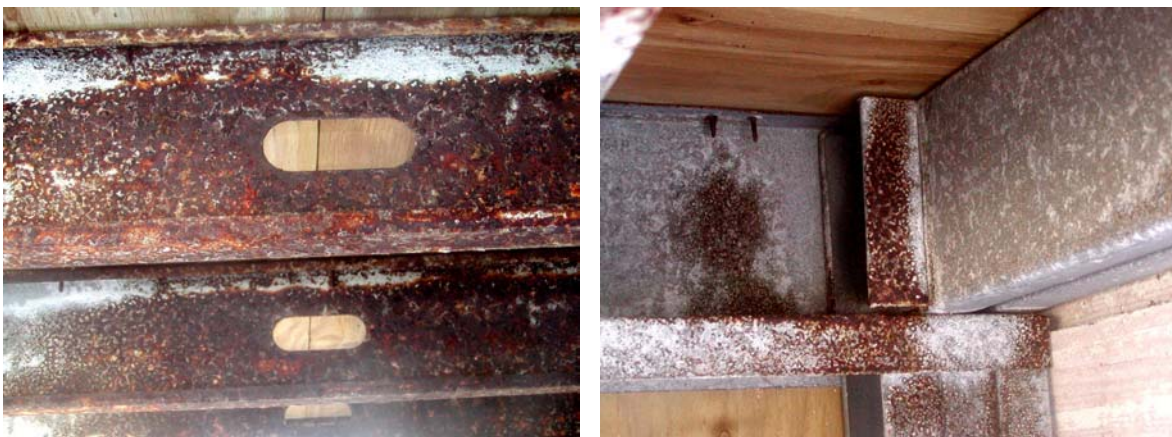
Figure 7.36: Crawl space exposed floor joists, MCBH Coastal after 21 months.

After 21 months, corrosion of the exposed floor joists had progressed to the point where it would be described as severe (Figure 7.36). Large areas of the zinc galvanizing have corroded completely, allowing significant corrosion of the underling steel sheet. Exposed fasteners in the joist end connections and between the plywood flooring and the joist top flange also showed significant corrosion. However, the joists covered by plywood sheathing were still in the original “like new” condition (Figure 7.37). The only signs of corrosion on these enclosed floor joists were at the end connections where there was corrosion on the member cut ends and the connection fasteners. This corrosion was attributed to leaking of exterior air between the end of the plywood sheathing and the cripple wall top plate (Figure 7.37). This edge of the plywood sheathing simply butted against the edge of the top plate, and had not been sealed.

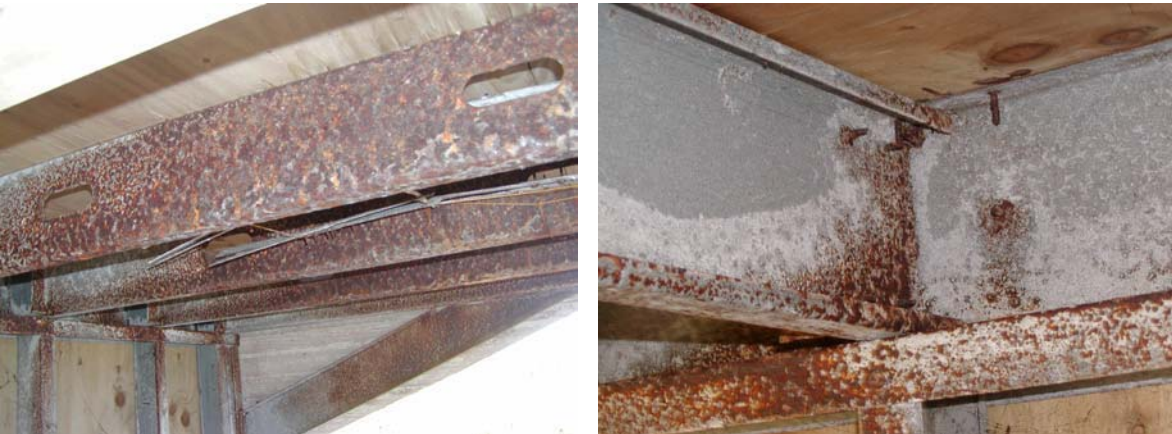
Figure 7.38: Crawl space exposed floor joists, MCBH Coastal after 28 months.

After 28 months, corrosion of the exposed floor joists had extended over virtually the entire length and depth of each joist (Figure 7.38). Connection fasteners had significant ferrous oxide on exposed heads and threads.
