Phase 1 Inspection Report: National Dam Safety Program. White River Basin. Ozark Lead Tailings Dam, Reynolds County, Missouri

OZARK LEAD TAILINGS DAM
REYNOLDS COUNTY, MISSOURI
MO 30166

PHASE 1 INSPECTION REPORT NATIONAL DAM SAFETY INSPECTION

APRIL 1981

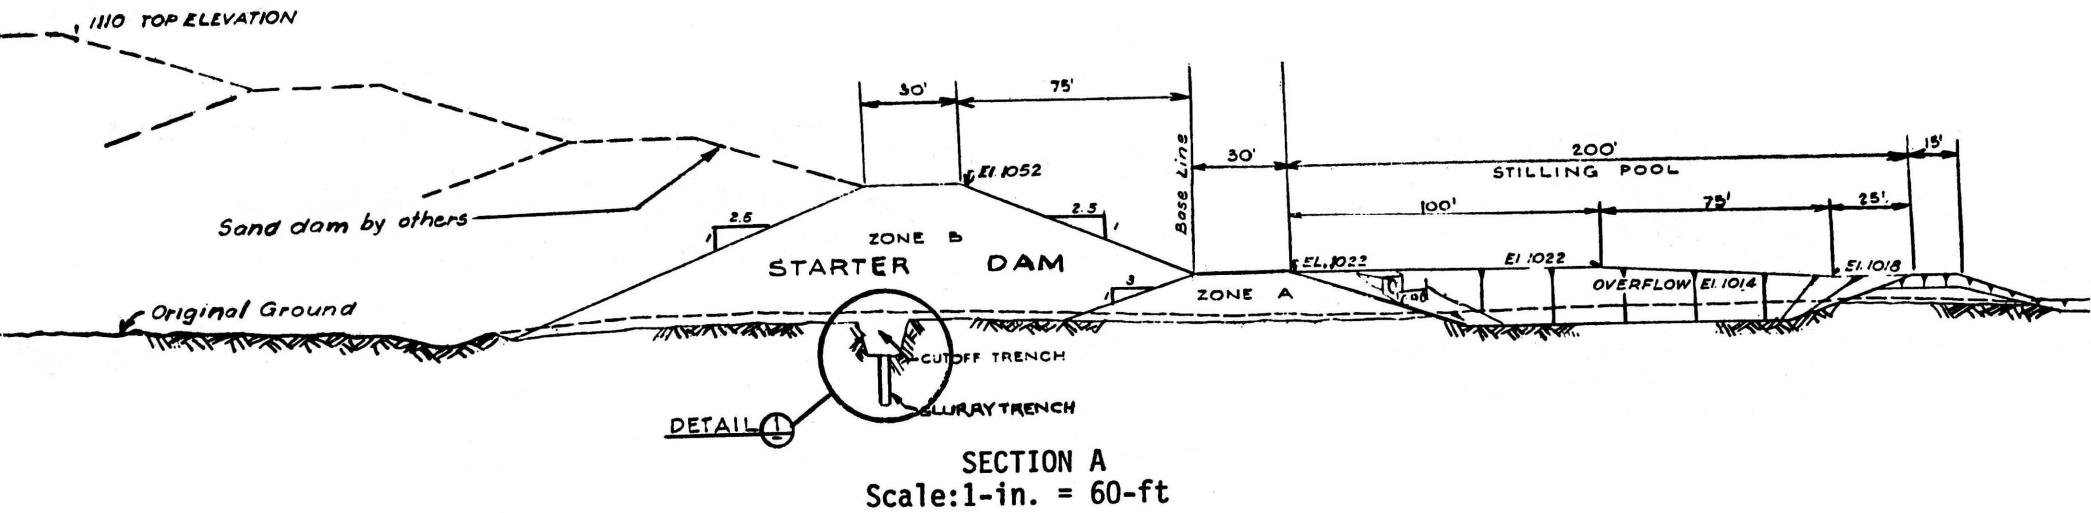
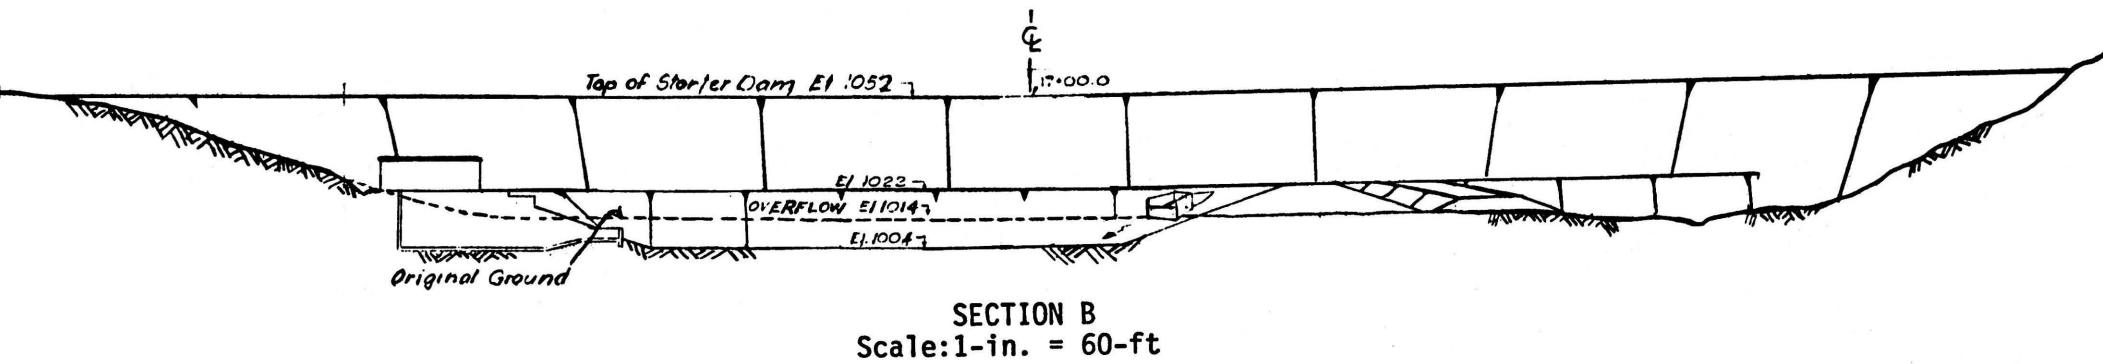
SECTION AND PROFILE OF STARTER DAM	
OZARK LEAD TAILINGS DAM	
MO 30166	Fig. 3-B

The construction of this dam has progressed in several stages. The starter dam and appurtenant structures were designed and constructed by Arthur G. McKee and Co in 1967-1968. A 10-ft wide, 7-ft deep cutoff trench with a 3-ft wide, 6 to 15-ft deep slurry trench was excavated at the centerline of the starter dam (Fig. 3B and 3C). The starter dam was constructed of locally obtained clay soil to a crest elevation of 1052 ft.

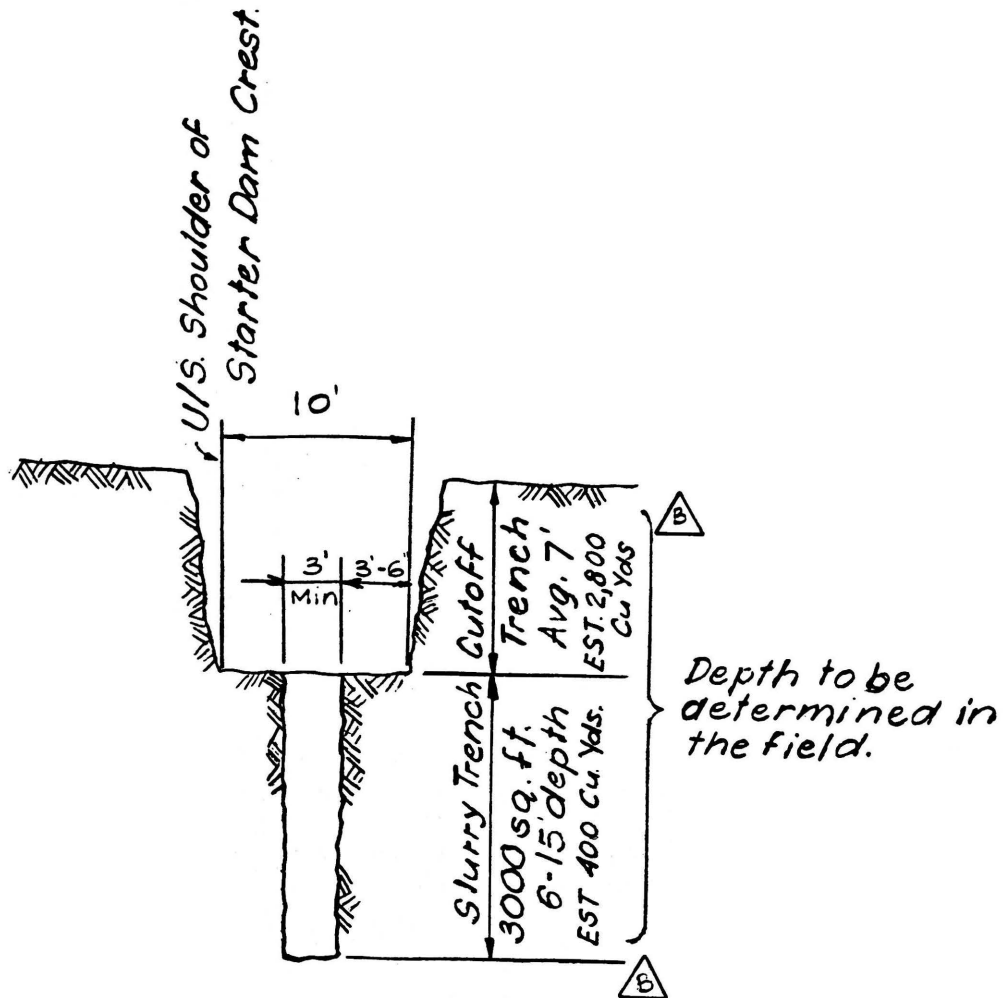
CUT-OFF AND SLURRY TRENCH DETAIL	
OZARK LEAD TAILINGS DAM	
MO 30166	Fig. 3-C

Zoning	Compacted earth starter dam; cyclone deposited sand embankment upstream of starter dam; gravel blanket drain through embankment; compacted earth embankment overlying and downstream of tailings embankment. See Fig. 3E.
Impervious core	Starter dam and earth embankment modification to dam are impervious. Sloping blanket drain separates these two impervious zones. See Fig. 3E.
Cutoff	10 ft wide cutoff trench with 3 ft wide slurry trench at bottom. Cutoff trench averages 7 ft deep, slurry trench 6 to 15 ft deep, depth determined during construction. See Fig. 3-C.
Grout curtain	None

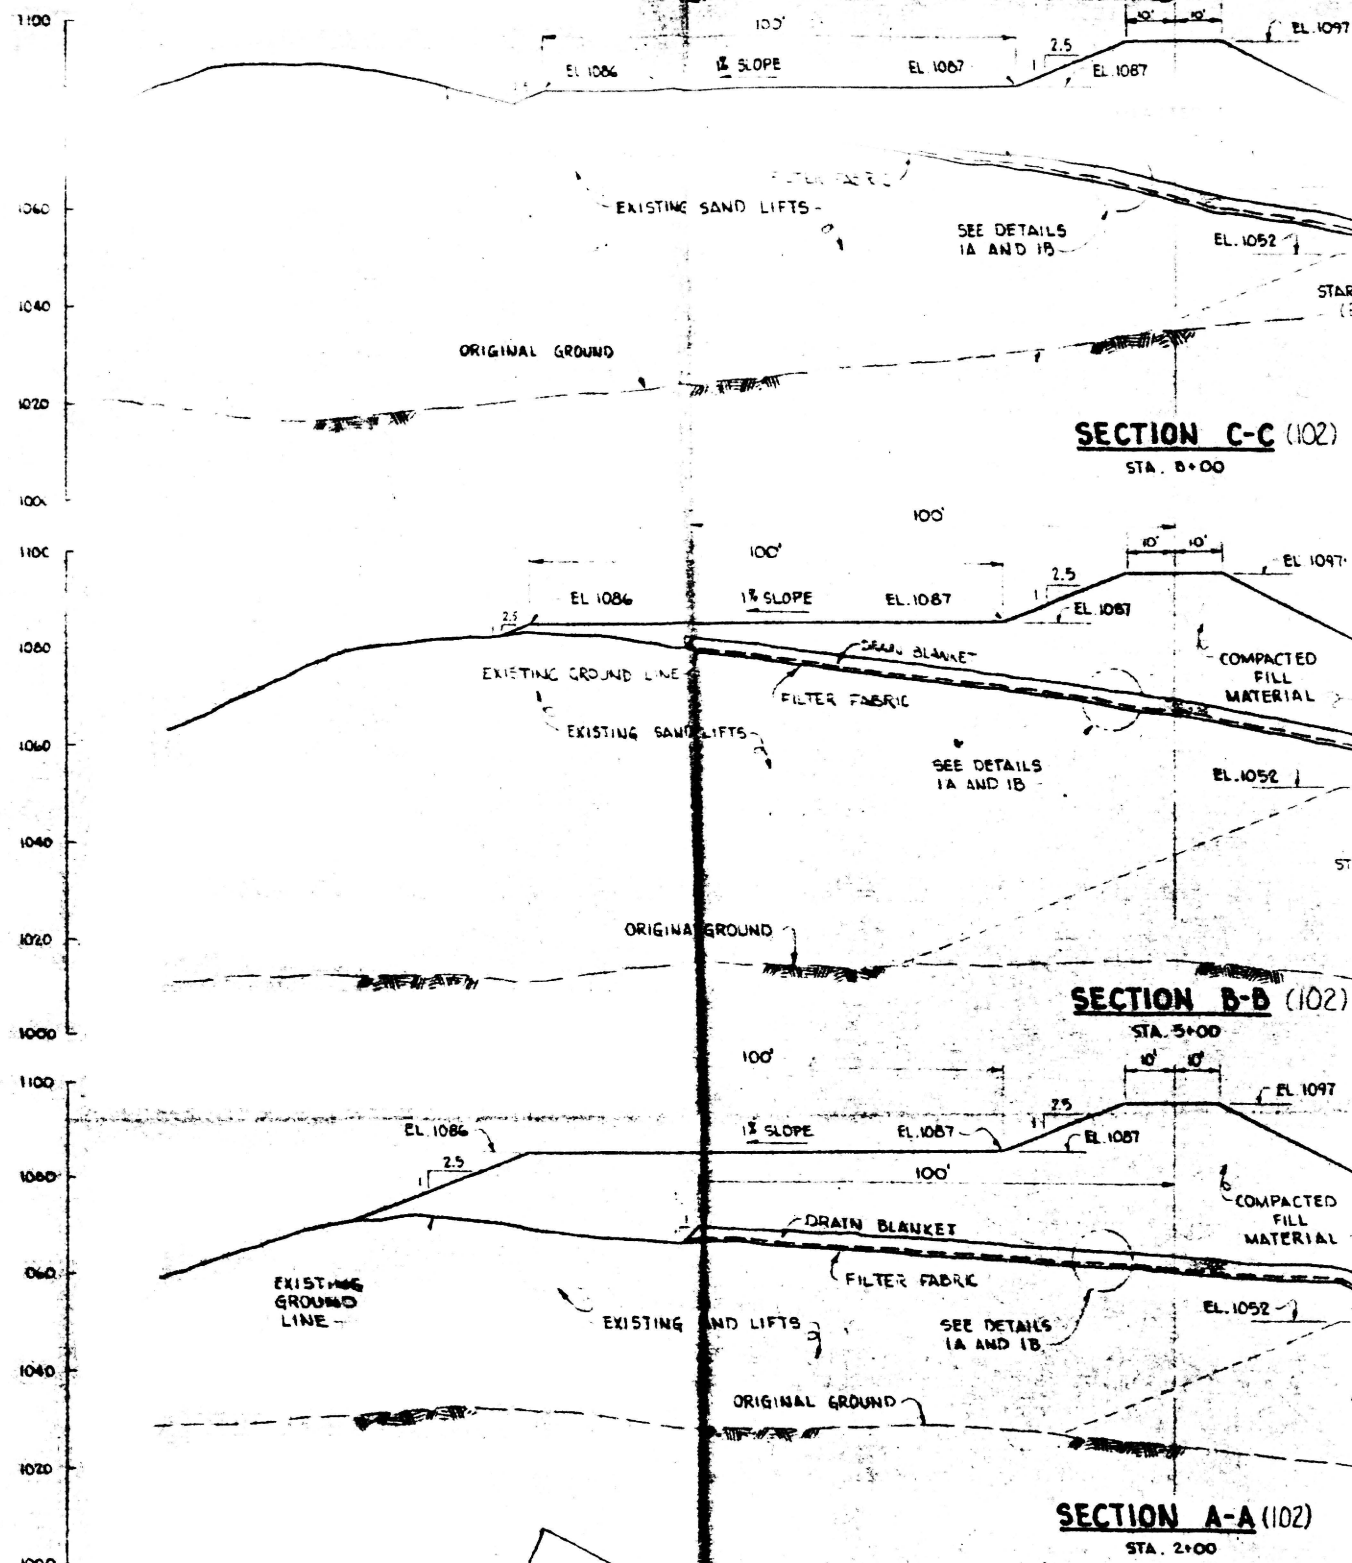
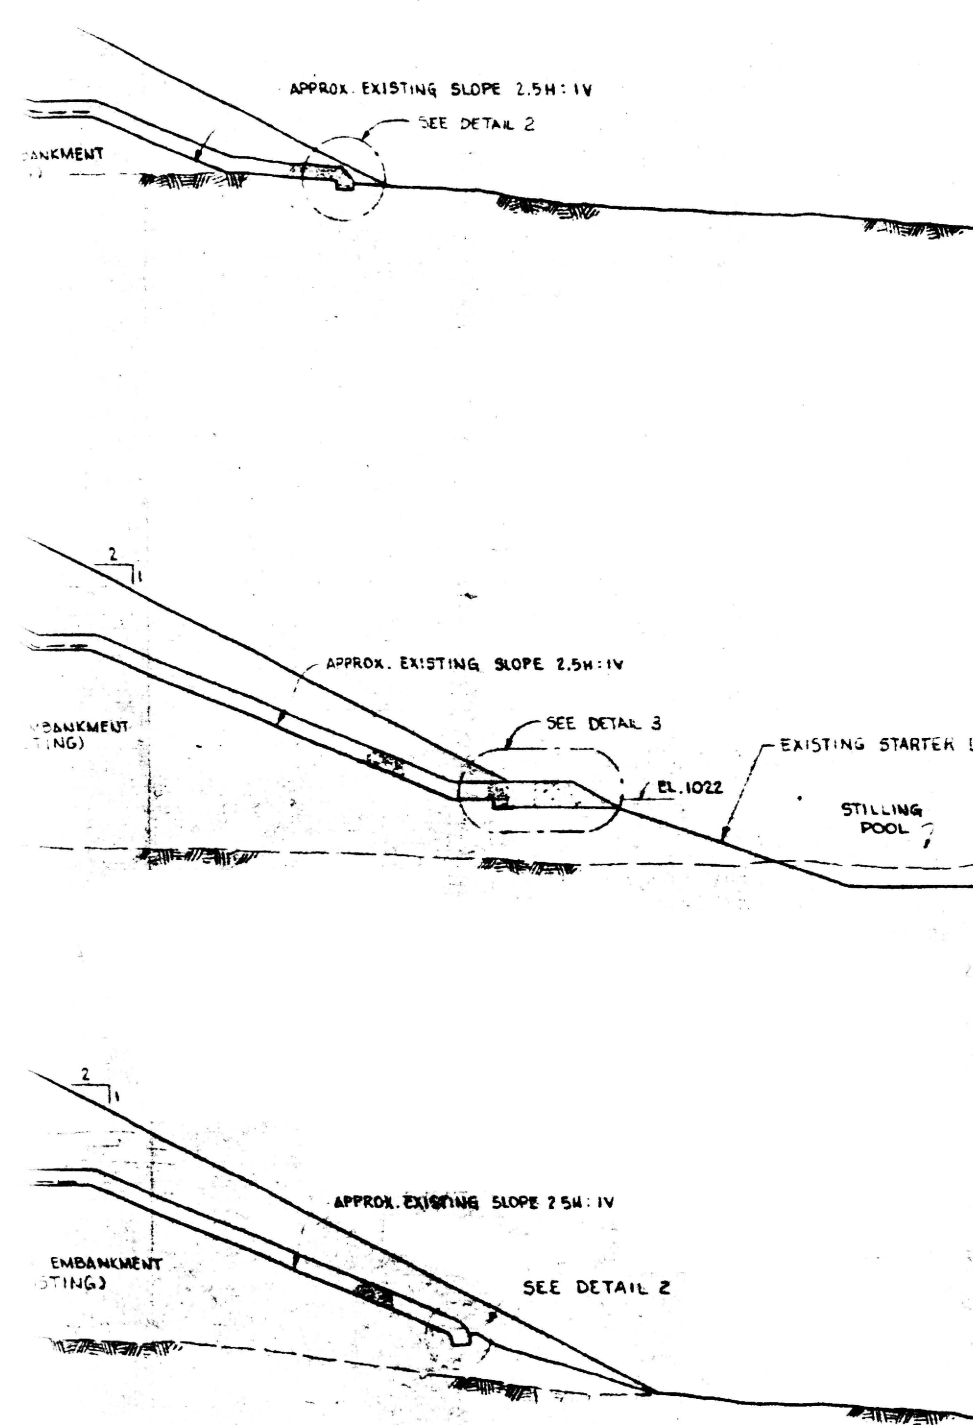
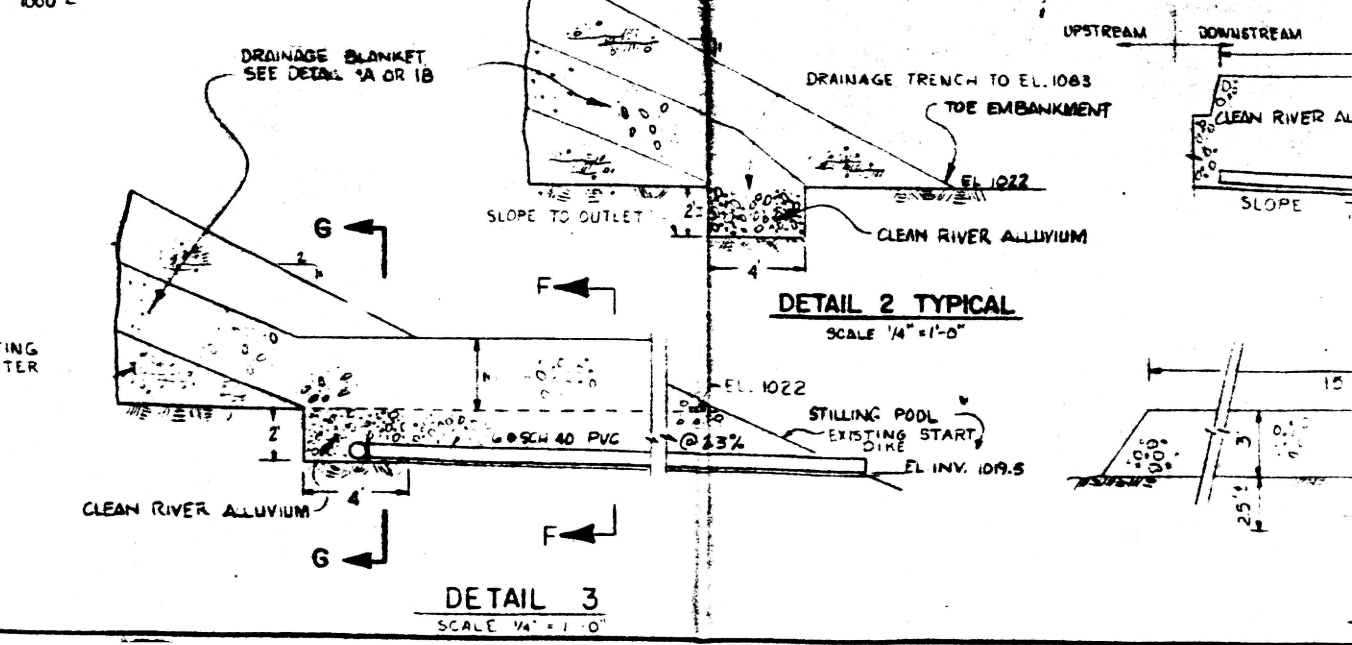
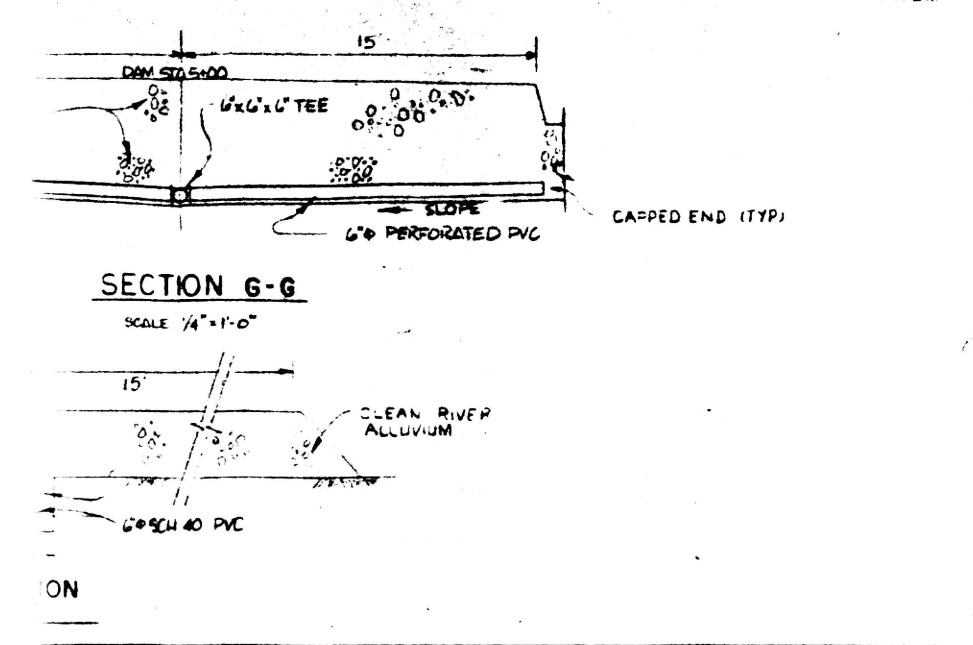
MO 30166 Fig. 3-E

Construction of the new earth embankment included a sloping blanket drain over the tailings embankment and starter dam (Fig. 3E). A fabric filter was laid over the existing dam and a 3-ft thick layer of river alluvium was placed over the fabric to act as a drain (Photo 2). This blanket drain has 3 discharge pipes at the downstream toe of the dam. Weir boxes are used to measure flow from the pipes, which was reported to be fairly constant at approximately 45 gal/min total.
