Bridge Lessons Learned from the Wenchuan China, Earthquake

Bridge Lessons Learned from the Wenchuan, China, Earthquake

W. Phillip Yen, Genda Chen, Mark Yashinsky, Youssef Hashash, Curtis Holub, Kehai Wang, and Xiaodong Guo

A strong earthquake of M7.9 occurred in Wenchuan County in Sichuan Province, China, on May 12, 2008. This paper presents the field observations on various types of bridge damages, including unseating of girders, longitudinal and transverse offset of decks, pounding at expansion joints, shear key failure, bearing displacement, column shear, and flexible cracks. Plausible causes of damages and collapses are discussed and the lessons learned from this event are briefly summarized. Some of the postearthquake temporary constructions are also reported.

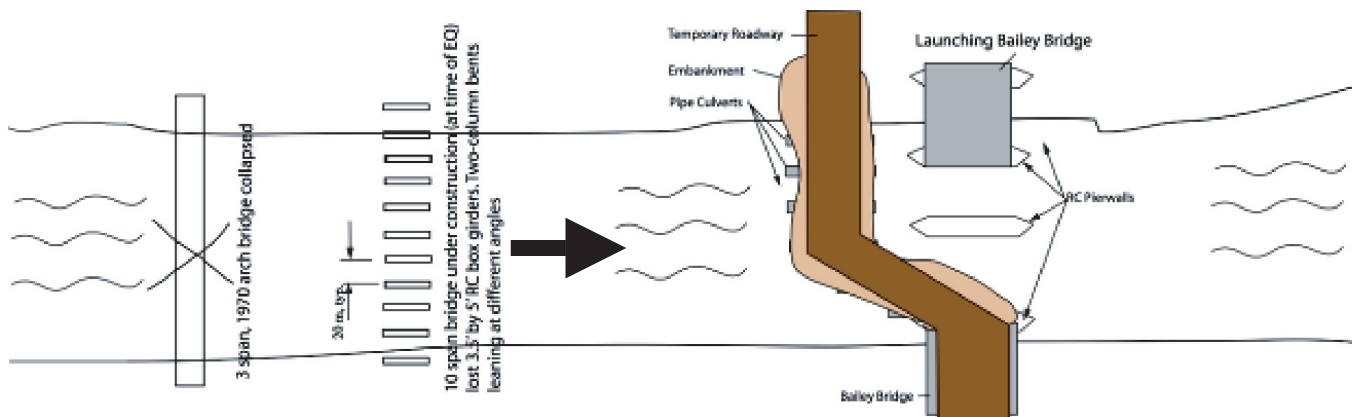
FIGURE 2 Three bridges at Nanba Town.

Three bridges crossed a river (the river's name was not known) near Nanba Town as shown in Figure 2. The west structure was a

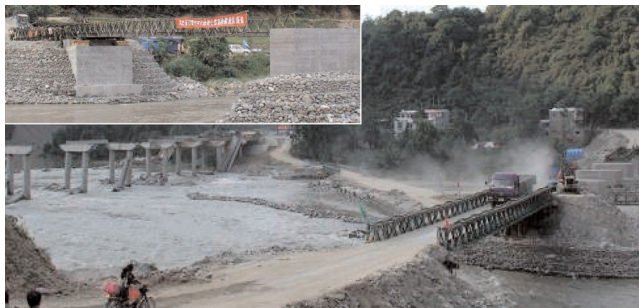
FIGURE 5 Construction of a temporary bridge.

On the east side of the old and new bridges is a temporary structure that was being constructed by launching Bailey bridges onto new reinforced concrete (RC) pier walls at the time of field reconnaissance. As shown in Figure 5, vehicles were driving across the river on fill materials laid over culverts in the meantime.

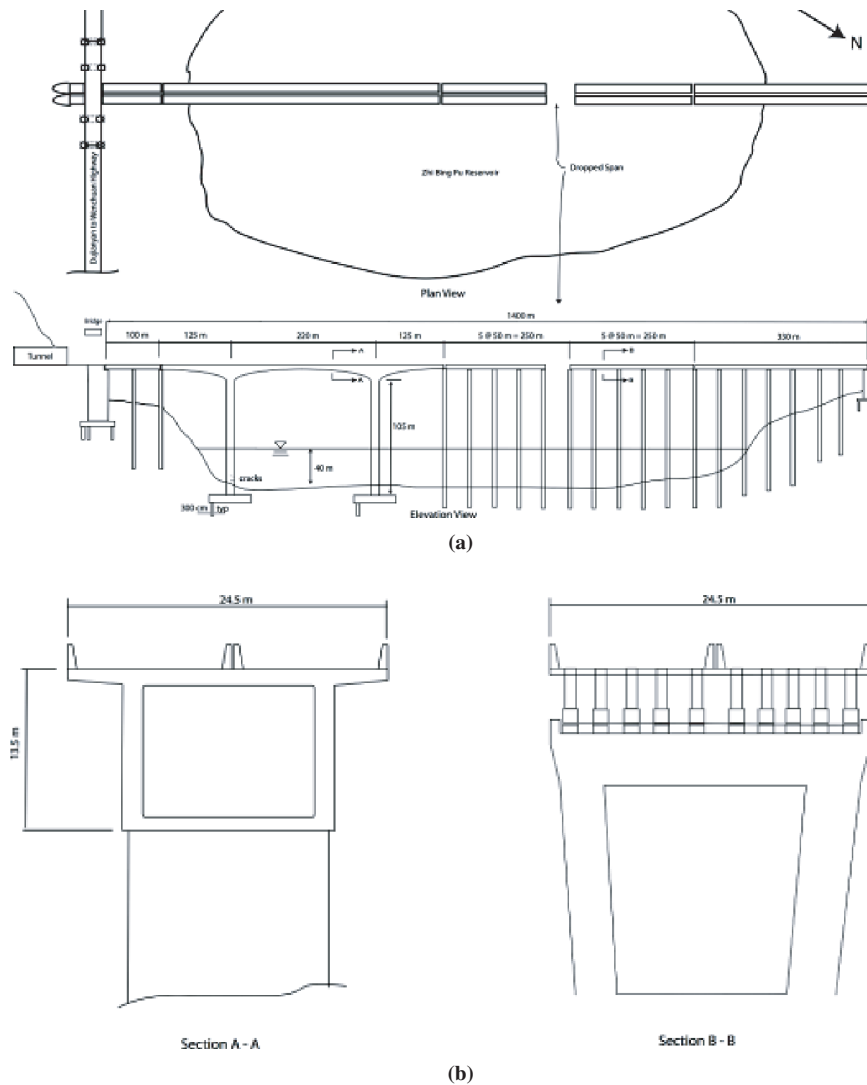
FIGURE 6 Schematic view of the Miaozhiping Bridge: (a) plan and elevation and (b) cross section of main span and approach bridge.

As shown in Figure 6, the approach spans near the tunnel consist of a two-span, RC girder structure with 50-m span length each. The bridge deck is supported on five RC girders and two-column bents with several cross-struts. The bridge deck is continuous but its supporting girders are simply supported on the bents. As shown in Figure 6, the main bridge is a continuous, nonprismatic, three-span structure supported on two intermediate wall piers with a length of

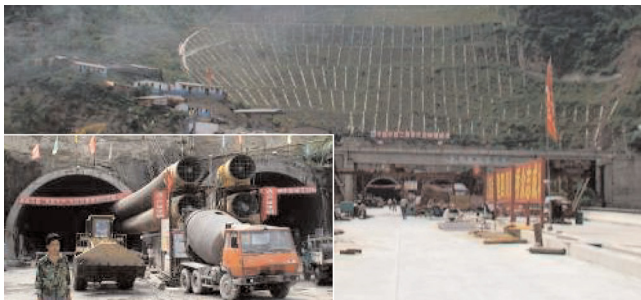
FIGURE 7 Miaozhiping Tunnel.

Miaozhiping Highway from Dujiangyan to Wenchuan was under construction during the earthquake. It consists of a tunnel at Zhipingpu and a bridge over the Ming River as schematically shown in Figure 6. The tunnel, shown in Figure 7, experienced little damage during the earthquake. The highway was scheduled to open in October 2008. Near the highway is the well-known Dujiangyan Dam. The bridge of approximately 1.4 km consists of three parts: a main span and two approach spans as shown in Figures 6 and 8.

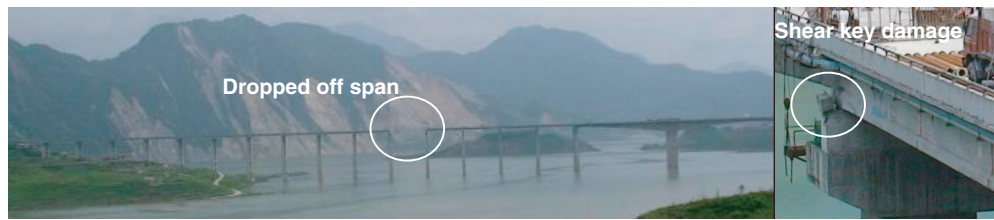
FIGURE 8 Overview of Miaozhiping Bridge.

The construction of the bridge was near completion except for the installation of expansion joints at the time of the earthquake. The most severe damage was to the end span of a five-span T-girder segment that became unseated at the expansion joint end as illustrated in Figure 9, fractured in the continuous deck at the other end due to gravity load, and fell off the supporting bent caps during the earthquake. The bent seats were approximately 300 mm in length but the bridge experienced at least 500 mm of longitudinal movement due to earthquake shaking. Since the columns of each bent are approximately 105 m tall, the accumulated displacement at the bent cap was likely significant during the earthquake. There were other indications of large longitudinal movement. As shown in Figure 10, the barrier rails were overlapped by about 300 mm at the southeast expansion joint. The barrier also moved transversely for approximately 250 mm. Divers found cracks at the bottom of the main span columns due to earthquake shaking. Shear key failure was also observed as shown in Figure 8. After the earthquake, the bridge deck was jacked back into place with hydraulic jacks.

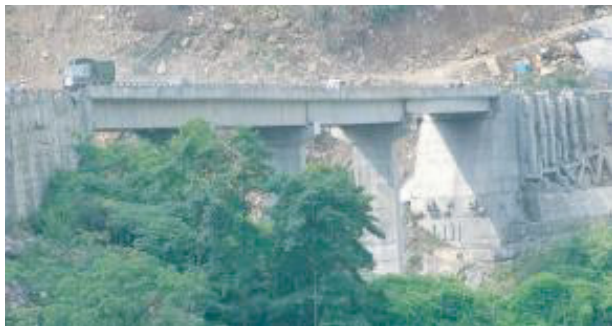
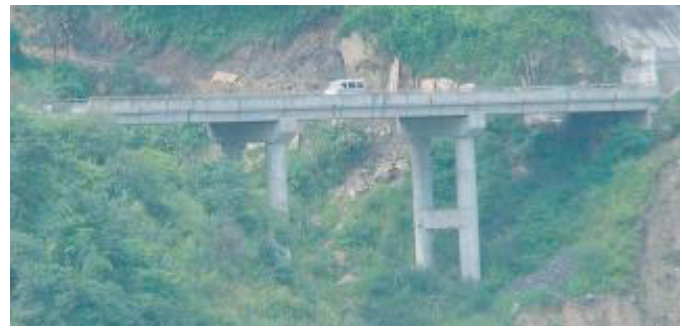
FIGURE 12 Bridges in the vicinity of Miaozhiping Bridge.

as seen in Figure 11. In the vicinity of Miaozhiping Bridge there are several RC girder bridges, as shown in Figure 12. These bridges appeared to suffer little damage. No weight limits were posted on these bridges.

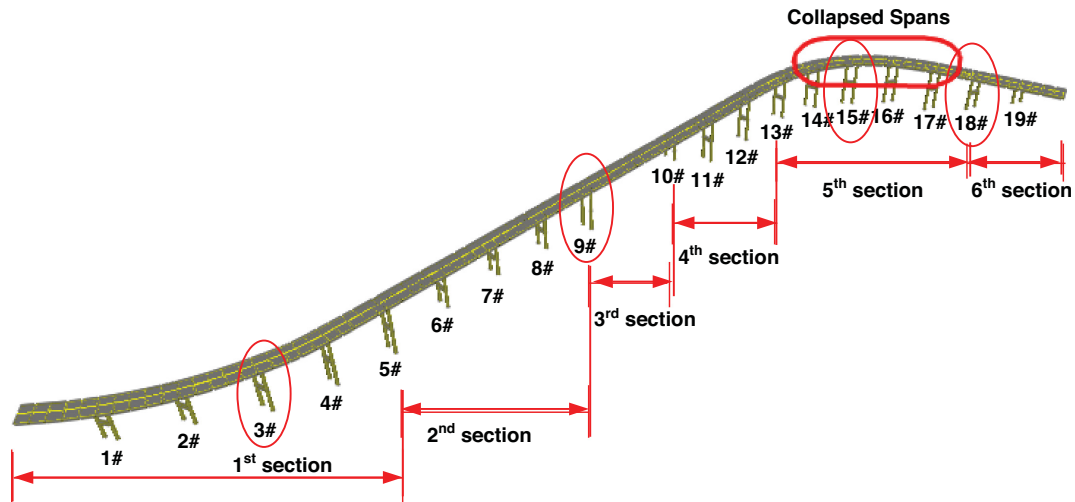
FIGURE 13 Schematic view of the Baihua Bridge before earthquake.

Baihua Bridge is part of a Class 2 highway from Dujiangyan to Wenchuan. It was built in 2004 by the owner of a nearby hydroelectric plant to bring in workers. As schematically shown in Figure 13, the bridge is an 18-span, RC structure with a total length of 450 m. The bridge superstructure was supported on two-column bents of varying heights as it climbs over the hilly terrain. The tallest bents have one or two struts to provide transverse restraint between the columns. The bridge has both straight and curved spans. For convenience, the bridge structure can be divided into six sections as summarized in Table 1. The superstructure was a prestressed box girder with a drop-in T-girder span between Bent 9 and Bent 10. There were expansion joints at Bents 2, 6, 9, 10, 14, 18, and at the two seat-type
