China Earthquake Reconnaissance Report: Performance of Transportation Structures during the May 12, 2008, M7.9 Wenchuan Earthquake

China Earthquake Reconnaissance Report: Performance of Transportation Structures During the May 12, 2008, M7.9 Wenchuan Earthquake

PUBLICATION NO. FHWA-HRT-11-029

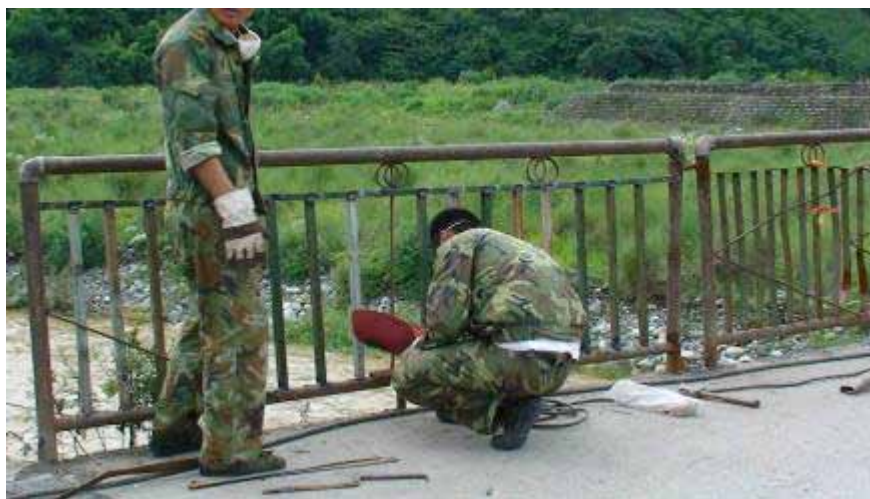
Figure 10. Photo. Welding on Bridge Railings.

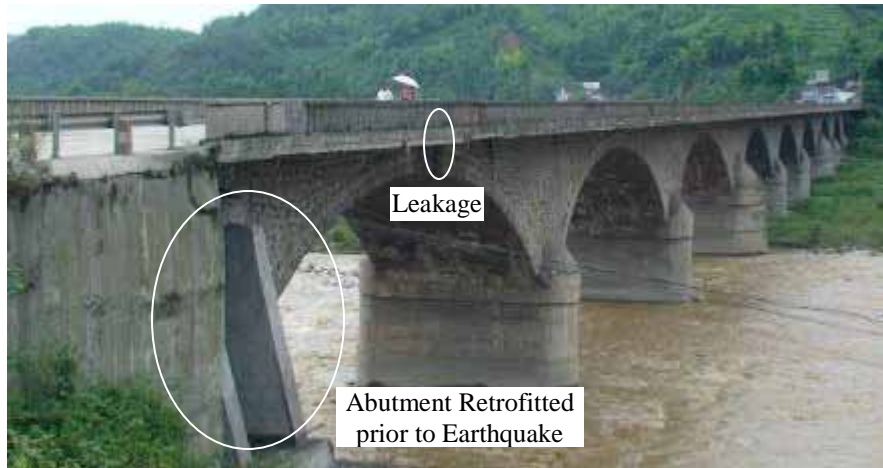
Tongji Bridge is a nine-span stone arch structure on reinforced concrete (RC) pier walls spanning a river, as shown in figure 13. Built in 1999, the bridge is located in the northwest of Chengdu Metropolitan Area and has a span arrangement of 29.5 to 110.5 ft (9 to 33.7 m). The abutment of the bridge on the river side was retrofitted to increase its strength against hydraulic forces, as indicated in figure 13. During previous floods, water rose to the arch level. It was observed that water leaked through the first arch from the bridge deck due to rains. Minor pounding damage at railing joints and approach settlement were observed, as illustrated in figure 14.

Figure 13. Photo. Overview of Tongji Bridge.

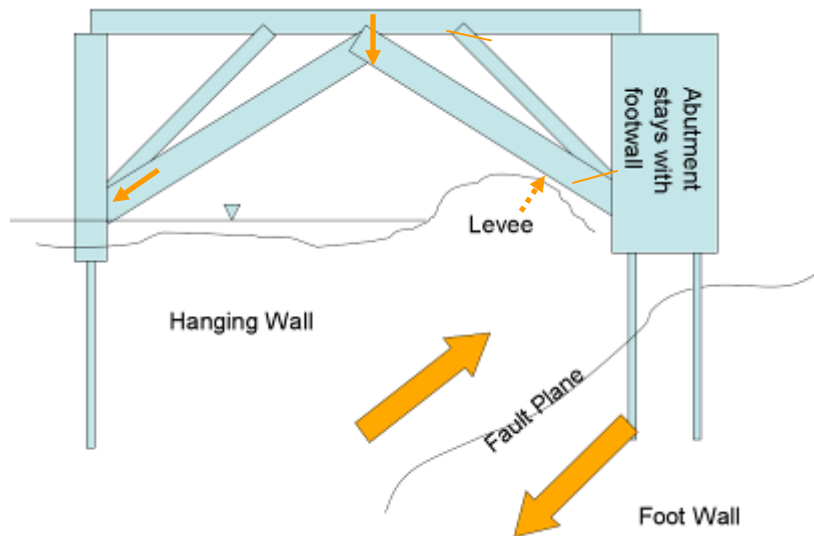
The damage to the easternmost span was likely caused by the surface fault near the east abutment, as shown in figure 7. Figure 21 presents a schematic of the interaction between the fault rupture and the east abutment of the bridge. When the hanging wall of the thrust fault moved up and right, relative to the foot wall supporting the east abutment, the levee began to bear on the arches and added significant shear forces and bending moments, especially at the east ends of the arches. Designed for axial forces, the arches failed in shear at their east ends. The top end of the arches remained intact due mainly to its larger section. Due to the shear failure in the arches, the east span deflected downward significantly, as shown in figure 19, and added more loads to the strut, resulting in its shear failure as well. At the same time, span 4 pushed toward bent 4 and caused flexural cracks at the pile shaft, as indicated in figure 22.

Figure 21. Illustration. Surface Fault Movement and Interaction with Bridge.

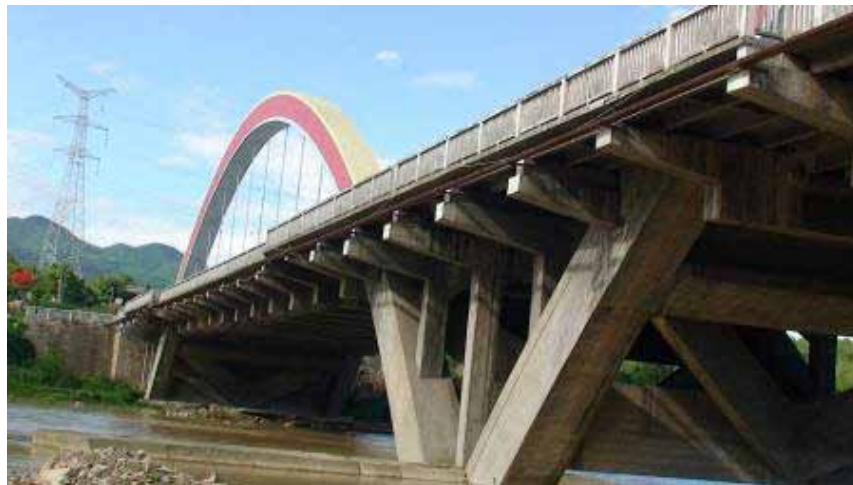
Anzhou Bridge, built in 1996, is a two-arch structure along Highway S105. Each arch is 262.4 ft (80 m) long, as shown in figure 24. A slab superstructure is hung from the two RC vertical arches using a number of cable suspenders, as shown in figure 25. Surprisingly, there is no cross bracing between the arches above the deck, which may explain why the cross bracing below the deck had cracks, as shown in figure 26. The cross bracing members are designed to restrain the arches from transverse movement. The concrete deck spalled around the cable suspenders, around the arches, and at the expansion joints, as shown in figure 27. The spalls and cracks suggest that the slab superstructure was shaken transversely and longitudinally during the earthquake.

Figure 25. Photo. Part of the Anzhou Bridge.

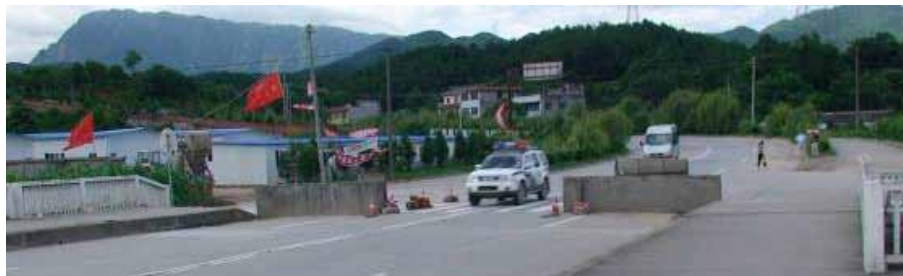
Although the damage was relatively minor, traffic was restricted to the middle of the deck, as shown in figure 28, as a precautionary measure. An attempt was made to build a roadway with embankment materials and pipe culverts to serve as a detour over the river, as shown in figure 29. However, it appeared that the building of the detour was abandoned because the river flow was too strong and the roadway was rapidly washed away.

Figure 28. Photo. Road Block on Highway.

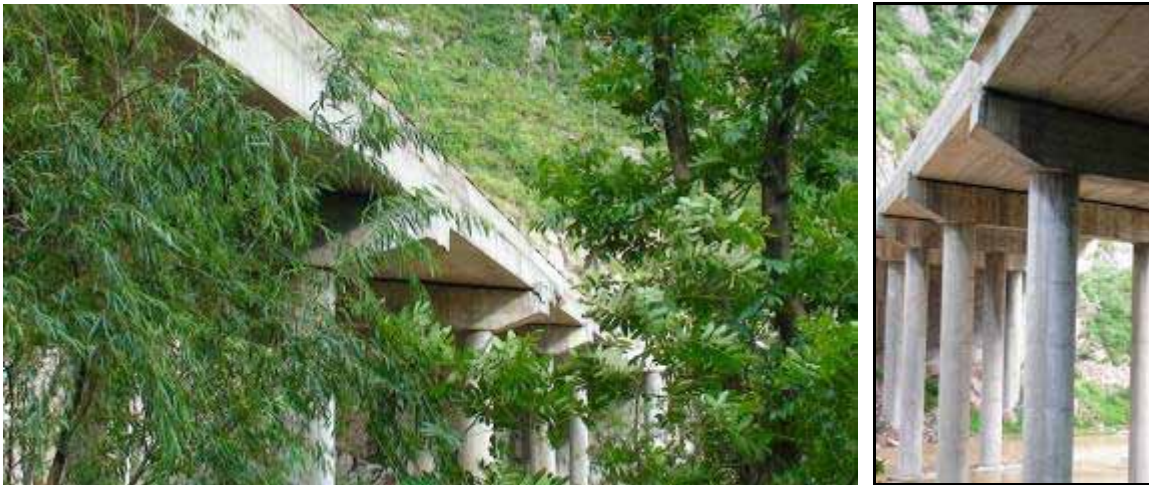
Baimayan Bridge is a six-span skewed slab bridge with a 68.88-ft (21-m) span length and carries north-south traffic along Highway S105. It was constructed in 2003. As shown in figure 30, the bridge is supported on three-column bents. During the earthquake, the bridge suffered minor damage. Concrete spalling was observed at the embankments, and shear keys were damaged, as shown in figure 31. Both indicated that the bridge was shaken during the earthquake. The expansion joints were offset by approximately 2.73 inches (70 mm) in the traffic direction and 1.56 inches (40 mm) in the transverse direction (see figure 32). The level of shaking at the bridge site is notable. In a nearby town, buildings were severely damaged, as shown in figure 33.

Figure 30. Photo. Overview of Baimayan Bridge.

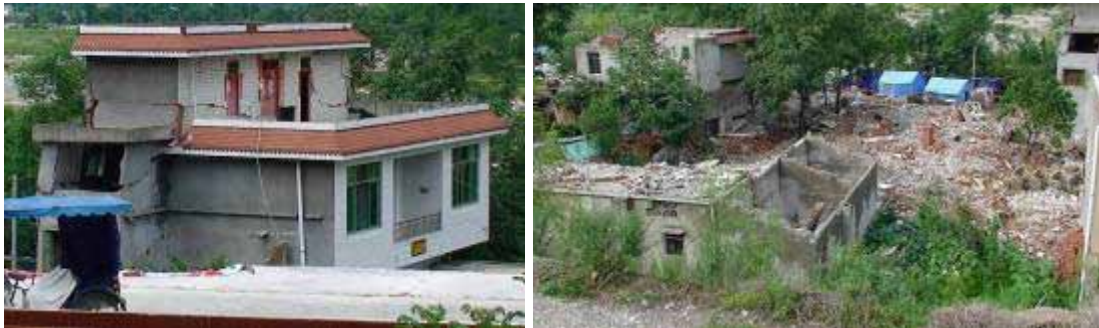
Figure 33. Photo. Building Damage in Nearby Town.

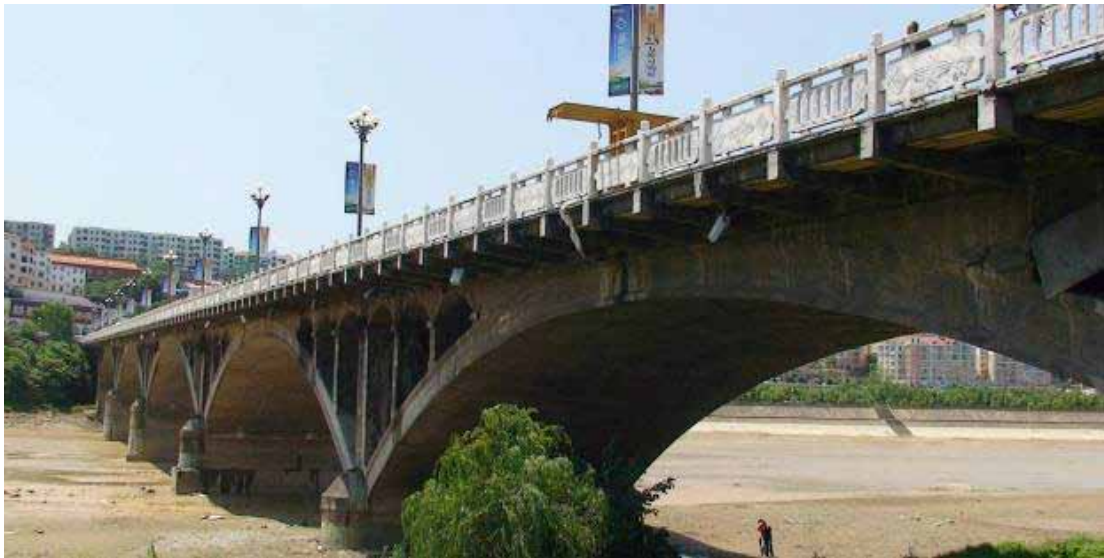
Built in 1989, Nanhe Bridge is a five-span open-spandrel arch structure with an additional slab bridge at the north end, as shown in figure 38. The bridge is oriented north-south. Six secondary arches (haunch soffit) are supported by the spandrel columns on each of the five main arches. As shown in figure 39, transverse cracks were observed at the crown of all secondary arches. The cracks covered the entire width of the secondary arches but did not penetrate the deck thickness. The damage pattern indicated that two adjacent secondary arches and their common supporting column may have rotated slightly during the earthquake.

Figure 38. Photo. Overview of Nanhe Bridge.

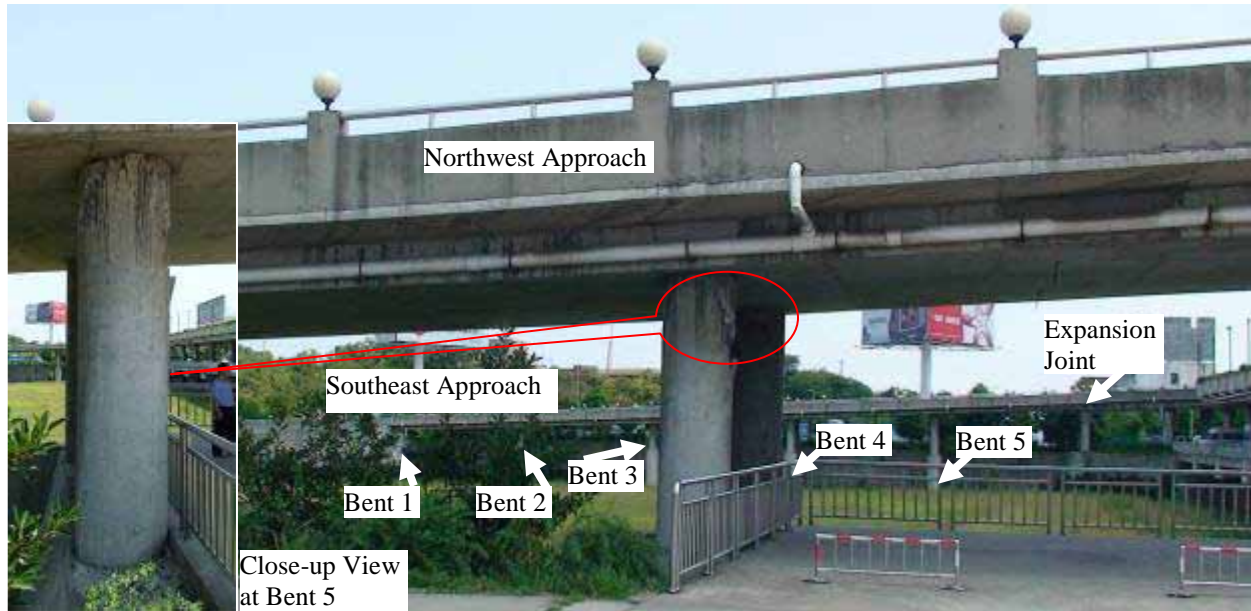
Figure 41. Photo. Overview of the Viaduct Structure.

The southeast approach consists of a five-span structure supported on columns of varying heights. The five-span structure is continuous, with expansion joints at both ends. The diameter of the upper portion of the columns (approximately 3.28 ft (1.0 m)) is smaller than that of the lower portion (approximately 4.92 ft (1.5 m)). The columns have a smooth #5 (metric) spiral spaced at 5.85 inches (150 mm) and 32 #29 (metric) bars for longitudinal reinforcement. The northwest approach also has five spans. The spans are similar to those on the southeast approach except that the lower portions of the tallest circular columns at bent 5 are connected by a concrete wall, as shown in figure 41. The concrete wall makes bent 5 much stiffer than its adjacent bents.

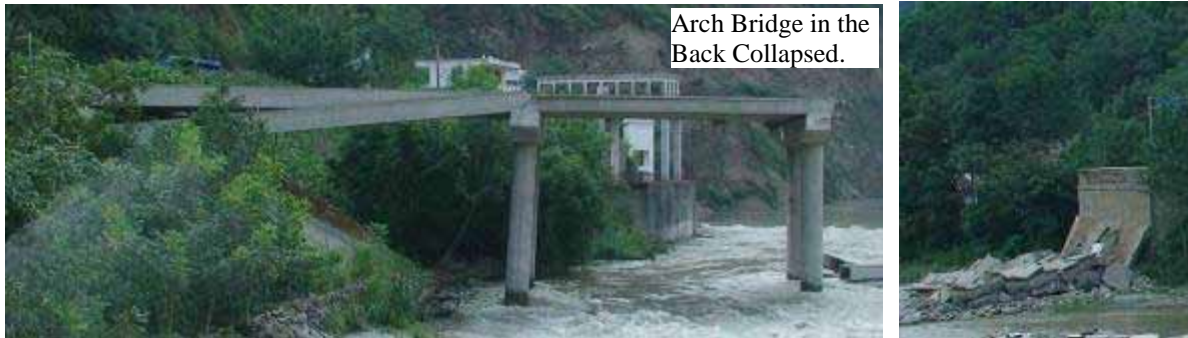
Three bridges cross a river near Nanba Town, as shown in figure 45. The west structure was a concrete and masonry three-span arch bridge built in the 1970s. The old arch bridge completely collapsed during the earthquake, as shown in figure 46. Immediately downstream of the arch bridge was a 10-span river crossing (on a 10-degree skew) that was under construction during the earthquake, as shown in figure 47. Each 19.68-ft (6-m)-long span was simply supported on two-column bents and seat-type abutments with 21.84-inch (560-mm) seats. As shown in figure 48, each span consisted of eight precast box girders with a cross section of 41.61 inches (1,067 mm) by 59.28 inches (1,520 mm). Each girder was supported on two 7.8-inch (200-mm) round elastomeric bearings at each end. The girders were in place, but the concrete deck had not yet been poured at the time of the earthquake, as seen in figure 48.

Figure 46. Photo. Collapse of the Old Three-Arch Bridge.

There was no indication that the 10-span bridge suffered any damage due to a fault crossing. As such, the three-span arch bridge must have been damaged by ground shaking, perhaps exacerbated by soil movement. Liquefaction, lateral spreading, or other soil movement also may have been responsible for the distortion of the two-column bents. The reconnaissance team was not able to discern what type of foundation system the bents were supported on, but apparently they were not sufficiently embedded in good material.

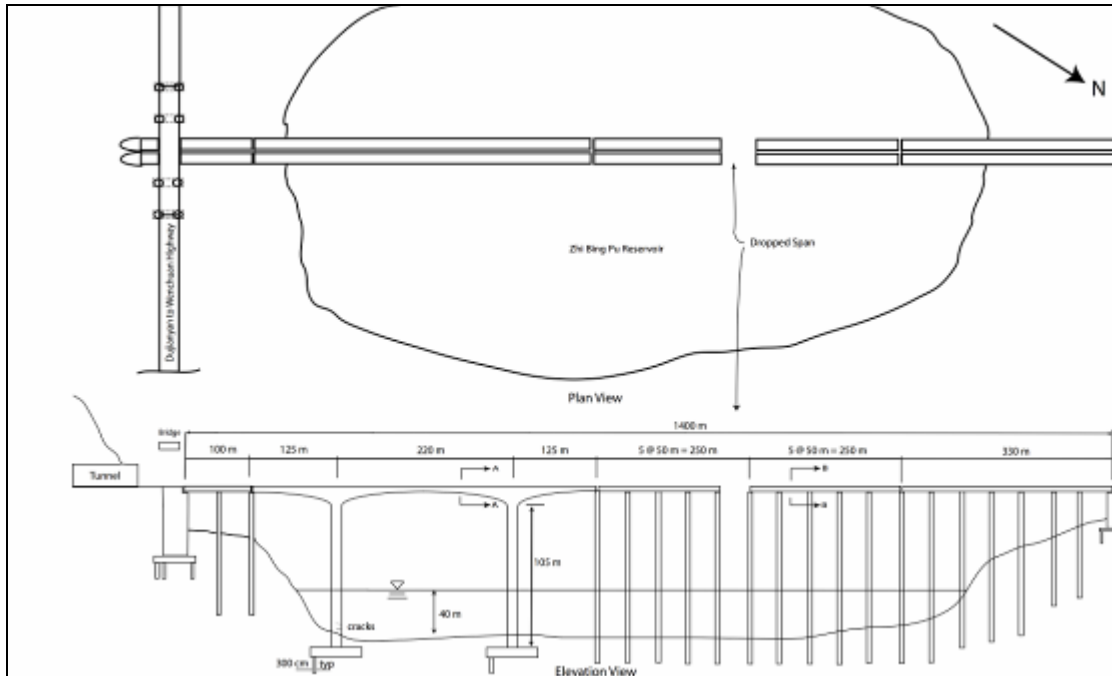
Figure 51. Illustration. Plan and Elevation View of Miaozhiping Bridge.

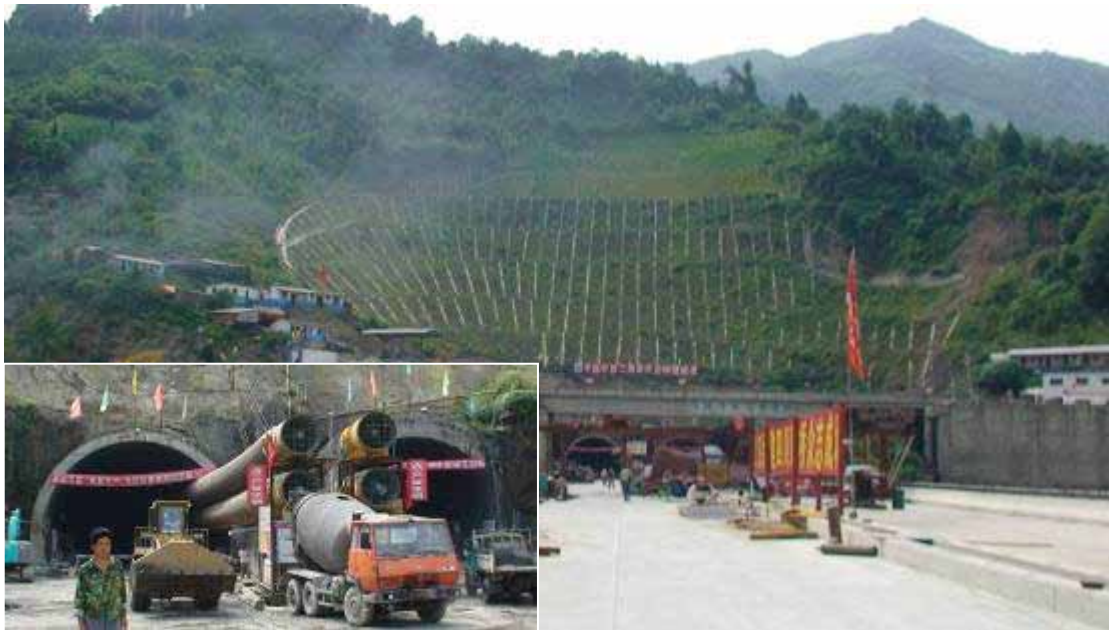
figure 52. The tunnel, shown in figure 53, experienced little damage during the earthquake. The highway was scheduled to open in October 2008. Near the highway is the Dujiangyan Dam. The bridge of approximately 0.87 mi (1.4 km) consists of three parts: a main span and two approach spans, as shown in figure 54.

Figure 53. Photo. Miaozhiping Tunnel.

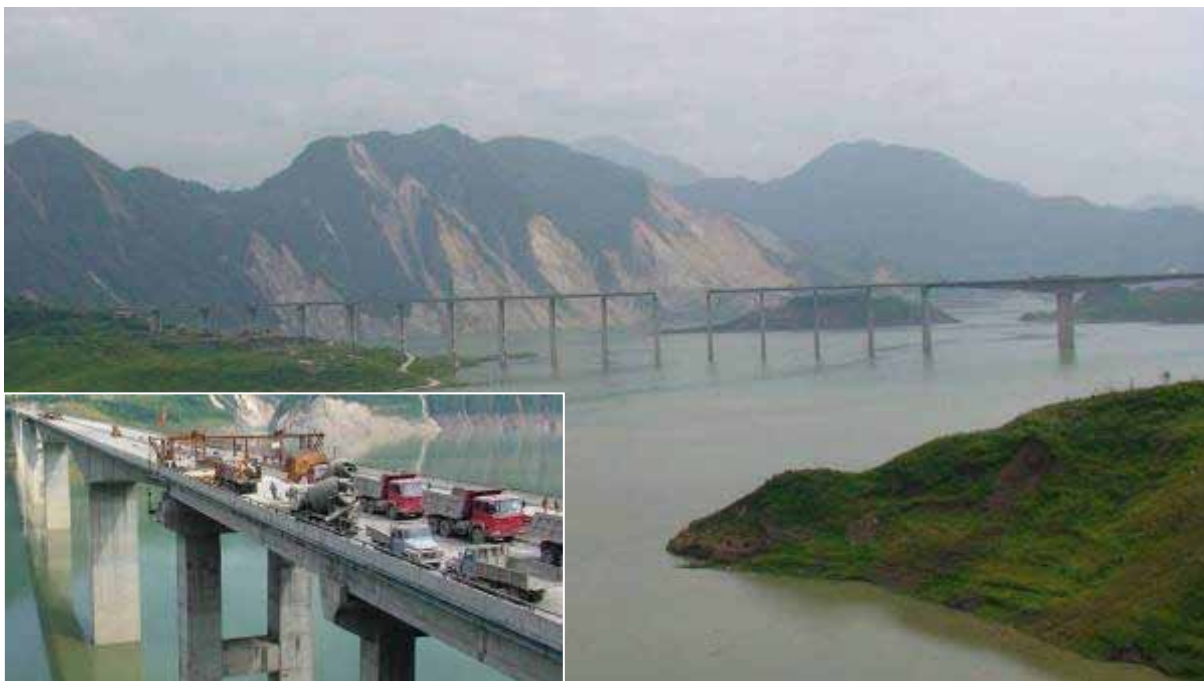
Figure 54. Photo. Overview of Miaozhiping Bridge.

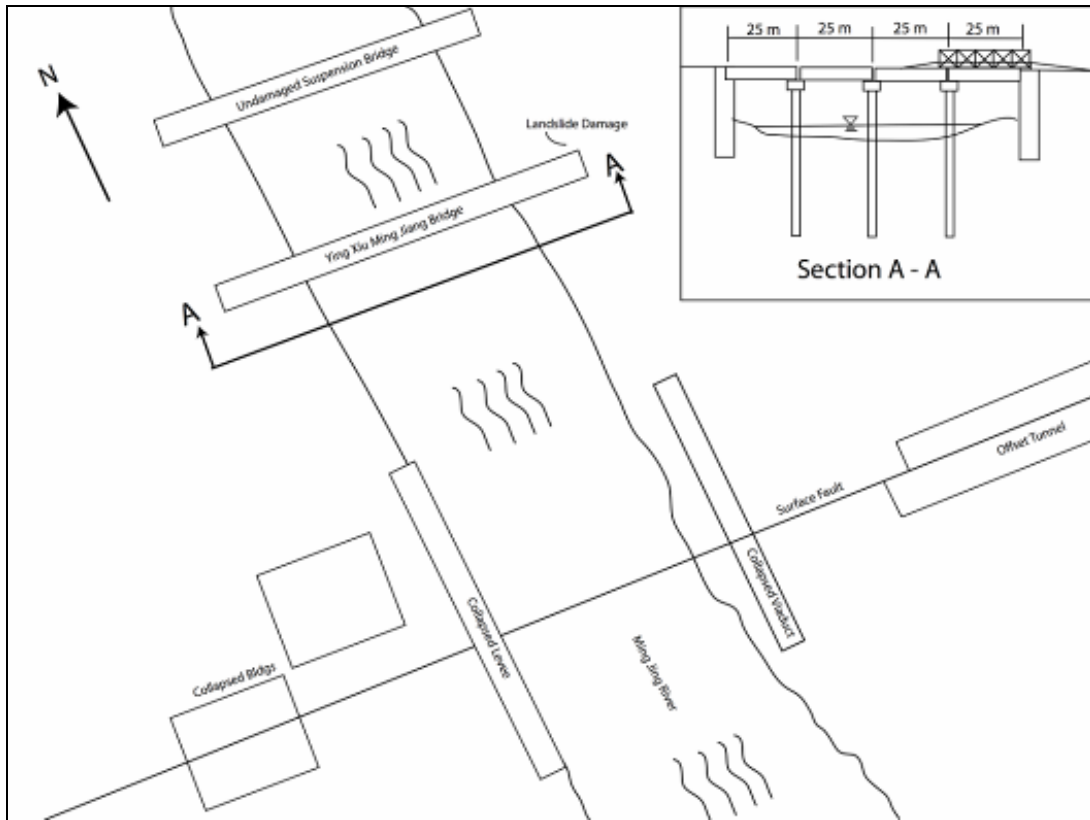
Figure 61. Illustration. Schematic of Mingjiang Bridge at Yingxiu.

Mingjiang Bridge at Yingxiu is located about 1,640 ft (500 m) north of the fault. The bridge was built in 2007 and is a T-girder structure with two-column bents that are supported on pile shafts. It has a span arrangement of 13.12–82 ft + 3.28–88.56 ft (4–25 m + 1–27 m), as shown in figure 61 and figure 62. It had some damage due to a landslide at the east span. As a result, the Sichuan Province Government built a Bailey bridge over the east span to carry vehicles over the damage. There were several other structures that were damaged in the same vicinity, including an elevated viaduct, a tunnel, and a levee, as shown in figure 62.

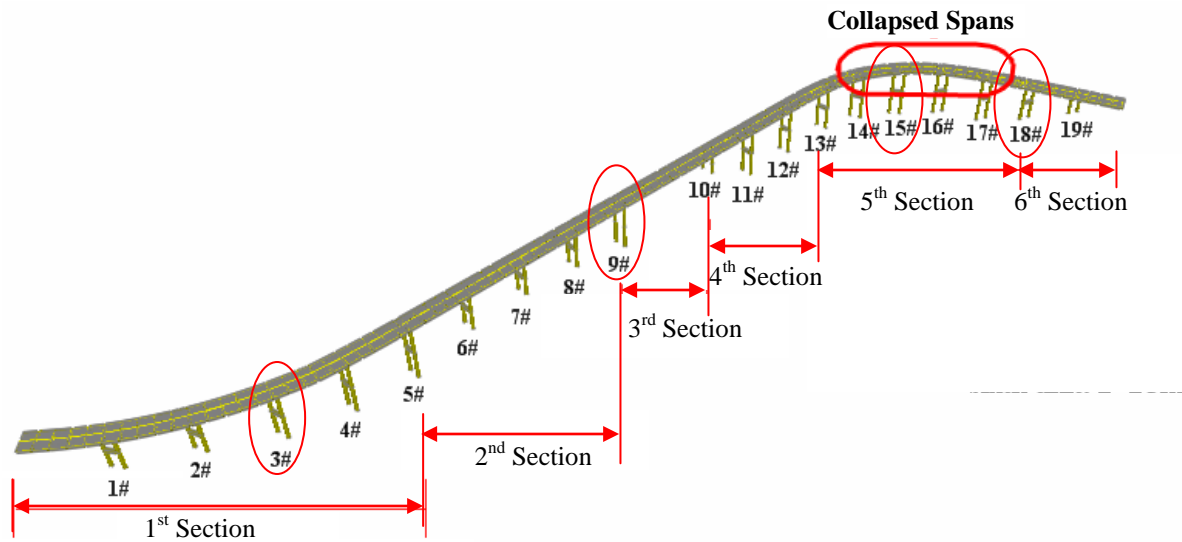
Figure 63. Illustration. Schematic of Baihua Bridge Before the Earthquake.

Baihua Bridge is part of a Class 2 Highway from Dujiangyan to Wenchuan. It was built in 2004 by the owner of a nearby hydroelectric plant. As shown in figure 63, the bridge is an 18-span, RC structure with a total length of 1,476 ft (450 m). The superstructure is supported on two-column bents of varying heights as it climbs over the hilly terrain. The tallest bents have one or two struts to provide transverse restraint between the columns. The bridge has both straight and curved spans. For convenience, the bridge structure can be divided into six sections, as summarized in table 2. The superstructure is a prestressed box girder with a drop-in T-girder span between bent 9 and bent 10. There are expansion joints at bents 2, 6, 9, 10, and 14 and at the two seat-type abutments. For the drop-in span, the bridge deck rests on the bent cap at both ends.

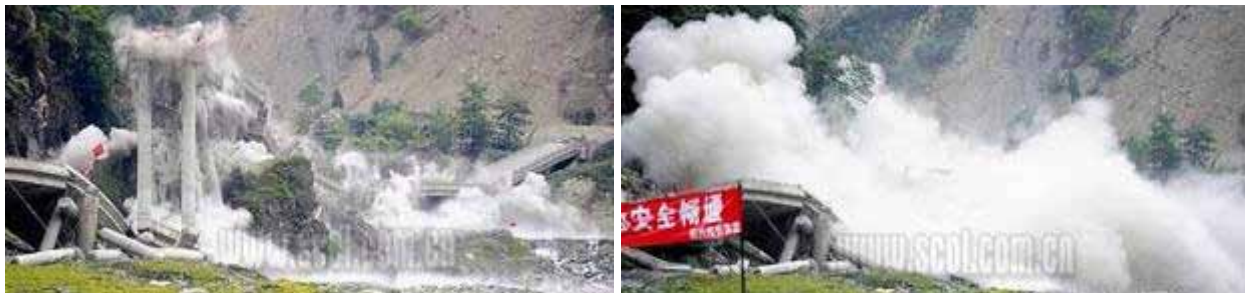
Figure 70. Photo. Blast Demolition of Baihua Bridge.

The curved part of the bridge was probably subjected to higher deformation and stress during the earthquake, resulting in collapse. Due to the tall columns, the earthquake caused tilting that pushed the superstructure almost off its support at several locations in the straight part of the bridge. A detour was graded along the side of the damaged bridge. Considering the high risk of further collapse during an aftershock, the bridge was demolished with dynamite, as shown in figure 70 and figure 71.

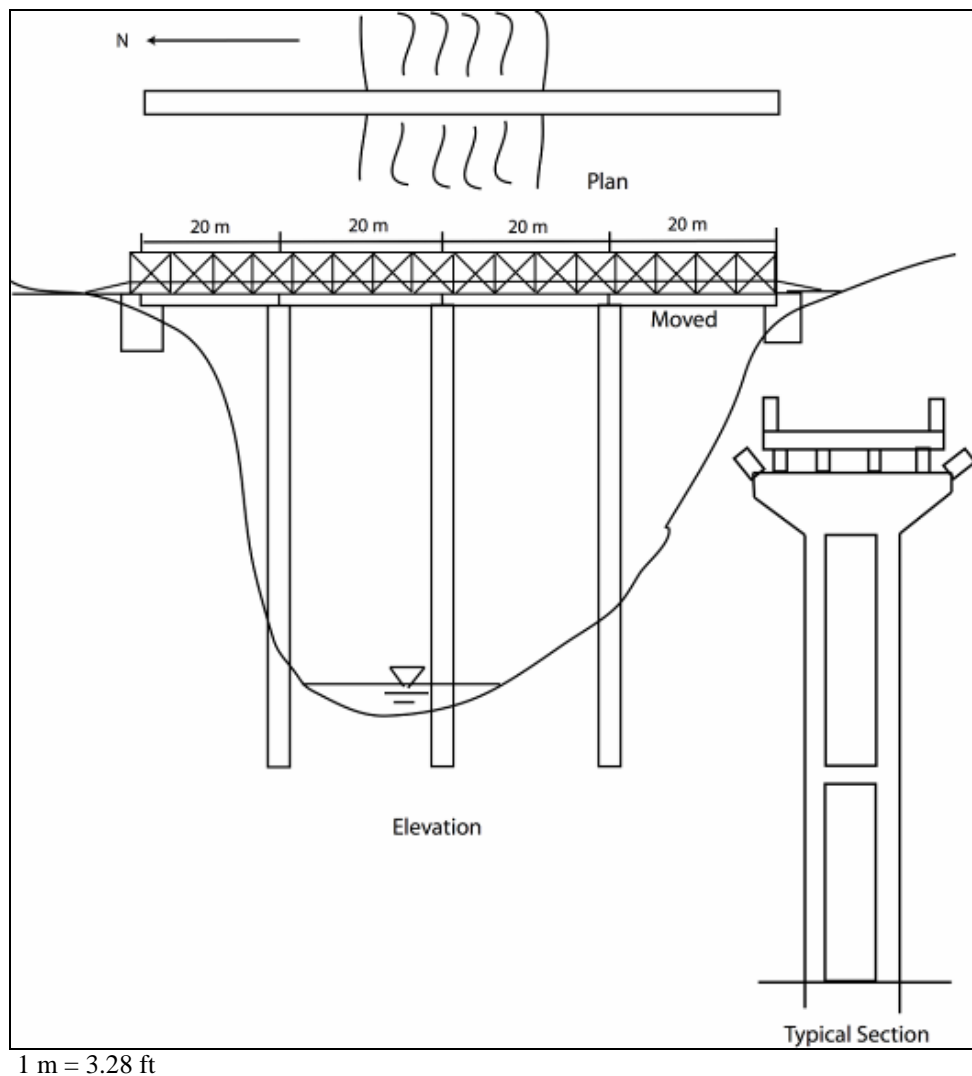
Figure 72. Illustration. Schematic of Zhima Bridge.

Zhima Bridge has four spans of 65.6 ft (20 m) and is an RC T-girder structure, as shown in figure 72. It is supported on very tall RC two-column towers. The bridge is a river crossing link across the deep canyon shown in figure 73. The bridge suffered significant movement both longitudinally and transversely. Most shear keys were damaged, as shown in figure 73. As a result, a long Bailey bridge was launched over the existing superstructure to support traffic. It appeared that the north span may have almost dropped.

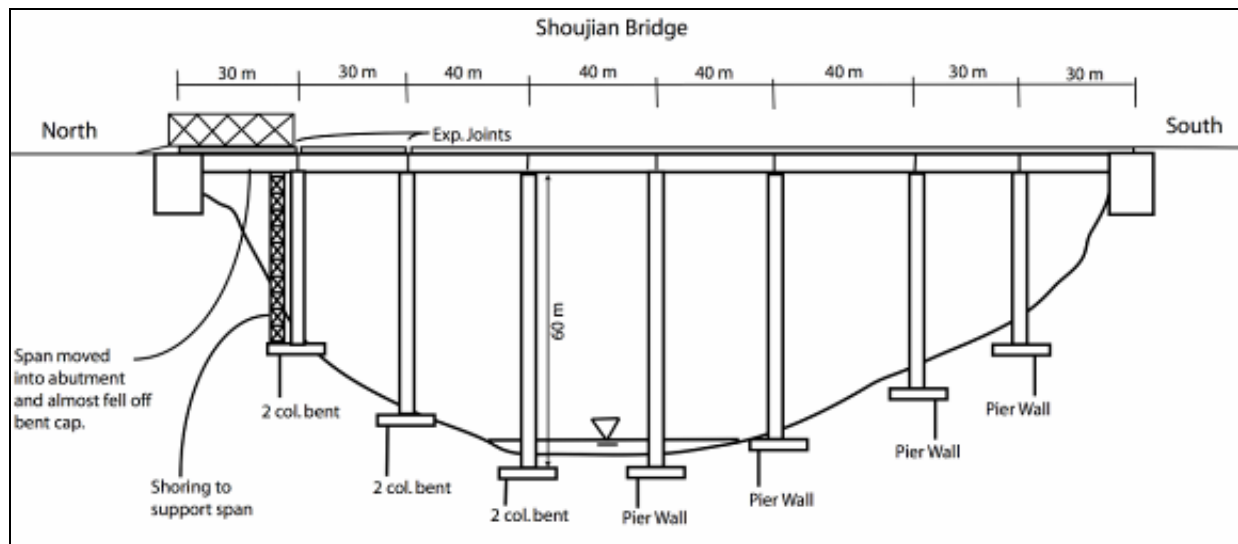
Figure 74. Illustration. Schematic of Shoujiang Bridge.

Shoujiang Bridge is an eight-span, 918.4-ft (280-m)-long, T-girder superstructure supported on very tall two-column towers and pier walls, as shown in figure 74. The tallest piers were approximately 196.8 ft (60 m) high, the approach spans were 98.4 ft (30 m) long, and the four main spans were 131.2 ft (40 m) long. Both the towers and the pier walls were supported on pile foundations.
