# Forensic Investigation of Failed Mast Arms of Traffic Signal Supported Structures

Genda Chen, Michael Barker, D. Scott MacKenzie, Christopher Ramsay, Joe Alderson, Lokeswarappa Dharani, and Jiaqing Yu

**In Missouri, 11 traffic signal mast arms fractured at the arm-post weld connection in 7 years. To reduce this fatigue failure, the Missouri Department of Transportation developed a fatigue-resistant weld profile that increases the weld leg and reduces the slope of the weld at the toe. This study investigated causes of the failed arms, compared performance of new and old weld profiles, and suggested retrofitting measures for further investigation. The scope included a metallurgical investigation of one failed field mast arm, laboratory fatigue testing of five prototype mast arms (two new and three old profiles), and laboratory failure analysis of one arm tested to cracking. Metallographic and fractographic analyses indicated that the fatigue crack in the failed mast arm initiates near the weld toe of the arm due to undercutting, creating a sharp local toe angle. Location of undercutting at the heat-affected zone of the base material, where the material is softest, further contrib

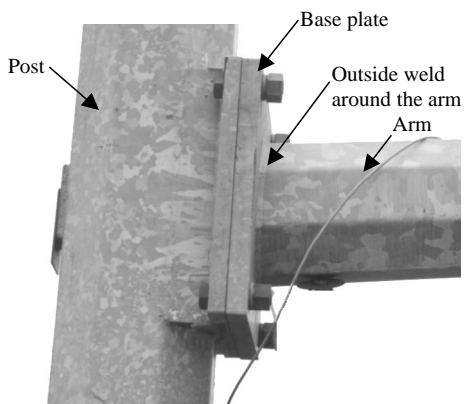
FIGURE 1 Arm-to-post connection.

The cracks on almost all the failed mast arms are located at the connection of the arm to the base plate. They were observed to initiate on top of the arms and are primarily associated with the bending effect of the mast arms in the vertical plane.

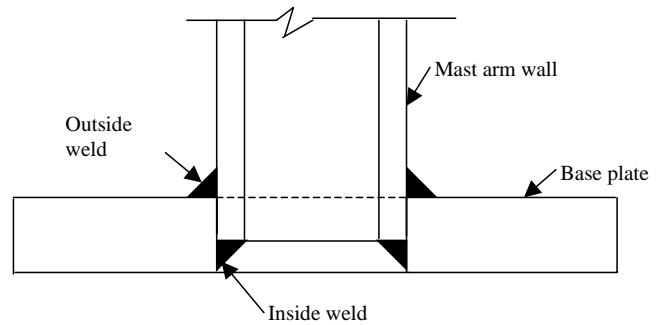
FIGURE 2 Cross-sectional view of a mast arm and base plate.

Four specimens were taken from locations in the mast arm assembly. Specifically, in reference to Figure 2, two specimens were cut from the outside weld in cracked and uncracked regions, which are respectively designated “CT” and “ET.” The other two specimens were cut from the inside weld in cracked and uncracked regions, respectively denoted as “BC” and “BE.” The resulting sections are shown in Figure 4. The sections were prepared metallographically using standard practice and were then etched using 2% Nital (2 ml HNO<sub>3</sub>, 98 ml CH<sub>3</sub>OH) to reveal the microstructure.
