Rapid Repair of Severely Damaged RC Columns with Different Damage Conditions: An Experimental Study

Ruili He¹⁾, Lesley H. Sneed^{1),*}, and Abdeldjelil Belarbi²⁾

(Received December 31, 2012, Accepted February 13, 2013)

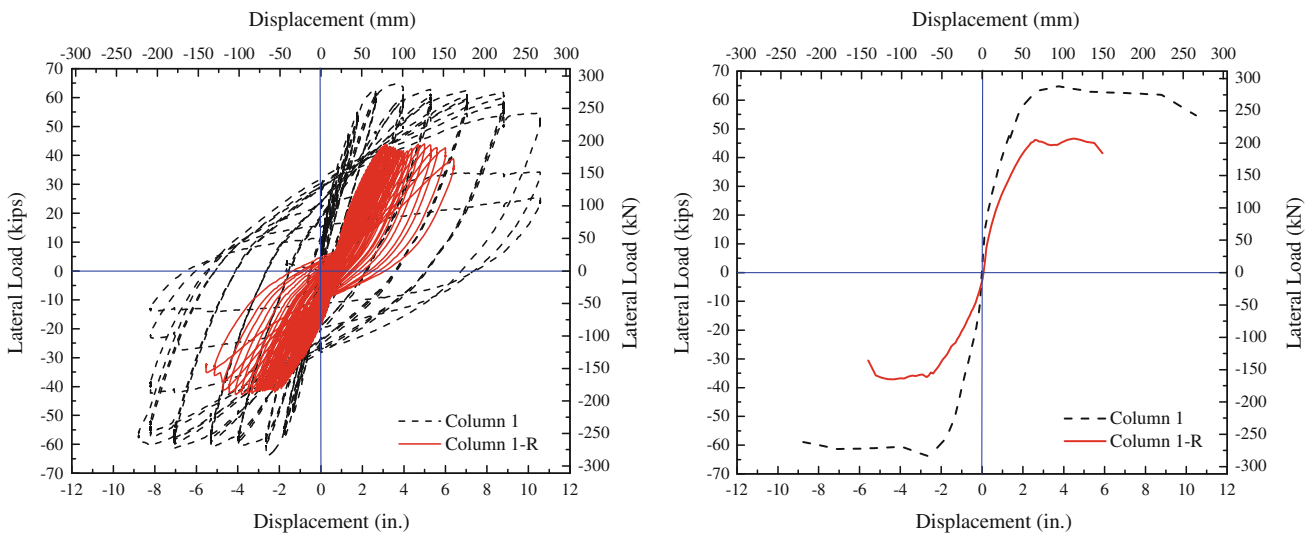
The general response of each repaired column relative to the corresponding original column is described in this section. The measured load–displacement and torque–twist relationships of the repaired columns compared to the corresponding original columns are shown in Figs. 10 to 14, in which both the hysteresis and envelope responses are provided. As illustrated in the figures, the repaired columns behaved asymmetrically in the positive and negative cycles. This response can be attributed to the unsymmetrical damage in the original column, the unsymmetrical removal and replacement of loose concrete during the repair procedure, and possibly some original displacement at the beginning of testing the repaired columns, which was due to the fact that the repaired column was not perfectly straightened.

Repaired column	Failure mode	
Column 1-R (T/M = 0)	Premature failure related to the detailing of the longitudinal CFRP anchorage system, followed by fracture of two additional longitudinal reinforcing steel bars	Flexure dominant
Column 2-R (T/M = 0.2)	Rupture of CFRP (flexure), crushing of concrete in the repaired region	
Column 3-R (T/M = 0.4)	Testing terminated due to limitations of the actuators	
Column 4-R (T/M = 0.6)	Crushing of concrete in the unrepaired region (torsion) followed by CFRP rupture next to the unrepaired region	Torsion dominant
Column 5-R (T/M = ∞)	Rupture of CFRP, crushing of concrete (torsion)

Fig. 10 General behavior of Column 1-R compared to Column 1

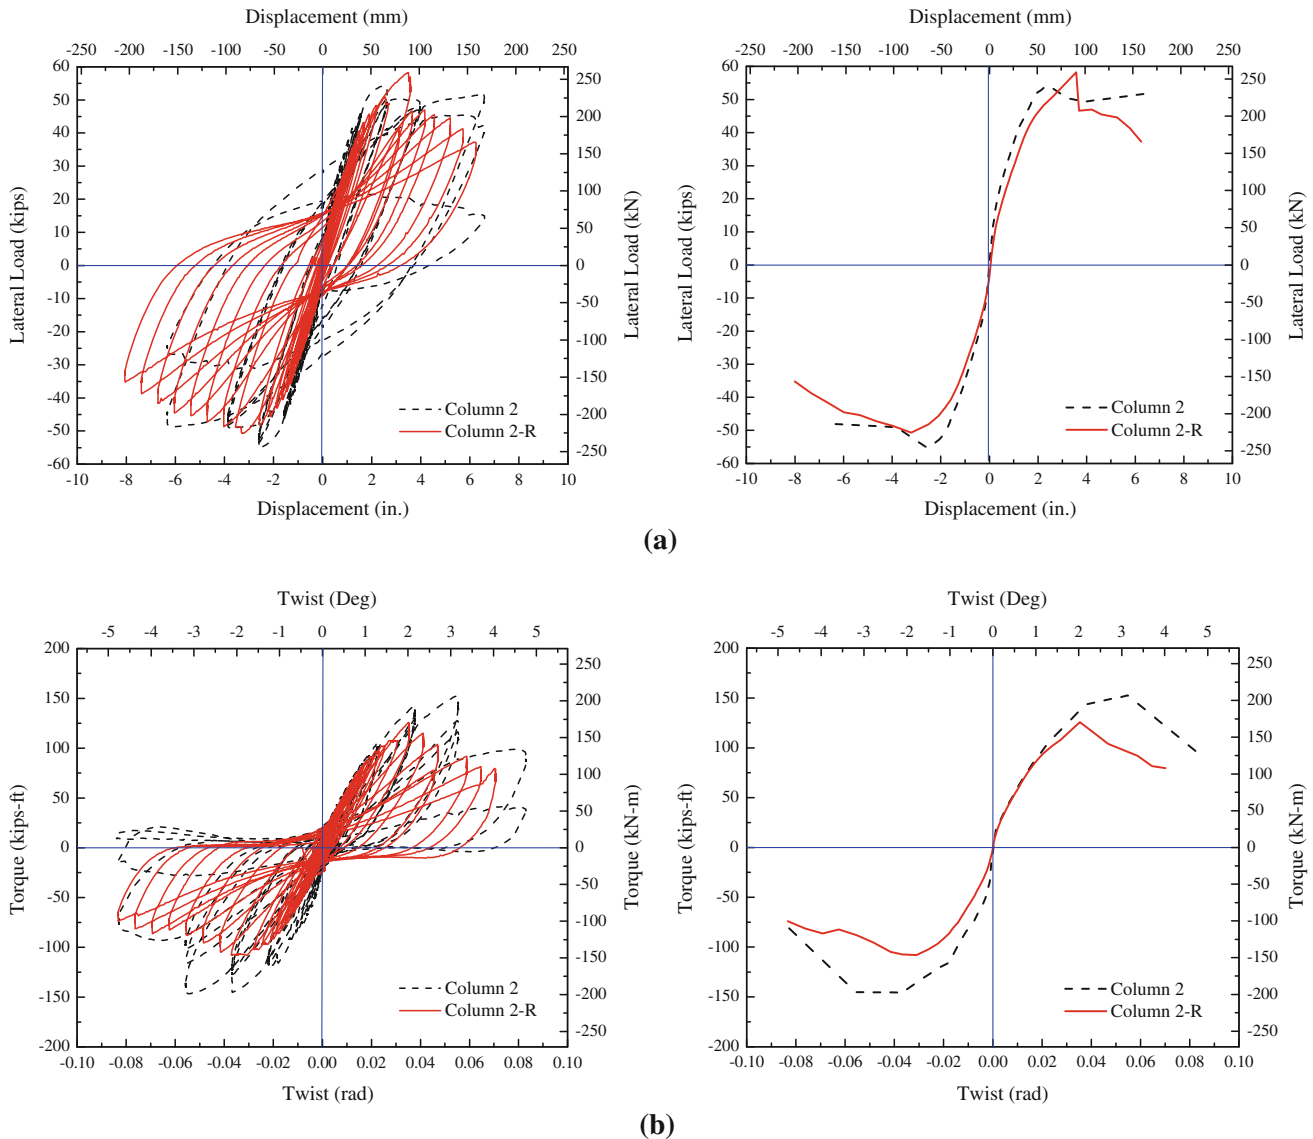
Figures 11 and 12 show that both the flexural strength and ductility of Columns 2-R and 3-R were mainly restored to

Fig. 11 General behavior of Column 2-R compared to Column 2. a Bending behavior. b Torsional behavior.

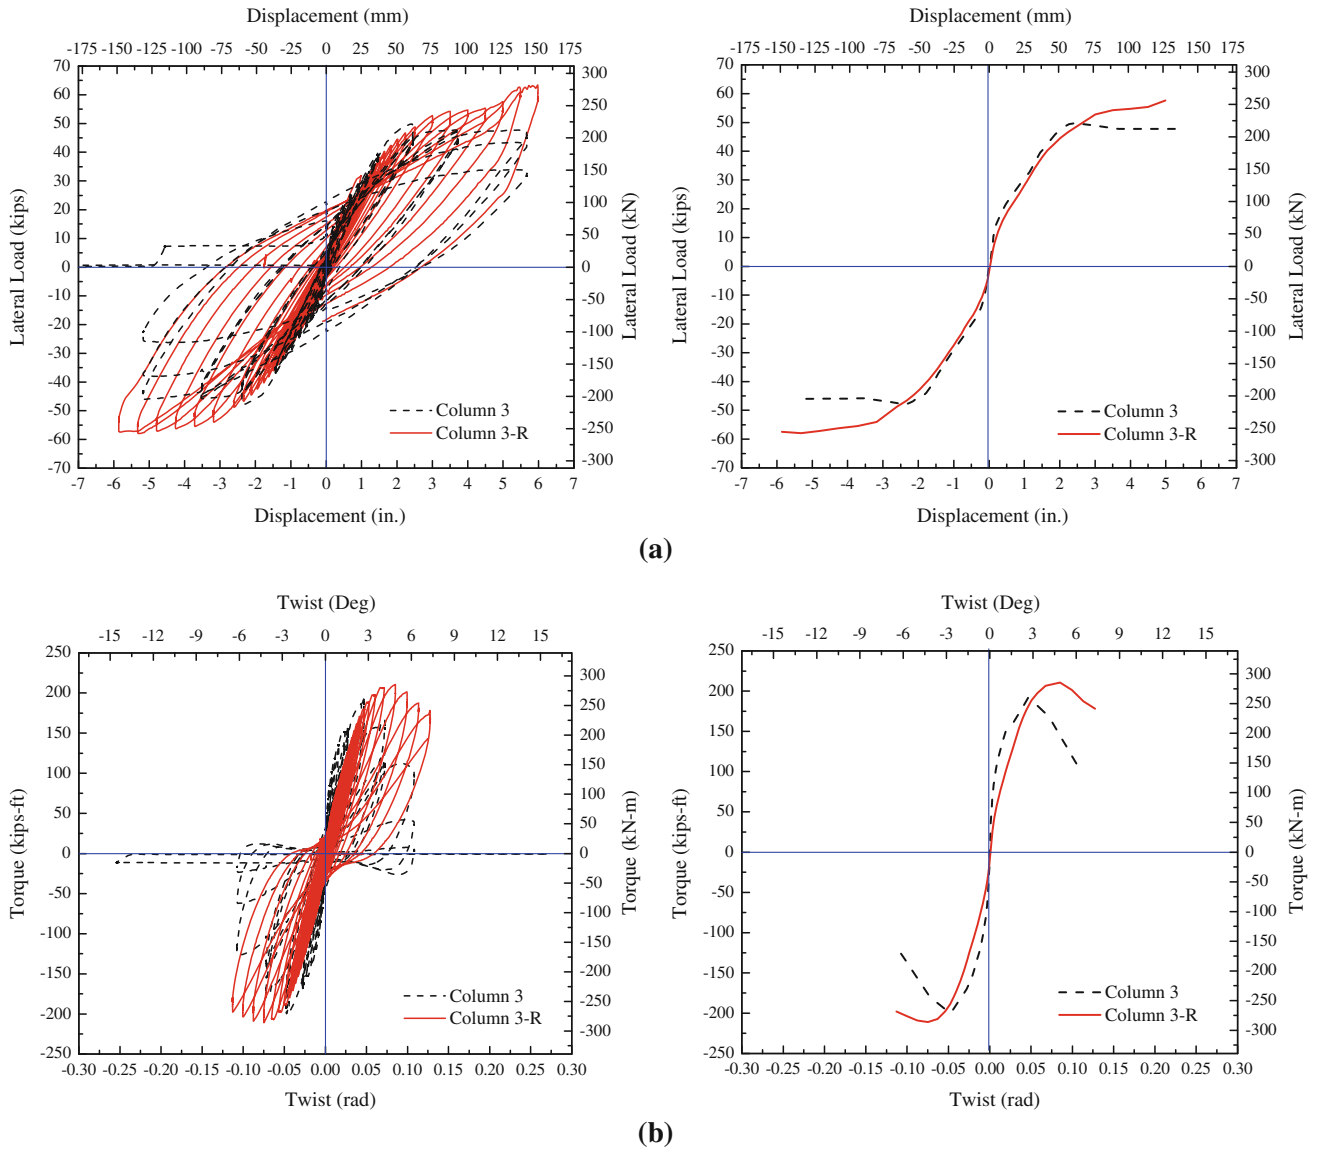
Fig. 12 General behavior of Column 3-R compared to Column 3. **a** Bending behavior. **b** Torsional behavior.

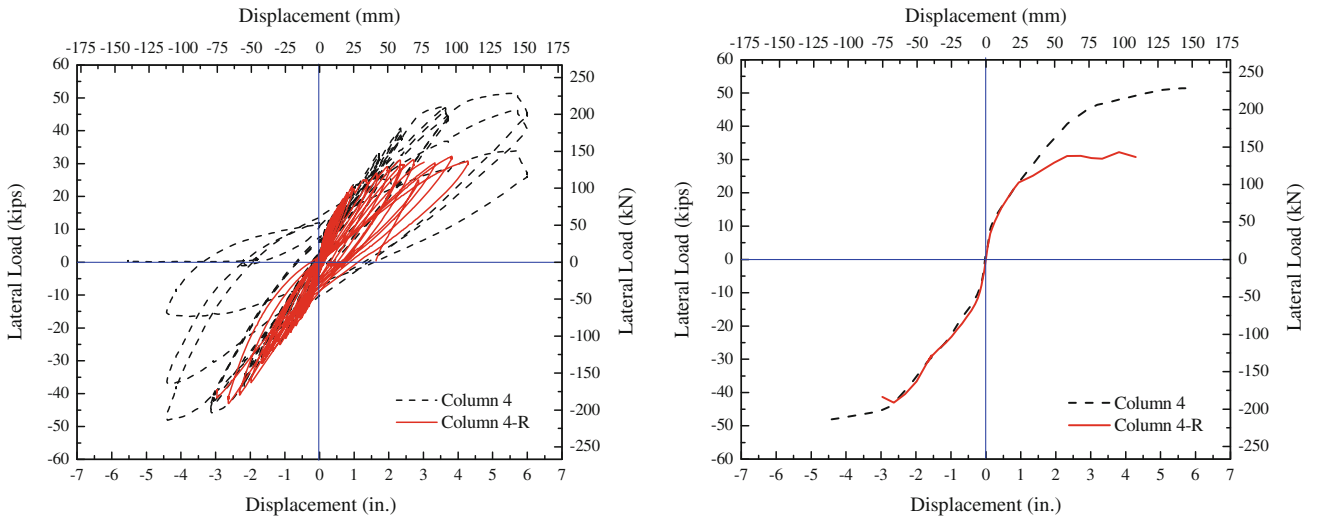
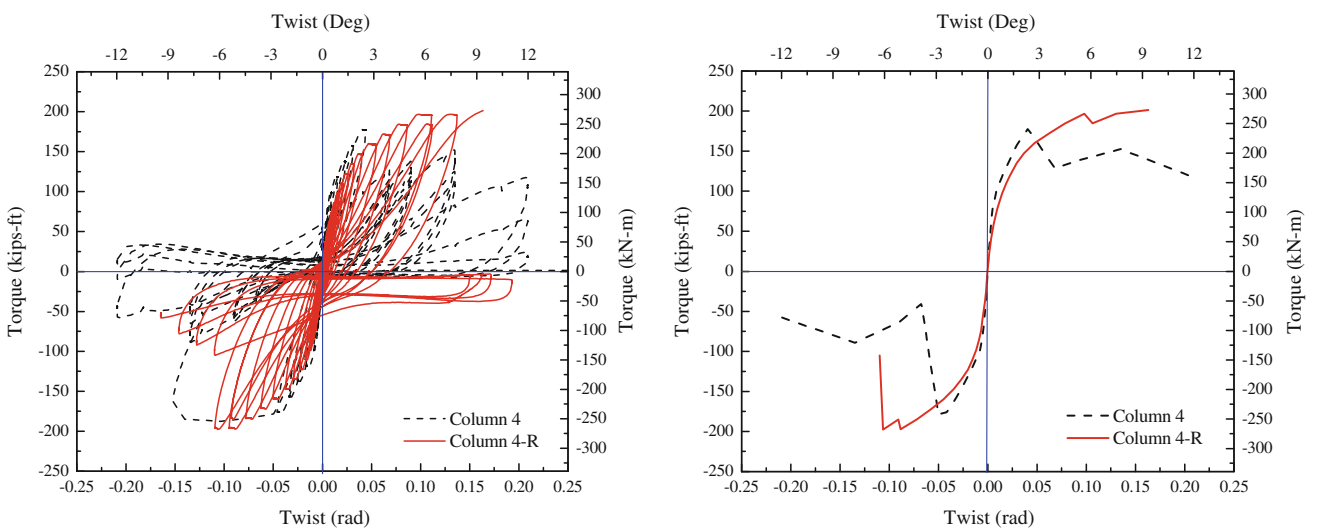
Columns 2 and 3, although the maximum torque of Column 2-R did not reach that of original column. Similarly for Column 4-R, Fig. 13 shows that the torsional strength was improved compared to Column 4, but the measured lateral load and displacement did not reach the original state. To explain the differences in bending and torsional strength restoration for each repaired column, the difference in the loading protocol details between the repaired column and corresponding original column must be noted. As discussed previously, it was difficult to maintain the torque-to-moment ratio after shifting to displacement control, which resulted in the applied load with different torque-to-moment ratios for the repaired and original columns. For instance Fig. 15 shows the torque-to-moment ratios (T/M) for the applied load on Column 4-R and Column 4. The torque-to-moment ratio of Column 4 reduced significantly after shifting from load control to displacement control at a lower load level compared to Column 4-R. This resulted in higher bending moment in Column 4 compared to Column 4-R, since this bending moment was reached at a lower torque compared to

Fig. 13 General behavior of Column 4-R compared to Column 4. **a** Bending behavior. **b** Torsional behavior.

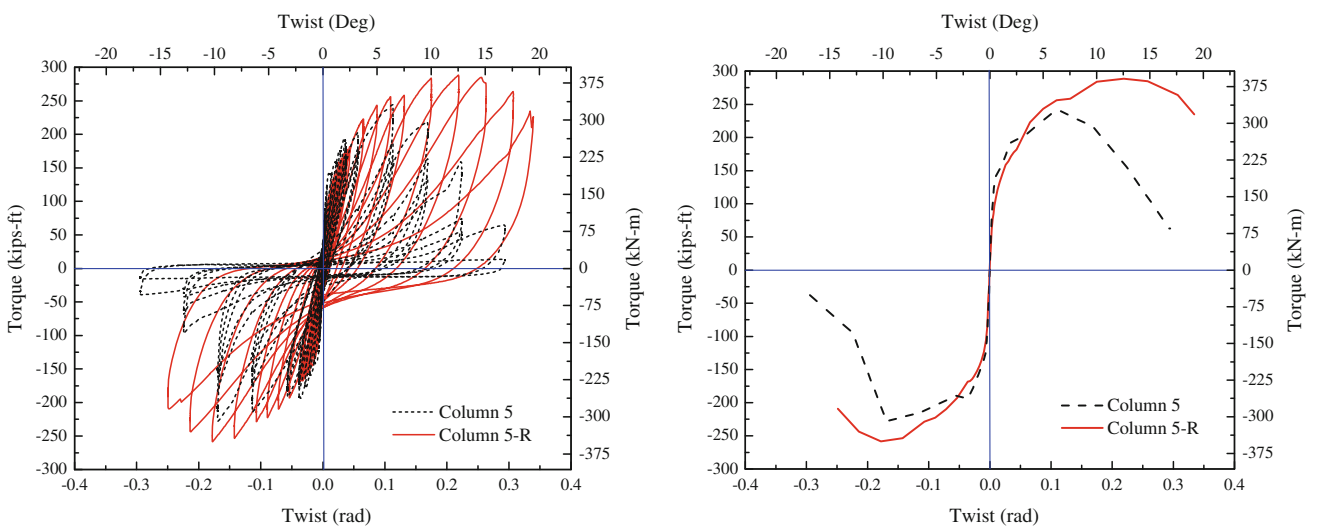
Comparison of the applied torque-twist envelopes of Column 5 and Column 5-R in Fig. 14 indicates that the torsional strength and twist at maximum torque were enhanced by the repair. For Column 5, the torsional strength reduced rapidly after the maximum torque was achieved because the core concrete crushed and thus could not provide further torsional resistance. The post-peak response of Column 5-R was characterized by a reduction in torsional strength with increasing applied torque, but not as rapidly as that of Column 5. This phenomenon can be explained in part by the confinement provided by the transverse CFRP wrap.

Fig. 14 General behavior of Column 5-R compared to Column 5.

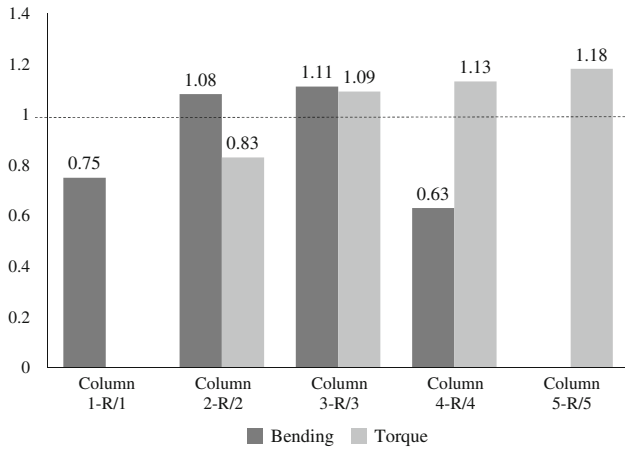
The strength indices for the columns are provided in Fig. 16, which illustrates that the repair method is effective in restoring the bending and/or torsional strength. The flexural strength restoration ranged from 63 to 111 %, and torsional strength restoration ranged from 83 to 118 %. Although Column 1-R was restored to 75 % of its original flexural strength, the results can be misleading since the strength restoration was limited by the flexural capacity of the repaired cross-section section with fractured bars, because the longitudinal CFRP failed prematurely. For Columns 2-R, 3-R, and 4-R, which were subjected to combined bending and torsion, either the flexural strength, the torsional strength, or both, were fully restored. Bending-torque interactions played a role in the level of bending and torsional strength restored as discussed in the previous sections. For Column 5-R subjected to pure torsion, the torsional strength was fully restored.

Fig. 16 Strength indices for repaired columns.

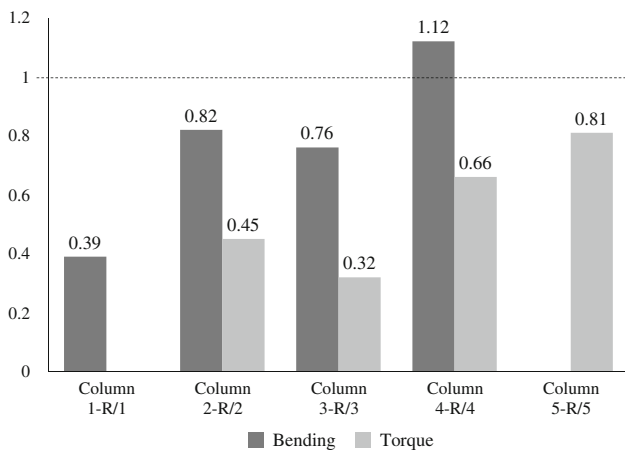
The initial stiffness indices for the repaired columns are illustrated in Fig. 17. The initial bending stiffness indices ranged from 39 to 112 %, and initial torsional stiffness indices ranged from 32 to 81 %. With the exception of the bending stiffness of Column 4-R/4, the initial stiffness of the repaired columns was lower than that of the corresponding original columns. This reduction in initial stiffness is due to the unrepaired cracked portions of the repaired columns and material degradation during the original tests.

Fig. 17 Stiffness indices of initial state for repaired columns.

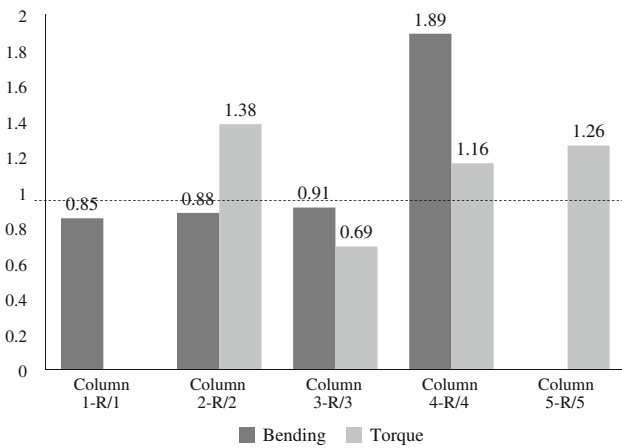
The general service stiffness indices of the repaired columns are summarized in Fig. 19. The general service stiffness indices for bending ranged from 85 to 189 %, and general service stiffness indices for torsion ranged from 69 to 138 %.

Fig. 19 General service stiffness indices for repaired columns.

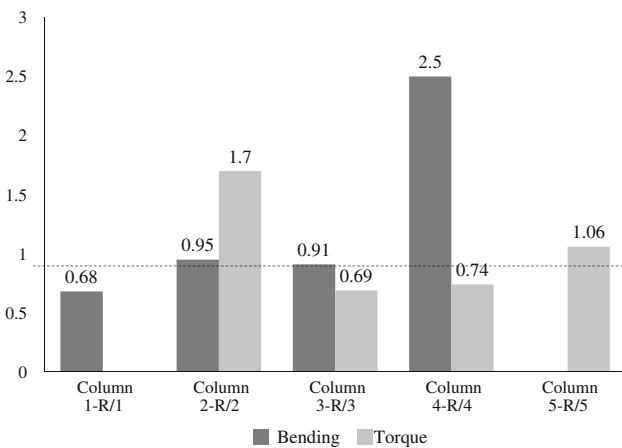
The ductility indices in terms of both bending and torsion are illustrated in Fig. 20. The ductility indices for bending ranged from 68 to 250 %, and for torsion ranged from 69 to 170 %.

Fig. 20 Ductility indices for repaired columns.
