On the breakage of rock drill steel

Muir Luken Frey

MASTER OF SCIENCE IN METALLURGY

1923.

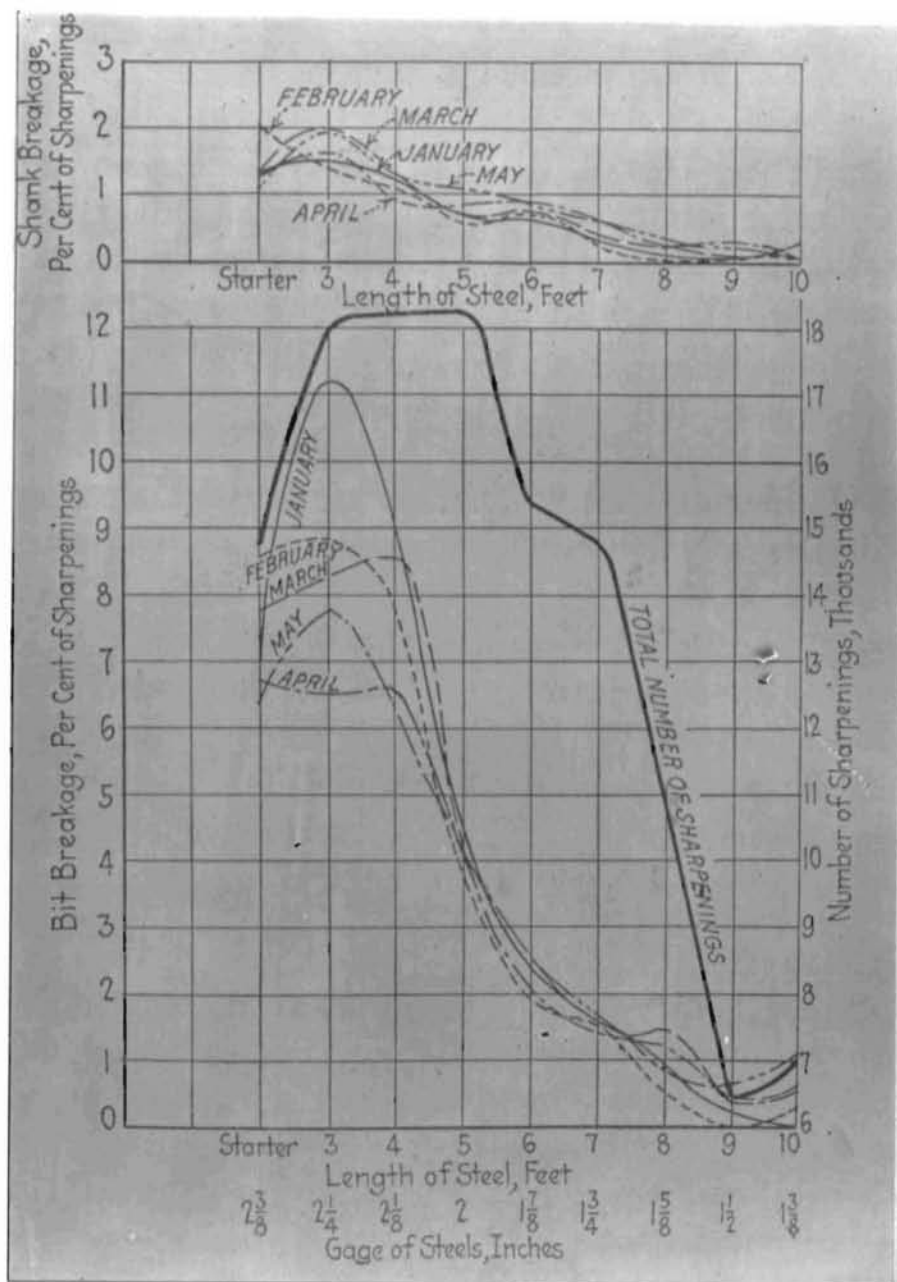
FIG. 1

particularly noteworthy because 80% of the failures occur within six inches of the bit, whereas, in nearly all other cases, the major portion of the breakage is at the shank end of the steel.¹ The reports from the company, it being one of the few that keep extensive records of performance, show that the majority of failures occur in the 3, 4, and 5 foot lengths, the gages of which are 2-1/4, 2-1/8 and 2 inches respectively. Figure 1 is a reproduction of a curve drawn from data furnished by the company.

Chart showing bit breakage as per cent of total sharpenings for the various lengths of drill steel, Homestake Gold Mines.¹

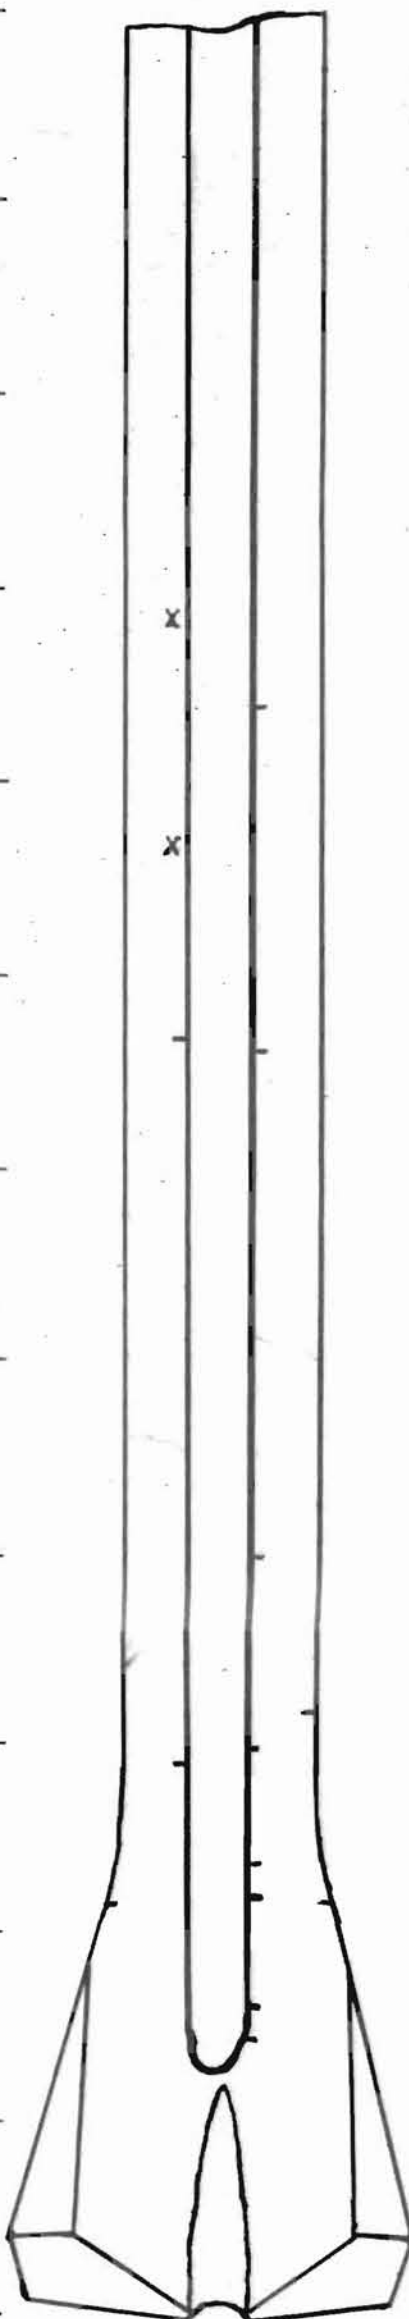
BIT NO.3.
Gage---2 1/8 in.

Bit No. 3 is very similar to No. 2 in that it has few cracks and may be considered relatively sound. Such unsoundness as exists is in the region of metallurgical break.

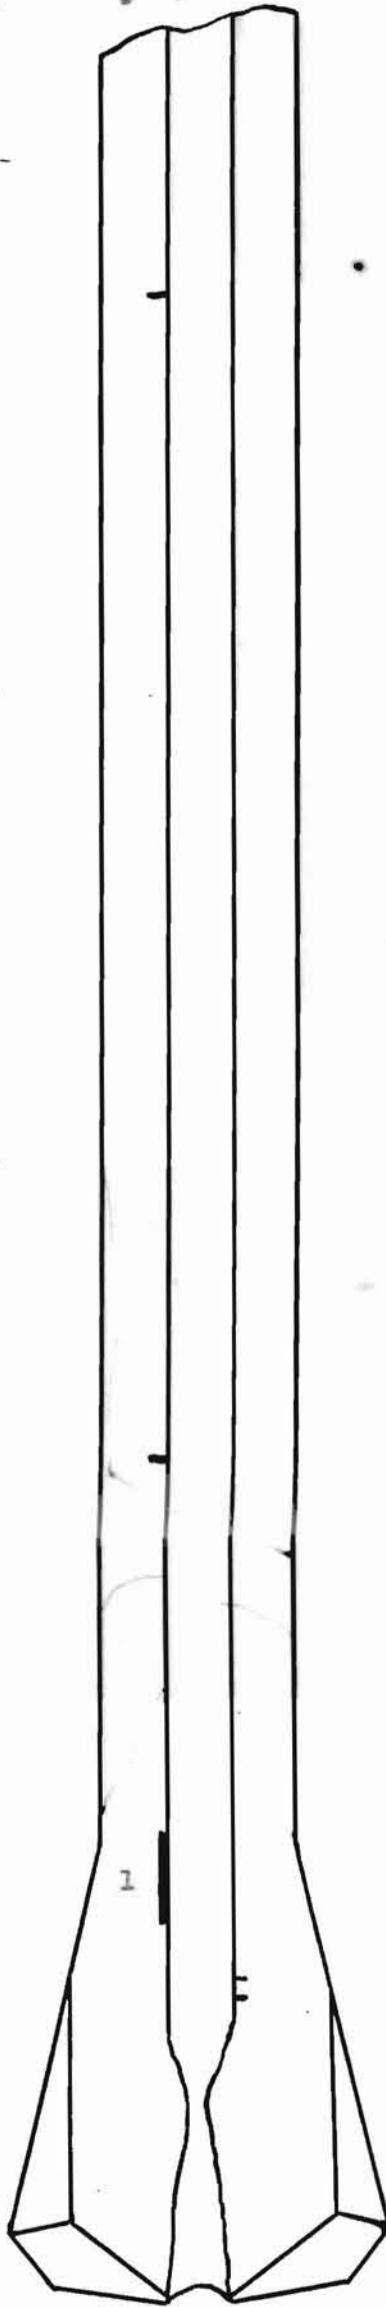
BIT NO. 4.
Gage—2 in.

In bit No. 4 is found once more the semblance of a relation between the metallurgical break and the area of most cracks. However, the deepest cracks occur just beyond the region of structural change.

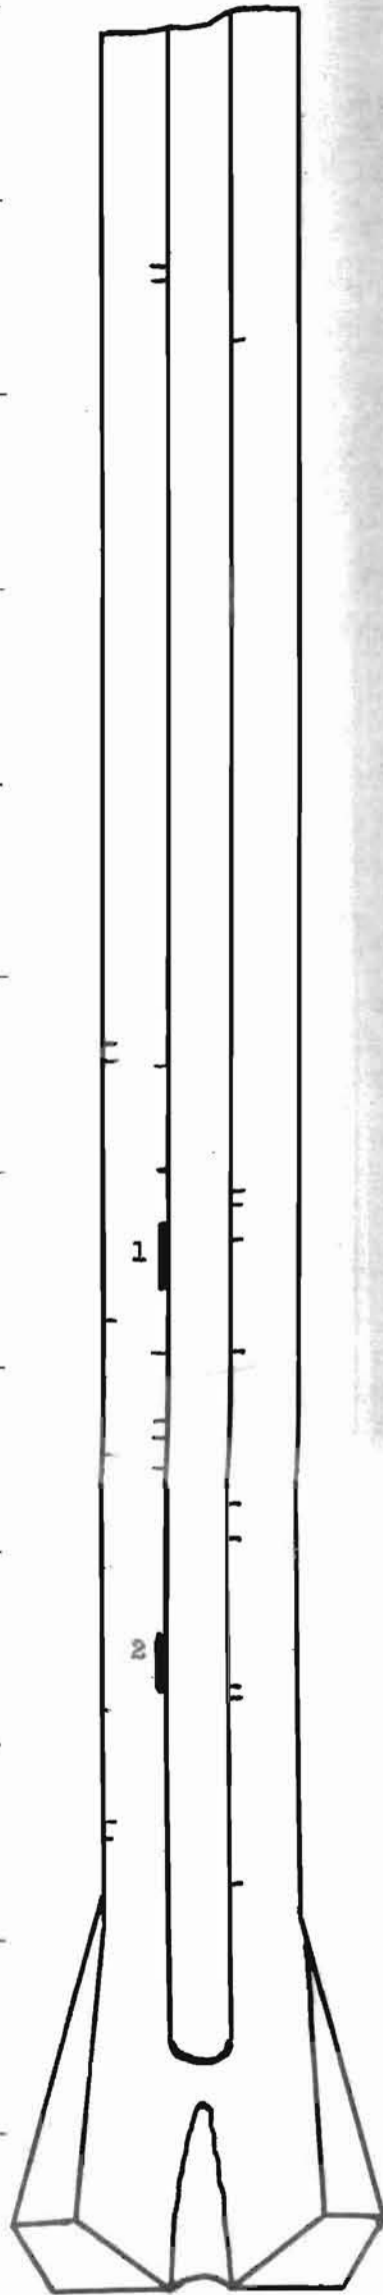
BIT NO. 5.
Gage—1 15/16 in.

In bit No. 5, the worst condition with respect to cracks is in the region of structural change. There are five zones embracing areas in which there are numerous cracks, and four of these five zones are in that region. Practically all of the deepest cracks, also, are in this region. The bit is relatively in very poor condition. It may be cited as the poorest of the lot.

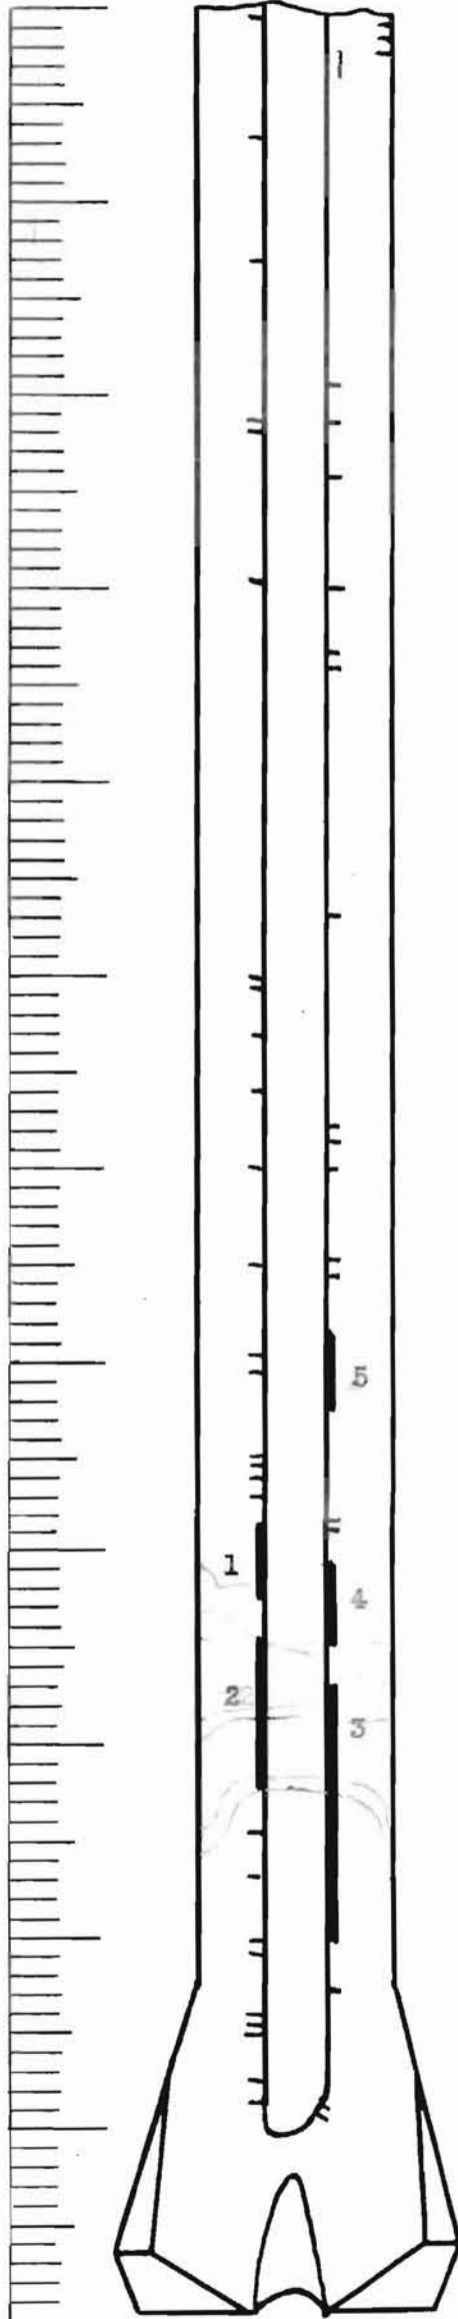
BIT NO. 7
Gage— 1 11/16 in.

As regards cracks, No. 7 is a fairly good specimen. There seems to be no connection between the metallurgical break and the location of the deepest crack. However, there are numerous small and incipient

cracks within the area of structural change.

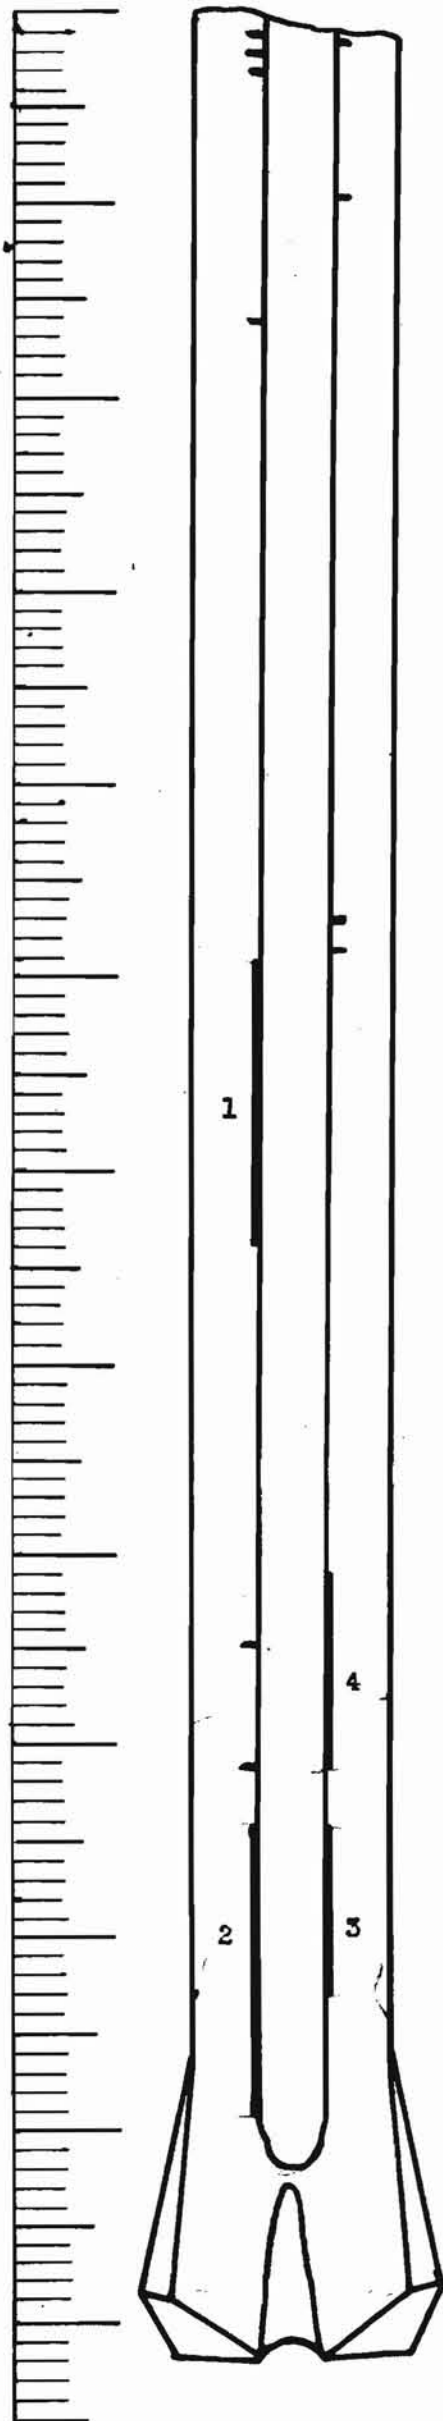
SIT No. 8.
Gage—1 9/16 in.

The most serious cracks in bit No. 8 are, generally speaking, not within the region of structural change, but are in the as-rolled section of the bar. The bit would be classed as poor.

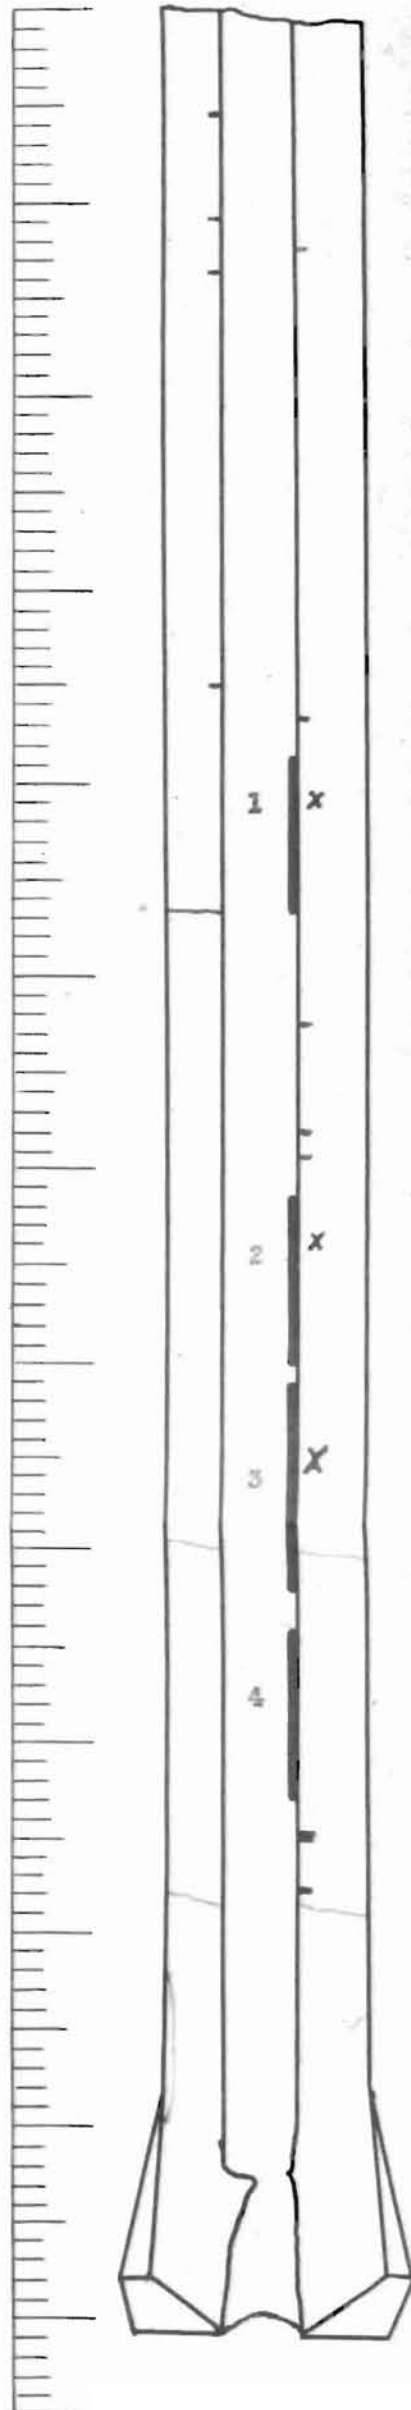
A similar condition to that of bit No. 7 is found in bit No. 9. There are few deep cracks in any portion of the specimen. The deepest one, 0.924 mm., is distinctly in the as-rolled section. The bit may be classed as passable.
