**Fishway Assessment and Cost Analysis Report, Royal River,  
Yarmouth, ME**

# Fishway Assessment and Cost Analysis Report

ROYAL RIVER, YARMOUTH ME

**PREPARED FOR THE NATURE CONSERVANCY  
FINAL – JULY 2017, REVISED JANUARY 2018**

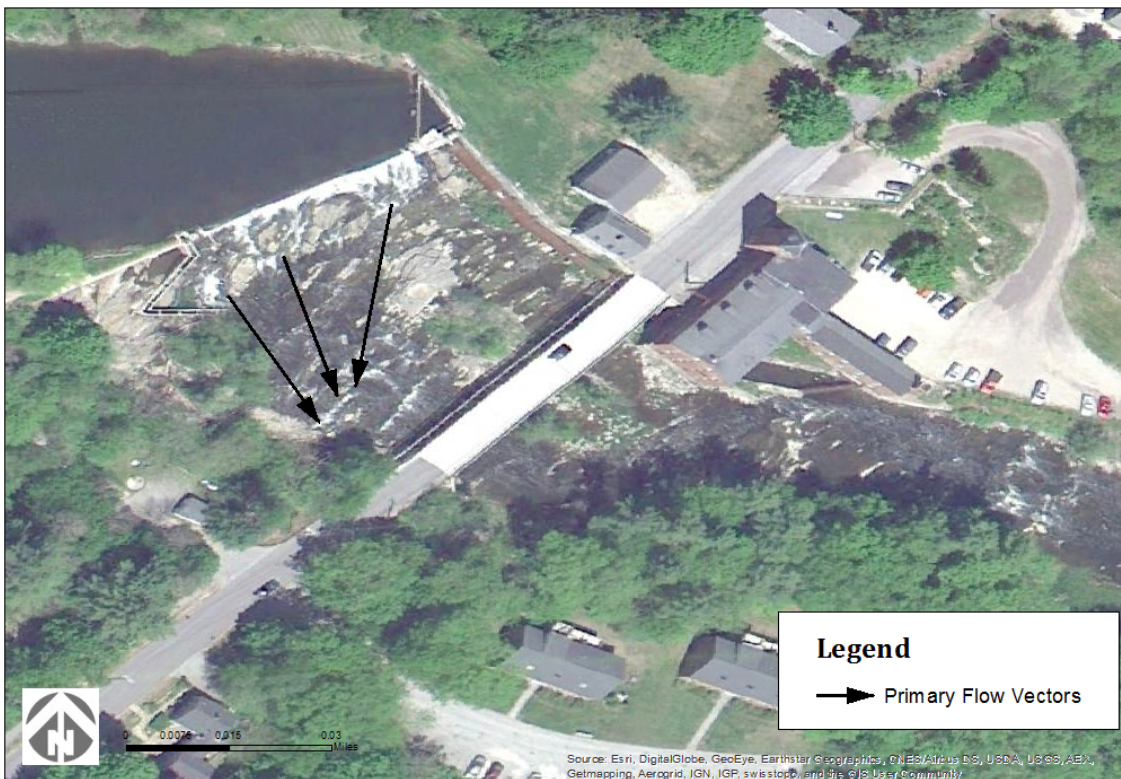
Upstream of the tailrace, fish encounter the beginning of the ledge outcrop and the bridge. Based on the review of the available high resolution aerial photography and previous topographic survey results (Titcomb 2013), the predominant flow patterns downstream of the spillway over the ledge outcrop tend to orient to the river right margin, with several primary streams converging in the vicinity of the fishway entrance (Figure 8). During the highest flows, there is a secondary flow pathway on river left but based on review of the aerial photos, this appears to be a shallower, less substantial flow alignment. As fish migrate closer to the fishway entrance, however, they will encounter several competing signals during many flow conditions, with the exception of the lowest flows (Figure 7 and Figure 8). These patterns may present challenging far-field attraction conditions for upstream migrating fish over a notable portion of the fish passage operational range. This trend is exacerbated by the relatively modest discharge that is able to be passed through the fishway while still operating in the target flow condition for upstream passage (discussed in more detail below).

**Figure 8:** Site map of the Bridge Street site indicating primary flow vectors. Date of imagery is May 16, 2010. Flow direction is left to right.

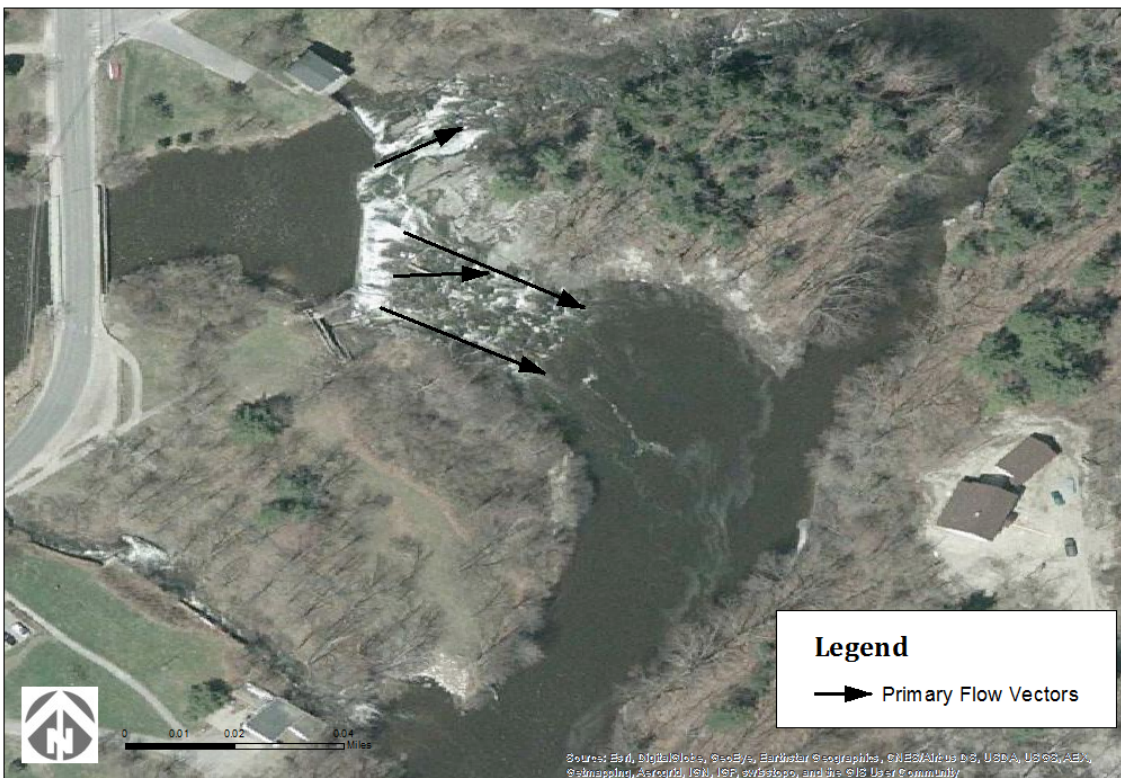
outflow from the left (or back) side of Gooch Island also does not appear particularly prominent in the aerial photo record suggesting the primary attraction cue will be to the river right side of the island (Figure 9 and Figure 10).

**Figure 10: Site map of the East Elm Street site indicating primary flow vectors. Date of imagery is December 31, 2002. Flow direction aligns with flow vectors.**

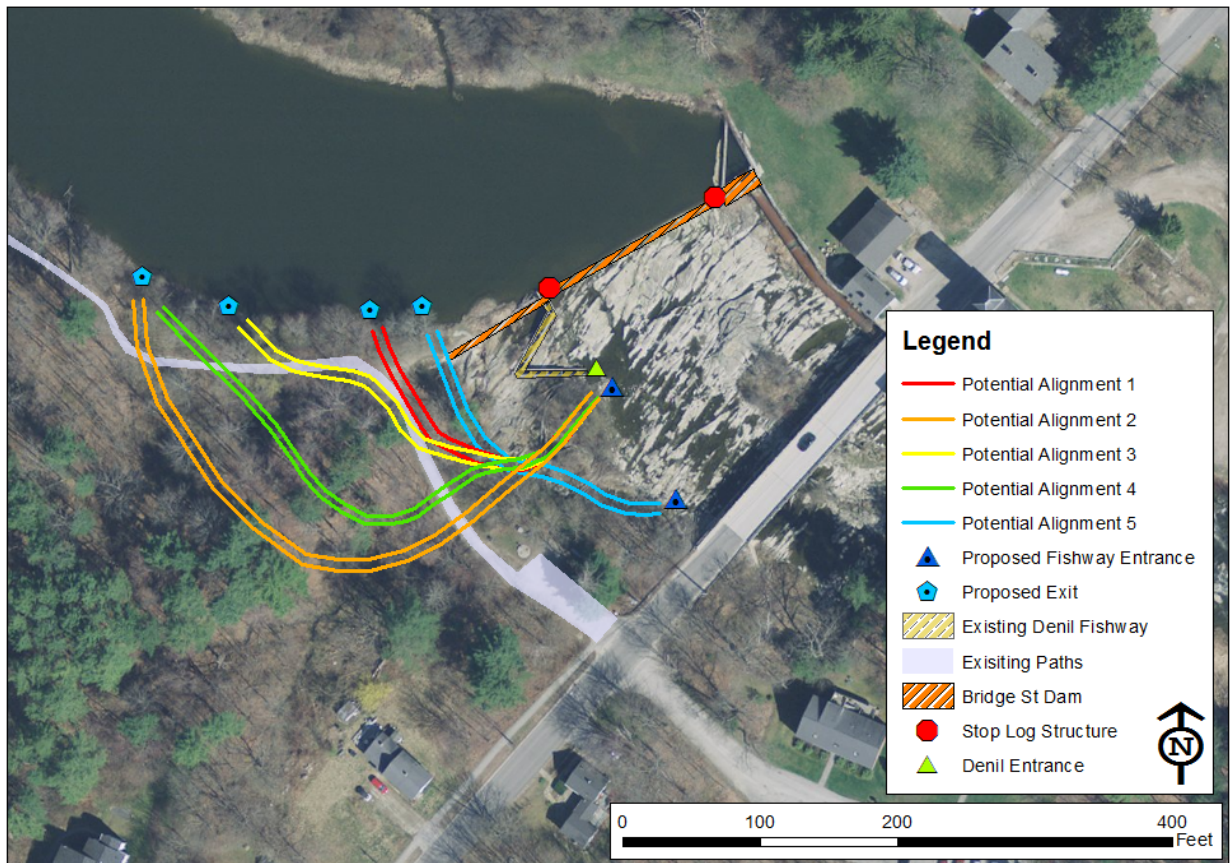
Additional design development would be required to optimize the nature-like bypass approach. However, several potential alignments were identified (Figure 12), which range in average channel slope from ~2.5-7% (Table 12). Ideal nature-like average channel gradients fall in the 2% to 3% range or less, with a maximum of up to 5%. Flatter channel slopes will facilitate passage by the broadest range of target species. These potential alignments would accommodate 100% of low fish passage flows (95% exceedance quantile), 60% of median fish passage flows (50% exceedance quantile), and up to 20% of high fish passage flows (5% exceedance quantile). All alignment options would make use of natural channel features such as pools and riffles, step-pools, and resting boulders to dissipate energy and create a diversity of flow patterns that fish would utilize as they ascend the channel, similar to native flow patterns in a natural stream. The differences between the alternative alignments are generally simply related to their overall lengths. With a longer channel alignment, the associated slope will be flatter. With flatter slope, velocities and hydraulic forces are reduced, leading to a higher degree of fish passage performance. The diversity of velocity and depth within the nature-like fishway would result in sufficient opportunity to increase the success rate of upstream passage (Aaerstrup 2003; Calles and Greenberg 2005).

The potential Bridge Street Dam bypass channel would connect into the main channel upstream and downstream of the dam on river right. Several of the alternative alignments would require construction on the Town of Yarmouth parcel as well as an adjoining private parcel adjacent to the right dam abutment. Downstream constraints for the alignment of this alternative include sanitary sewer infrastructure 125 feet downstream of the dam on river right. Several of the alternative alignments shown in Figure 12 cross the existing footpath adjacent to the river, which would require reconfiguration of a short stretch of the path, and possible addition of a footbridge. For the purposes of the cost analysis, a 481-foot-long nature-like bypass channel was assumed, which represents the lowest slope option listed in Table 15. This is a conservative assumption, as this also results in the longest length of channel construction and hence the greatest estimated construction cost among the alternative alignments shown.

Figure 12: Potential alignment options for the nature-like fishway alternative at the Bridge Street dam Location. Potential nature-like fishway construction constraints are included, such as pump station and drainage outfall locations.

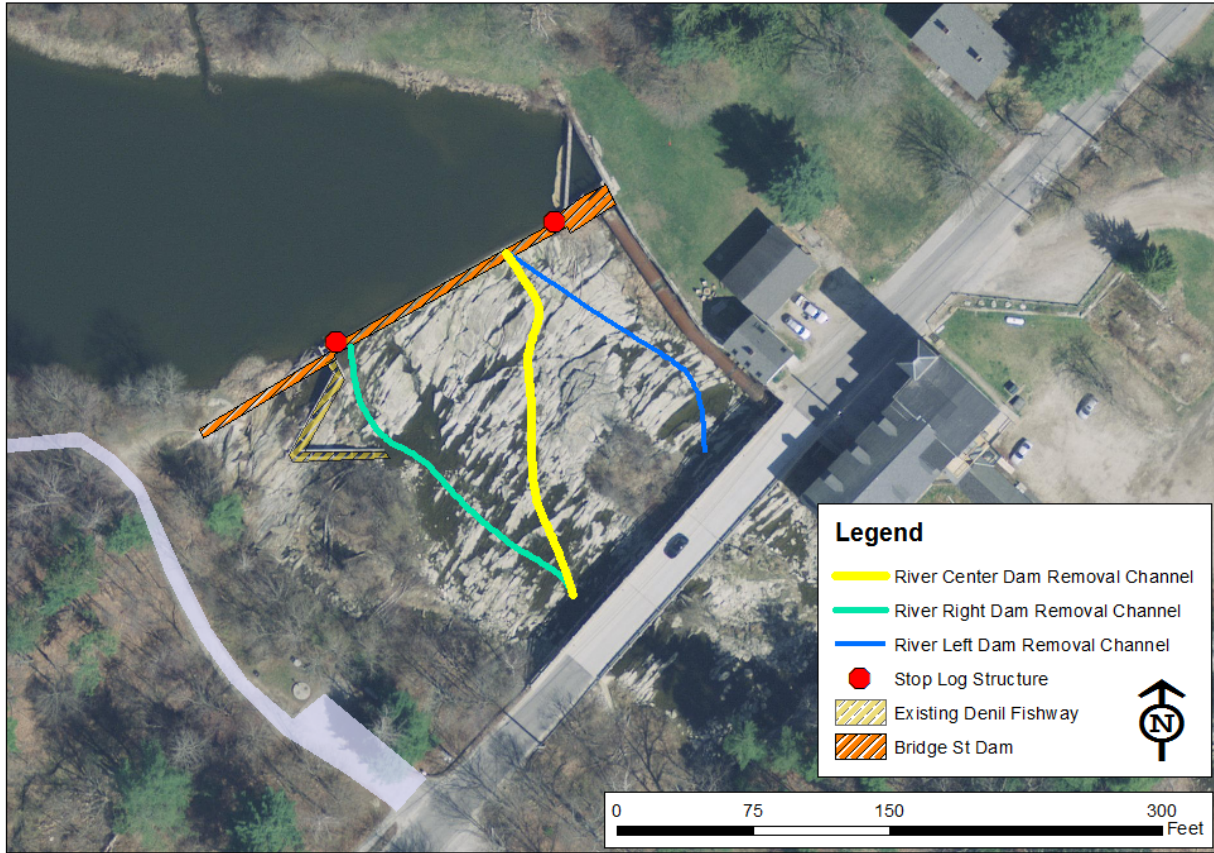
Based on the current observable site condition, probable post-dam removal fish passage channels are indicated in Figure 13. These alignments were estimated based on comparisons of bedrock elevations, field observations, and aerial photograph analyses, and constitute the likely primary flow paths if the spillway were to be removed. Slopes and lengths of these channels are provided in Table 13. The average channel gradients along these alignments are relatively steep. It is anticipated that the diversity of flow patterns along the ledge outcrop would provide a variety of opportunities for passage by native fish, similar to that which occurs in numerous rivers in similar settings along the Maine Coast. However, it was also assumed that select enhancement of passage conditions through ledge modification may be required associated with dam removal. Optimization of the passage design associated with dam removal would need to be advanced in subsequent project phases.

Figure 13: Probable post-dam-removal fish passage channels at the Bridge Street Dam site.

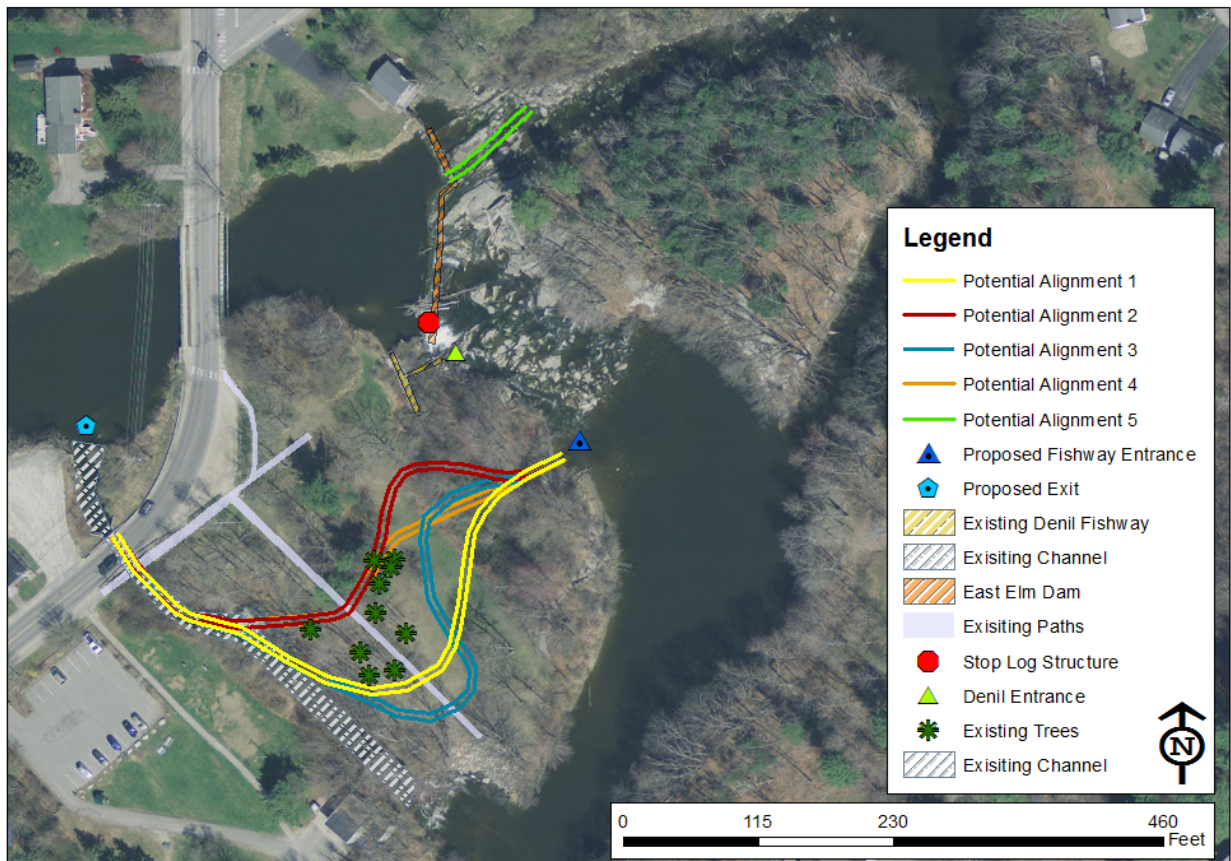
As with the Bridge Street site, additional design development would be required to optimize the nature-like bypass approach. However, several potential alignments were identified (Figure 15), which range in average channel slope from ~2.5-3.7% (Table 14). The alternative alignment 5 takes advantage of an existing seam in the ledge outcrop near the left end of the spillway, and would require additional investigation of the potential for ledge outcrops upstream of the dam spillway to fully establish its feasibility. This alignment would route passage flows around the back side of Gooch's Island, which would likely provide adequate attraction signal at low passage flows, but may be more limited at high fish passage flows.

The remainder of the alternate alignments shown in Figure 15 would make use of the upstream inlet to the existing foundry channel. These alignments split from the foundry channel downstream of the historical spillway in the foundry channel, bending towards the main river channel across the park, with a fishway entrance at the terminus of the ledge outcrop in the existing main channel pool.

Except for alignment 5, all of the alignments shown in Figure 15 would require construction on the adjacent parcel owned by the Town of Yarmouth. The same alignments cross the existing footpath

Figure 15: Potential alignment options for the nature-like fishway alternative at the East Elm Street dam site.

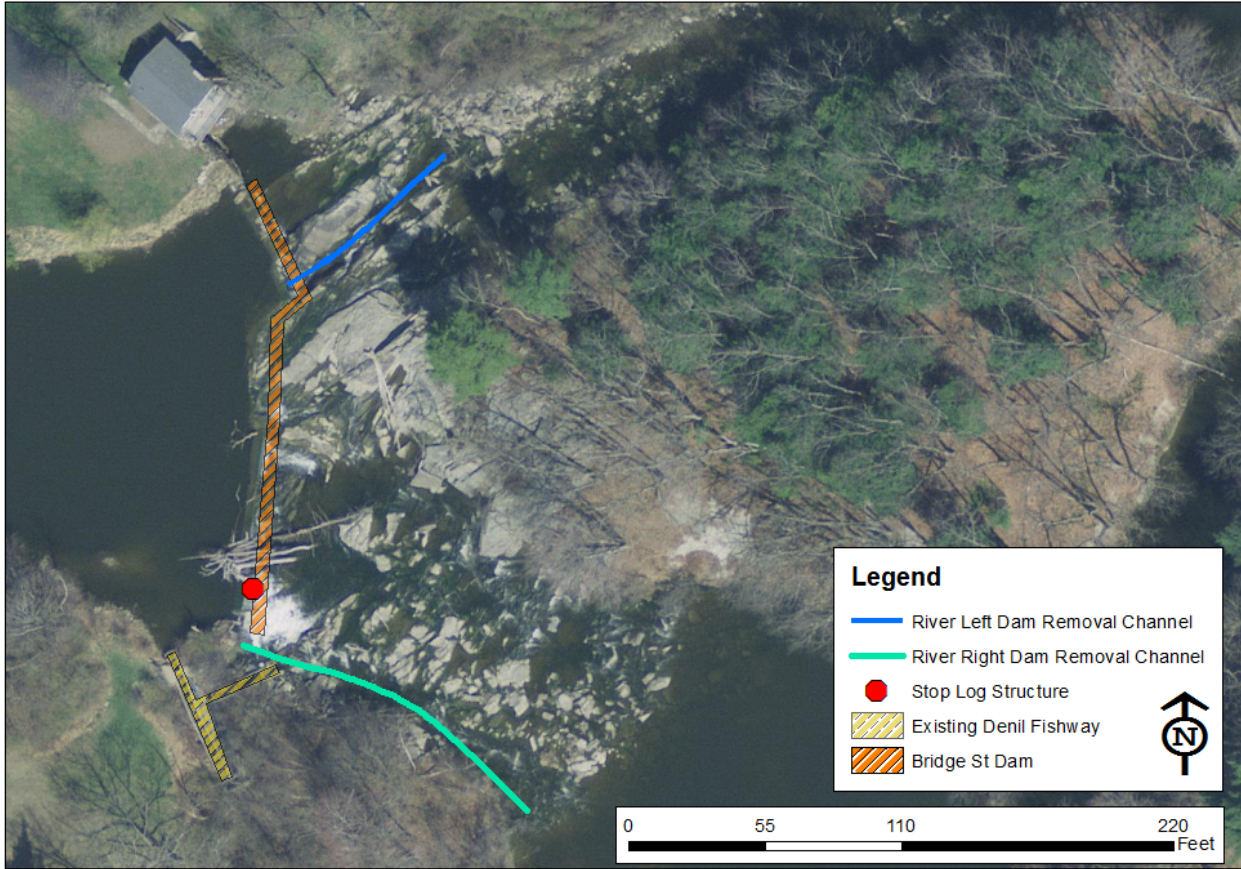
Based on the current observable site condition, probable post-dam removal fish passage channels are indicated in Figure 16. These alignments were estimated based on comparisons of bedrock elevations, field observations, and aerial photograph analyses, and constitute the likely primary flow paths if the spillway were to be removed. Slopes and lengths of these channels are provided in Table 15. As with the Bridge Street dam removal alternative, the average channel gradients along these alignments are relatively steep. It is anticipated that the diversity of flow patterns along the ledge outcrop would provide a variety of opportunities for passage by native fish, similar to that which occurs in numerous rivers in similar settings along the Maine Coast. However, it was also assumed that select enhancement of passage conditions through ledge modification may be required associated with dam removal. Optimization of the passage design associated with dam removal would need to be advanced in subsequent project phases.

See Section 5.1 for additional assumptions in the cost analysis related to mitigation of infrastructure impacts and sediment management. Sediment management associated with removal of East Elm Street dam in particular is a potentially major cost factor.

Figure 16: Probable post-dam-removal fish passage channels at the East Elm Street dam site.
