Nondestructive evaluation of concrete bridge columns rehabilitated with fiber reinforced polymers using digital tap hammer and infrared thermography

Nondestructive Evaluation of Concrete Bridge Columns Rehabilitated With Fiber Reinforced Polymers Using Digital Tap Hammer and Infrared Thermography

**Master of Science
in
Civil Engineering**

**Department of Civil and Environmental Engineering
Morgantown, West Virginia**

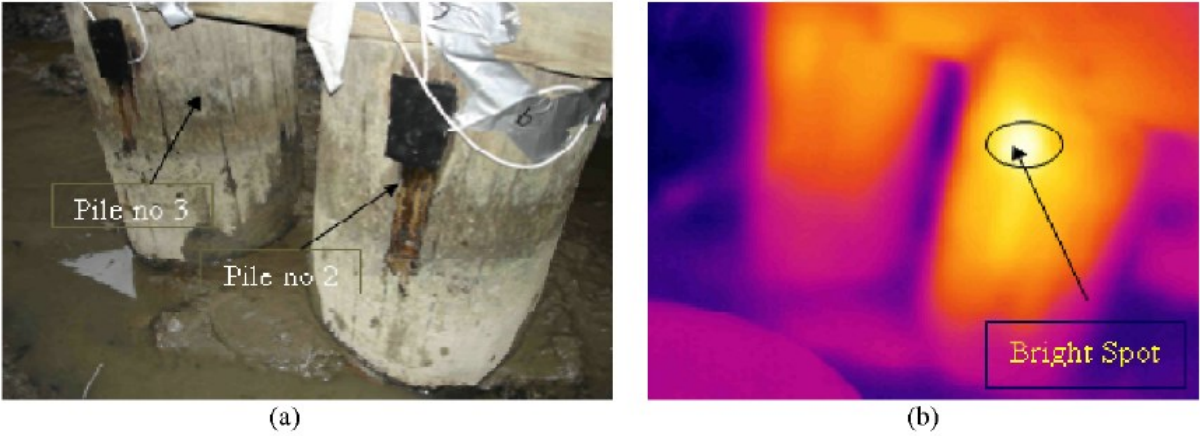
A second and third pile were observed, however, site conditions limited infrared thermography to just pile two. The infrared image of the second pile indicates a debond is present due to the bright region within the image. Analysis of the image identifies the temperature of the “hot-spot” to be 59.1 °C with the sound region coming in around 40.9 °C. Again, tap testing supported this finding. The visual image and infrared can be seen in Figure 2.27 (a) and (b) respectively. Once the piles were wrapped with the GFRP composite, piles one and two were again

Figure 2.27: (a) Visual image of second & third timber piles (b) Infrared image of pile two prior to wrapping (Halabe et al. 2008).

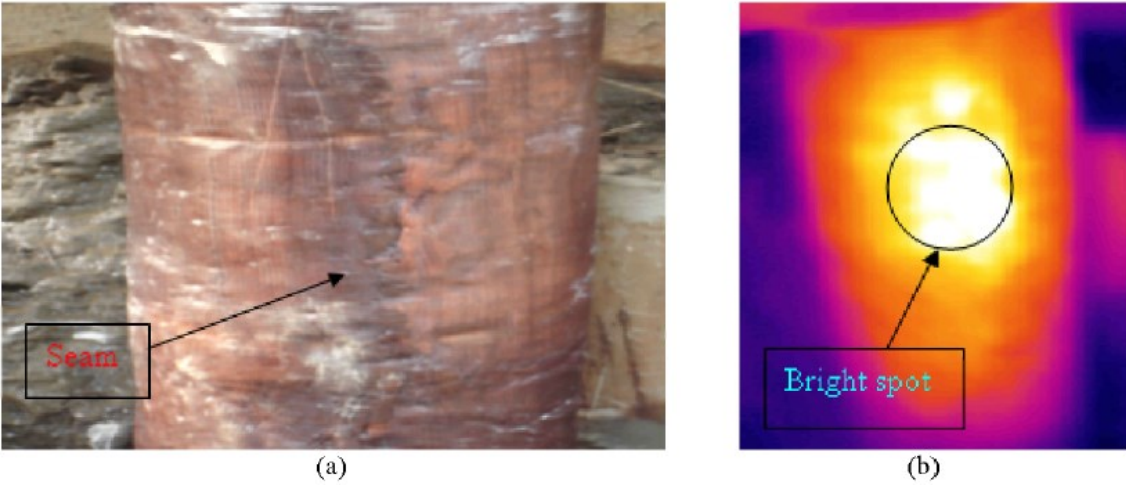
examined via IRT. As shown in Figure 2.28 (b), a bright region or “hot-spot” was found in the first pile with a temperature difference of 36.0 °C between the debond and defect-free region. However, this “hot-spot” was actually found to be a seam in the FRP. Tap testing conducted on the region confirmed that no debond or delamination was present. The same phenomenon occurred in pile number three in which a “hot-spot” on the infrared image was found to be a seam in the FRP. Figure 2.29 show the visual and infrared image of pile number three after the GFRP wrapped was installed.

Figure 2.28: (a) Visual image of first timber pile with seam (b) Infrared image of first pile after wrapping (Halabe et al. 2008).

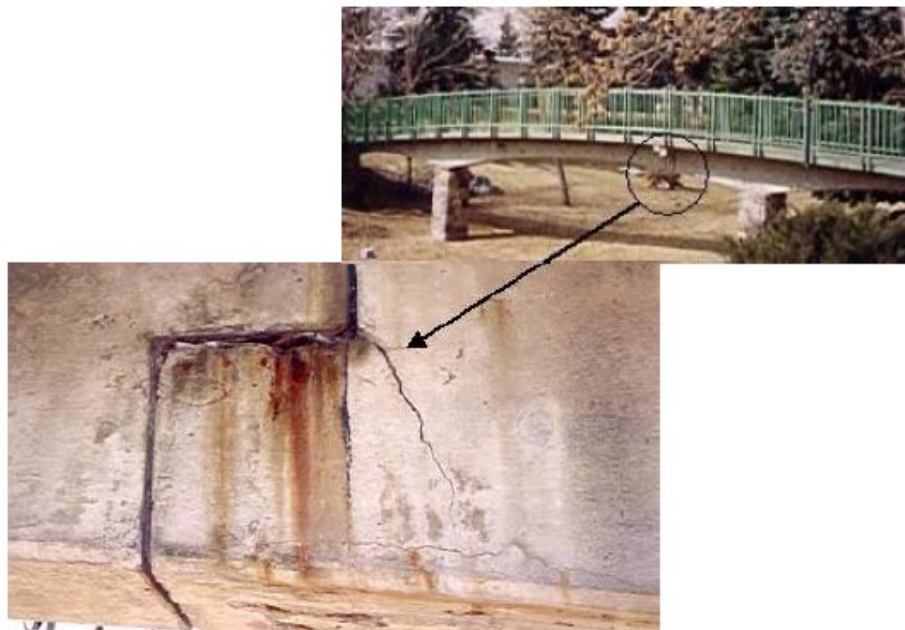
The Jaques Lodge Bridge is a pedestrian bridge located in Calgary, Alberta. This particular bridge is constructed of a precast concrete girder that is “dropped in” and supported on both ends by a cantilevered girder. The concrete corbels that supported the main girder showed cracking that originated from unexpected frictional forces and a lack of internal diagonal reinforcement. Figure 2.38 represents a close-up of one of the corbels in reference to the global location on the bridge.

Figure 2.38: Cracking of a corbel on the Jaques Lodge Bridge (Hutchinson et al. 2003).

Engineers chose to use a strut and tie model for the basis of design of the CFRP rehab, and the strains in the CFRP sheets were held to a maximum of 4 millistrains. To achieve a thorough repair, the entire main span girder was lifted up off of the corbels. This allowed applicators to clean and prep the surface of the concrete. Once the surface preparation was completed, Replark CFRP sheets were again used to make the repairs. A combination of one horizontal layer and one diagonal layer was applied to both sides of the corbel as shown in Figure 2.39. Once the epoxy used to impregnate the FRP was cured, a protective coating was applied and the main span girder was lowered back down. Figure 2.40 shows the bridge after repairs were made. Repairs to the bridge lasted for six weeks.

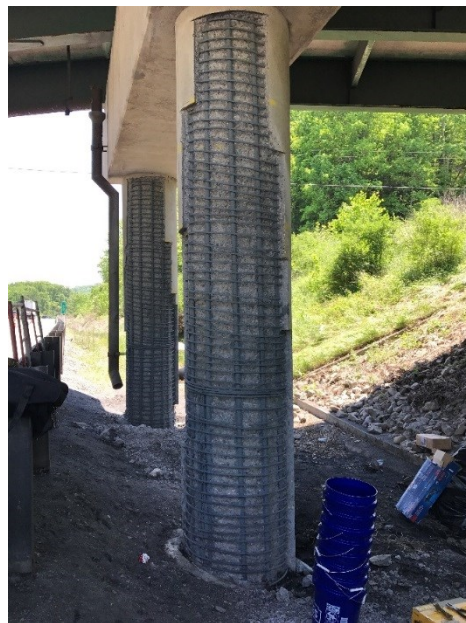
Figure 3.4: Pier 3 prior to patchwork.

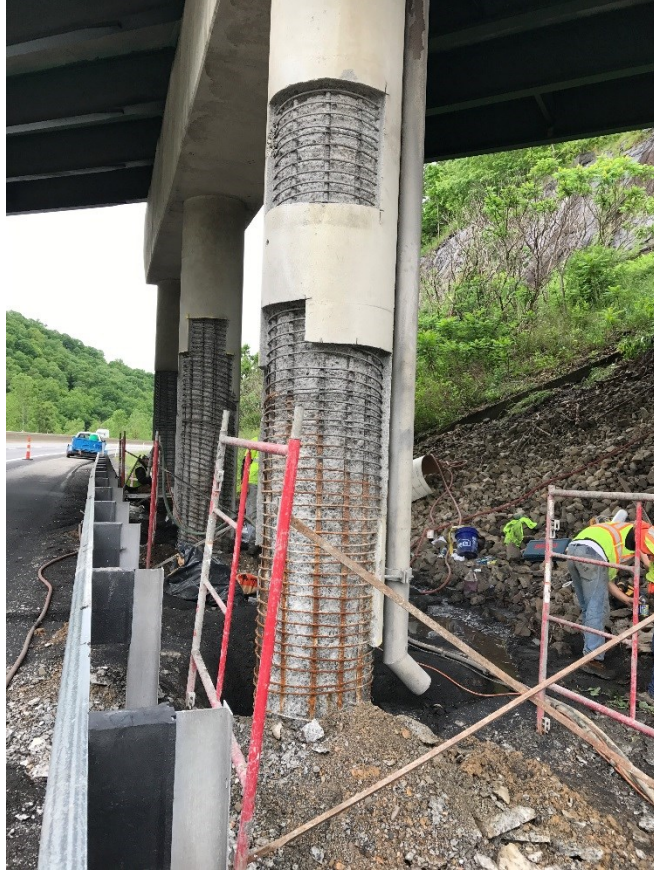
Figure 3.5: Pier 1 prior to patchwork.

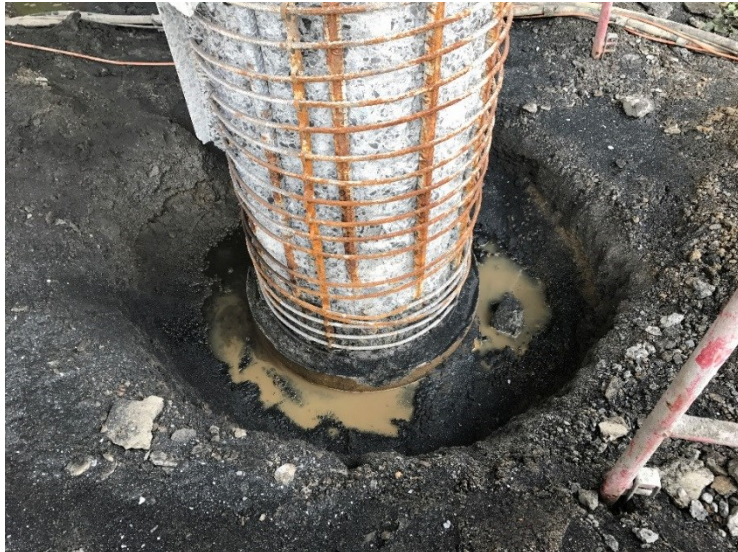
Figure 3.6: Excavation for patchwork.

Crews with Titan Industrial Services, the general contractor awarded to conduct the work, began the repairs by first establishing with WVDOH the areas of concrete that needed to be removed and replaced. Original quantities provided at the time of bid called for 346 square feet of concrete patching to be completed prior to FRP wraps being applied. Once the contractor arrived on-site and began to remove the deteriorated concrete, it was found that more of the column had experienced spalling, and the justification was made between the contractor and the WVDOH to remove the additional concrete via a written change order. Reports from the WVDOH indicated that the final square footage of concrete patch work was nearly double the initial amount. Figure 3.4 illustrates the extent of the patching to be completed on pier 3, and Figure 3.5 displays the areas to be patched on pier 1. A large portion of the additional concrete patching stemmed from the quantities of “unsatisfactory” concrete on the interior side of the rebar stirrups. The extent of the patchwork also included patching elements approximately two feet below grade on piers 1 and 3 as depicted in Figure 3.6.

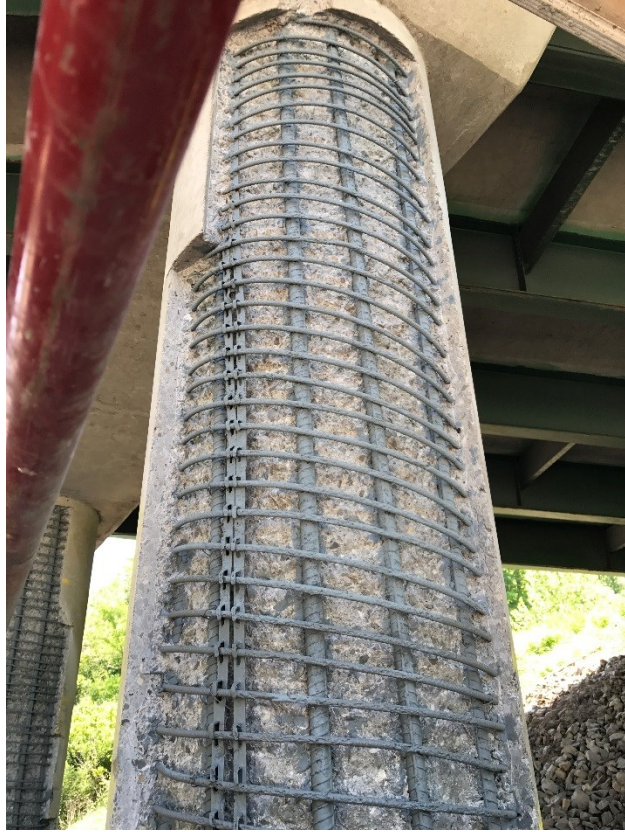
Figure 3.7: Rebar with corrosion inhibitor.

Upon the completion of removing all of the deteriorated concrete, the reinforcing steel had to be cleaned and coated with a corrosion inhibitor to prevent further corrosion. The process of coating the steel is time consuming because the inhibitor has to be brushed on to ensure that all of the rebar is covered. Figure 3.7 is an image of the reinforcing steel after the corrosion inhibitor is applied at which point the rebar is light grey in color. Once the rebar was sufficiently covered, the process of patching the concrete could commence. The irregular shapes of the areas to be patched in addition to the columns being round made forming patches in preparation for pouring of the concrete cumbersome. Thus, the contractor had to develop unique forming methods that involved strapping half of a three foot diameter sonotube to the column to act as a form for the concrete. The formwork would have a notch in the top where concrete could be poured into the form. The contractor chose to use a high strength MasterEmaco repair mortar in place of the deteriorated concrete. Images of the formwork and patches after the columns were repaired can be seen in Figures 3.8 and 3.9 respectively.

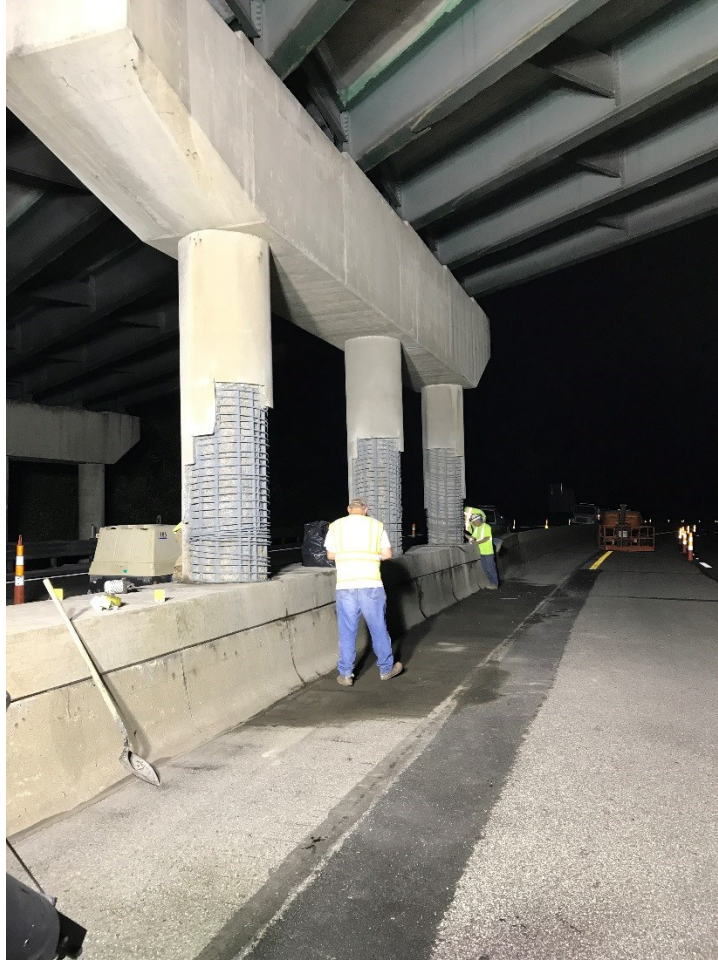
After speaking with the inspector for the WVDOH about the high number of debonds, it was noted that the temperatures were much cooler when the contractor wrapped the columns of pier 2 than when the other columns of piers 1 and 3 were wrapped. The majority of the defects were found in the bottom half of the columns on pier 2. Some of the tap hammer results eluded to the fact that the defects were actually in the concrete and not within the wraps. These two phenomena are reinforced by the fact that the lower portions of columns in pier 2 underwent extensive concrete repairs as depicted in Figures 4.19, 4.20, 4.21. Examples of debonds that were found in the columns of pier 2 are shown in Figures 4.22 and 4.23.

Figure 4.19: Image showing all three columns of pier 2 and the necessary concrete repairs being made.

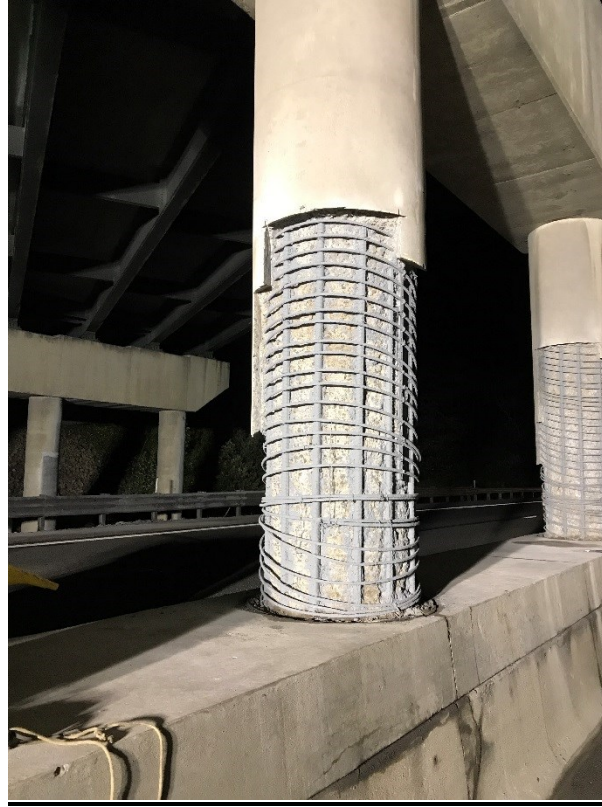
Figure 4.20: Center column of pier 2 in the process of being prepped for concrete repairs.

Based on the results from field observation and specifications from ACI440.2R-17, all of the debonds found via tap hammer and infrared testing could be filled with resin by the contractor. This is because the wrap is nonstructural. If the wrap was being used in a structural manner, then all of the delaminations greater than 25 in² would need to be removed and replaced. In Piers 1 and 3, the highest number of defects found in one column was 41 as shown in Appendix A. Columns within Piers 1 and 3 were roughly 377 ft² in total surface area. This means that the 41 debonds were scattered across 377 ft² equating to a little more than one debond in 10 ft² which is less than the 10 allowed by ACI. Although columns in Pier 2 produced the highest number of debonds per column with 82, the total area of each column in this pier was approximately 245 ft², which translated to a little more than 3 debonds per 10 ft². Again, this number falls in the permissible range of ACI 440.2R-17. It is also important to note that care should be given when patching the concrete structure at or below finish grade to achieve a smooth finish before applying the FRP wraps. There were multiple locations identified during tap hammer testing in piers 1 and 3 where the concrete at or below grade had considerable defects.

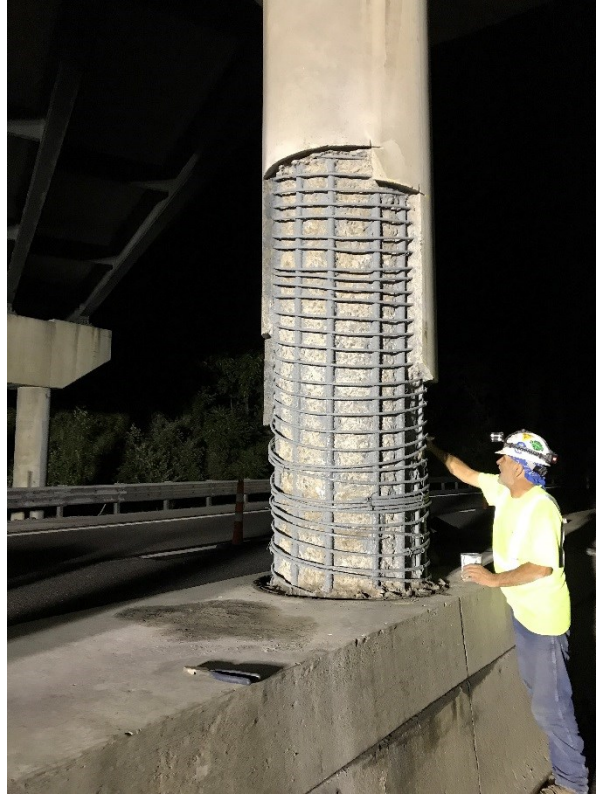
Figure 4.21: West column of pier 2 while corrosion inhibitors were being placed on the rebar.
