## Assessment of application, effectiveness, and compliance of forestry best management practices in West Virginia

**ASSESSMENT OF APPLICATION, EFFECTIVENESS, AND COMPLIANCE OF  
FORESTRY BEST MANAGEMENT PRACTICES IN WEST VIRGINIA**

**Keywords: Best Management Practices, Compliance Assessment, Water Quality,  
Timber Harvesting, Forest Operations, Forest Management**

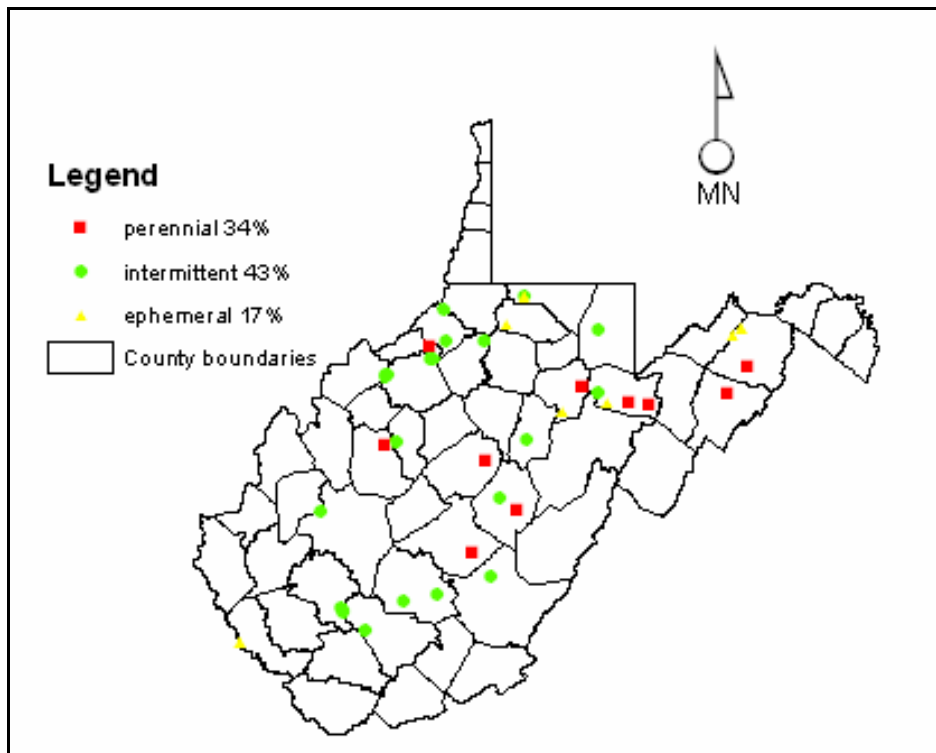
Figure 3.12. SMZ stream type by site.

The stream type distribution across the state showed that more intermittent streams were encountered in districts one and three. With the highest compliance being found on intermittent streams, this meant that these districts showed a good application of the BMPs. The perennial streams, having the lowest compliance, should be focused on more across the state.

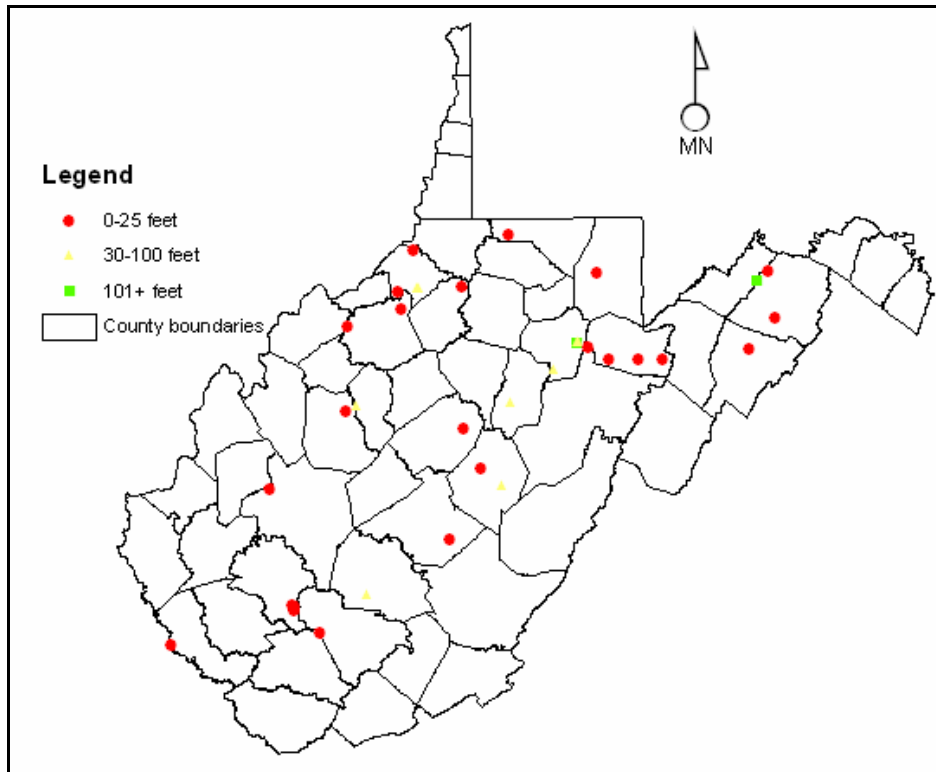
Figure 3.15. SMZ width by site using straight-line distance.

The required buffers appeared to be constructed more towards the central and north central part of the state (Figure 3.15). The greatest distances left from streams were found in the District 1 and District 2. This figure shows the location of the SMZs and the distance that was measured for each stream. There were no concentrated points for any one district, which means this could be a point of interest for each of the districts.

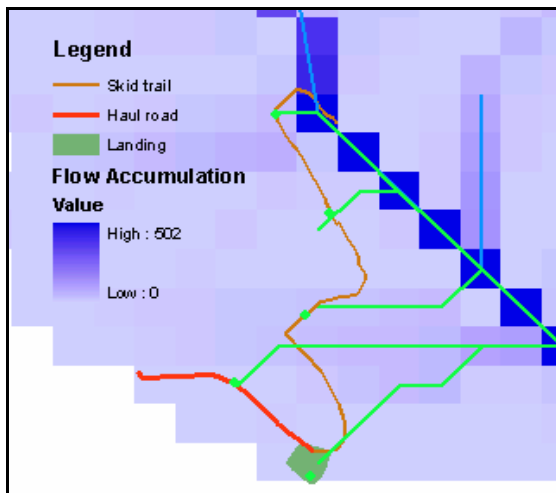
Figure 3.16. A site with Berks soil type.

Five major soil types were noticed on these sites. An example showing a site with four landings was found to have a Berks soil type (Figure 3.16). The Berks soil series tend to have lower ratings for the two soil characteristics that were focused on. This site had ratings of “slight” for both equipment limitations and erosion hazard. High levels of effectiveness were found on this site. This could be attributed to the soil type and also the buffer zone that was used.

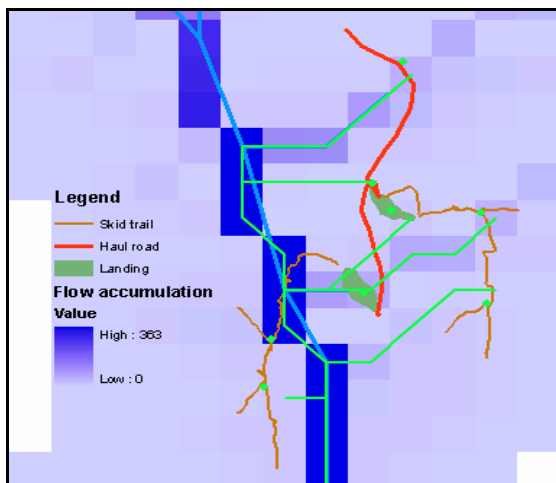
Figure 3.17. A site with Gilpin soil type.

The Gilpin soil series had slightly higher ratings for the characteristics of erosion hazard and equipment limitation, which was found on some of the sites. The two soil characteristics in this example site (Figure 3.16) had “severe” ratings. The combination of the sensitive soil, and the activity in the SMZ resulted in the low effectiveness levels on this site. Erosion was very noticeable on the landing and skid trails. Sediment had entered the stream from both places of activity. Better application of the BMPs could have been applied on this site, but with the other factors combined their effectiveness levels may not have increased.
