This article focuses on an original case history of replacement of a leaky 245 kV OIP bushing of a 220/132/33 kV, 160 MVA, transformer on site at the 220 kV Jabalpur substation, in Madhya Pradesh state in India with an available 245 kV OIP bushing having longer L-2.

Retrofitting of 245 kV OIP bushing with longer oil-end

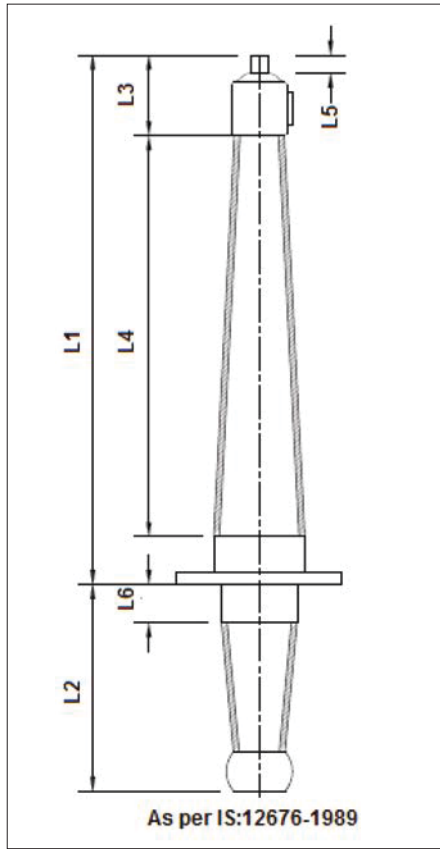
ment of a 245 kV bushing of a 160 MVA, 220/132 kV transformer made by GEC (year of manufacture - 1993) arose. The available 245 kV OIP bushing in the stores of M.P. Power Transmission Utility was with longer length of L-2, Fig. 1 (oil end length from flange to bottom) and to install the same was not possible as it would have fouled with the core coil assembly clamping frame (end frame) of the transformer. The OEM of the transformer was contacted and the extension piece of tur-

Figure 1. OIP bushing's physical dimensions depicting L2. [1]

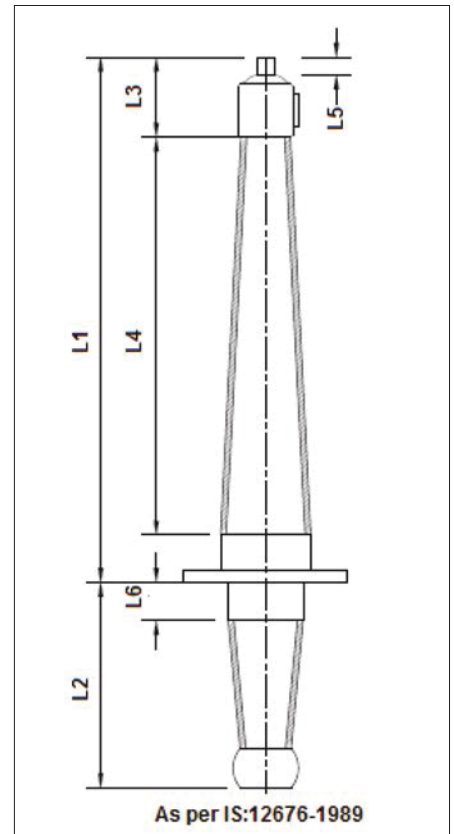
Contrary to the standard IS: 12676:1989 specification pertaining to the physical dimensions of the OIP bushings, the manufacturer M/S GEC Ltd, did not follow the same and designed the transformer with bushing of oil-end length L-2 of 830 mm, jeopardizing and disabling the option of interchangeability of major/main components of 160 MVA transformers putting the M.P. Power Transmission Co. Ltd. in trouble.

Figure 3. OIP bushing dimensions (in erect position) as per IS: 12676-1989 [1]
