7. Surface Ruptures Observed at Ejido Saltillo, Baja California after the Mexicali Valley Earthquake of 9 June, 1980

R.V. Sharp

8. A Review of Geological Effects and Damage Distribution of the June 9, 1980 Mexicali Valley Earthquake

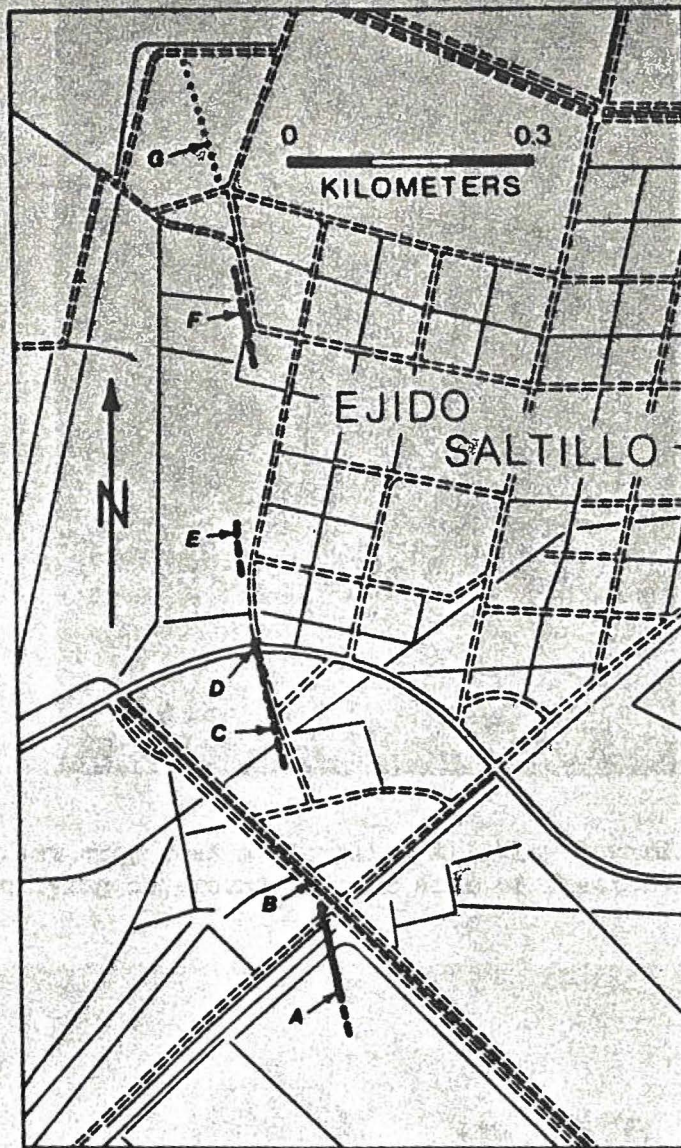
Figure 7.2 Map of fault features at Ejido Saltillo. Light lines indicate the following cultural features: single solid lines - land boundaries, edges of fields, drainage ditches, and irrigation canals; double solid lines - pavement of Pascualitos - Pescaderos highway; double dashed lines - unpaved secondary roads and levee roads. Heavy lines represent new surface fractures and other possible fault traces: solid lines - fractures observed on ground surface in this investigation; dashed lines - observed fractures whose extents were not determined, and fractures that were observed by residents but were obliterated before our investigation; dotted line - pronounced lineament in cultivated field that is visible on aerial photographs. Letters at arrows indicate localities discussed in the text.

Locality G: This field was not checked for new rupture because at the time of our visit we were unaware of the pronounced contrast in the appearance of vegetation on aerial photographs of this field. I have no direct evidence that this photolineament is fault related, but I show it in Figure 7.2 because of its remarkably suggestive position and orientation with respect to the breaks that were observed farther south. No other photolineaments along the line of new breaks or along its projections were detected.
