Thorough Geological Investigation is of Prime Importance When Selecting a Dam Site

Strength and Stability of Structure Often Jeopardized by Location Upon Inadequate Foundation which may Superficially Appear Suitable

By F. L. RANSOME

Professor of Economic Geology, California Institute of Technology

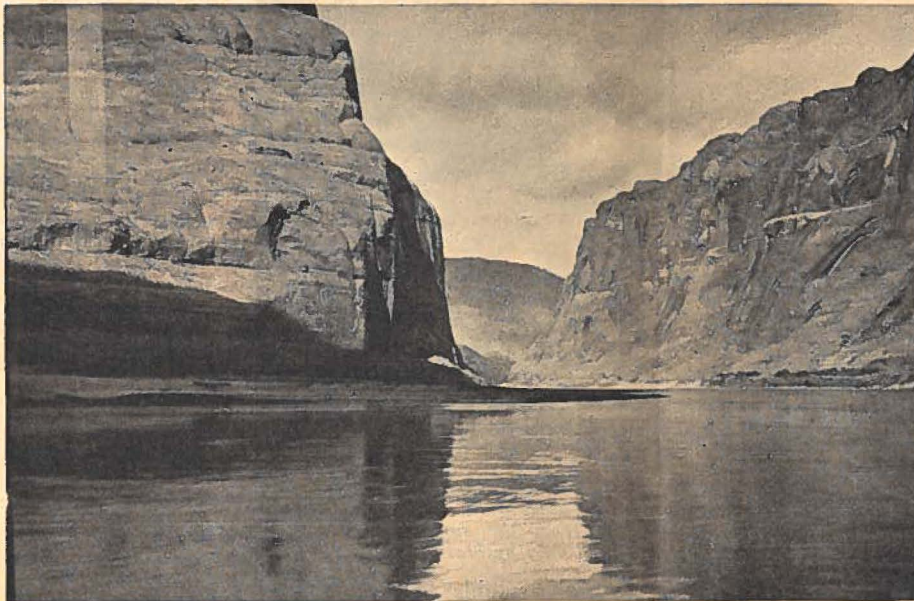
Glen Canyon dam site, on the Colorado, near Lees Ferry, Arizona, showing adequate abutments of a soft but massive sandstone.

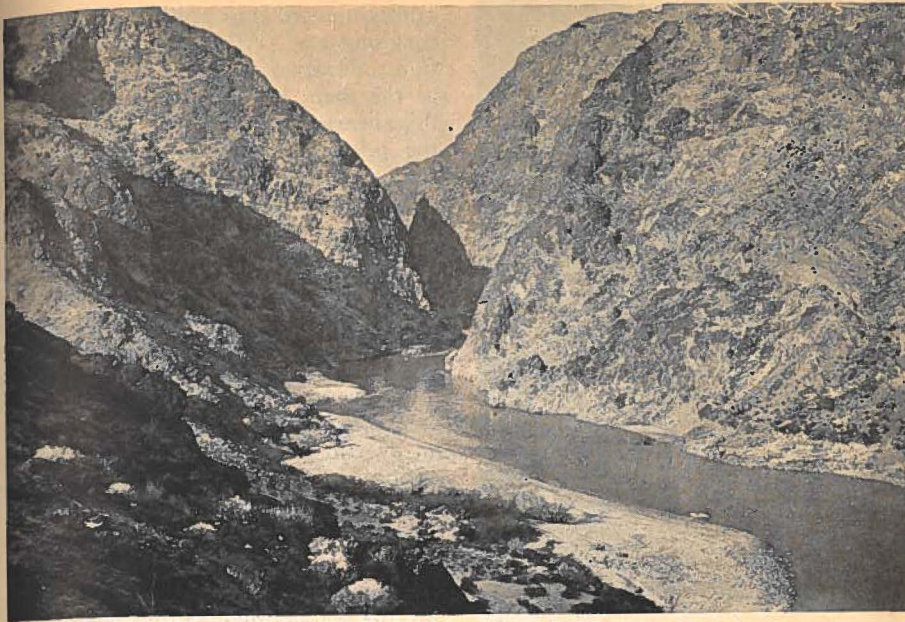
Looking downstream into Boulder Canyon, on the Colorado, illustrating an excellent dam site in hard but minutely jointed granite.

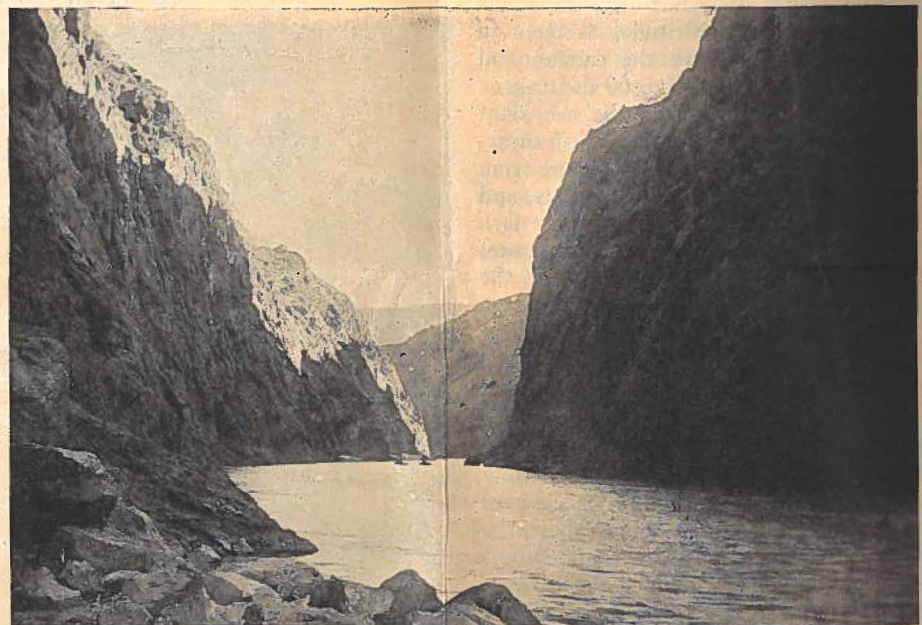
Black Canyon dam site on the Colorado, from down-stream side. An excellent site in hard, moderately jointed volcanic breccia.

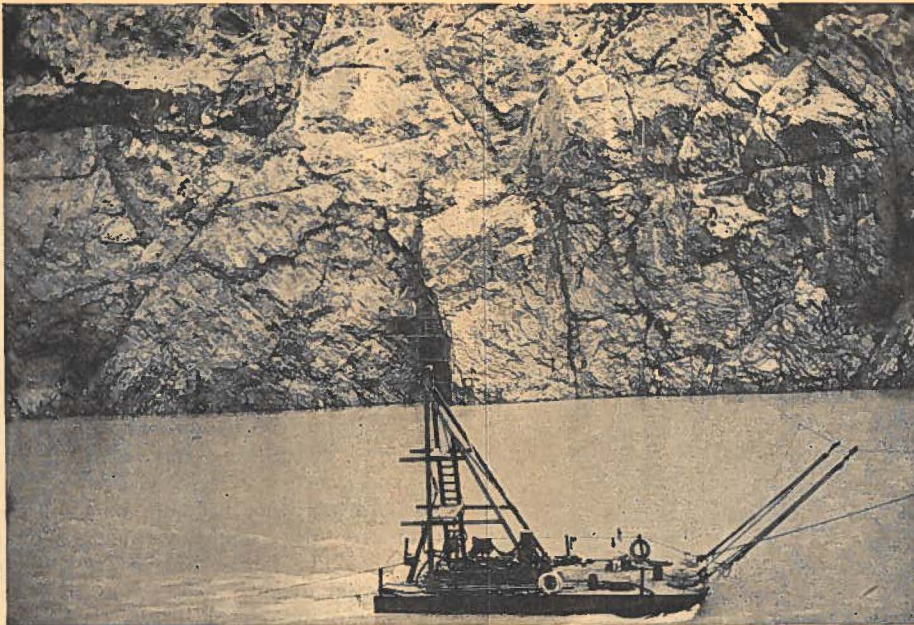
The west abutment of the Black Canyon site on the Colorado. Hard volcanic breccia, dipping upstream. Diamond-drill barge in foreground.
