Research Report
KTC-96-17

EVALUATION OF EDGE DRAINS
ON INTERSTATE 64
FAYETTE, SCOTT, AND WOODFORD COUNTIES

July 1996

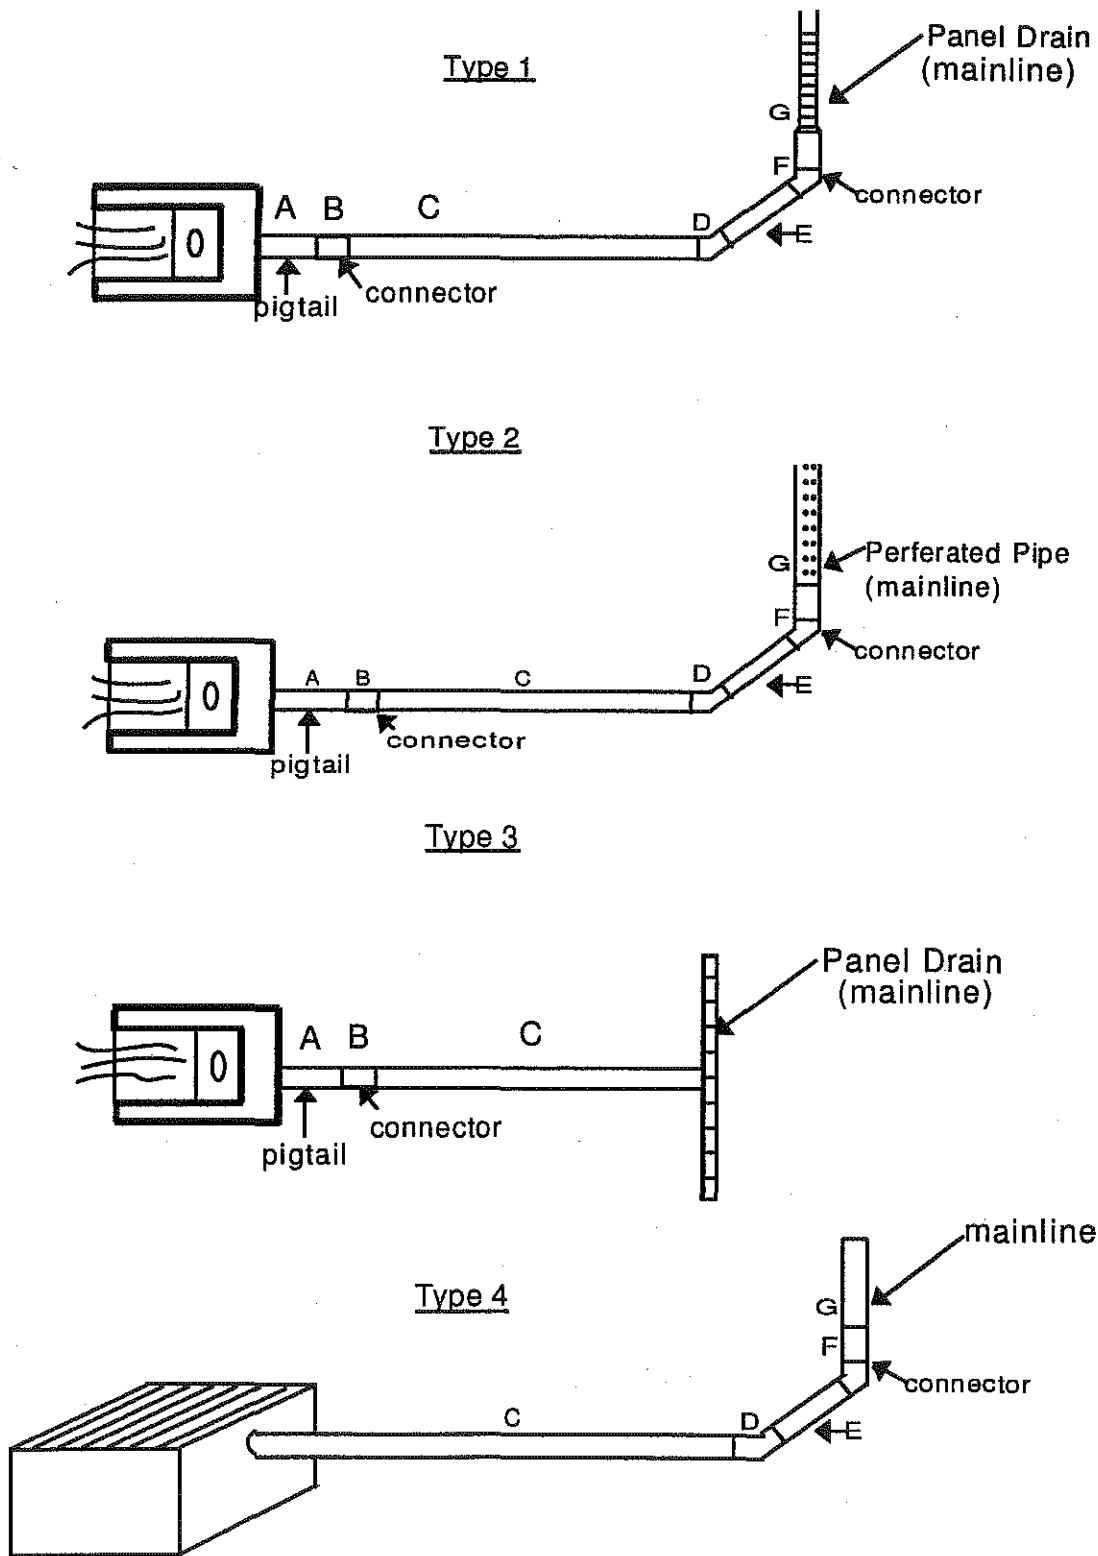
FIGURE 10. OUTLET PIPE TYPES AND SECTIONS.

The edge drain outlet pipes were inspected for sags, siltation, standing water, compression, rips, and other noticeable distress. The edge drain system was inspected with a mini camera. The system was divided into sections for inspection and analysis. The assigned outlet pipe sections are shown in Figure 10. Detailed information from the inspection is contained in Appendix B. The inspection revealed that, on the average, approximately 32 percent of the 106 outlet pipes were not fully functional. Significantly more distress was observed on the backside of the headwall than any other place in the outlet pipe system. Table 1 shows the type and frequency of distress recorded in each pipe section. This information is also shown in Figures 11, 12, and 13.
