Research Report  
KTC-95-2

FIELD PERFORMANCE REPORT  
ON PVC PIPE CAMPBELL COUNTY

The Kentucky Transportation Center was requested by the Kentucky Transportation Cabinet to monitor the field performance of Polyvinyl Chloride (PVC) Pipe on KY 9 in Campbell County (Project NO. FSP 019 0009 013-015 C-DE-STPM 0020 (804)).

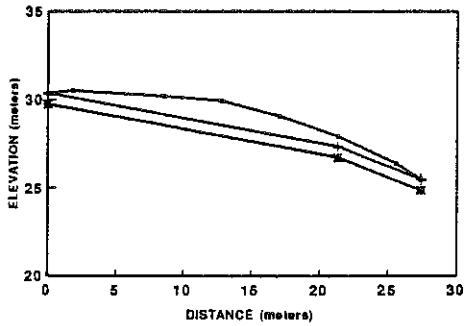
Station 129 + 72 (0.61 m pipe diameter)  
(Installed 6-28-93)

The cross drains were monitored during construction, and have been visually inspected several times since installation. The pipes were last inspected in December 1994 with a Cues Mini Camera. A majority of the cross drains appear to performing well. Significant distress was observed in one of the cross drains. The distress was observed in a 0.61 m (24 inch) cross drain at Station 129+72. Distress was observed toward the outlet end of the cross drain. During a visual inspection shortly after installation, approximately 2.4 meters (8 feet) of pipe on the outlet end was unsupported (Figure 7). It was apparent that the pipe had not been cut off and/or the fill around the pipe had eroded. In October, 1993, at a later inspection, it was apparent that this section of pipe had been covered during the reshaping of a sliding embankment (Figure 8). It appears that in this process the pipe was bent down causing the pipe to crack and deflect approximately 8.3 percent (Figure 9).
