Research Report
KTC-94-20

EVALUATION OF PAVEMENT EDGE DRAINS
AND THE EFFECT ON
PAVEMENT PERFORMANCE

September 1994

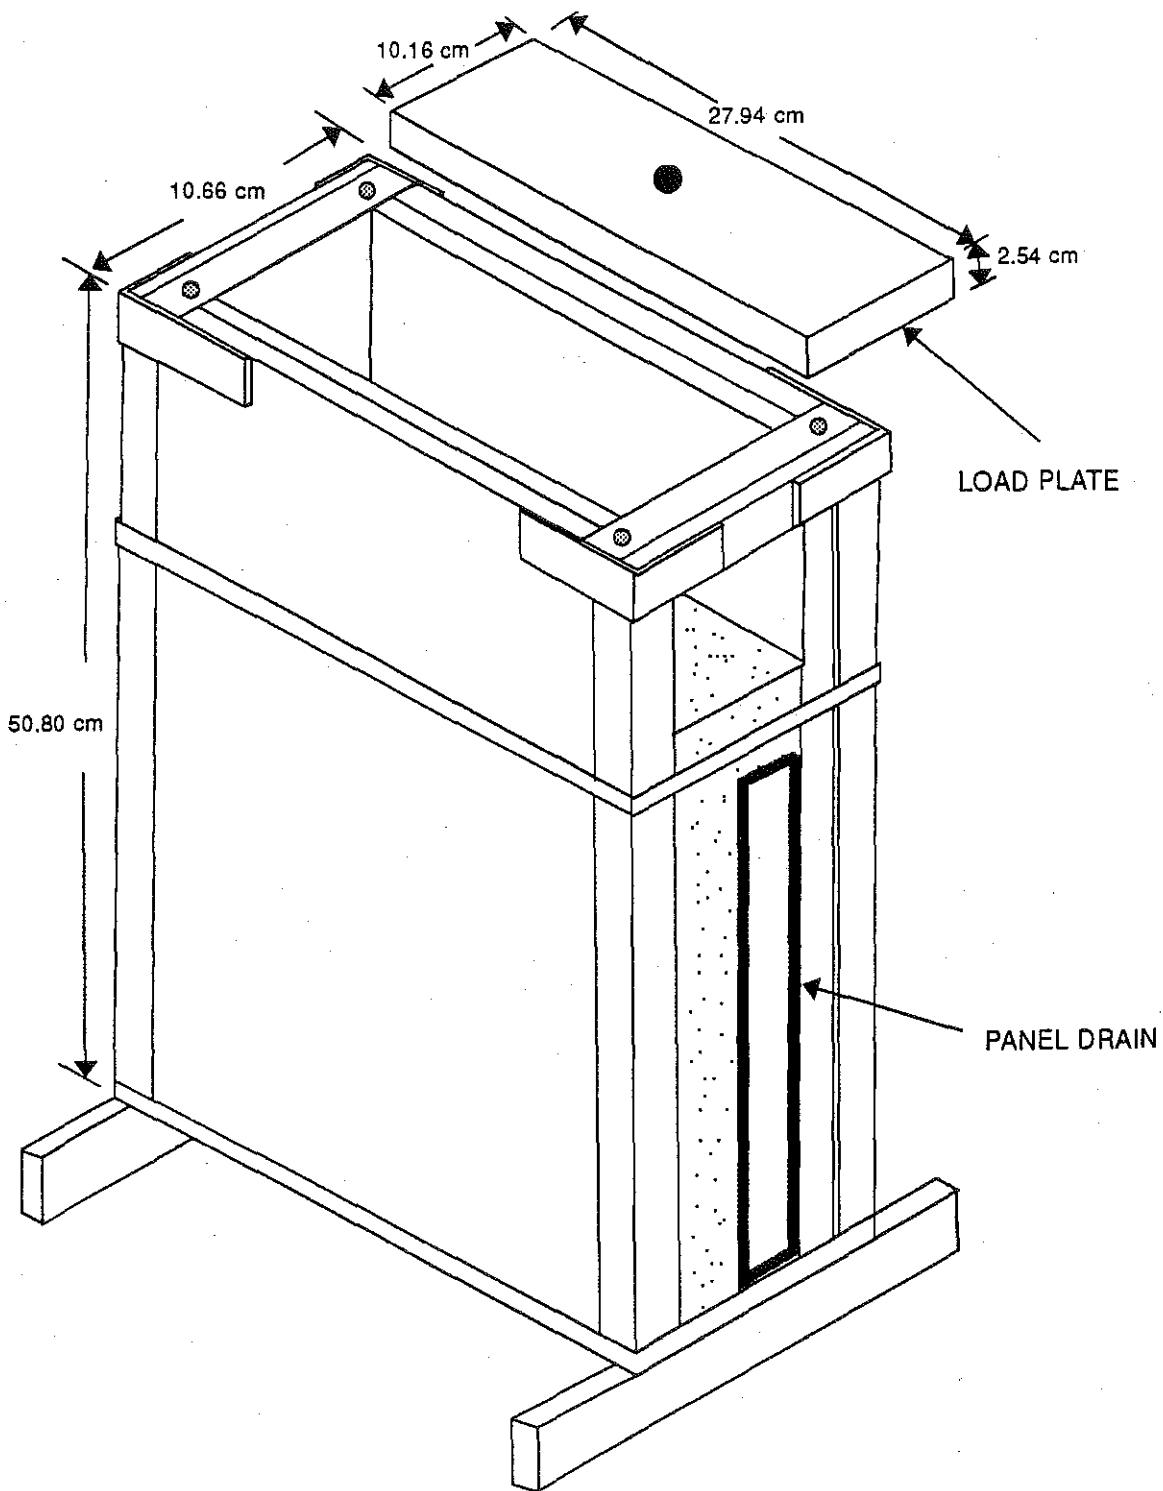
FIGURE 2. EDGE DRAIN COMPRESSION CHAMBER

A vertical edge drain compression chamber was constructed to test edge drains under conditions similar to those encountered in the field. The inside chamber dimensions are 311 mm (12.25 inches) in length, 106 mm (4.20 inches) in width, and 501 mm (19.75 inches) in height. The front and the back of the chamber are made of 12.7 mm (one-half inch) tempered glass for viewing the specimen. The remainder of the chamber is constructed of stainless steel, and high grade aluminum alloy. The bottom of the chamber is perforated to allow water to escape. A 101 mm (4-inch) by 279 mm (11-inch) aluminum plate 25.7 mm (one inch) in thickness is used as a loading plate. The chamber is shown in Figures 2 and 3.

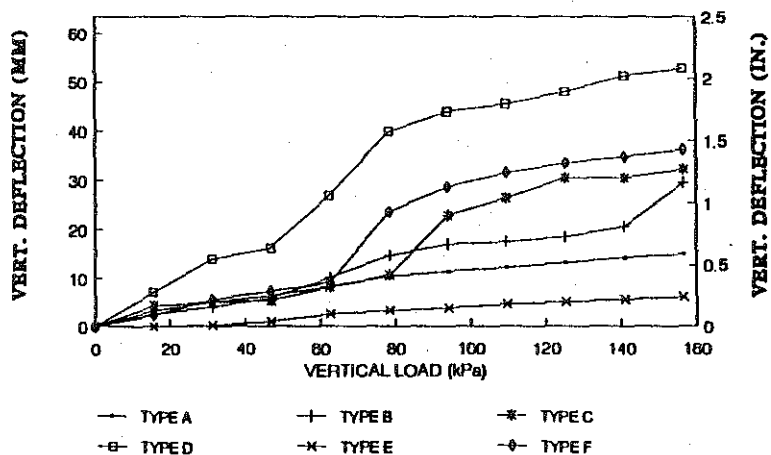
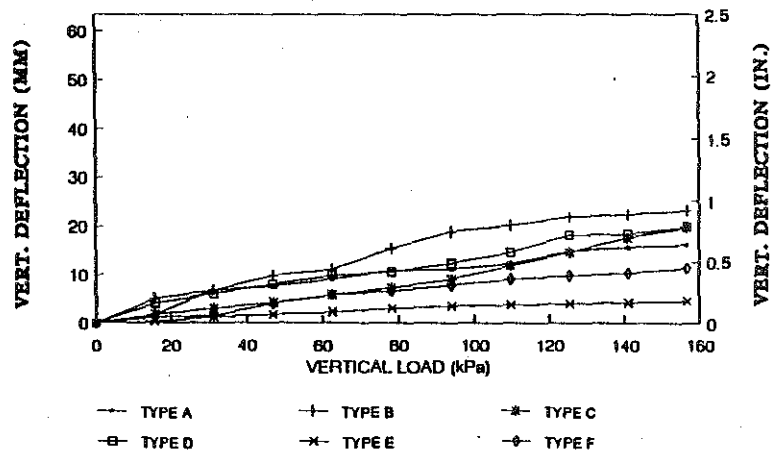
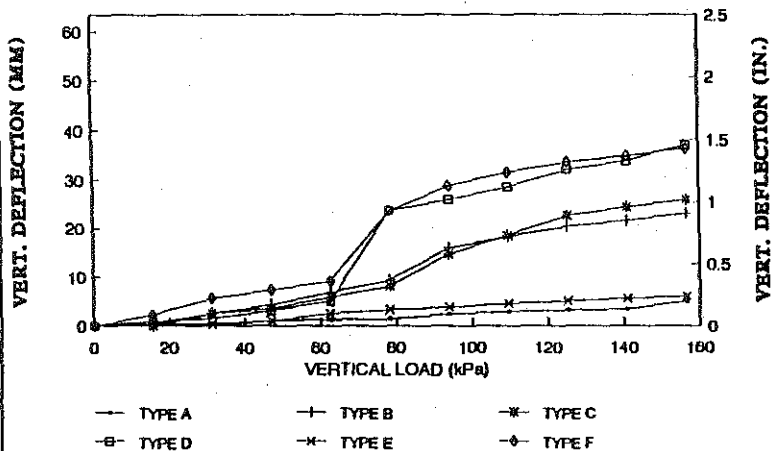
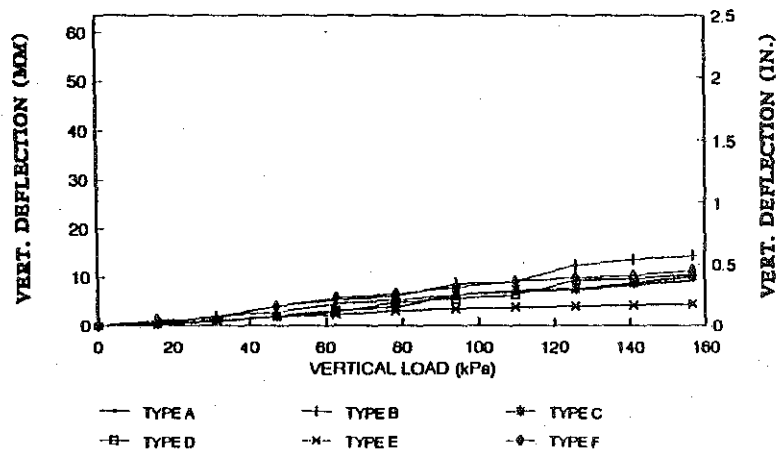
FIGURE 4. VERTICAL COMPRESSION (SERIES 1-4)

The vertical deflection measurements are contained in Figure 4 and Table 5. The Type E core deflected the least of the panels tested. At 160 kPa (23.2 psi), Type F deflected 6 mm (0.24 inch) (1.9 percent). Type D deflected the most. At 160 kPa (23.2 psi) of vertical load, Type D deflected 52.8 mm (2.08 inches) (16.8 percent).

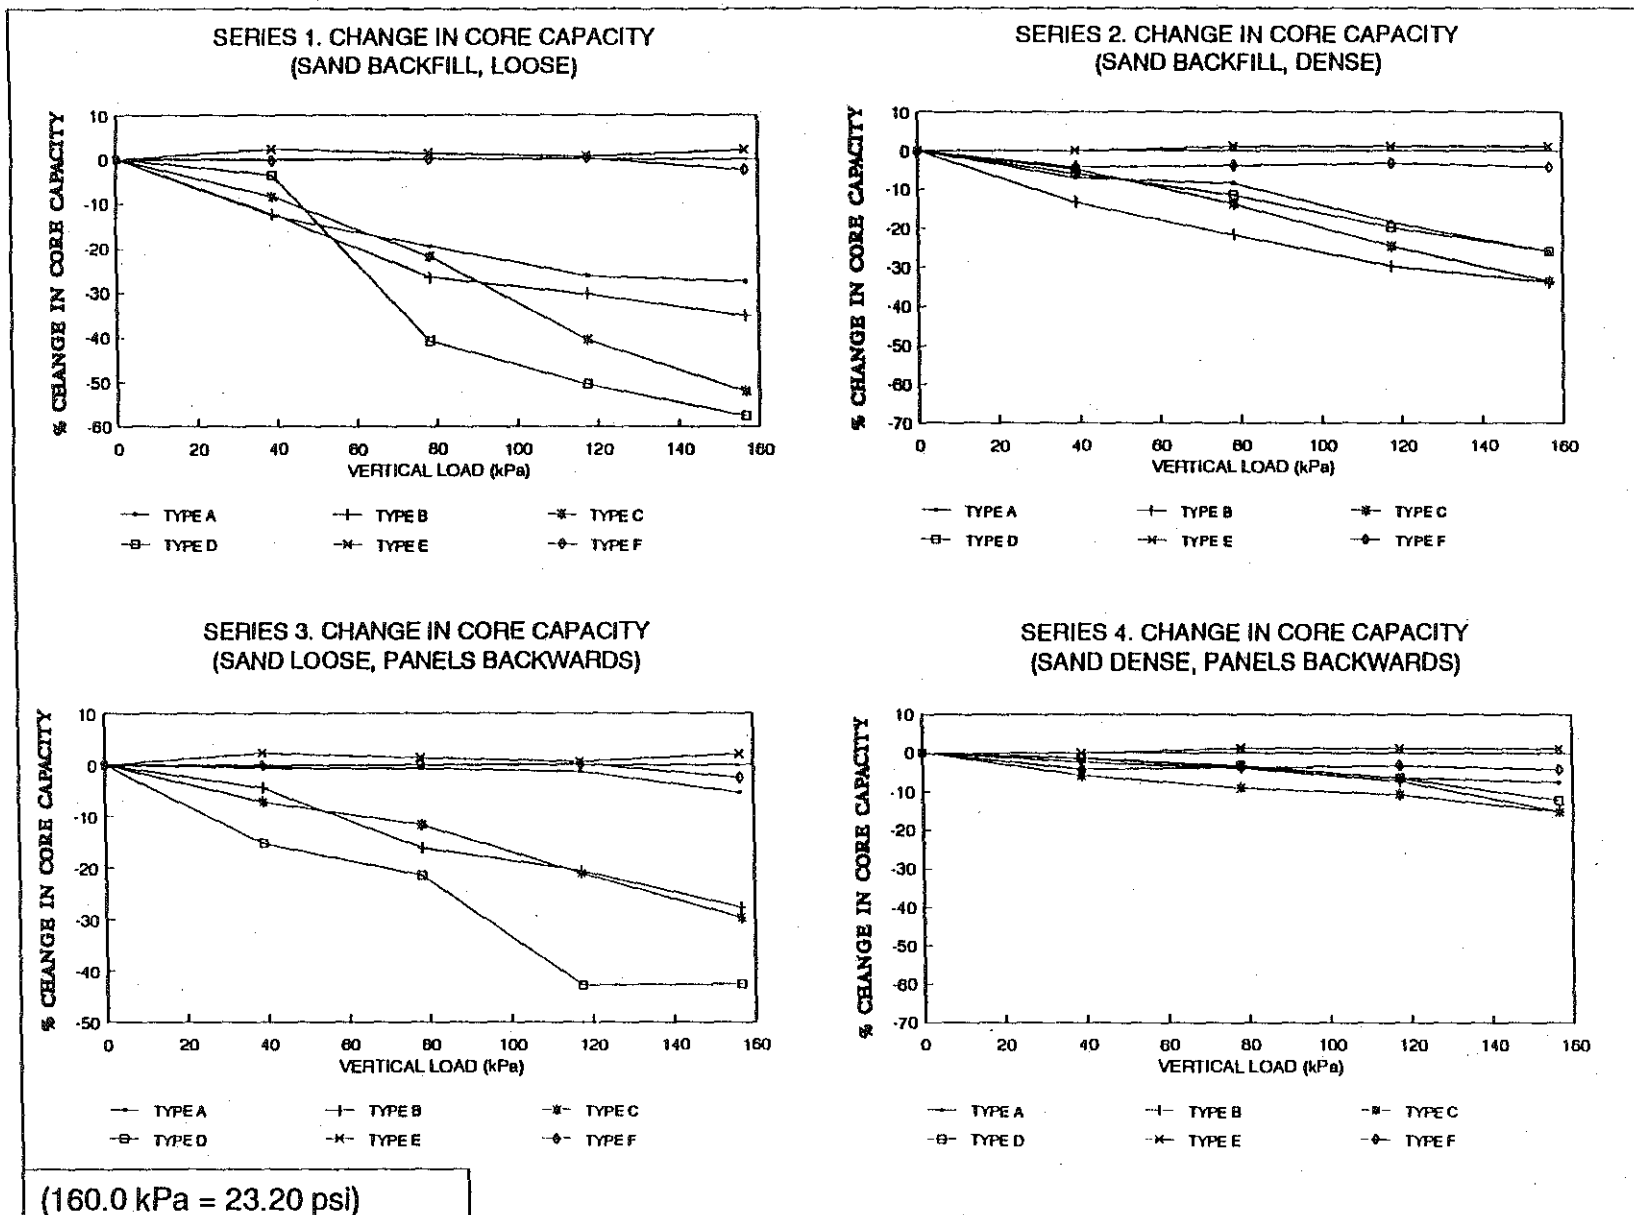
FIGURE 5. CHANGE IN CORE CAPACITY (SERIES 1-4)

The changes in core capacity of each panel drain at 160 kPa (23.2 psi) are contained in Figure 5 and Table 6. The two inclosed cores performed the best (Type F and Type E). The core capacity of Type E core increased by 2.1 percent and Type F core decreased by 2.46 percent. The capacity of Type D core reduced the most at 57.6 percent. The capacity for each core type for a given load is shown in Figure 6 and Table 7.

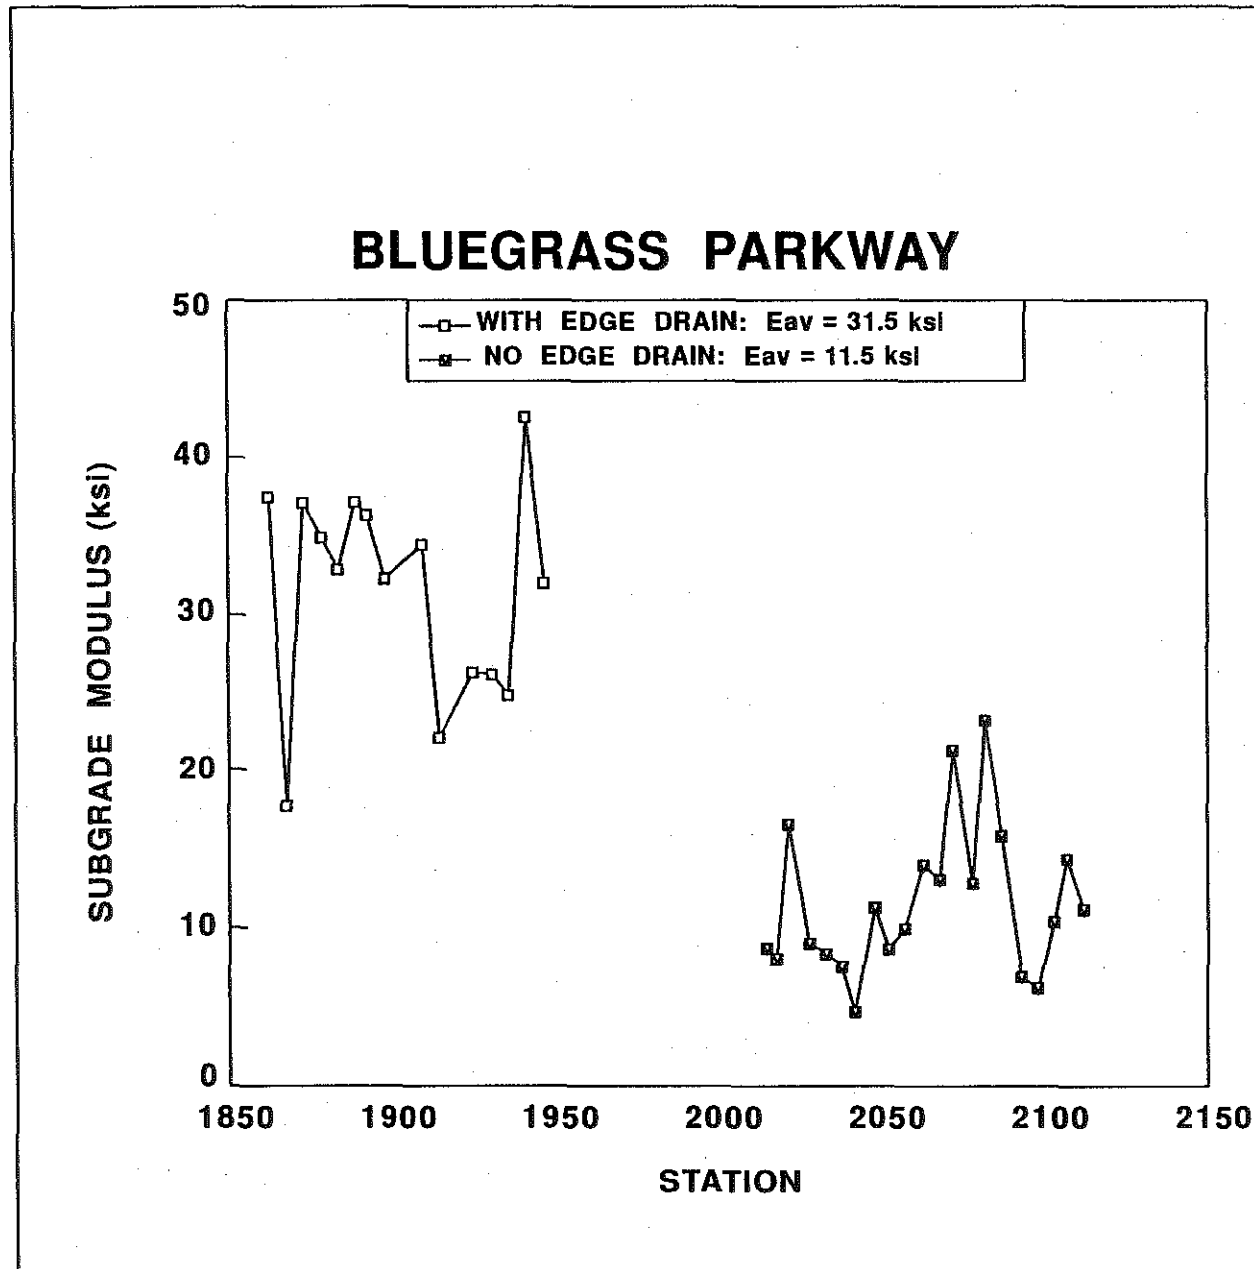
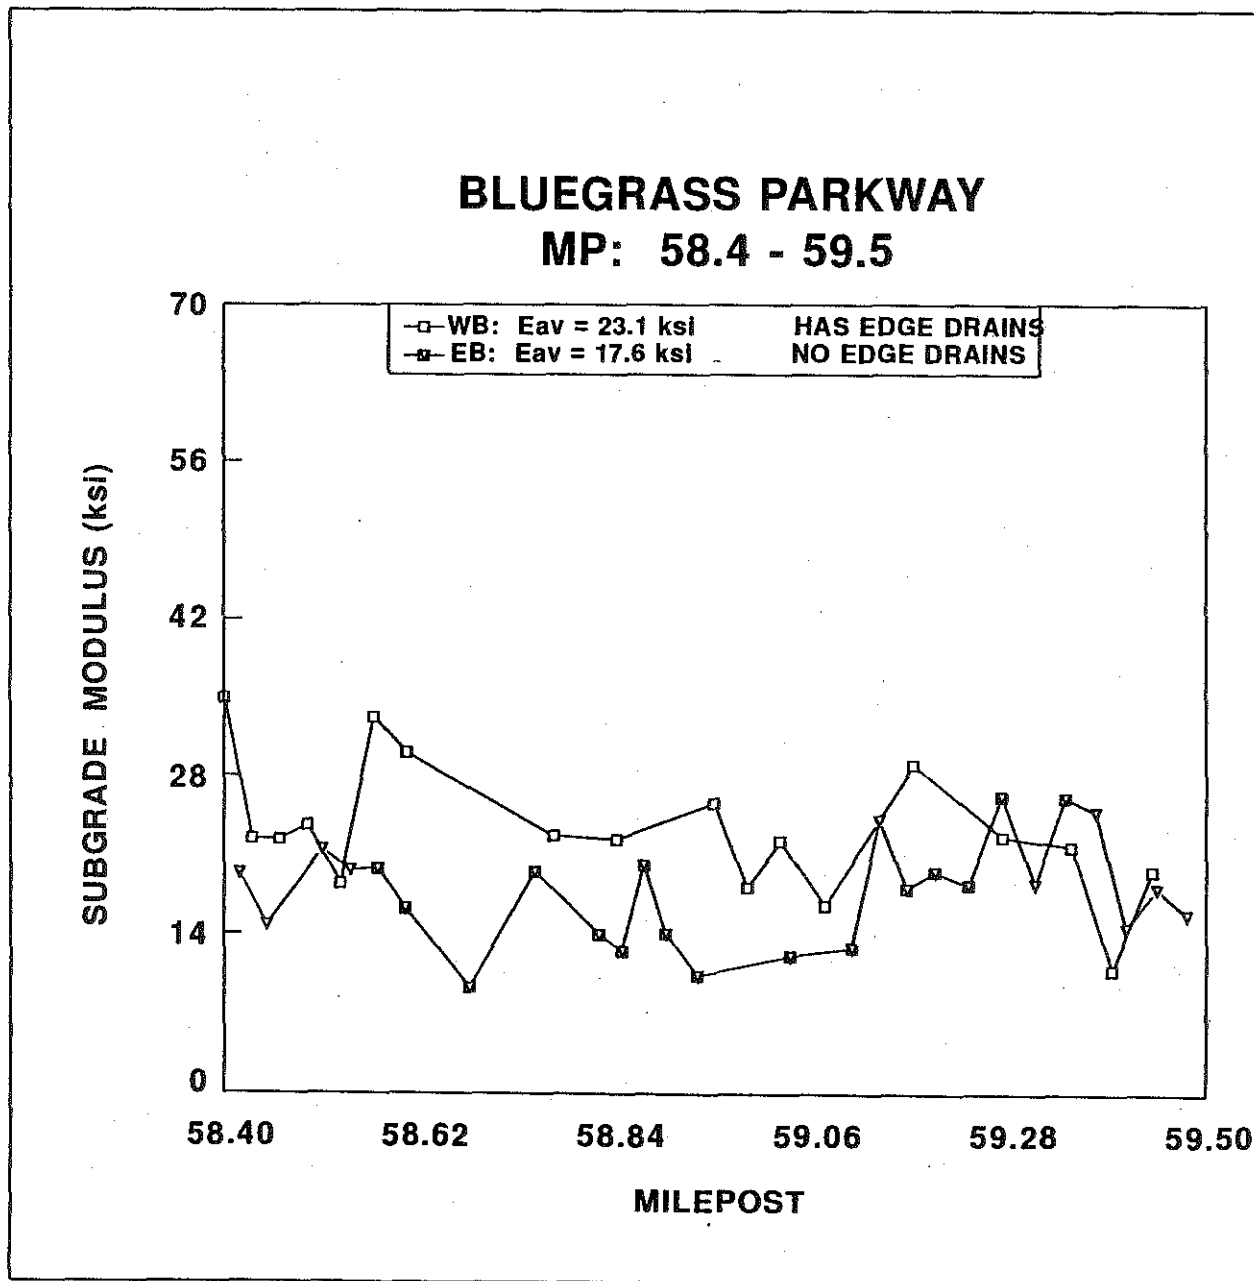
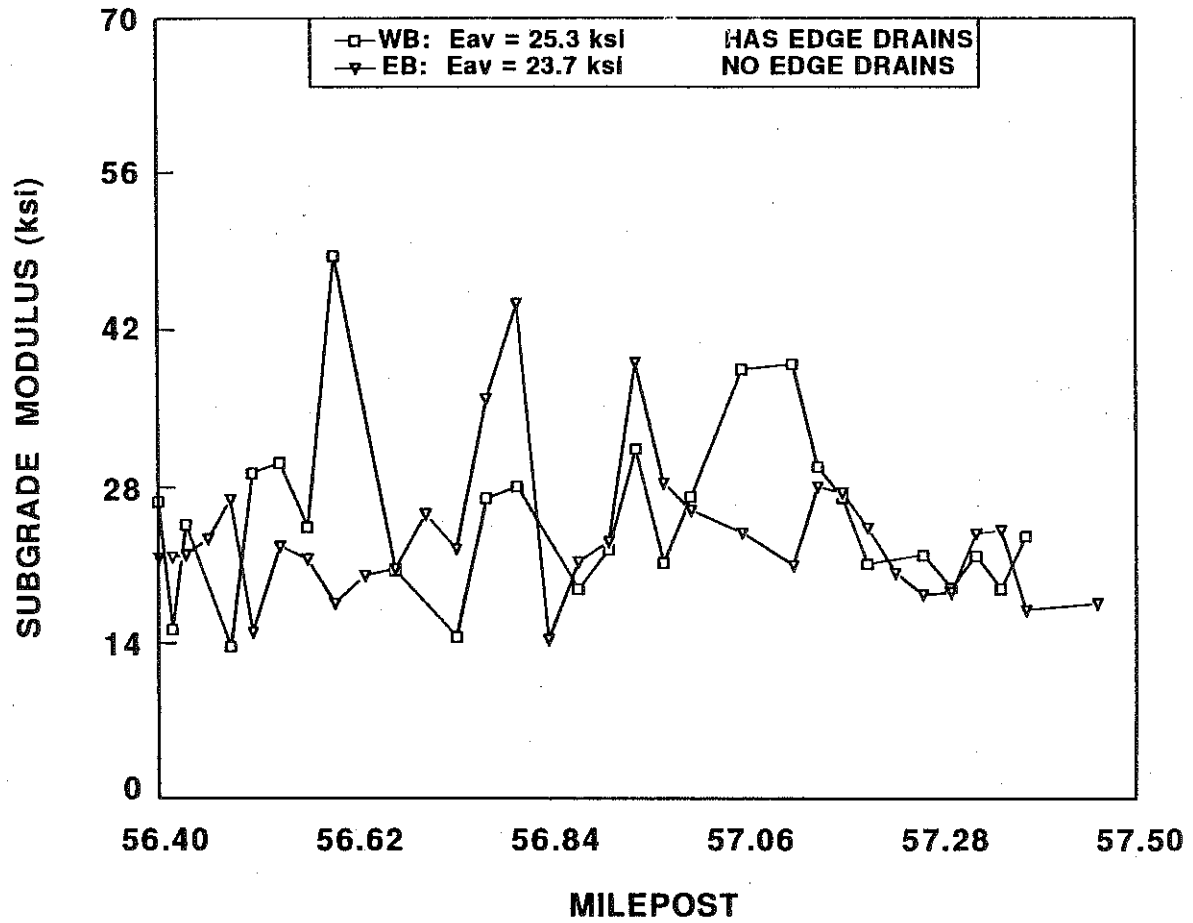
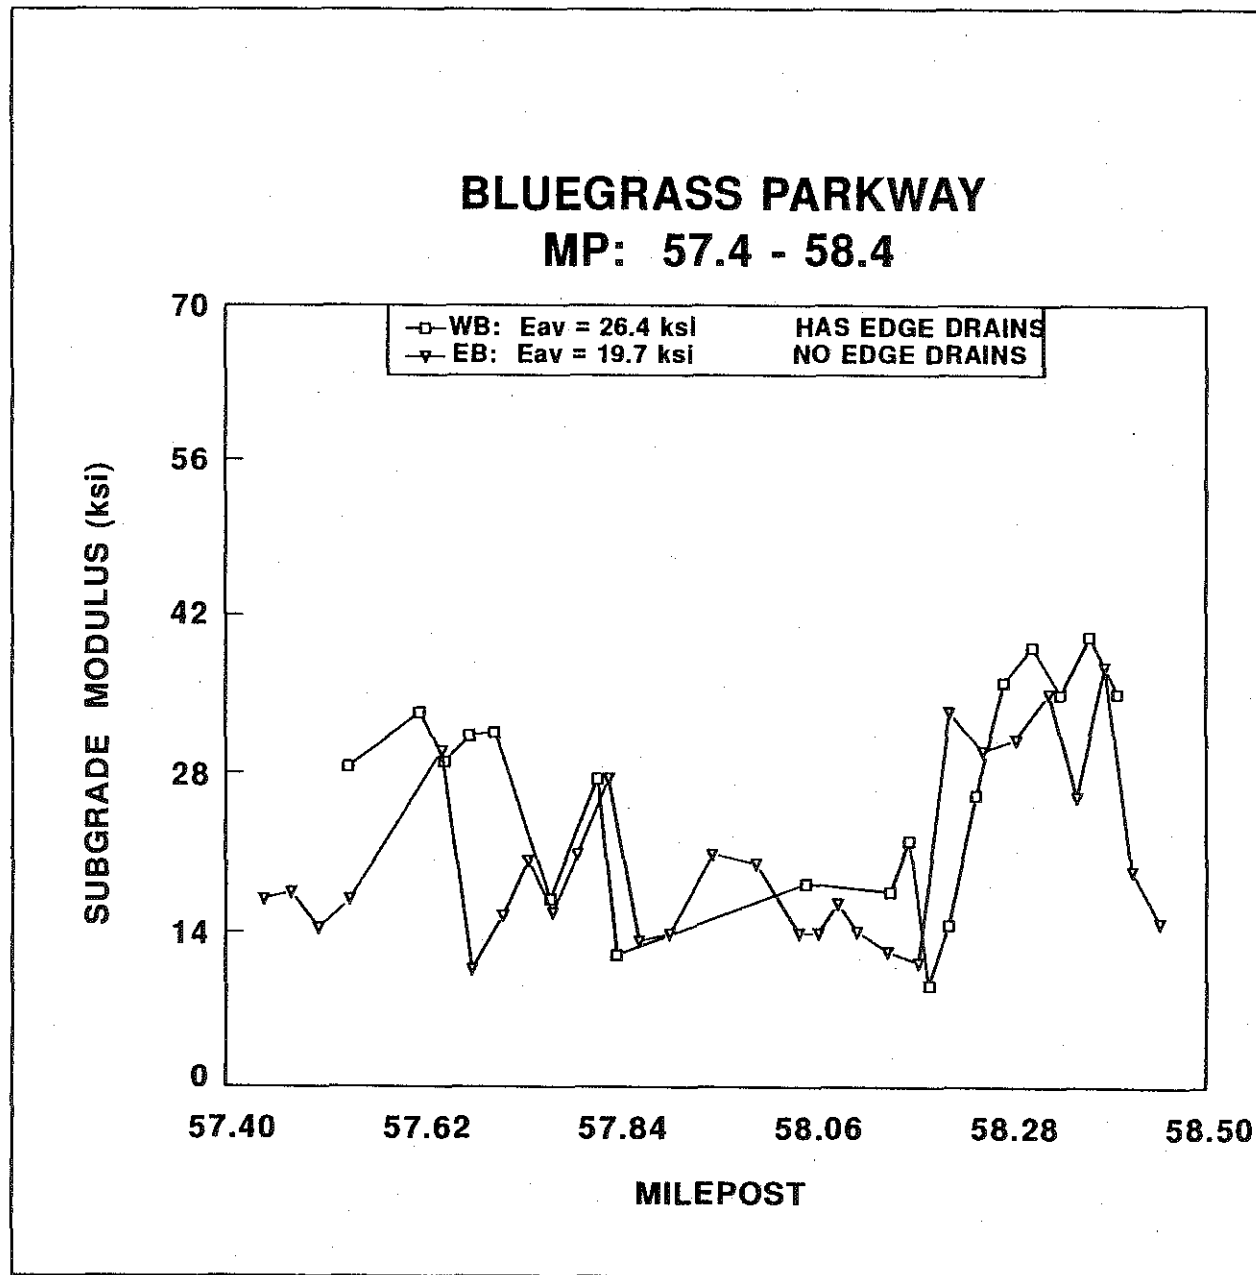
FIGURE 25. SUBGRADE MODULUS FOR PAVEMENT WITH EDGE DRAINS AND PAVEMENT WITHOUT EDGE DRAINS.

FIGURE 26. SUBGRADE MODULUS FOR PAVEMENT WITH EDGE DRAINS AND PAVEMENT WITHOUT EDGE DRAINS.

FIGURE 27. SUBGRADE MODULUS FOR PAVEMENT WITH EDGE DRAINS AND PAVEMENT WITHOUT EDGE DRAINS

FIGURE 28. SUBGRADE MODULUS FOR PAVEMENT WITH EDGE DRAINS AND PAVEMENT WITHOUT EDGE DRAINS.

AVERAGE SUBGRADE MODULUS (KSI)	MILEPOST (56.4-57.4)	MILEPOST (57.4-58.4)	MILEPOST (58.4-59.4)
WITH EDGE DRAIN	25.3	26.4	23.1
WITHOUT EDGE DRAIN	23.7	19.7	17.6
% DIFFERENCE	6.3	25.4	23.8
