Research Report  
UKTRP-87-1

BRIDGE DECKS AND OVERLAYS

Kentucky Transportation Research Program  
College of Engineering  
University of Kentucky

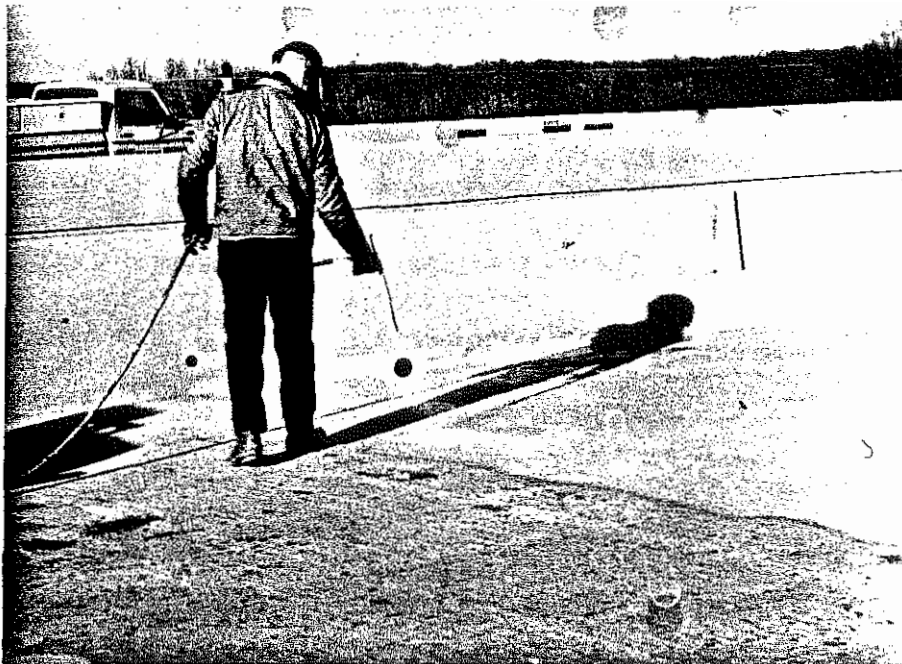
(Figure 4). Often, solvents in those formulations evaporated and sufficient sealant thicknesses or penetrations were not achieved. Epoxy resin was investigated in the early 1970's. One of its primary appeals was that it consisted of two stable liquids that could be blended in the field. Subsequently, the compound hardened to great strength without significant loss of volume. Thus, concrete could be penetrated, sealed, and possibly strengthened. Unfortunately, the epoxy tended to separate from the concrete as it hardened. Due to that phenomenon, the epoxy-sand seal coats attempted on bridge decks debonded. The debonding mechanism was not widely understood at that time and no suitable remedies were formulated.

Figure 4. Sealing of the I-24 Bridge over the Cumberland River with a Concrete Curing Compound (1980).

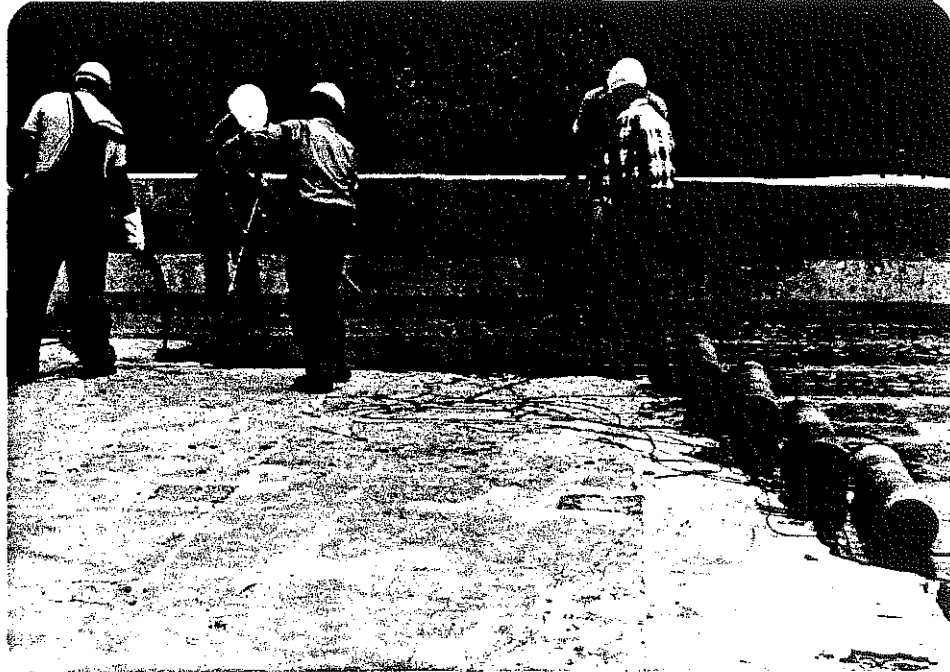
The Transportation Cabinet prepared specifications for both liquid-applied and sheet-type membranes using simpler designs than employed by Illinois. The liquid-applied membrane specifications allowed the use of either Super Seal 4000 or NEA 4000. Only the Super Seal product was employed in Kentucky (Figure 5). Liquid membranes also were required to have a protective cover of asphalt roofing paper covered by 2 inches of a Class I, Type A modified surface asphaltic concrete mixture.

Figure 5. Placing a Liquid-Applied Membrane (Superior Products Super Seal 4000) on the KY-676 East-West Connector over the Kentucky River (1979).

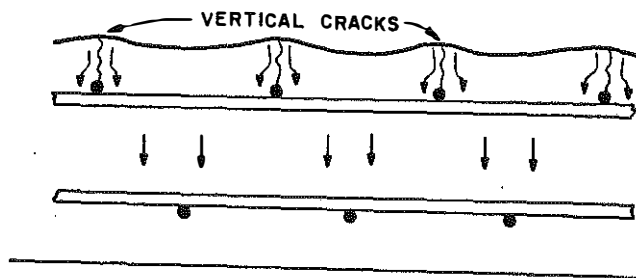
A likely explanation of early cracking over reinforcing steel is depicted in Figure 9. During placement, the fresh concrete subsides between and around the steel but is perched over the bars and is not perfectly settled. Bleed water may eventually exit upward around the bars or remain there long enough to create a void. As the concreting advances, the additional load may cause the steel in the concrete behind to rise and induce cracks. The cracks may result from workmen walking on and flexing steel adjacent to previously placed concrete.

Figure 9. Possible Cause of Early Cracking in Steel Reinforced Concrete.

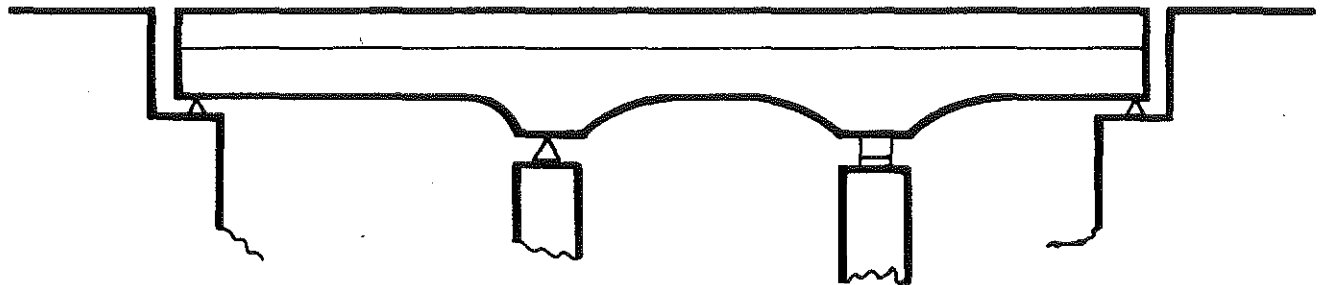
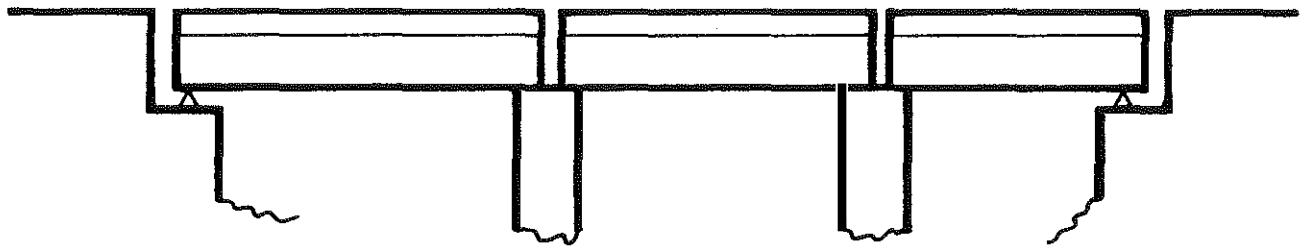
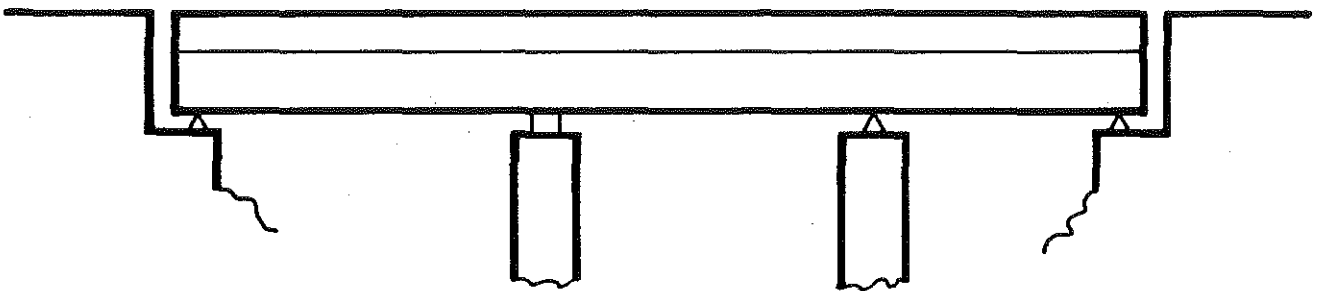
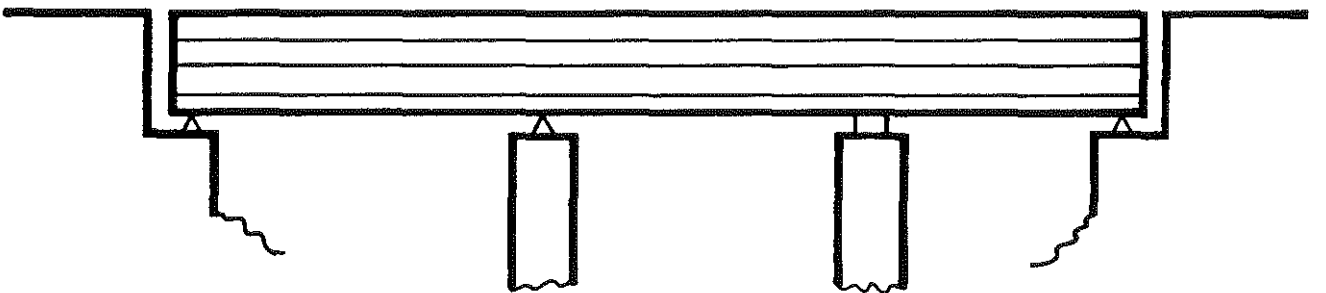
Figure 11. Styles of Bridges.

By superimposing or combining temperature cracks with flexural cracks, it is possible to define fairly well the natural crack patterns that will be detected upon inspection of mature bridges (Figures 11 and 12).

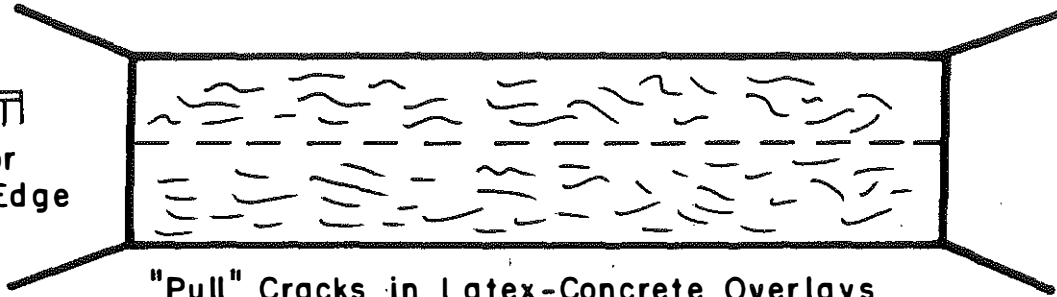
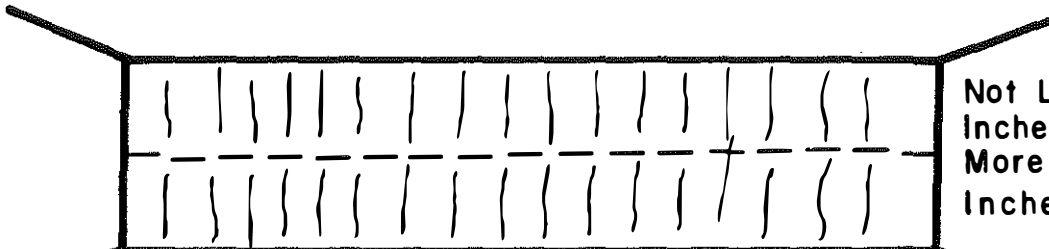
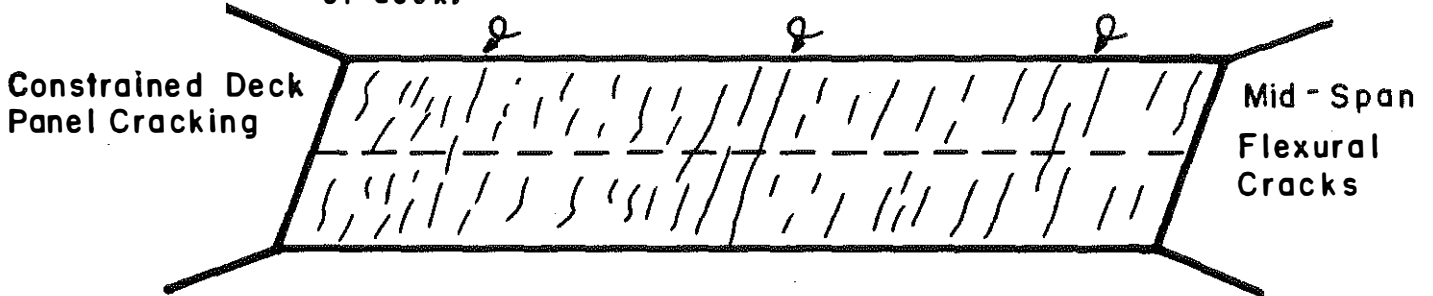
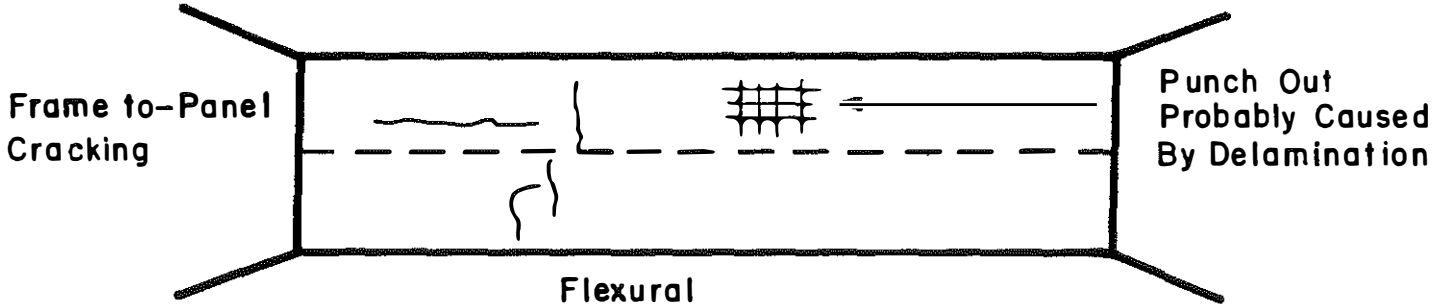
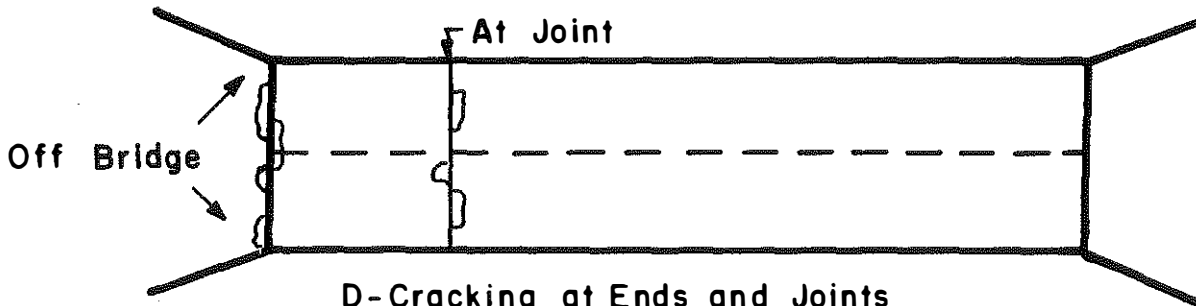
Figure 12. Topside Deck Cracking Patterns.

Temperature Cracking: Uniformly 30 inches Apart; In All Reinforced Concrete  
Some become working cracks and show efflorescence at Bottom side of deck.

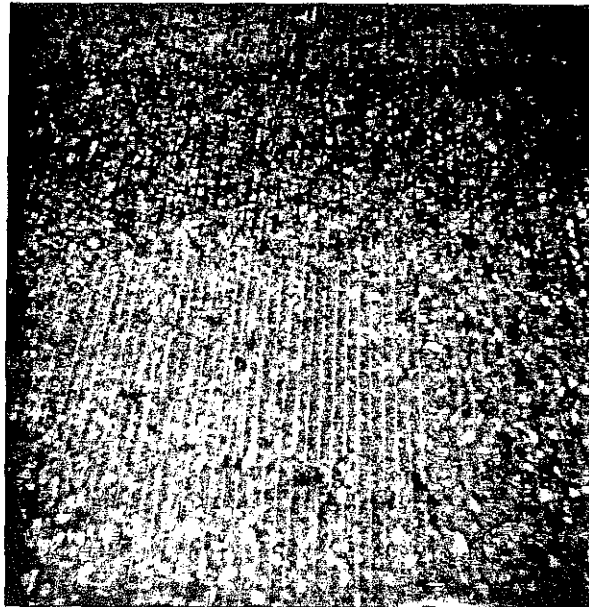
generally tend to be irregular (Figure 16). Even when properly performed, tining may pull aggregates and roughen deck surfaces (Figure 17). A recent report by the New Jersey Department of Transportation noted tining to be unsatisfactory and recommended that it be replaced with sawed grooves (13). Grooves were sawed on the Manchester Avenue approach to the Jefferson Street Viaduct in Lexington (Figure 18).

Figure 18. Sawcut Grooves in Pavement (Manchester Avenue Approach to Jefferson Street Viaduct in Lexington (1987).

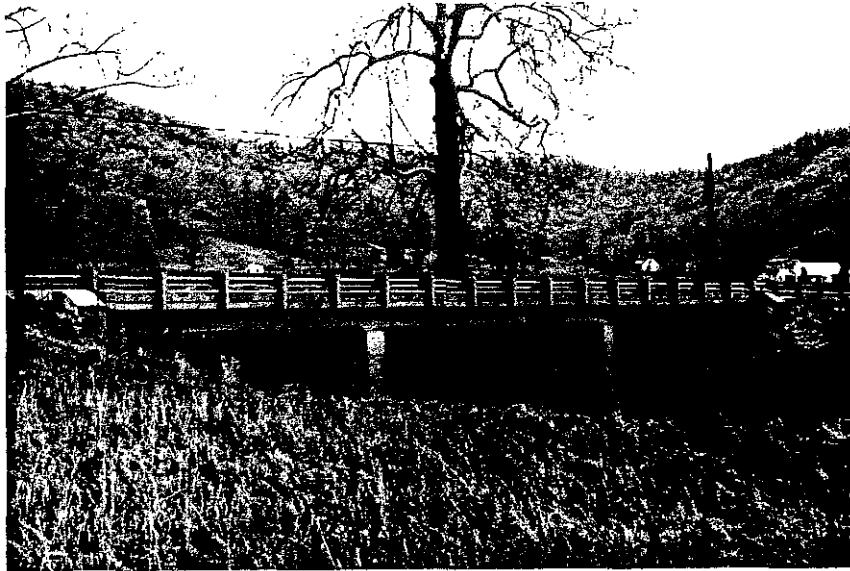
Three of the seven integral abutment bridges constructed (or reconstructed) in the 1970's were T-beam, reinforced-concrete, continuous, multi-span structures having three or four spans (Figures 25 and 26). The other four bridges used precast, prestressed I-beams (PCIB). The span length of the RCDG structures varied from 28 to 50 feet. Span lengths of the PCIB bridges ranged from 37 to 80 feet. Bridge lengths ranged from 86 to 259 feet and deck widths were from 24 to 48 feet. Deck areas ranged from 2,568 to 12,303 square feet.

Figure 25. Three-Span RCDG Integral Abutment Bridge (KY 989 over Salt Lick Creek)(1984).

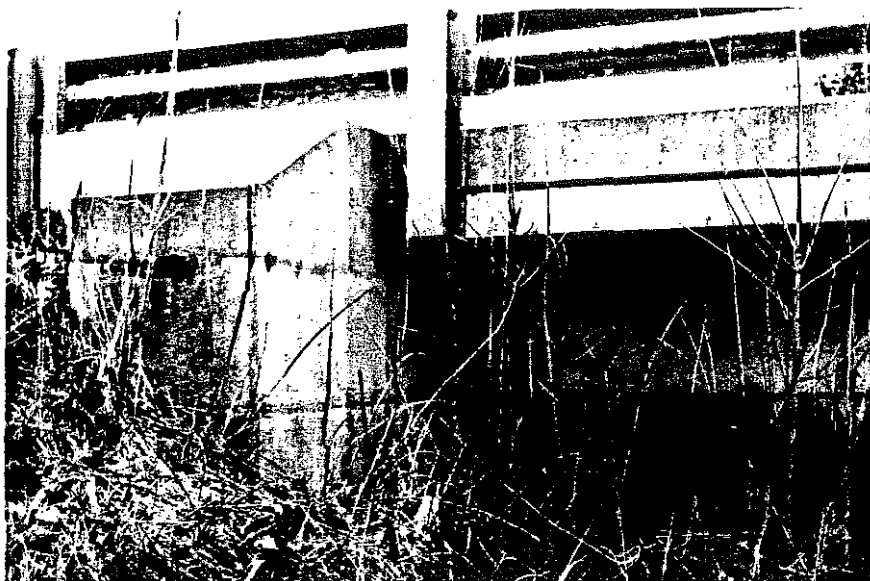
Figure 26. Integral Abutment Detail of RCDG Bridge (KY 989 over Salt Lick Creek)(1984).
