Research Report  
UKTRP-84-14

CORROSION OF CABLE SUSPENSION BRIDGES

May 1984

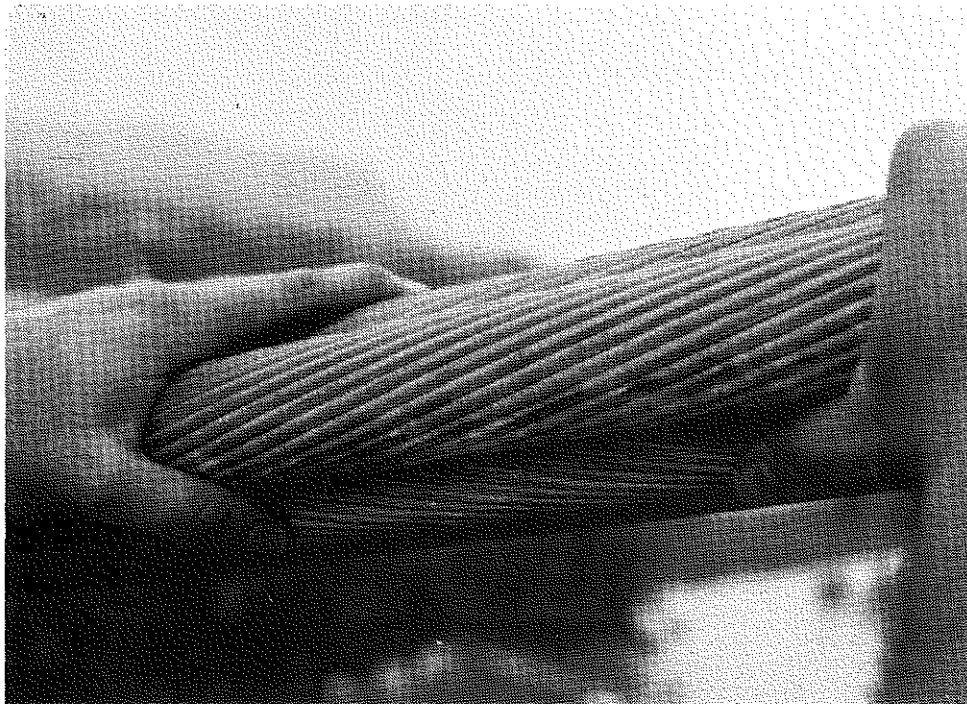
Figure 13. Stage 1 Condition on New Helical Strand.

From the inspections of the Portsmouth Bridge, both prior and subsequent to the recabbling operation, it was determined that galvanized helical strand experiences four distinct stages of deterioration. During Stage 1, the strand is in "as new" condition (Figure 13). Zinc coating has a bright metallic appearance, though some slight spot corrosion of the zinc may be evident in the form of a thin, white powdery coating. The strand is in good condition during Stage 2. The zinc has a dull gray appearance. The white corroded-zinc film may be present near interfaces and on exterior surfaces of the wires. When the white film is removed by scraping, no rust is evident. As previously mentioned, the second layer of wires may be in worse superficial condition than the outer layer. But, as long as the outer layer of wires is stable, interior wires will probably remain structurally sound. Much of the strand is covered with a thick, white zinc corrosion product in Stage 3. Spotted rust is also visible on the wires. When the corrosion product is scraped off, the steel under the surface reveals some rust and pitting. Wire fracture by corrosion cracking is possible in that stage; however, breaks will not be clustered in large numbers,

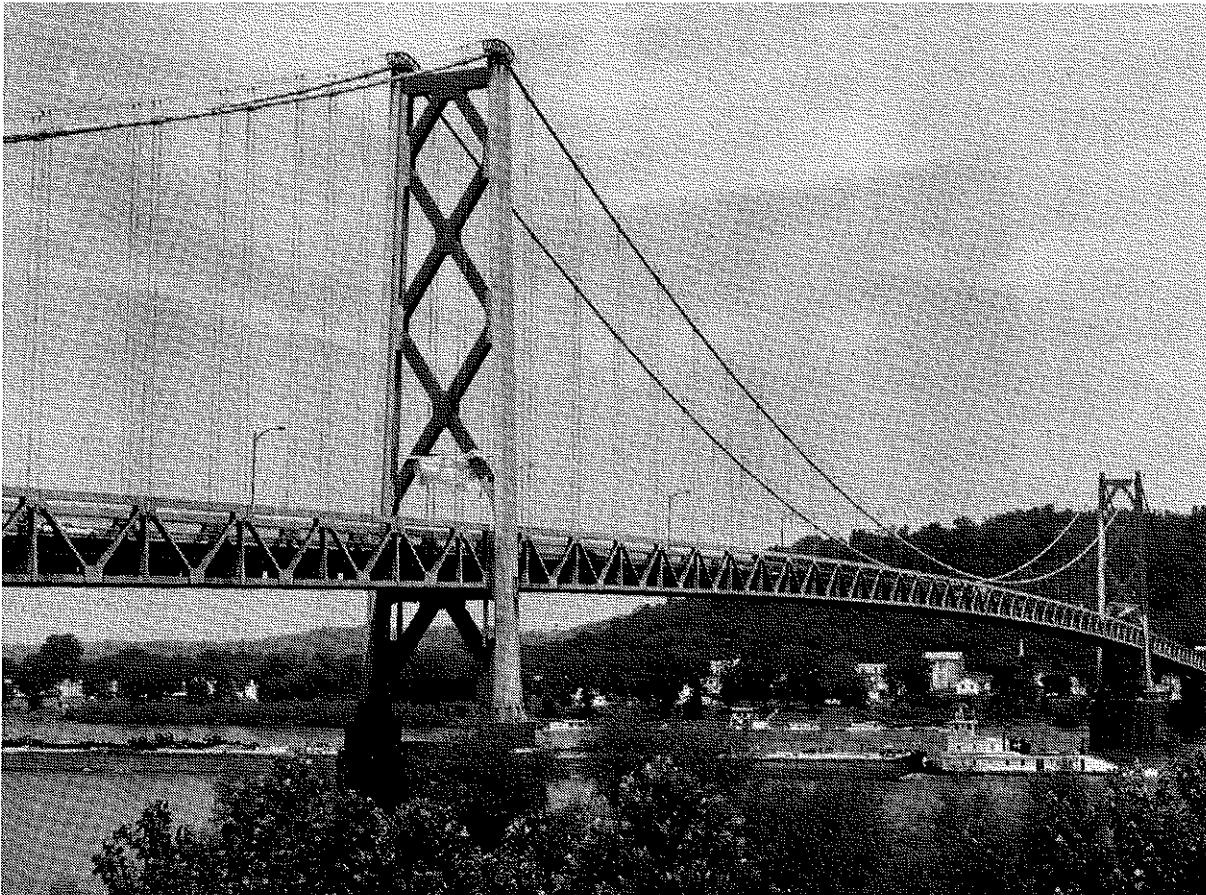
Figure 14. The Maysville Bridge (1977).

Inspection of the Maysville Bridge (Figure 14) began in June 1979. The bridge had been in continuous service for 49 years. It had no known history of corrosion problems. The first three inspections (June-August 1979) consisted of external inspections of wrapped bridge cables and splayed wire-rope strands inside the bridge anchorages.

Externally, the paint was in fair condition. The cables were last painted in 1974. Transverse cracks had developed in the paint on the upper portion of the cables. Paint had peeled from the lower surfaces of the cables in spots. This usually was observed where inclination of the cables was slight. Many points on the undersides of cables, adjacent to bands, showed signs of frequent peeling in the previous top coat of paint.

Suspender ropes were in good condition. Unlike conditions on the Portsmouth Bridge, which was designed to have drain holes in the lower packing, only two drain holes were provided per cable on the Maysville Bridge. Those were located in the lower packing of bands at the center

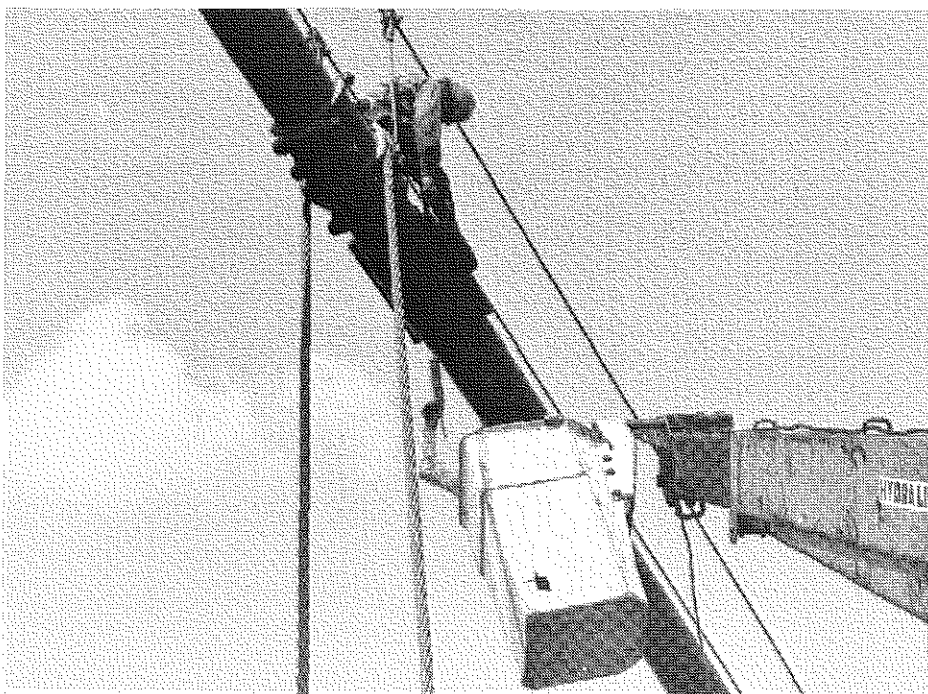
Figure 16. Installation of Inspection Port on the Maysville Bridge (1980).

In August 1979, bridge maintenance personnel installed seven inspection ports on the Maysville Bridge (Figure 16). Those were located at Panels 0-1, 7-9, 11-13, 59-61, 65-63 and 69-69 on the Ohio side span and main span (Figure 17). Ports were installed at points near bands having pop-outs and on panels where cable paint had deteriorated.

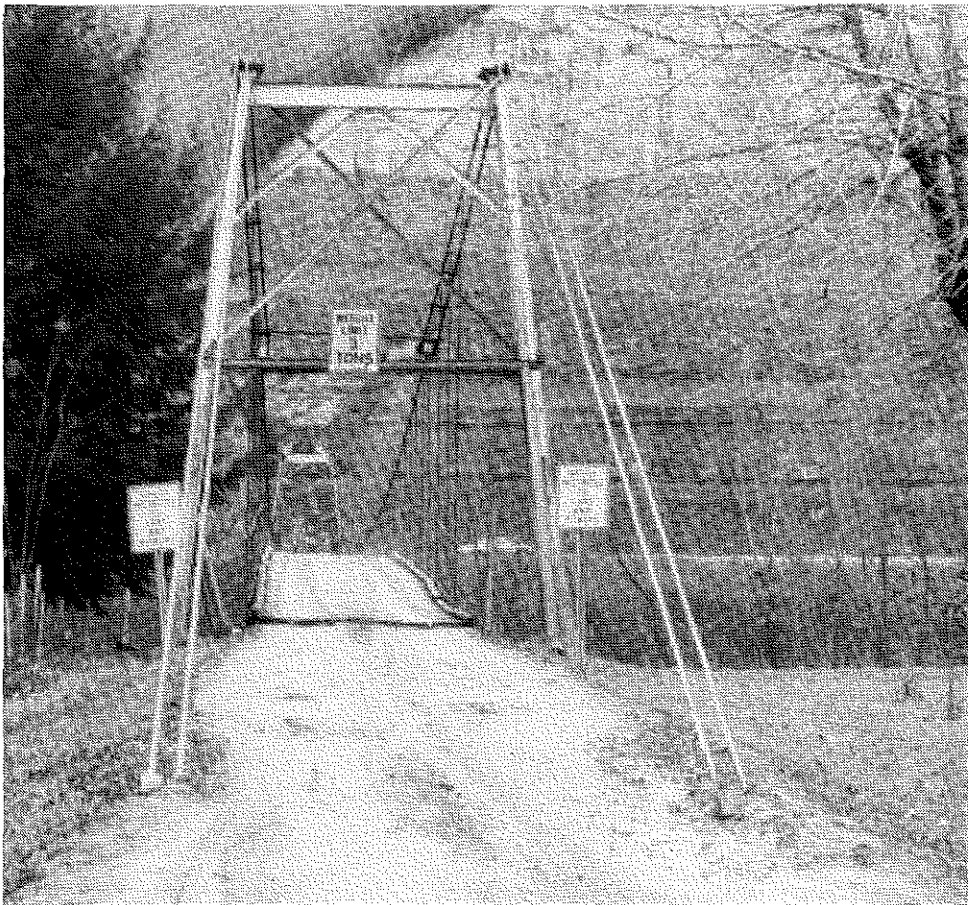
Figure 23. Unstiffened Suspension Bridge in Eastern Kentucky (1982).

On November 19, 1982, two small, unstiffened single-lane suspension bridges at Tram and Sutton in Pike County (Figure 23) were examined. The main cables of those bridges were helical strands that were exposed to the atmosphere. The strands had served well over their 30-year service lives. The wires showed some light corrosion of the zinc at the wire interstices, but no ferrous rust was detected (Figure 24).

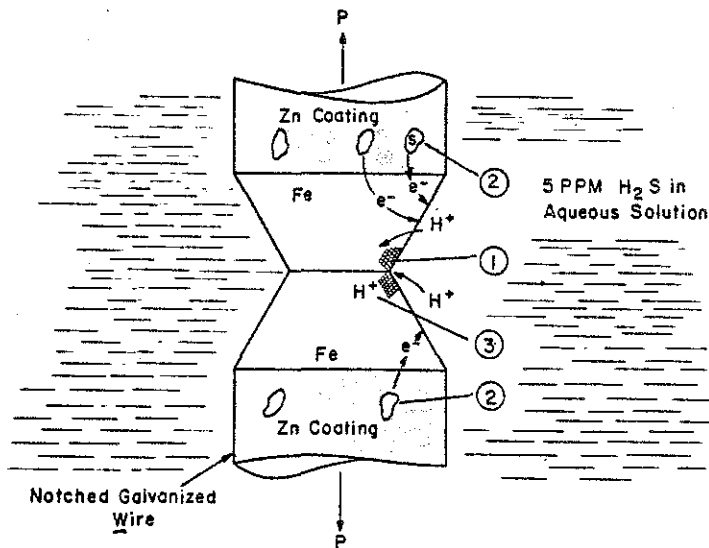
Figure 25. Hydrogen Charging at Notch due to Corrosion of Galvanic Coating.

When the zinc begins to corrode, it acts as an anode and donates electrons to the exposed steel at the notch (Figure 25). The surface of the exposed steel becomes cathodic and attracts atomic hydrogen to low energy locations in the iron lattice (with sulfur promoting this action). However, when the rate of hydrogen charging or the applied stresses are too low, the corrosion product  $Fe_xS$  may be deposited in sufficient thicknesses on the notch to act as a diffusion barrier. That will prevent further charging of hydrogen into the exposed steel. In effect, the reaction is auto-extinguishing. The Boeing investigators used acetic acid to suppress formation of a  $Fe_xS$  diffusion barrier; however, that may not have been effective.

- A. Corrosion of wire initiates at 1 with the reaction  $x \text{Fe} + \text{H}_2\text{S} \rightarrow \text{Fe}_x\text{S} + \text{H}_2$ .
- B. Zn coating acts as an anode at 2 and furnishes  $e^-$  to exposed Fe. This, in turn, cathodically charges the exposed Fe with  $\text{H}^+$  that diffuses to low-energy locations in the Fe lattice at 3.
- C. However,  $\text{Fe}_x\text{S}$  forms a barrier to  $\text{H}^+$  trying to penetrate into the notch, and the embrittling reaction stalls.

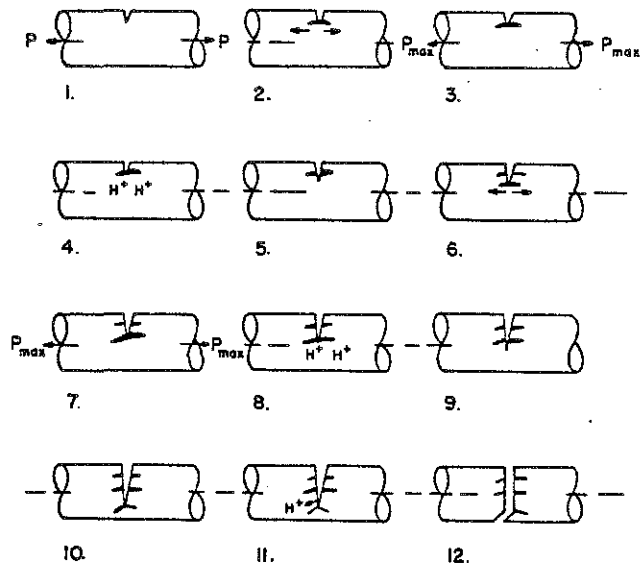
Figure 26. Proposed Corrosion-Fatigue Mechanism for Wire Cracking.

The type of corrosion-fatigue mechanism hypothesized for the Portsmouth Bridge wires initiates with formation of a crack on the wire surface (Figure 26). Cracks form on exterior surfaces of the wire on the outer layer of the strand. The crack initiation site may be a pit or possibly a localized rupture of the protective surface film caused by other corrosion processes. It should be noted that fatigue corrosion of steels in acids is not always related to pits. Crack arrests due to insufficient driving stresses and due to a corrosion-product barrier at the crack tip prevent extended corrosive attack at that location. Points along crack walls, which are exposed to the aqueous corrodant, may experience secondary dissolution along the elongated grain boundaries.

1. Crack initiation and arrest at a point of  $H^+$  damage.
2. Crack tendrils form as  $Fe_xS$  barrier forms.
3. Cyclic load breaks barrier, corrodant contacts Fe.
4. Corrosion action charge Fe with  $H^+$  at crack tip.
5. When sufficient  $H^+$  is charged,  $K_{IX} > K_{ISCC}$  and crack grows.
6. Crack stalls beyond area of  $H^+$  damage and  $Fe_xS$  barrier forms.
7. Cyclic load again breaks barrier.
8. Repeated  $H^+$  charging into Fe.
9. Repeated crack growth in  $H^+$  damaged area.
10. When the crack has grown to a sufficient size,  $K_{IX} \gg K_{ISCC}$ . The fracture mechanism changes. Crack reorients along texture plane.
11. Crack has opened sufficiently that no cyclic effects are required for wire fracture.
12. The wire fractures with the resulting flat and invert fracture surface.
