Research Report
UKTRP-84-7

SPECIALLY CONSTRUCTED BRIDGES: ACTIVITIES FOR
FISCAL YEAR 1983

April 1984

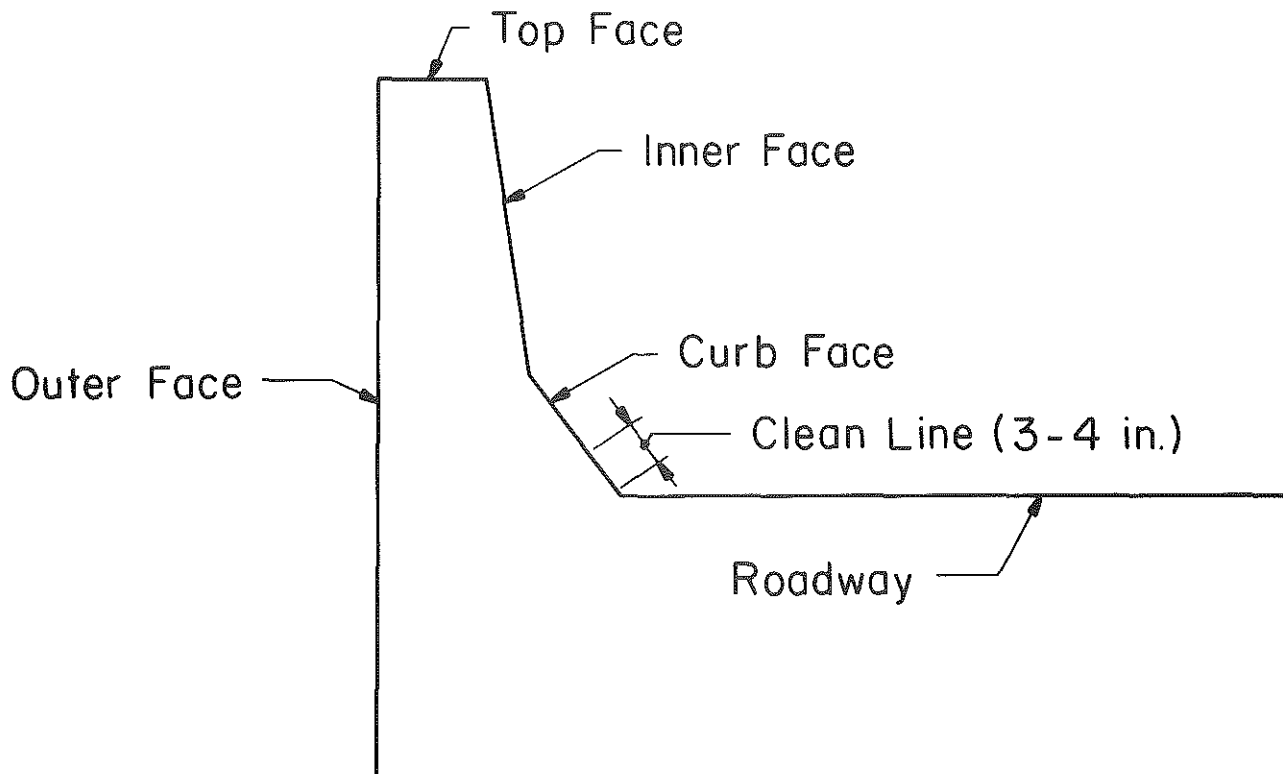
On September 29, 1982, the sidewalls/guardrails were inspected. The sidewall section is shown in Figure 26. The following observations were made.

Figure 26. Cross Section of I-471 Bridge Sidewall.
