1. Report No.		2. Government Accession No.		3. Recipient's Catalog No.	
4. Title and Subtitle Analysis of Accidents Involving Crash Cushions				5. Report Date June 1984

Research Report
UKTRP-84-17

ANALYSIS OF ACCIDENTS INVOLVING CRASH CUSHIONS

Kentucky Transportation Research Program
College of Engineering
University of Kentucky
Lexington, Kentucky

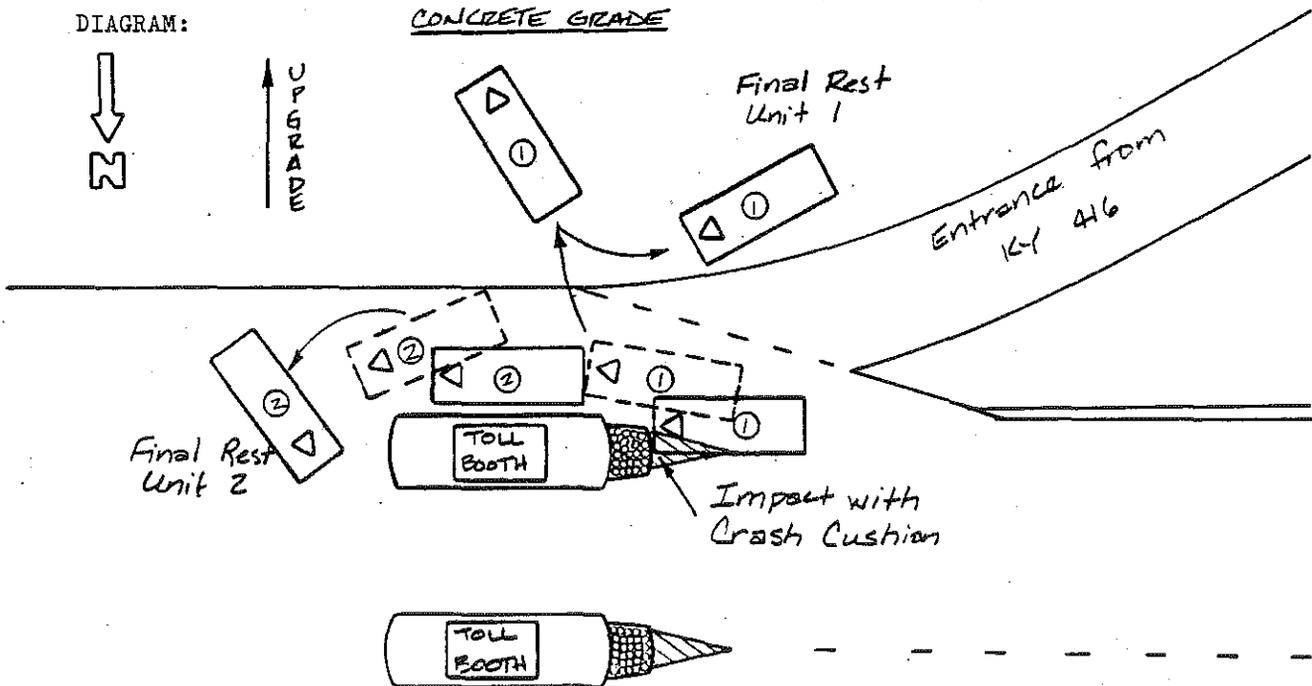
COMMENTS: The vehicle, a 1977 Oldsmobile Cutlass, was weaving on the roadway, due to the driver being intoxicated, as it approached the toll plaza. The automobile glanced off the crash cushion dividing the entrance/exit lane and the right-hand through lane, then struck a vehicle stopped in front of it in the area of the driver's-side headlight (it previously struck the crash cushion in the same area). The vehicle then bounced off the car in front (as it had begun to exit the toll plaza), ran up the concrete grade on the right side of the toll plaza, then rolled backwards down the slope before coming to rest. Disabling damage was done to the Oldsmobile, but it cannot be determined whether or not the crash cushion caused the damage. The passenger of the Oldsmobile suffered a possible head injury; no one else was injured. Neither driver nor passenger were wearing safety belts.

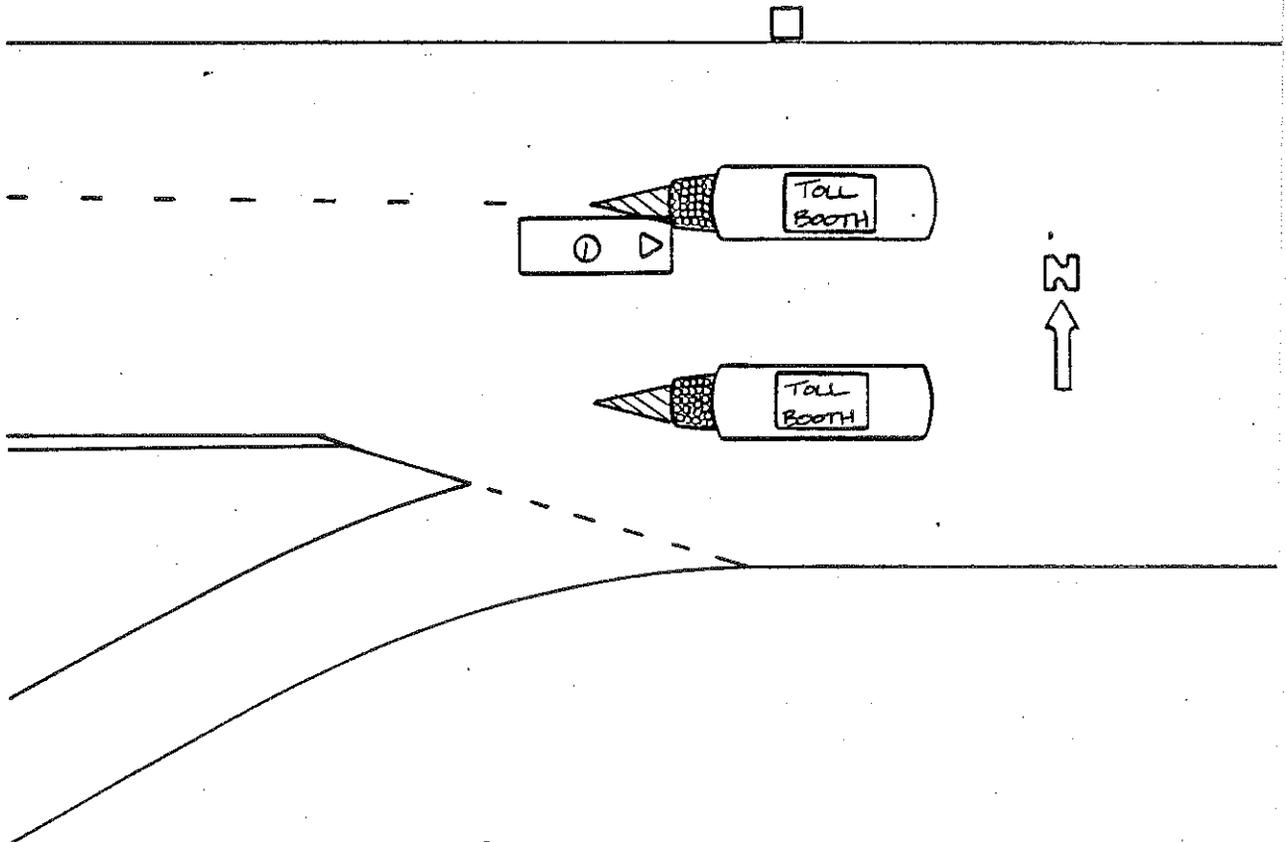
COMMENTS: A witness at the scene stated that a 1971 Chevrolet El Camino approached the toll plaza at a high speed. The vehicle sideswiped the crash cushion on the left and the driver's side-view mirror went through the toll booth window. The vehicle continued past the toll plaza, crossed the median and opposite lanes, then hit a light pole and stopped. The vehicle was disabled (left front corner), but it cannot be determined if the crash cushion or light pole caused the most damage. The driver was uninjured. He was not wearing a safety belt.

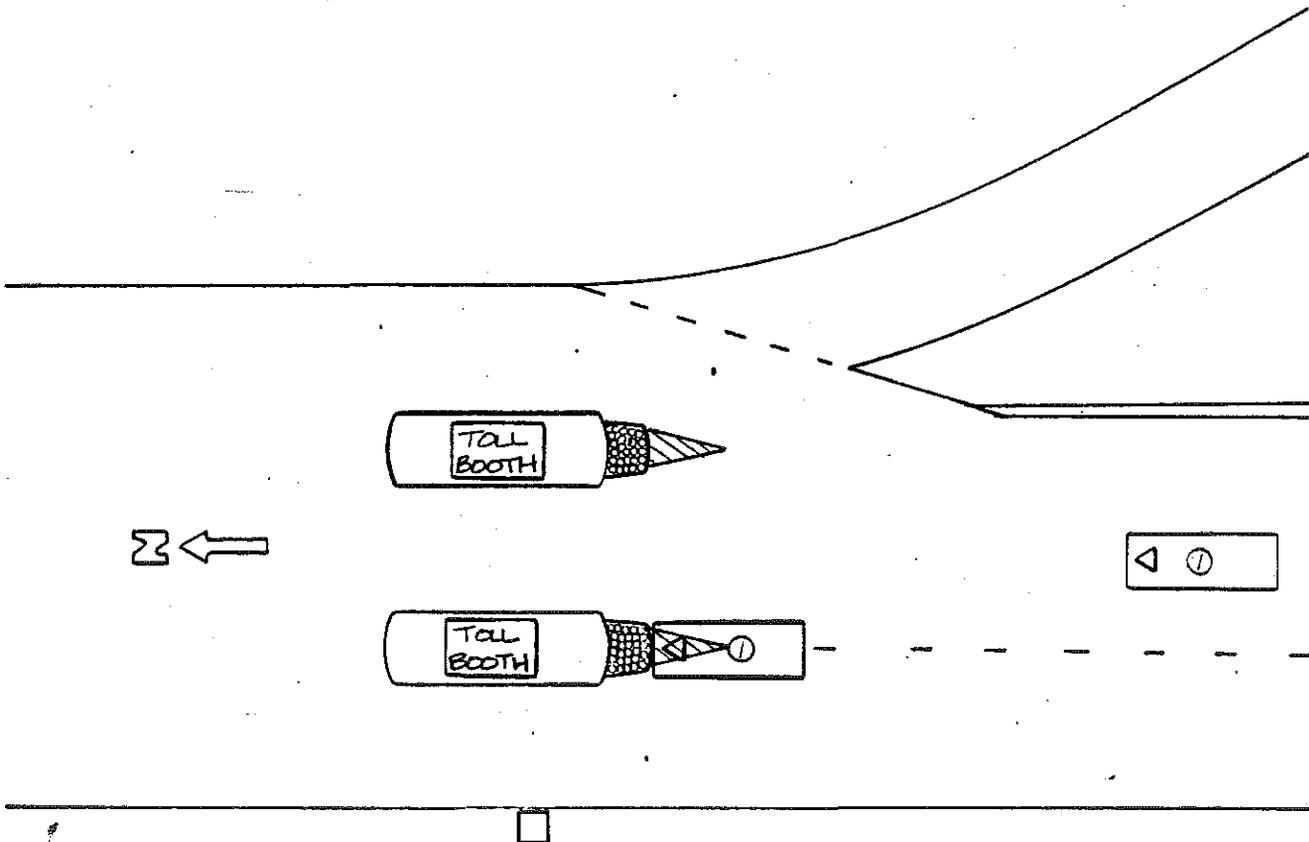
COMMENTS: The driver of a 1968 Dodge 2-door sedan lost control as he applied the brakes and veered sharply to the left, where he bumped into the crash cushion head-on. The damage to the front end of the car was non-functional and it remained in service. The driver, who was uninjured, did not wear a safety belt. Road conditions were wet.

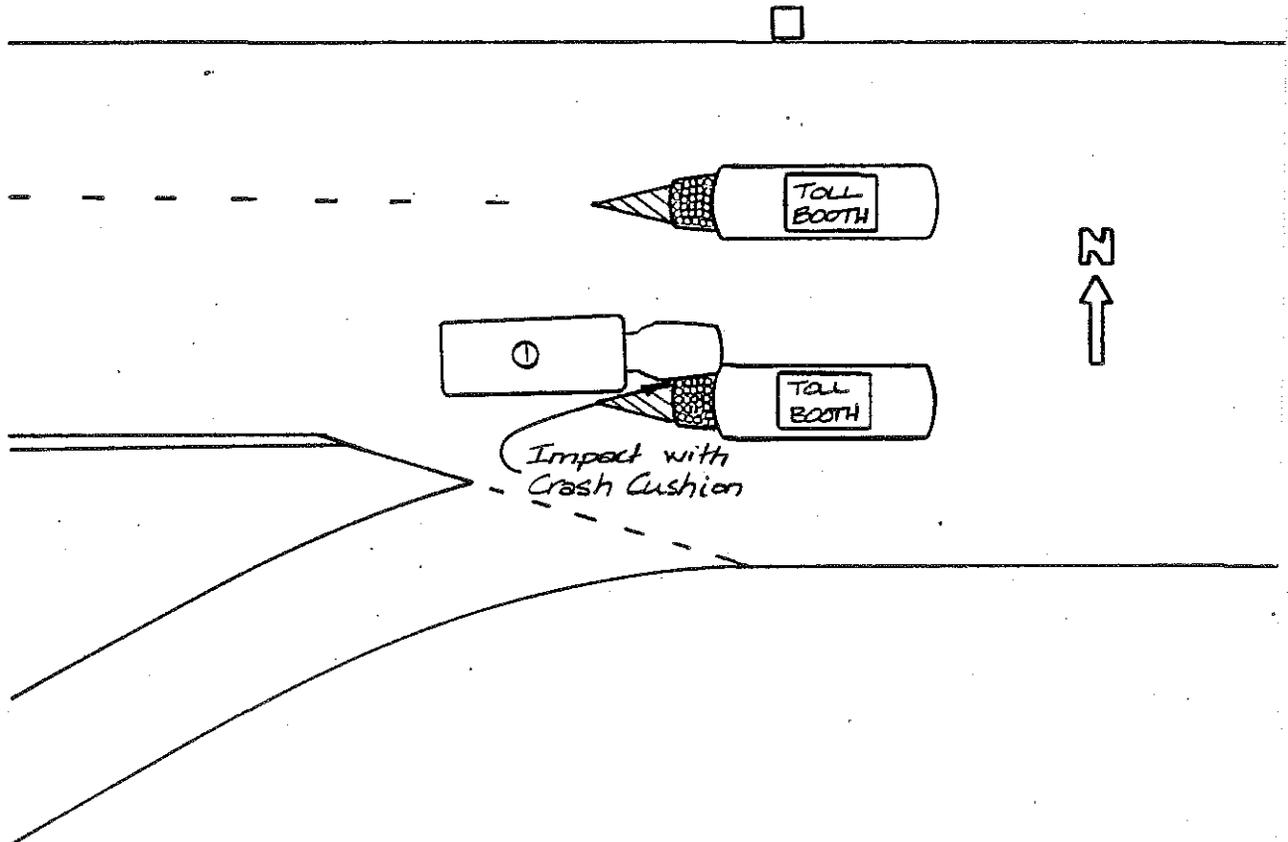
COMMENTS: A 1975 Freightliner tractor and semi-trailer lost air brake pressure as it approached the toll plaza and side-swiped the right-side crash cushion with the passenger side of the cab. It then continued approximately 300 feet past the toll plaza before stopping. There was non-functional damage to the cab. The driver was not wearing a safety belt; he was uninjured.

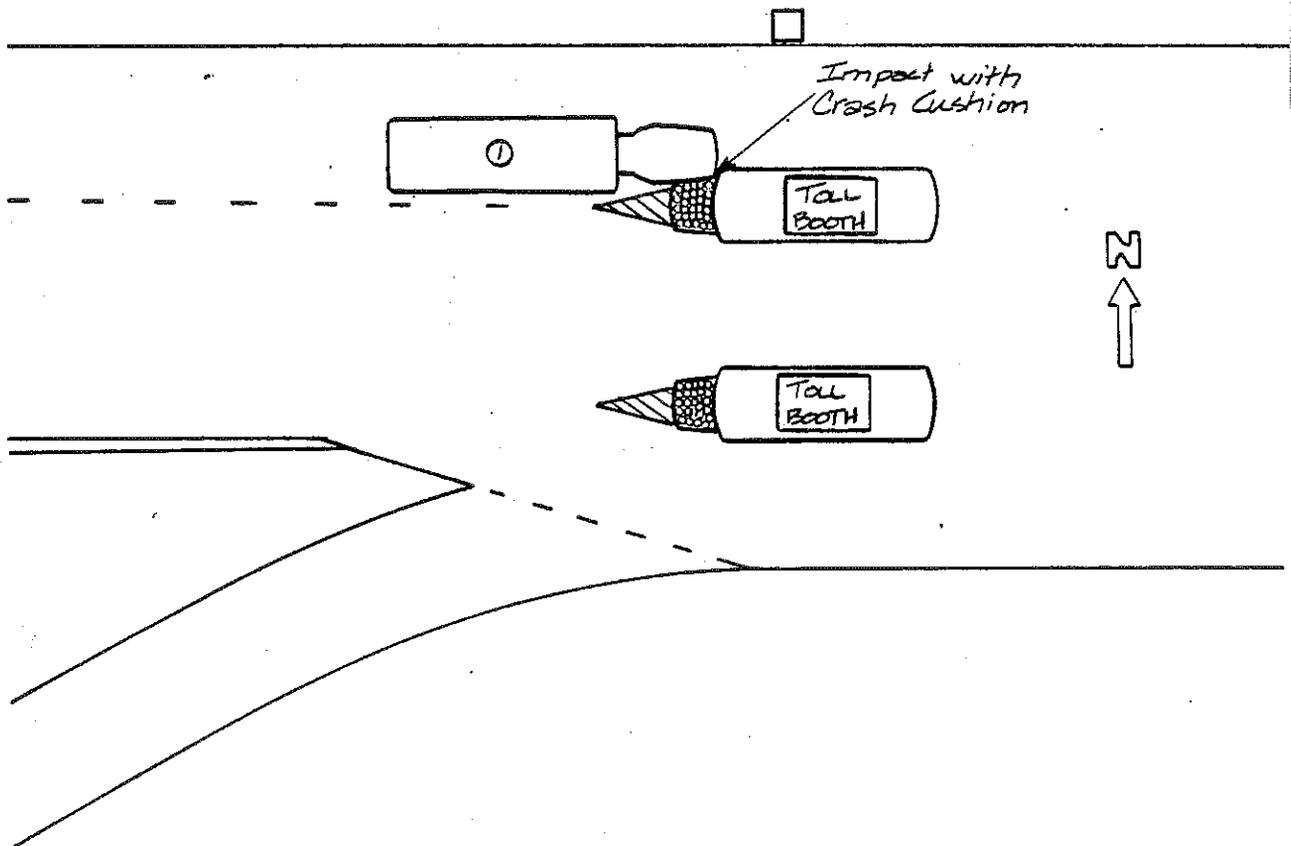
COMMENTS: The right rear drive wheel of a 1969 Freightliner tractor and semi-trailer caught the side of the crash cushion as the truck passed through the toll plaza. There was no damage to the truck and neither the driver nor his passenger were injured. They were not wearing safety belts.

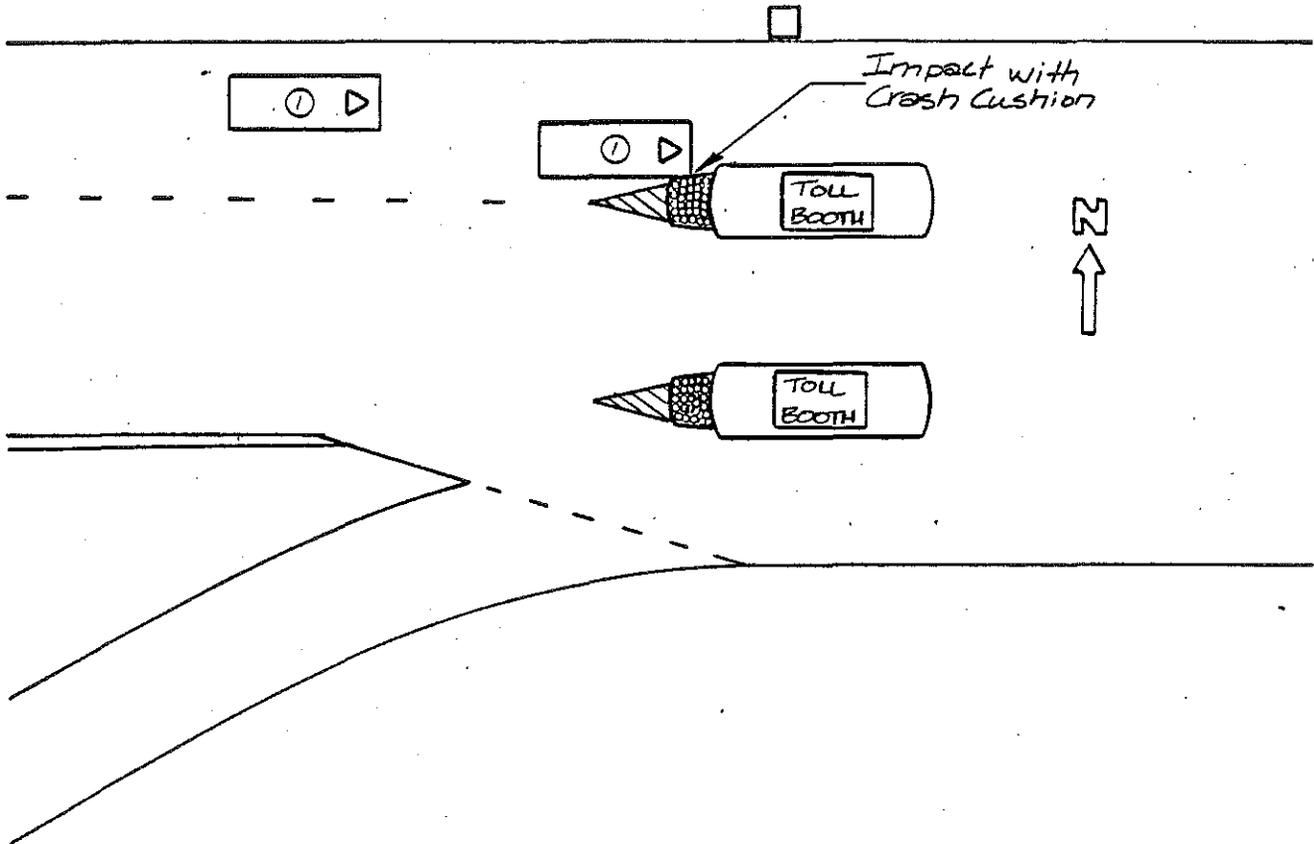
COMMENTS: A 1977 Ford station wagon slid on wet pavement as it approached the toll plaza and bumped the crash cushion on the right with the right front corner of the car. There was no damage to the car. The driver, who was not wearing a safety belt, was not injured.

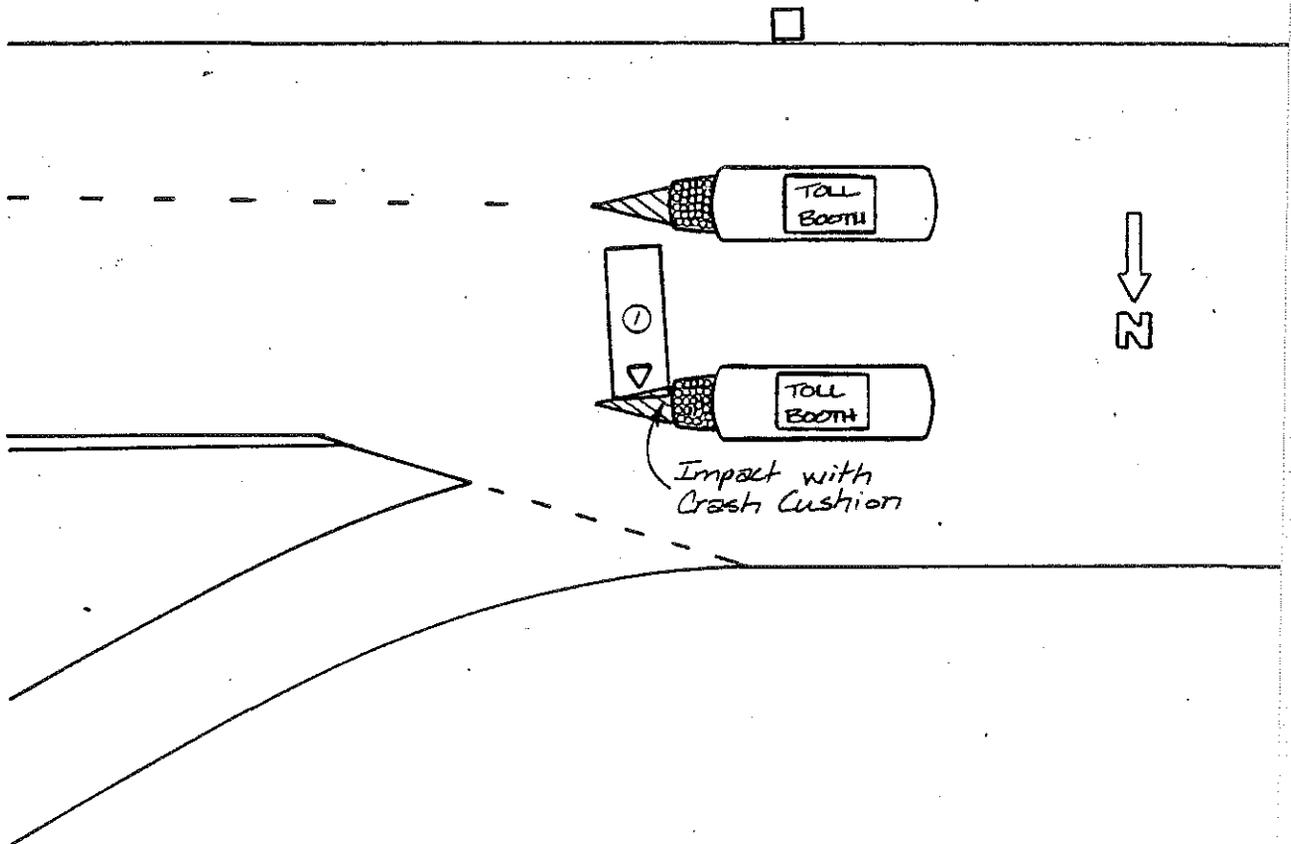
COMMENTS: A 1969 Dodge van impacted the crash cushion head-on and spun clockwise 90 degrees until the left rear came to rest against another cushion. Damage to the van was disabling. The driver received possible injuries and he was not wearing a safety belt.

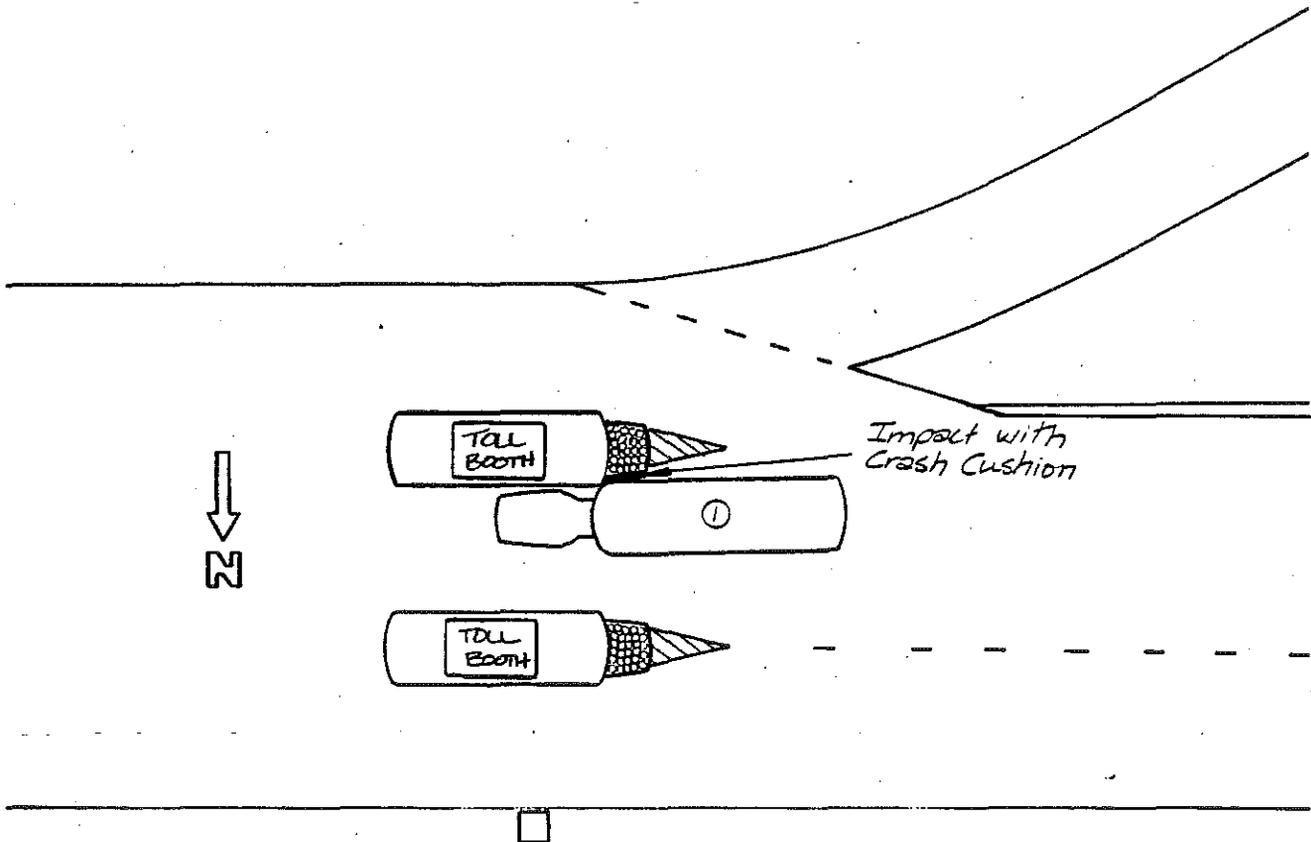
COMMENTS: A 1971 GMC tractor and semi-trailer attempted to go through a toll gate when part of the load on the trailer caught on the crash cushion. Damage was slight to the right side of the trailer. The driver was not injured and he was not wearing a safety belt.

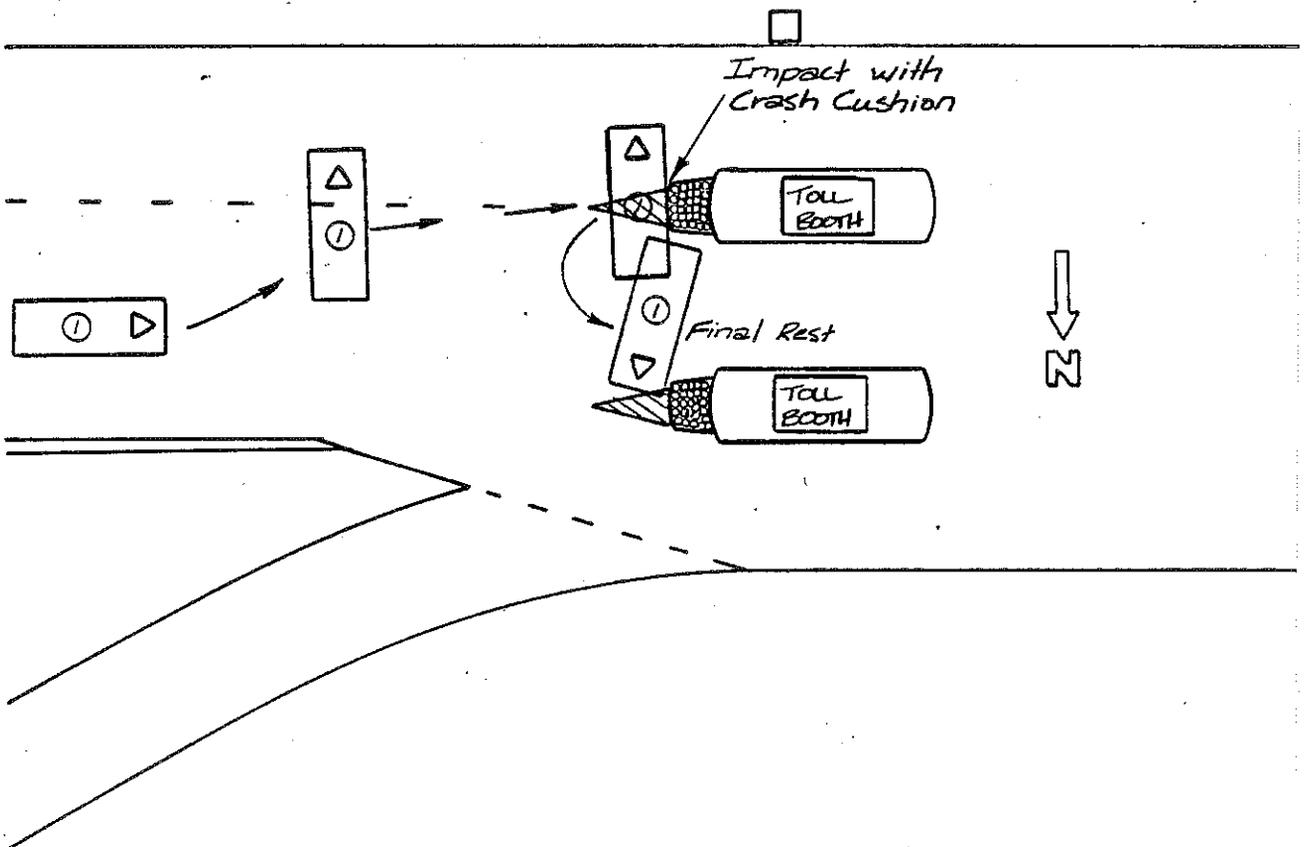
COMMENTS: A 1978 Chevrolet sedan hit a crash cushion broadside after the driver dozed off momentarily and then applied his brakes. The vehicle sustained disabling damage. The driver received a possible head injury. He was not wearing a safety belt.

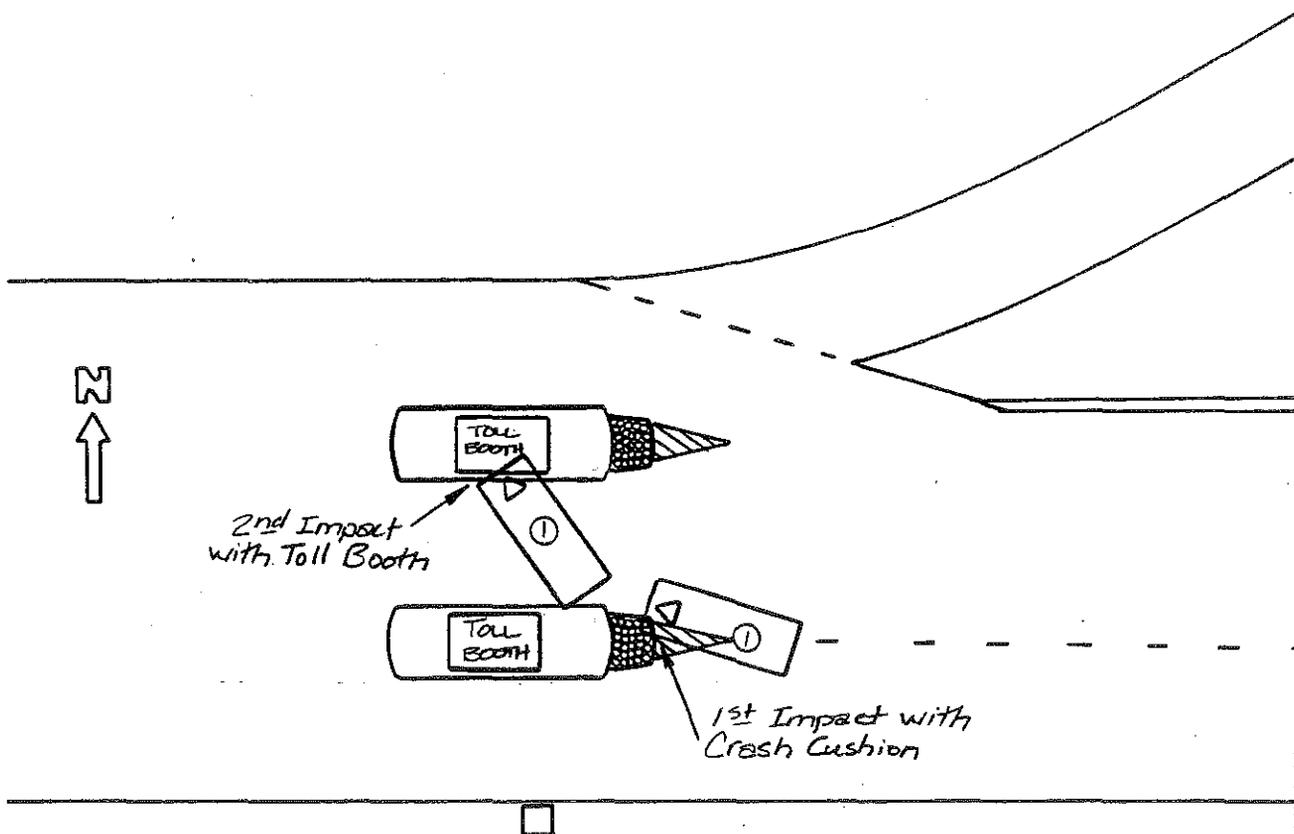
COMMENTS: The driver of a 1978 Mercury 2-door sedan fell asleep and struck a crash cushion head-on. The vehicle then rebounded to its right into the toll lane. The vehicle received disabling damage, and both the driver and his passenger received incapacitating injuries. Neither occupant was wearing a safety belt.

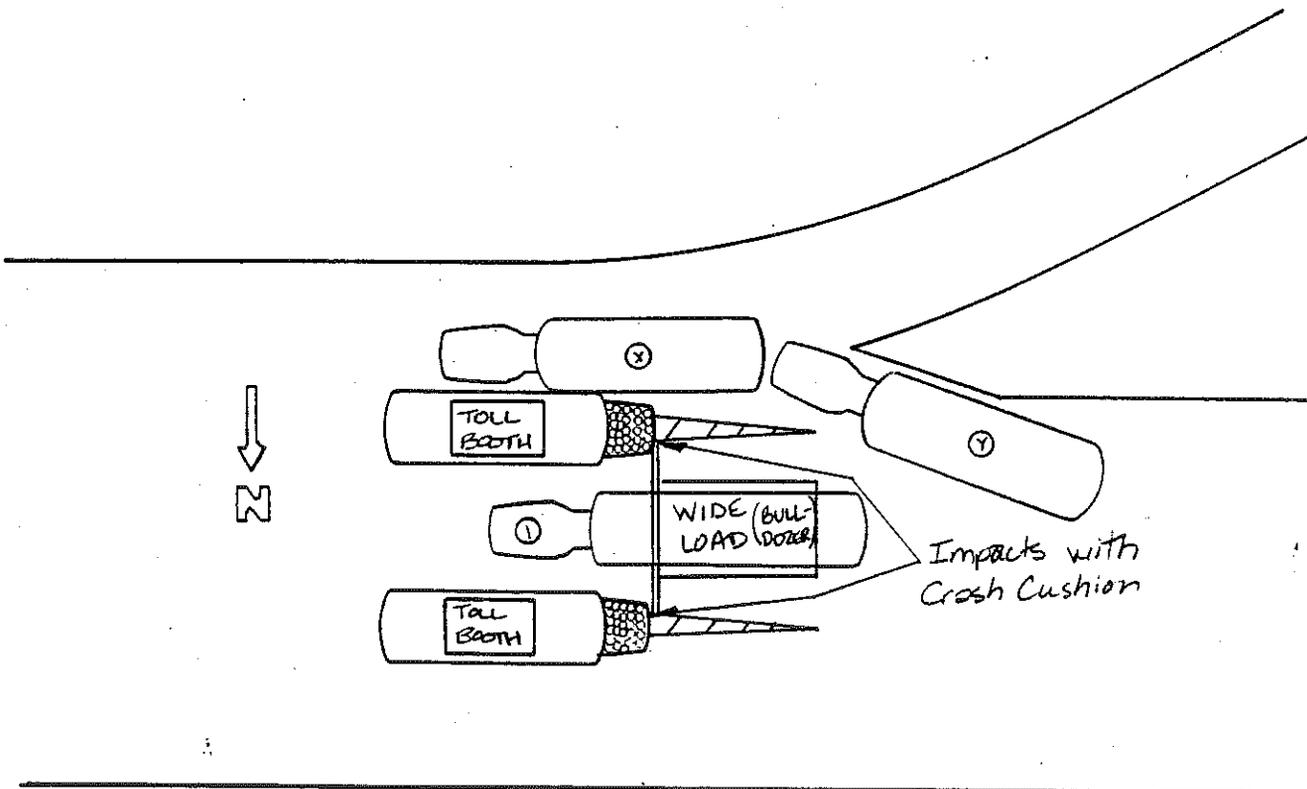
COMMENTS: The brakes on a 1975 White tractor and semi-trailer would not function properly and the truck impacted the crash cushion in an attempt to pass through the toll gate. The truck was hauling a bulldozer and the side of the dozer impacted the toll booth causing extensive damage. The tractor and semi-trailer was only slightly damaged. The driver was not injured and he was not wearing a safety belt.

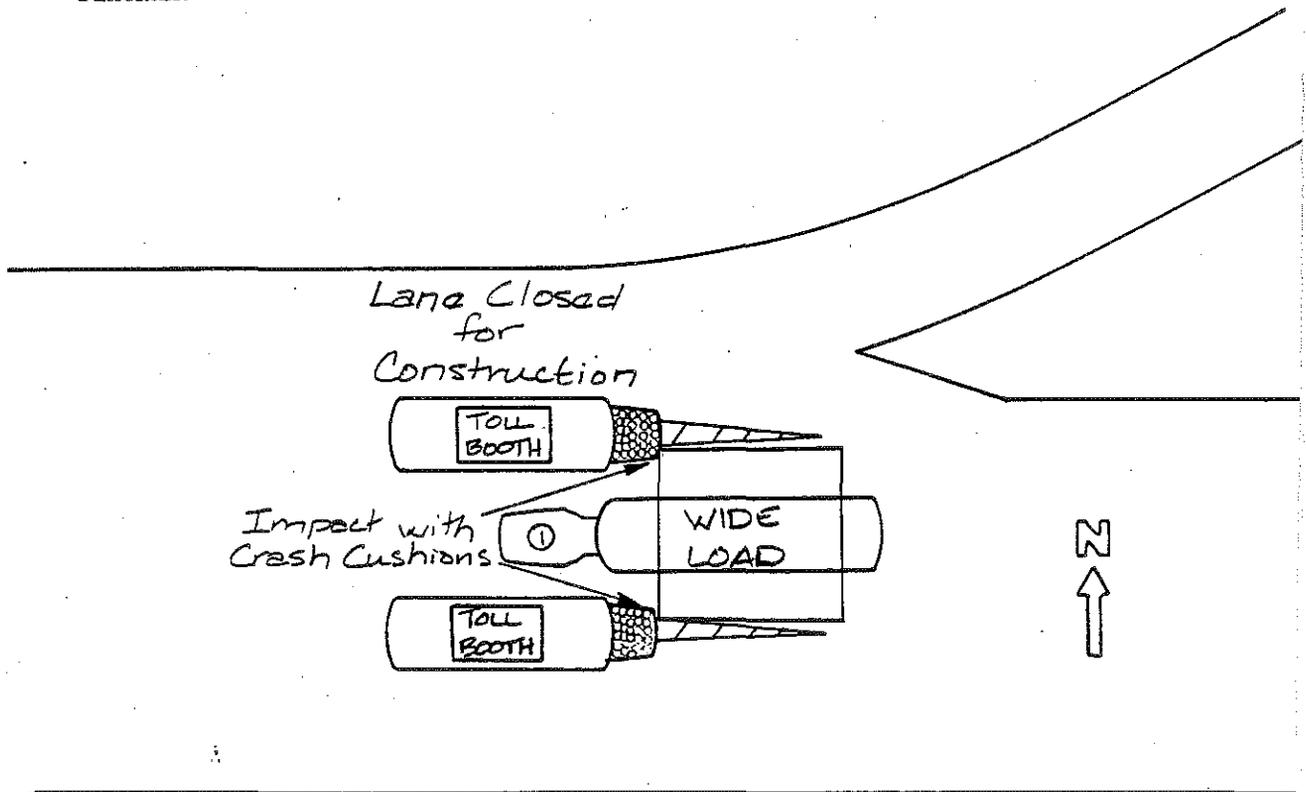
COMMENTS: The vehicle, a 1978 Peterbilt tractor and semi-trailer carrying a wide load, was forced to attempt to pass between the two toll booths at the toll plaza due to construction in the wide lane. The load was too wide and it caused damage to the crash cushions, walls, and toll booths. No injuries were reported and there was no damage to the vehicle. The driver was wearing a safety belt.

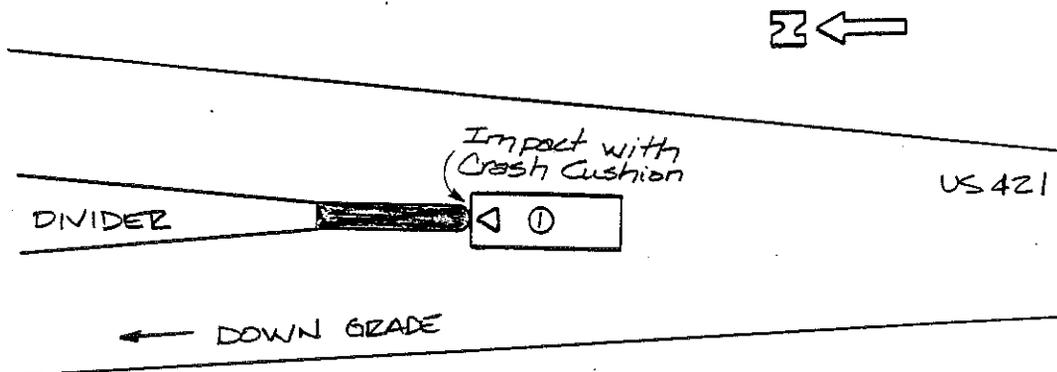
COMMENTS: The driver of a 1977 AMC Pacer was intoxicated and ran head-on into the crash cushion terminating the raised median divider. The front of the car received disabling damage. Neither the driver nor his two passengers received any injuries. None of the occupants was wearing a safety belt.

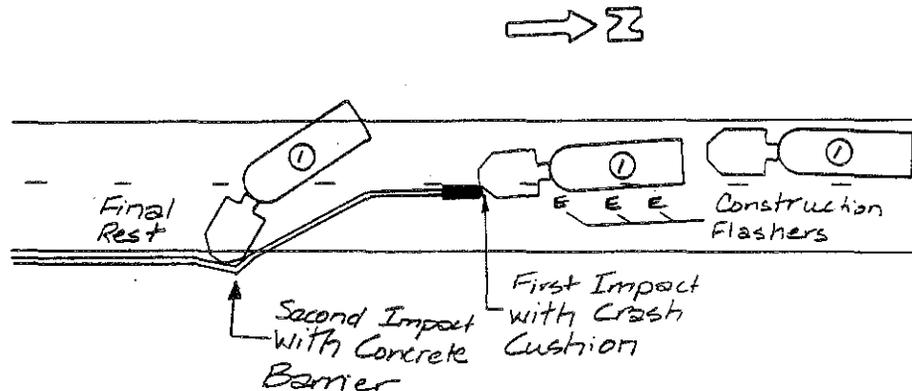
COMMENTS: The vehicle, a 1980 International tractor and semi-trailer, suffered a blowout in the left front tire, which pulled the vehicle to the left into a crash cushion terminating a temporary concrete barrier at a construction site. The truck bounced off the crash cushion and travelled 510 feet down the road before again striking the wall and coming to a halt. The truck received disabling damage to the front end. The driver suffered a non-incapacitating injury. He was not wearing a safety belt.

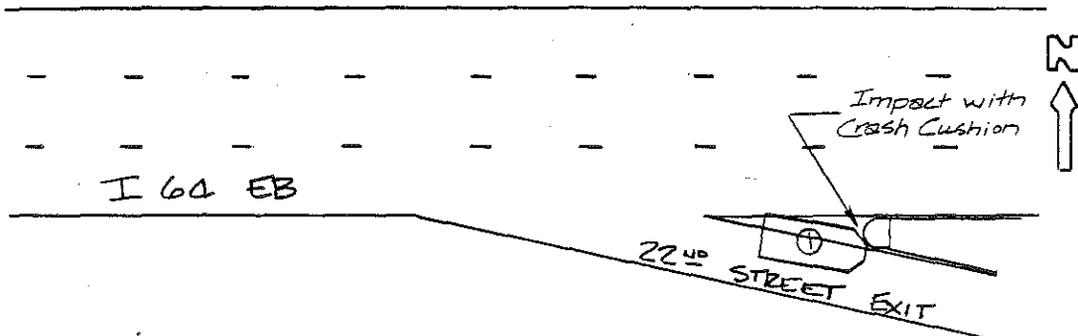
COMMENTS: A 1972 Dodge pickup appeared to be travelling onto the 22nd Street Exit when the left front tire blew out, causing the truck to veer left head-on into the steel barrel crash cushion at the ramp gore area. The truck was disabled, but the driver was uninjured. He was not wearing a safety belt.

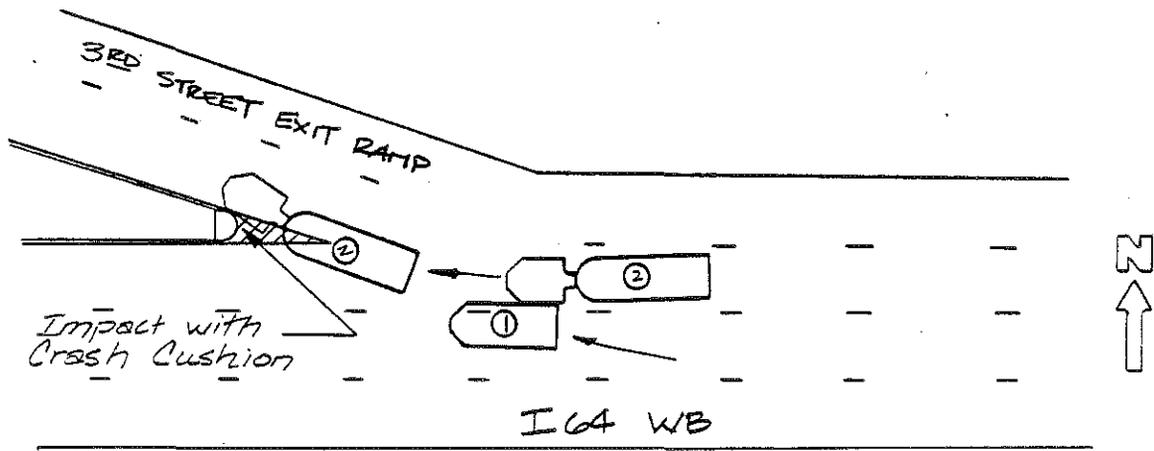
COMMENTS: Unit 1, a passenger sedan, was travelling in the middle lane (3 lanes each direction) of I 64 at the 3rd Street exit ramp. Unit 2, a 1977 International tractor and semi-trailer, was in the right-hand lane. The sketch on the police report shows that Unit 1 veered into the tractor-trailer, sideswiping the driver's side of the cab with its right side. The truck then veered to the right, striking the crash cushion at the gore area with the cab of the truck near the driver's side door. Neither driver was injured, but the truck was disabled. The driver of the truck was wearing a safety belt.

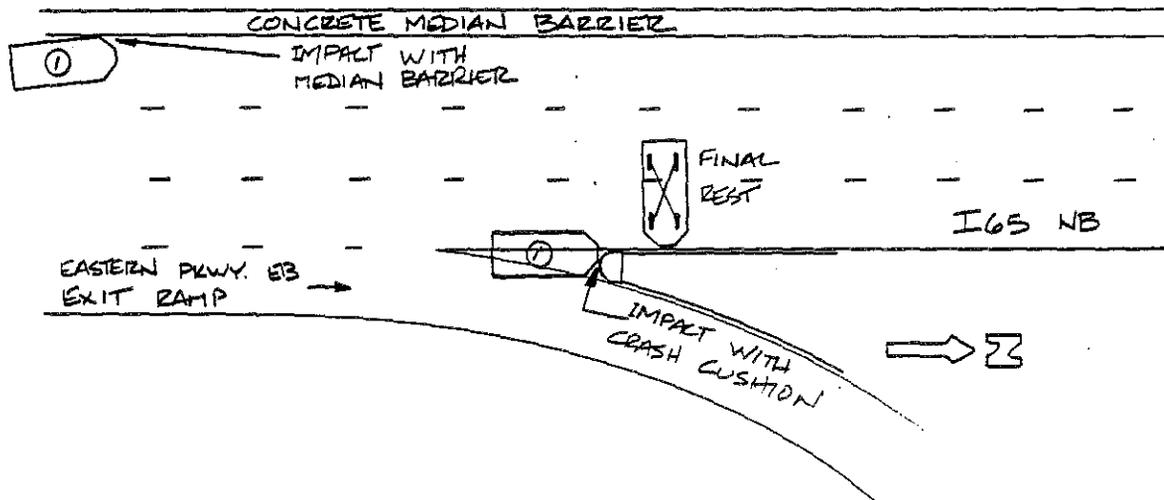
COMMENTS: A 1973 Pontiac Catalina collided head-on at high speed with a crash cushion. Prior to impact, the police report sketch shows that the car glanced off the concrete median barrier, crossed over three traffic lanes, impacted the crash cushion at the exit ramp, rotated 90 degrees clockwise and landed on its top in the gore area. The driver was fatally injured and was not wearing a safety belt. Disabling damage was done to the car and heavy damage was done to the crash cushion.

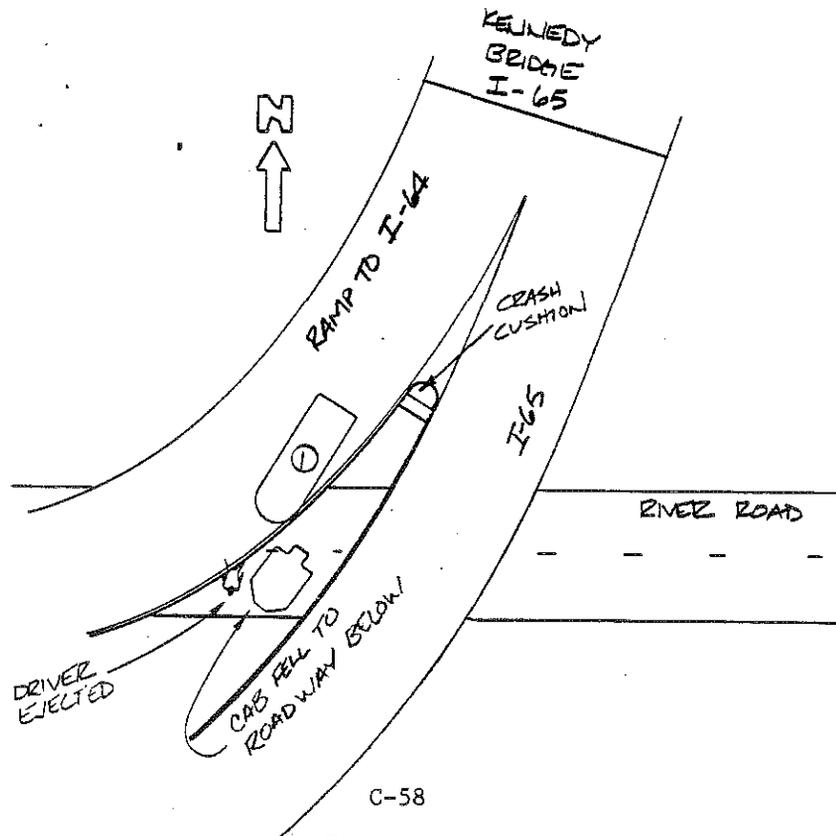
Figure C8. Accident Number 051, Jefferson County, I 65, MP 136.5, I 65 Southbound at I 64.

COMMENTS: The driver of a 1979 Mack tractor and semi-trailer was travelling southbound on I 65 when he came upon the exit ramp to I 64. At the last minute he swerved to the right in an attempt to make the exit ramp, but he reacted too late and struck the crash cushion in the gore area with the left front corner of the cab. The cab then rode up onto the bridge railing, became detached from the trailer and fell to the roadway below. The driver was killed, suffering multiple injuries as he was ejected from the cab. The truck was demolished. The driver was not wearing a safety belt. Heavy damage was done to the crash cushion.

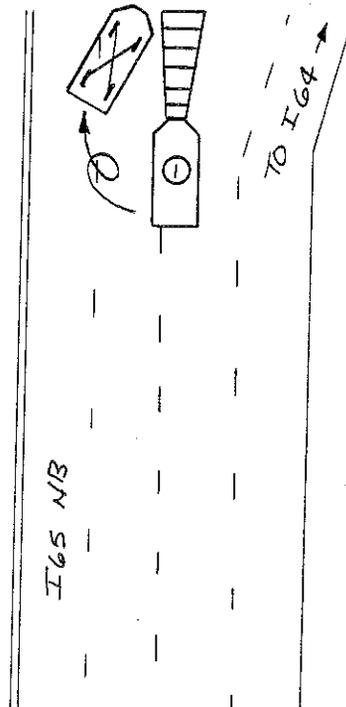
COMMENTS: The driver of a 1973 Chevrolet sedan lost control of the vehicle due to alcohol involvement and struck the crash cushion in the gore area head-on. The car then spun 360 degrees and landed on its top just to the left of the crash cushion. The driver suffered non-capacitating head injuries. The car was disabled, receiving heavy damage over the entire vehicle. The driver was not wearing a safety belt.

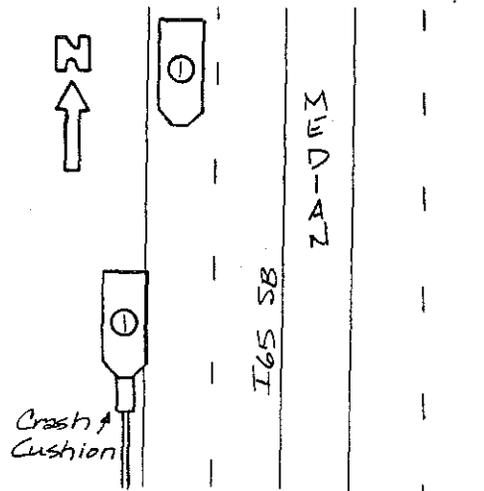
COMMENTS: The roadway in this section of I65 was narrowed by construction and the emergency lane was being used as a traffic lane. The driver of a 1979 Chevrolet pickup failed to observe the traffic control measures and ran head-on into the crash cushion terminating the temporary concrete barrier. Disabling damage was done to the front end of the truck. The driver was not injured; he was not wearing a safety belt.

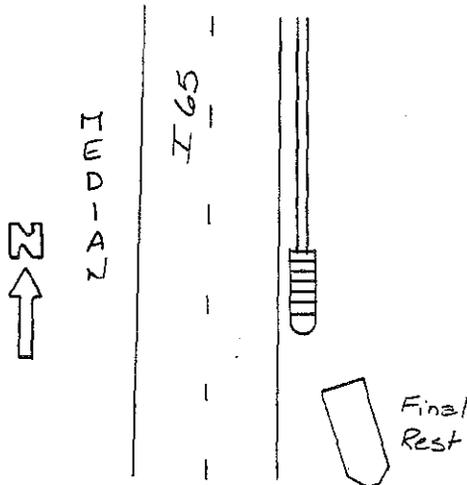
COMMENTS: The driver of a 1971 Ford 4-door sedan was not paying attention to the roadway construction and ran into the crash cushion at the end of a temporary concrete barrier. The vehicle impacted the crash cushion with the front end of the car and bounced back, spinning around 180 degrees. The car suffered disabling damage. The driver was not injured; he was not wearing a safety belt.

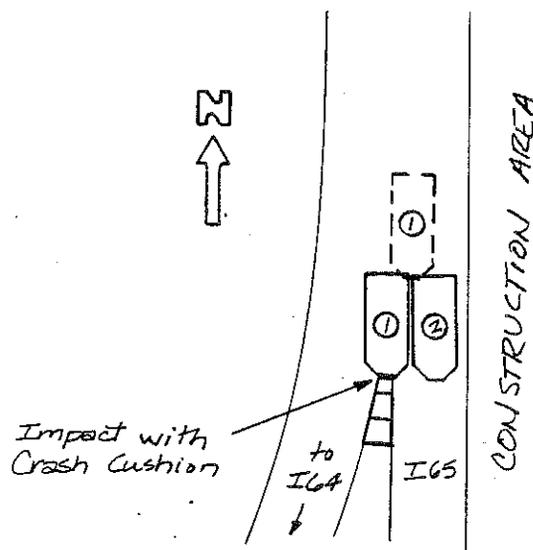
COMMENTS: The driver of a 1980 Ford Thunderbird was travelling through the construction area at an unsafe speed. Not watching the roadway, he ran into the rear of a slower vehicle in front of him and then veered to the right, striking a crash cushion at the I64 exit gore area head-on. The car was disabled from extensive front-end damage, but the driver was not injured. He was not wearing a safety belt.

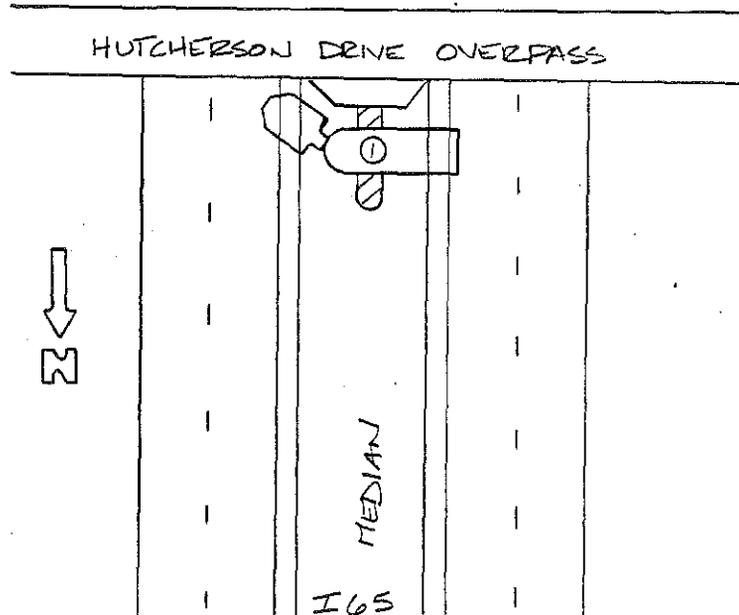
COMMENTS: The driver of a Kenworth tractor and semi-trailer lost control of his vehicle after striking a patch of ice on the roadway. The truck slid sideways into the median and struck the G.R.E.A.T. crash cushion protecting the bridge pier with the bottom edge of the right side of the trailer. The bottom of the trailer was heavily damaged. Photos show massive damage to the crash cushion. The driver suffered a non-incapacitating chest injury. He was not wearing a safety belt.

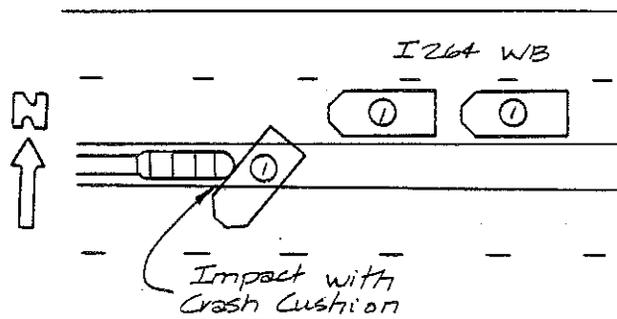
COMMENTS: The driver of a 1967 Ford pickup truck swerved into the median in order to avoid a collision with a vehicle making an illegal U-turn. The vehicle slid sideways into a crash cushion, striking it with the passenger side and causing slight damage. The vehicle remained in operation. The driver of the truck was not injured; he was not wearing a safety belt when the accident occurred.

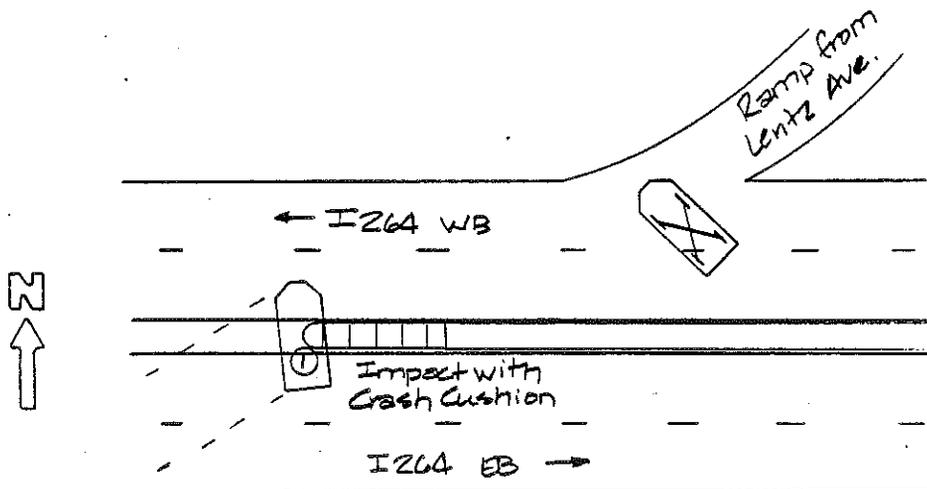
COMMENTS: A 1976 Chevrolet Monza went out of control due to high speed and slid sideways into the median, striking a crash cushion with the passenger side of the car. The vehicle then flipped over the crash cushion and landed on its top in the opposite lanes. The driver, who was wearing a lap belt and shoulder harness, suffered non-disabling injuries to the neck and back. The vehicle sustained extensive damage to the right side.

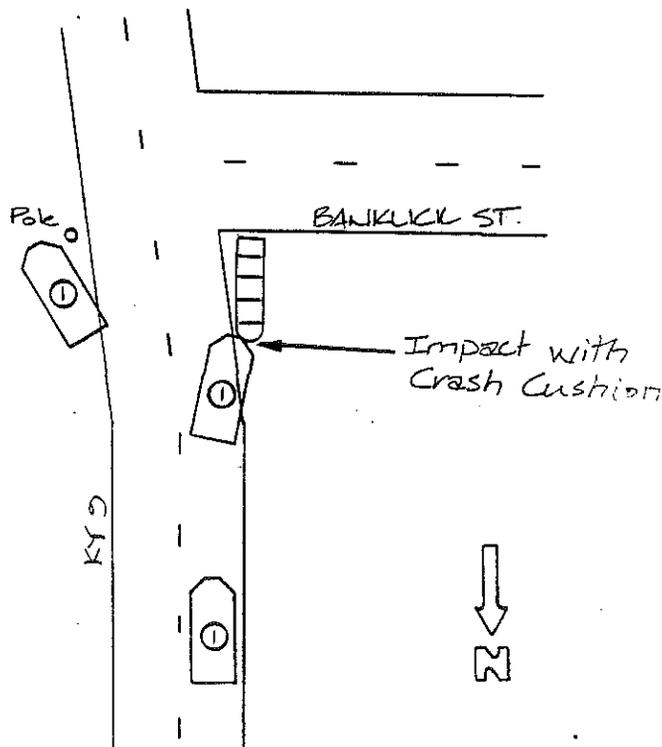
COMMENTS: The driver of a 1979 Ford 2-door sedan stated that an oncoming car with its headlights on high beam caused him to veer to the right and strike the crash cushion with the right front corner of his vehicle. The car then glanced off the crash cushion and crossed the roadway, where it ran off the other side. The driver received a non-disabling neck injury, while the passenger received a non-disabling head injury. Neither driver nor passenger were wearing safety belts.

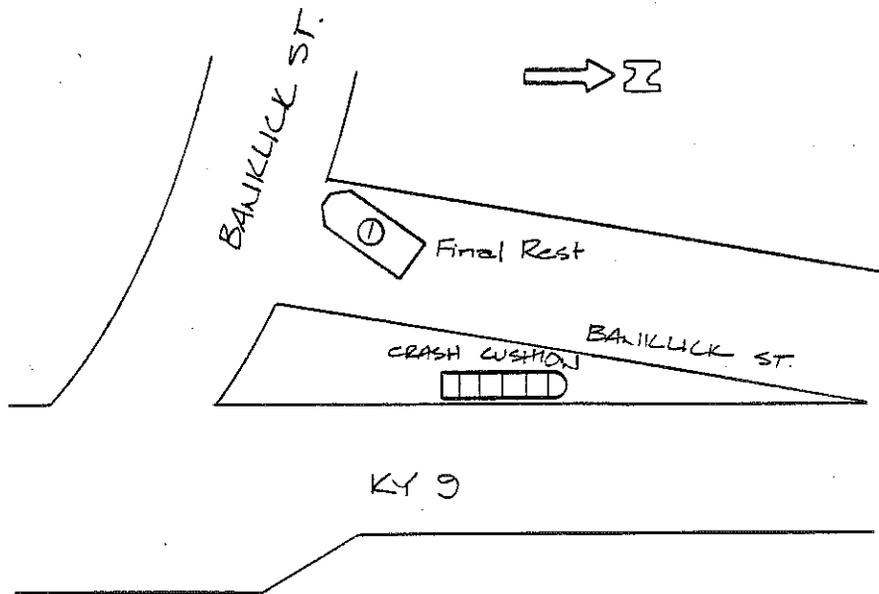
COMMENTS: The driver of a 1980 Plymouth 2-door sedan stated that an oncoming vehicle was across the centerline in his lane, forcing him to leave the roadway and strike the crash cushion. The car suffered disabling damage to the right front corner. The driver, who was not wearing a safety belt, was not injured.

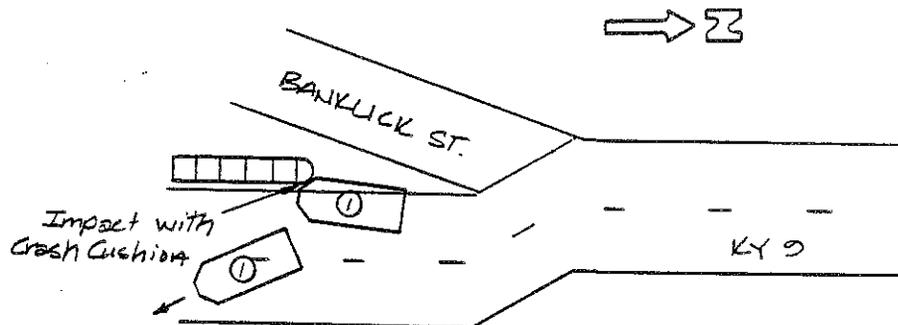
COMMENTS: The vehicle, a 1977 Chevrolet Nova, struck the crash cushion with the right front corner of the car, then glanced off the crash cushion across the roadway, where it ran off the other side and struck a tree. The car was disabled. The driver suffered possible arm injuries. She was wearing a safety belt when the accident occurred.

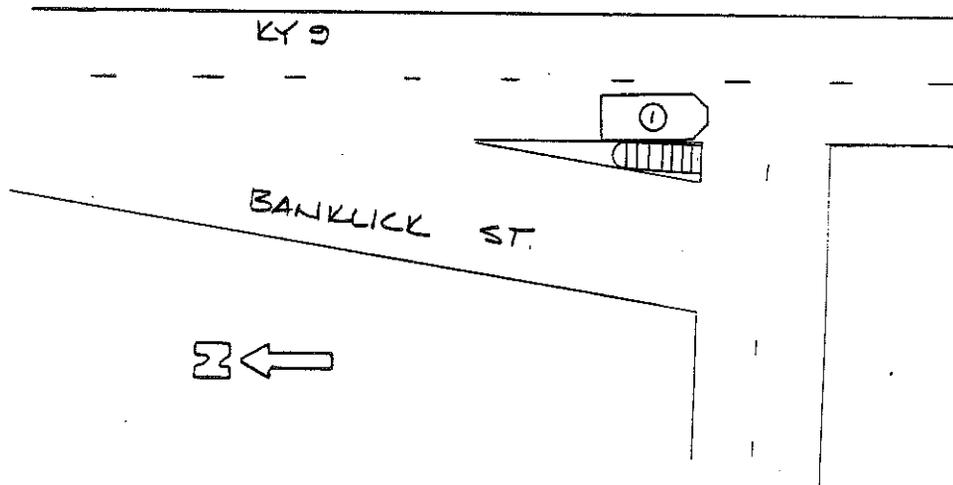
COMMENTS: A 1971 Ford 750 (Coca Cola truck) was traveling south on KY 9 and sideswiped the crash cushion with its right side. The vehicle received functional damage along the right side. The driver was not wearing a safety belt and was not injured. Damage to the crash cushion was moderate.
