1. Report No.		2. Government Accession No.		3. Recipient's Catalog No.	
4. Title and Subtitle Analysis of Accidents Involving Crash Cushions				5. Report Date June 1984

Research Report
UKTRP-84-17

ANALYSIS OF ACCIDENTS INVOLVING CRASH CUSHIONS

Kentucky Transportation Research Program
College of Engineering
University of Kentucky
Lexington, Kentucky

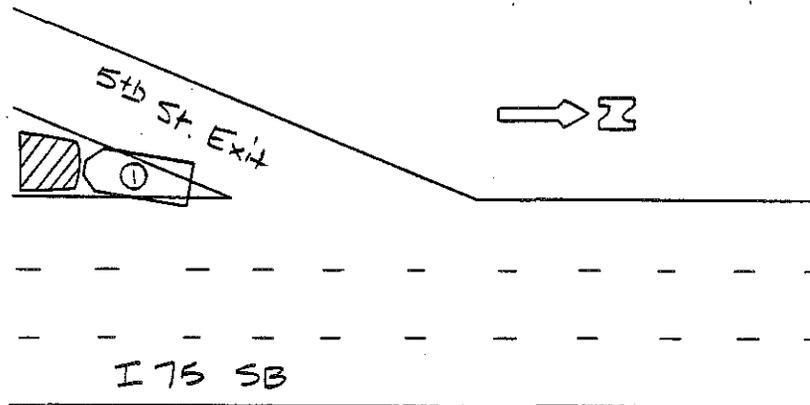
COMMENTS: The driver of a 1962 Ford 2-door sedan was southbound on I 75 when a vehicle forced him into the crash cushion resulting in a head-on impact. There were no injuries and the vehicle sustained disabling damage.

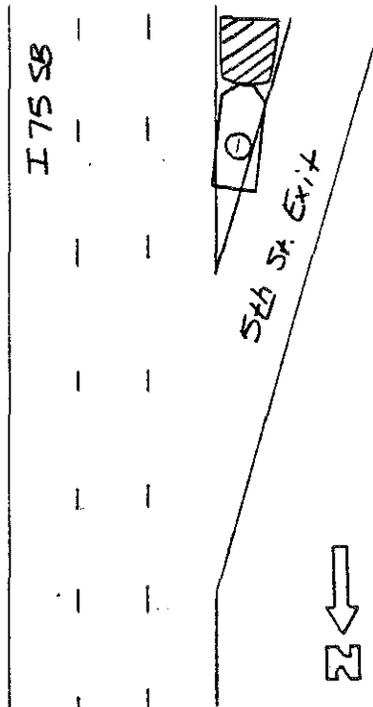
COMMENTS: The driver of a 1966 Oldsmobile 4-door sedan stated he took his eyes off the road to watch a car to his right and struck the crash cushion head-on. The vehicle was disabled and the driver received an incapacitating injury.

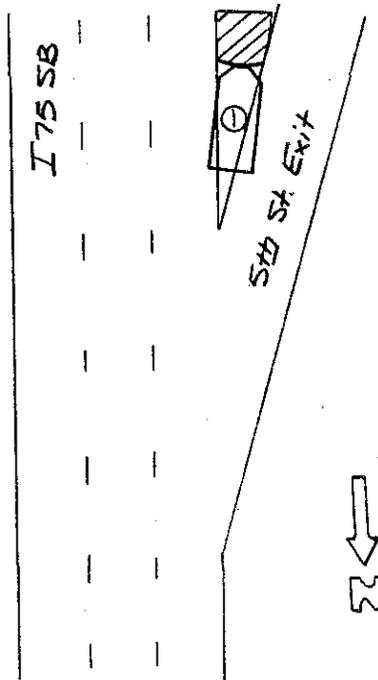
COMMENTS: The driver of a 1966 Plymouth sedan fell asleep and struck the sand barrels head-on. The driver was not injured. The vehicle sustained disabling damage to the front end.

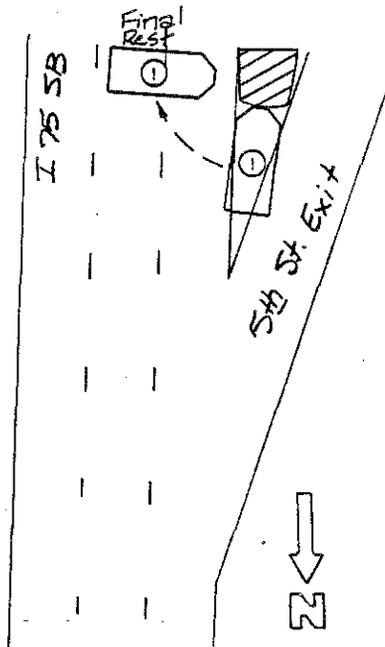
COMMENTS: The driver of a 1967 Chevrolet automobile was forced into the crash cushion by an unidentified vehicle. The vehicle hit the crash cushion head-on and rotated 90 degrees clockwise into the right-through lane. The driver was not injured. The vehicle received disabling damage to the front.

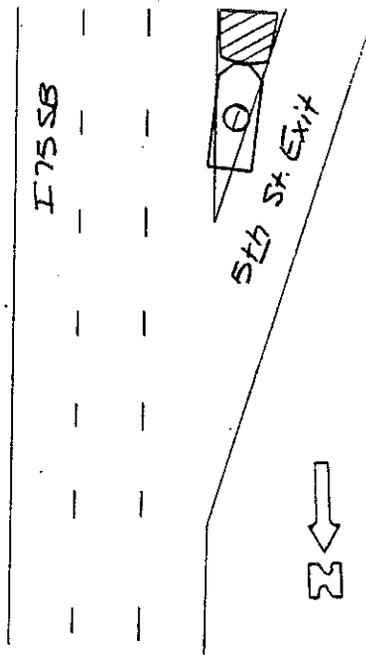
COMMENTS: The driver of a 1964 Ford automobile fell asleep and hit the sand barrels head-on. The driver was not injured. The vehicle sustained functional damage.

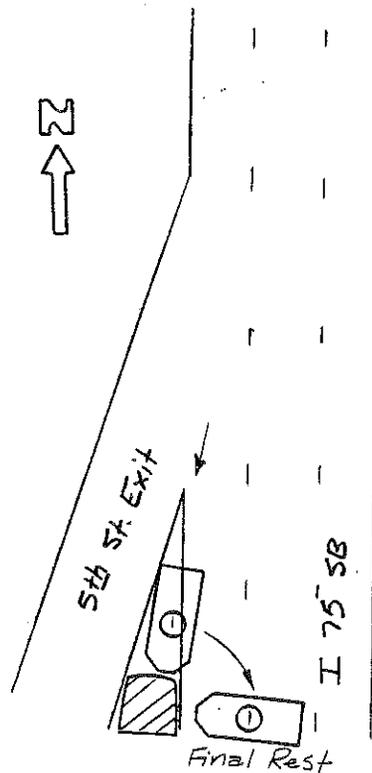
COMMENTS: The driver of a 1965 Chevrolet station wagon was south-bound on I 75 at the 5th Street exit in the right lane when another car cut in front of him. He swerved to miss the other vehicle and struck the sand barrels with the right-front of his vehicle and then rotated 90 degrees clockwise in the right lane. The driver and passenger received non-incapacitating injuries, and the vehicle sustained disabling damage.

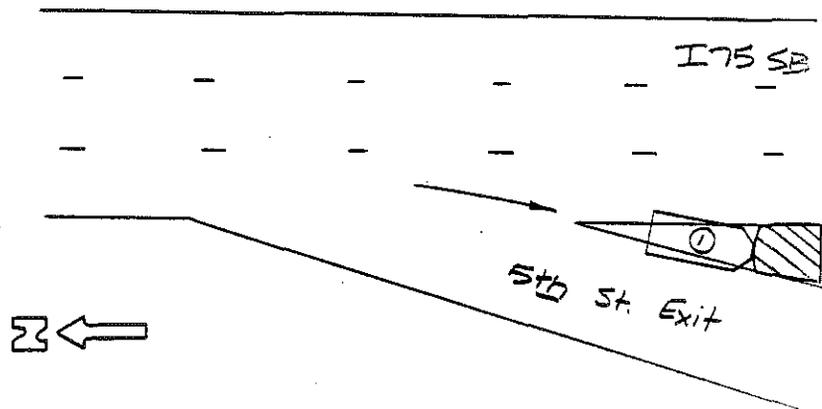
COMMENTS: A 1974 Buick 2-door sedan struck the crash cushion head-on. The driver, who was found to be intoxicated, stated that he remembered nothing before the accident. He received incapacitating chest injuries from impact with the steering wheel. The crash cushion was destroyed and the car was totalled. The driver was not wearing a safety belt.

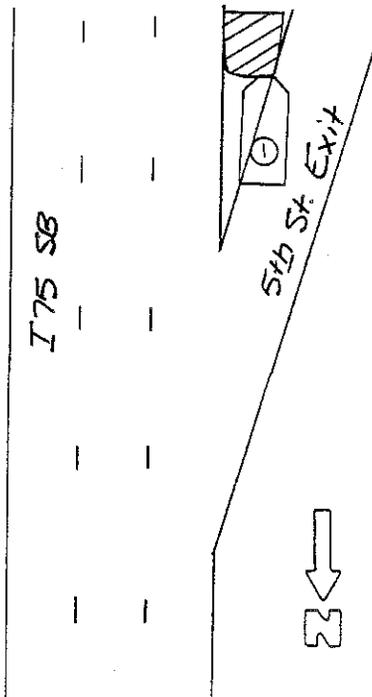
COMMENTS: The driver of a 1976 Ford sedan stated that as he was exiting the interstate, a truck in the right-hand lane cut into his lane, causing him to swerve and consequently strike the crash cushion head-on. Disabling damage was done to the front of the vehicle, but the driver was not injured. He was not wearing a safety belt.

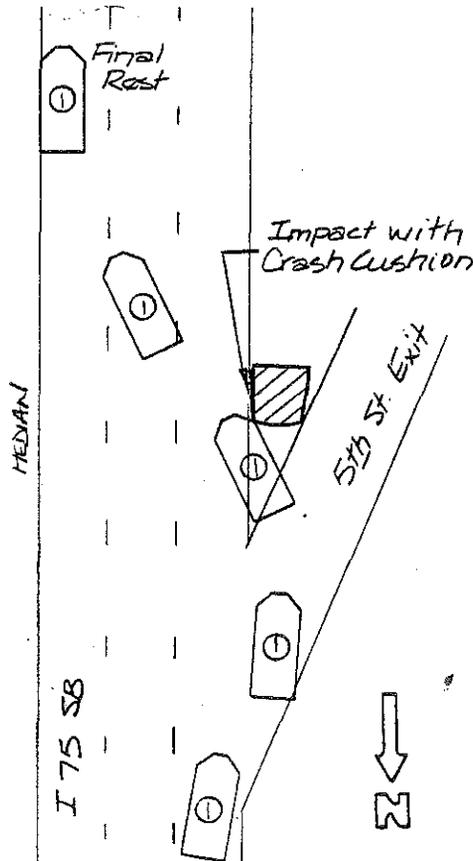
COMMENTS: The driver of a Freightliner tractor and semi-trailer was approaching the 5th Street Exit on I 75 southbound in the exit lane when he attempted to change lanes (he did not wish to exit) and struck the crash cushion at an angle with the front end of the cab. The driver stated that the steering wheel locked up as he was changing lanes. After the collision, the truck continued across both southbound lanes of I 75 for 300 feet before coming to rest. The truck was disabled, but the driver was not injured. Extensive damage was done to the crash cushion. The driver was not wearing a safety belt.

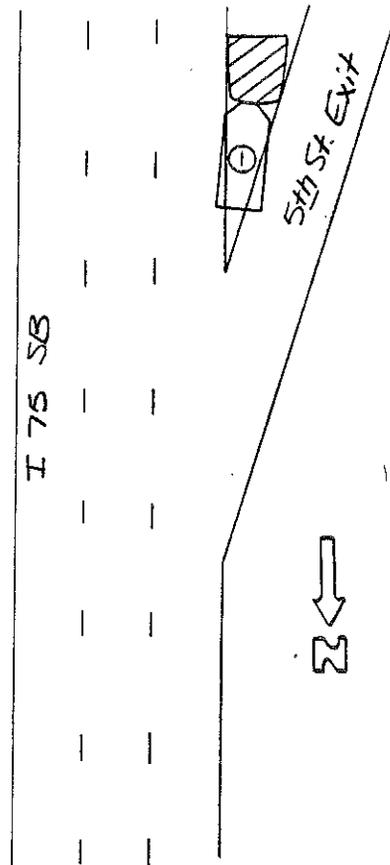
COMMENTS: The driver of a 1976 Chevrolet 2-door sedan mistook the exit lane at the interchange for a mainline lane and ran head-on into the crash cushion at the bridge abutment. The car received disabling damage to the front end. The driver suffered non-incapacitating head or face injuries. He was not wearing a safety belt.

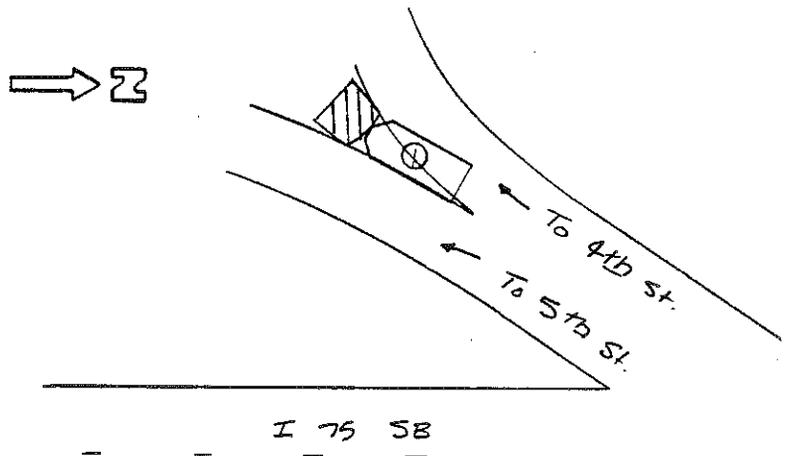
COMMENTS: An Oldsmobile sedan ran into the crash cushion in the gore area of the 4th Street exit, striking it with the left front end of the car. The car was disabled. Neither the driver nor passenger were injured. Neither occupant was wearing a safety belt.

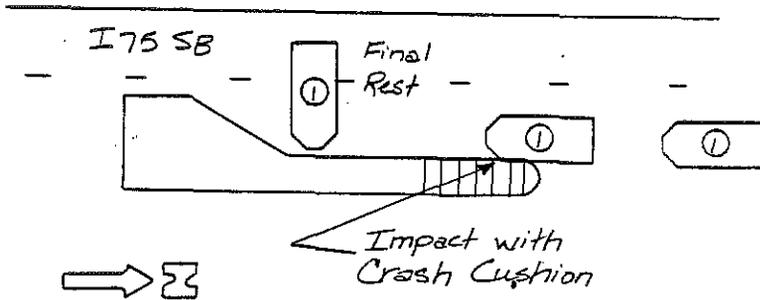
COMMENTS: The driver of a 1978 Ford Pinto said that he was suffering from heart trouble (he had a pacemaker) and felt very unsteady. He lost control of his vehicle and struck a crash cushion terminating a temporary concrete barrier at a construction site with the left front end and left side of the car. The car then spun counterclockwise 90 degrees and stopped. The car was disabled. The driver received incapacitating chest injuries. He was not wearing a safety belt.

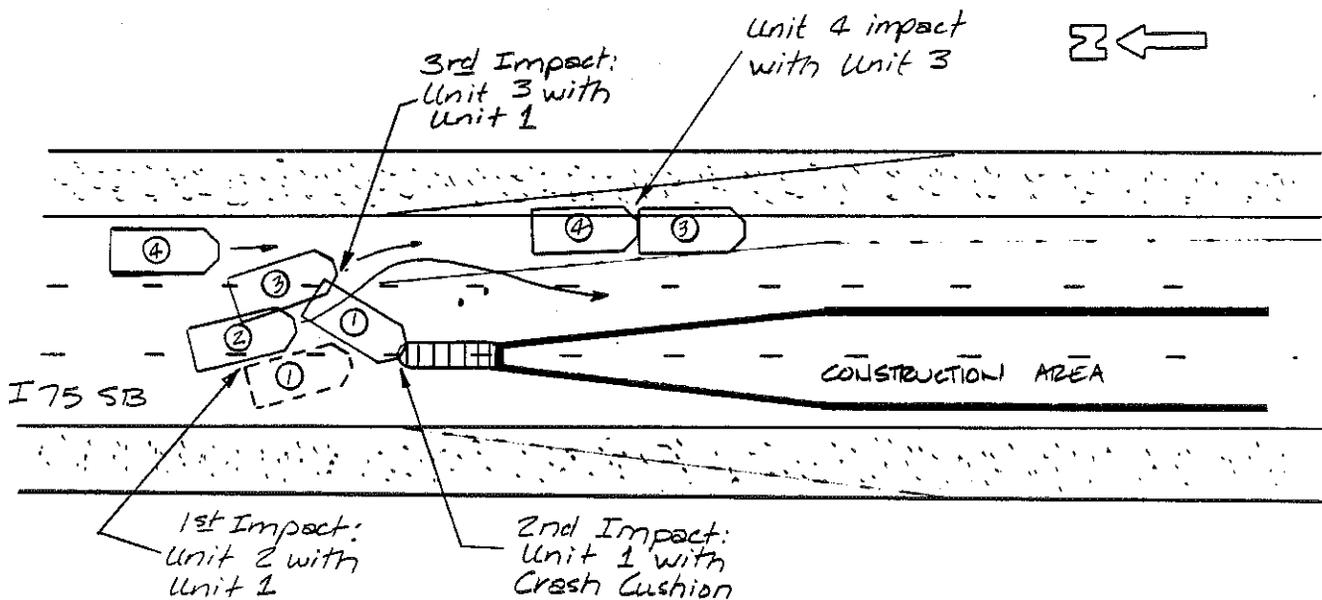
COMMENTS: The driver of a 1980 Toyota 2-door sedan became confused when he encountered a lane divider at a construction site. In an attempt to change lanes, he struck the temporary crash cushion head-on and spun approximately 45 degrees clockwise into the traffic lane. He was then struck by two other vehicles in the chain reaction that followed. The driver sustained a possible head or face injury. His passenger was not injured. The vehicle was disabled. Neither of the occupants was wearing a safety belt.

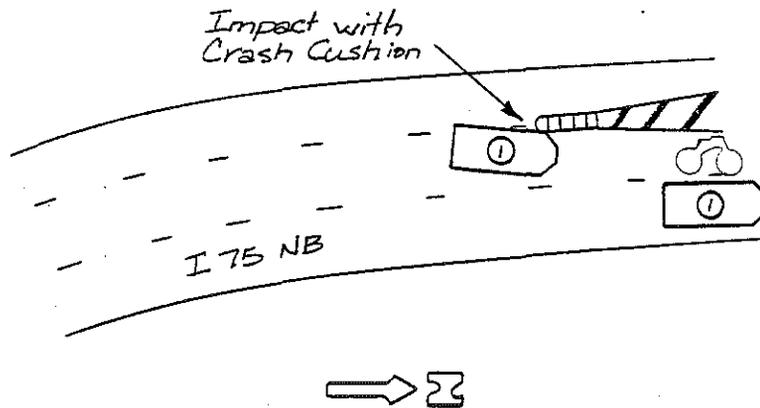
COMMENTS: The driver of a 1980 Chevrolet 2-door sedan became distracted by a bicyclist at the construction area and impacted the crash cushion with the left front corner of the car, disabling the vehicle. The driver was uninjured. He was not wearing a safety belt.

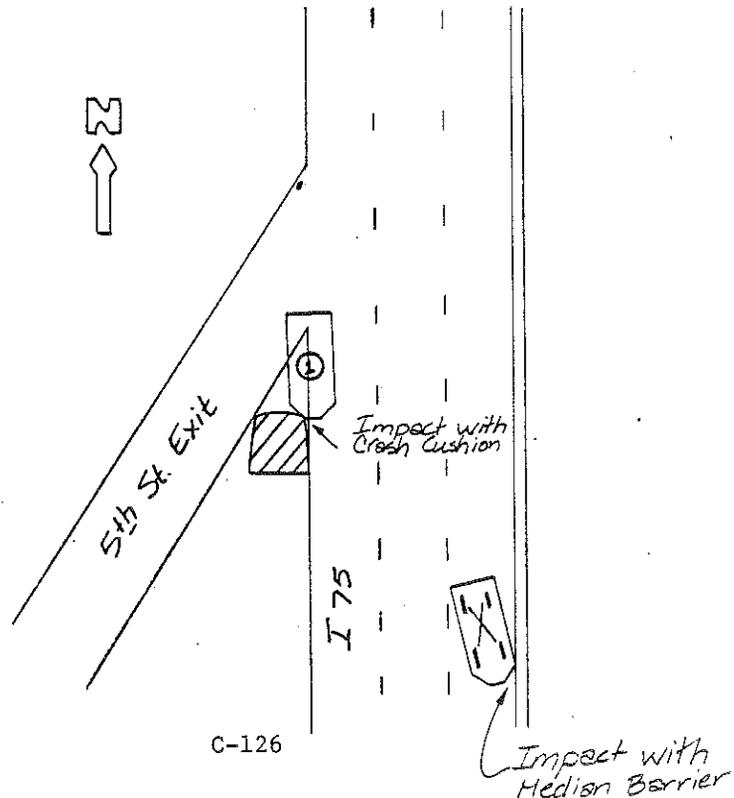
COMMENTS: A 1974 Ford van was travelling at a high rate of speed when it went out of control and struck a crash cushion head-on. It then flipped over on its top and slid approximately 250 feet, rendering fatal head injuries to one of the passengers. The driver, who registered a .439 percent BAC, received non-disabling head and chest injuries. He was charged with DUI and Reckless Homicide. Another passenger received non-incapacitating head injuries. The vehicle suffered heavy damage to the front end and top. The passenger who was killed was not wearing a safety belt, but the driver and other passenger were both wearing safety belts.

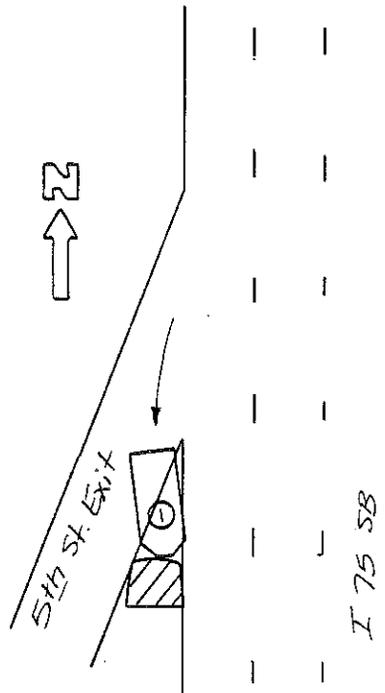
COMMENTS: The driver of a 1976 Chevrolet Monte Carlo swerved to avoid a motorcycle that had cut in front of him and struck the crash cushion head-on. He received slight head injuries. The car was disabled with extensive front-end damage. The driver was not wearing a safety belt.

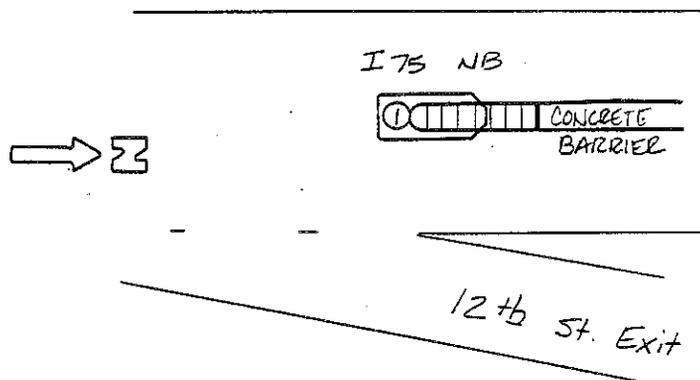
COMMENTS: The vehicle, a 1979 Pontiac 2-door sedan, swerved to avoid a collision with another vehicle and struck the temporary crash cushion at the construction site head-on. The vehicle was disabled with front-end damage. The driver received a possible head injury. He was wearing a shoulder harness and lap belt.

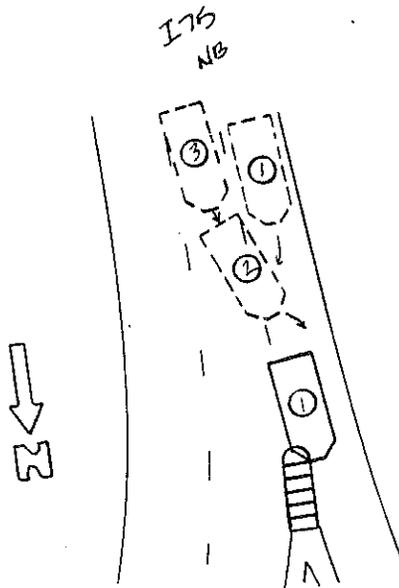
COMMENTS: The driver of a 1969 Dodge sedan, upon approaching a construction site, swerved to avoid two other vehicles and ran into the temporary crash cushion at the concrete barrier. The vehicle sustained disabling damage to the front end and right front corner. Neither the driver nor passenger were injured. Safety belts were not worn by the occupants.

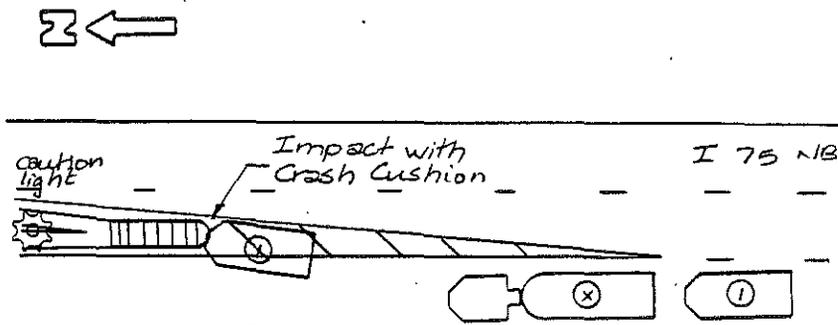
COMMENTS: The driver of a 1973 Pontiac 2-door sedan was following a tractor and semi-trailer too closely as they approached a construction site. The driver could not see around the truck and when it changed lanes to avoid the construction area, the driver could not avoid collision (head-on) with a crash cushion. Neither the driver nor his passenger were injured, but the car was disabled with front-end damage. The occupants were not wearing safety belts.

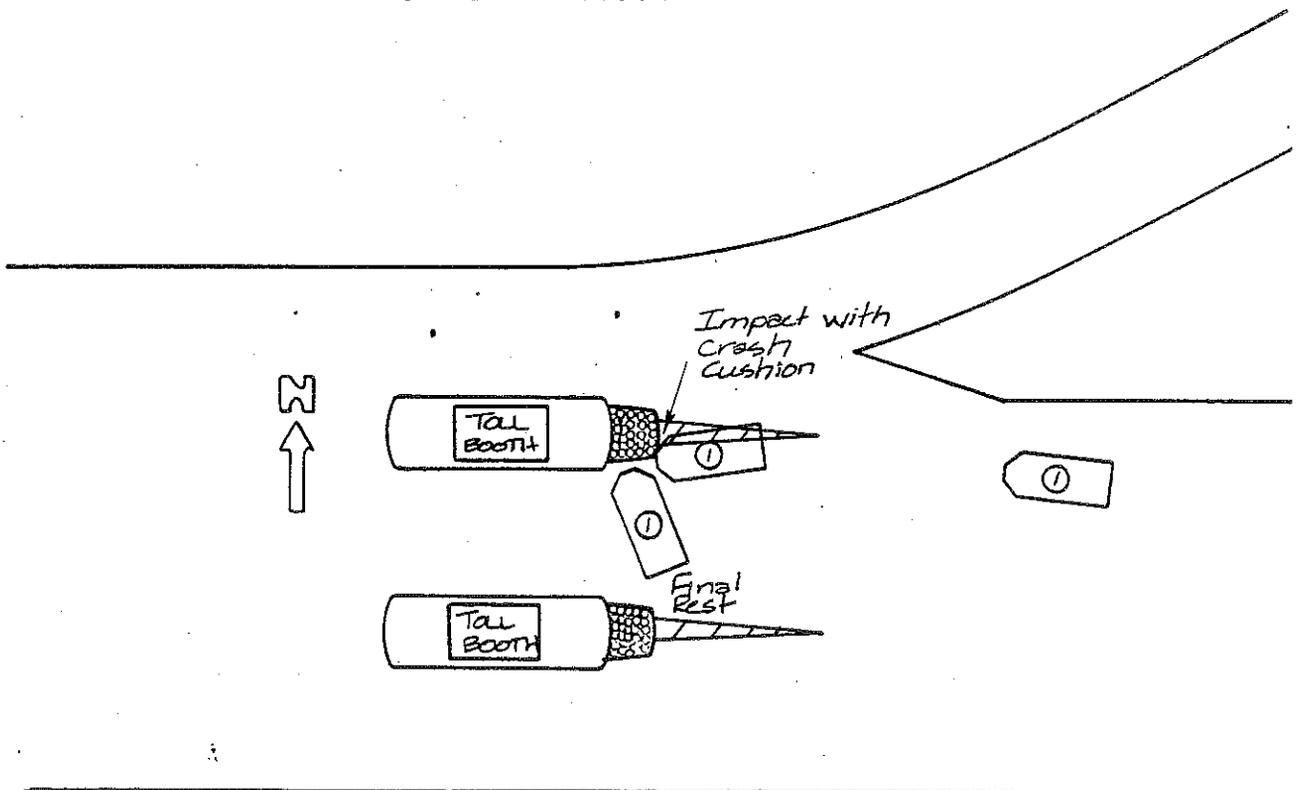
COMMENTS: The driver of a 1979 Ford sedan was indecisive about which lane to get in as he approached the toll plaza and impacted the front of the crash cushion with the right front corner of his vehicle. The car then spun 90 degrees clockwise after impact and came to rest in the middle of the traffic lane. The driver suffered incapacitating head injuries. Disabling damage was done to the front end of the vehicle.

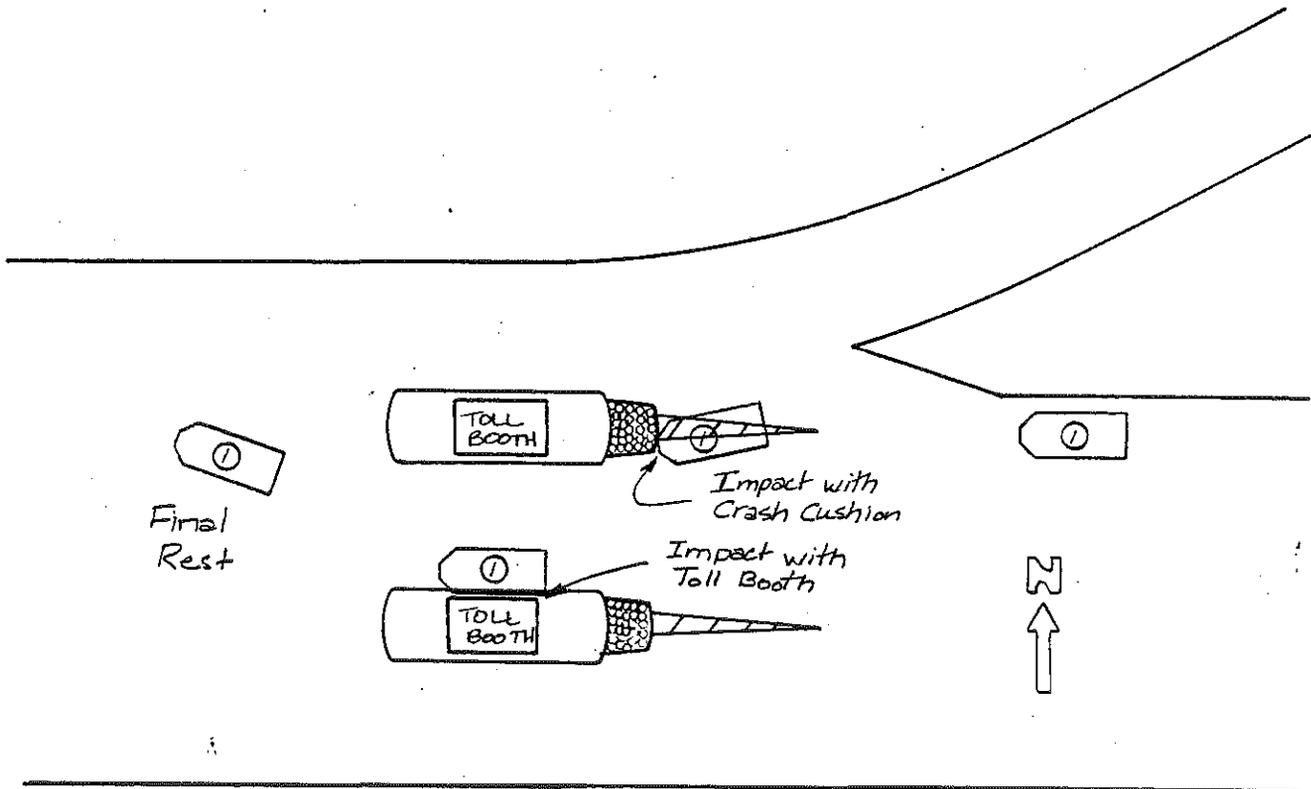
COMMENTS: The driver of a 1979 Chevrolet pickup stated that he lost consciousness as he approached the toll plaza. The vehicle first impacted the crash cushion head-on, then bounced left and continued through the toll booth with the front end. The car then travelled 96 feet before coming to rest. It appears that the driver was approaching in an intoxicated state at high speed; he received incapacitating head injuries. Disabling damage was done to the front of the vehicle. The driver was not wearing a safety belt.

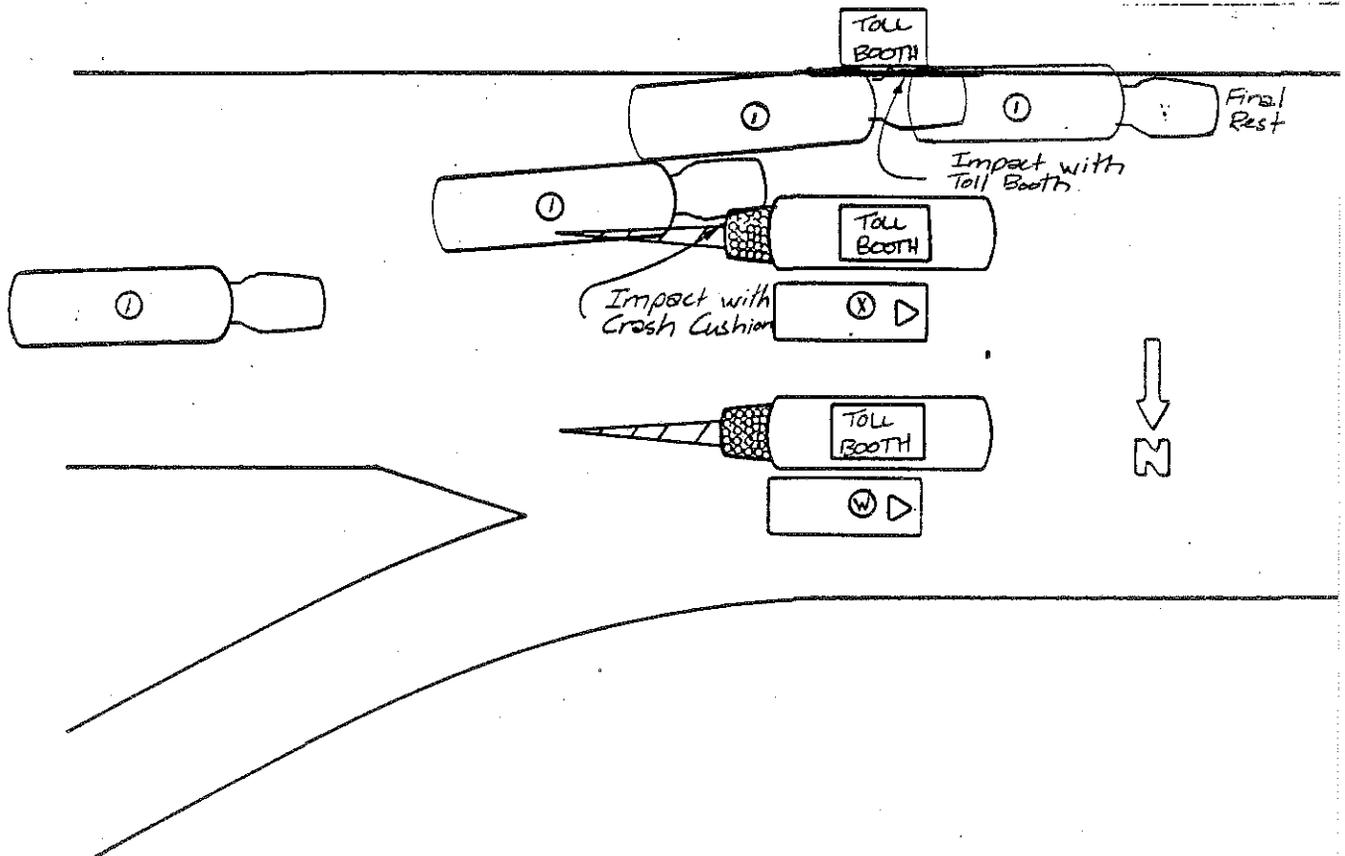
COMMENTS: A 1969 White tractor and semi-trailer was approaching a toll plaza when its brakes failed. The driver swerved to avoid a vehicle at the toll gate and impacted a crash cushion in front of a toll booth before continuing on into another toll booth. Damage to the truck was functional. The driver was not injured and he was not wearing a safety belt.

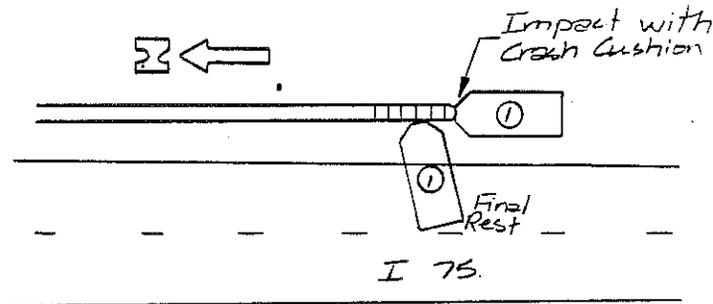
COMMENTS: A 1969 Plymouth 4-door sedan apparently ran off the right side of the road and hit the temporary crash cushion head-on. It then rotated about 90 degrees clockwise and stopped with the rear of the car sticking out into the near lane. The driver suffered incapacitating chest injuries. The car received disabling front-end damage. No safety belt was worn by the driver.

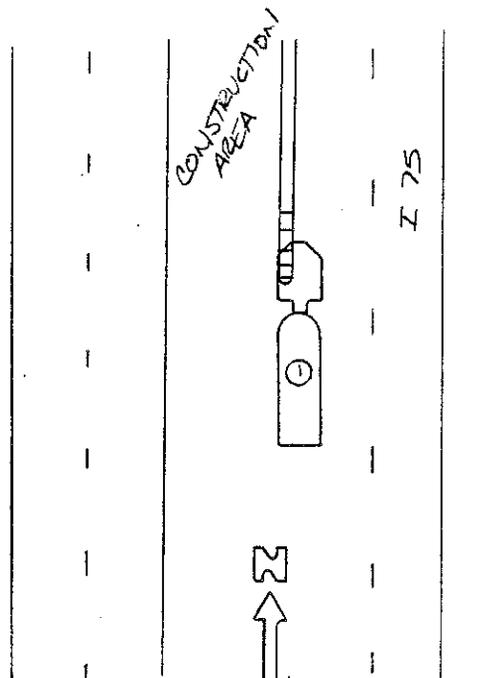
COMMENTS: The driver of a 1978 Kenworth tractor and semi-trailer swerved to the left from the left-hand lane in order to avoid a collision with another vehicle and struck the temporary crash cushion at the concrete barrier head-on. The driver received non-incapacitating leg injuries, while his passenger received non-incapacitating chest injuries. The extent of damage to the truck is indeterminate from the accident report but can be assumed to be moderate to heavy since the truck was towed from the scene. The occupants were not wearing safety belts.

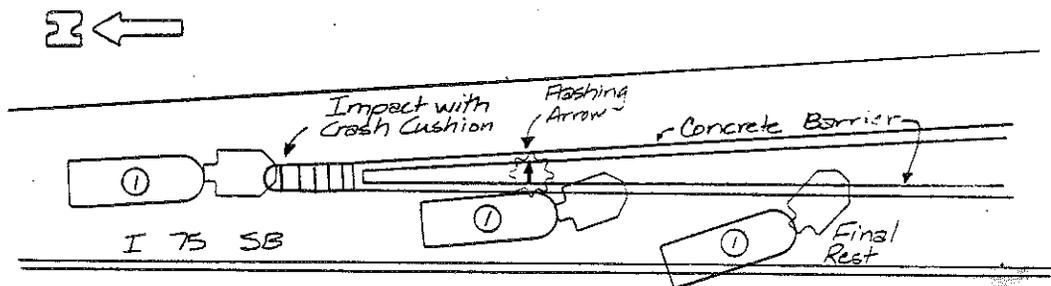
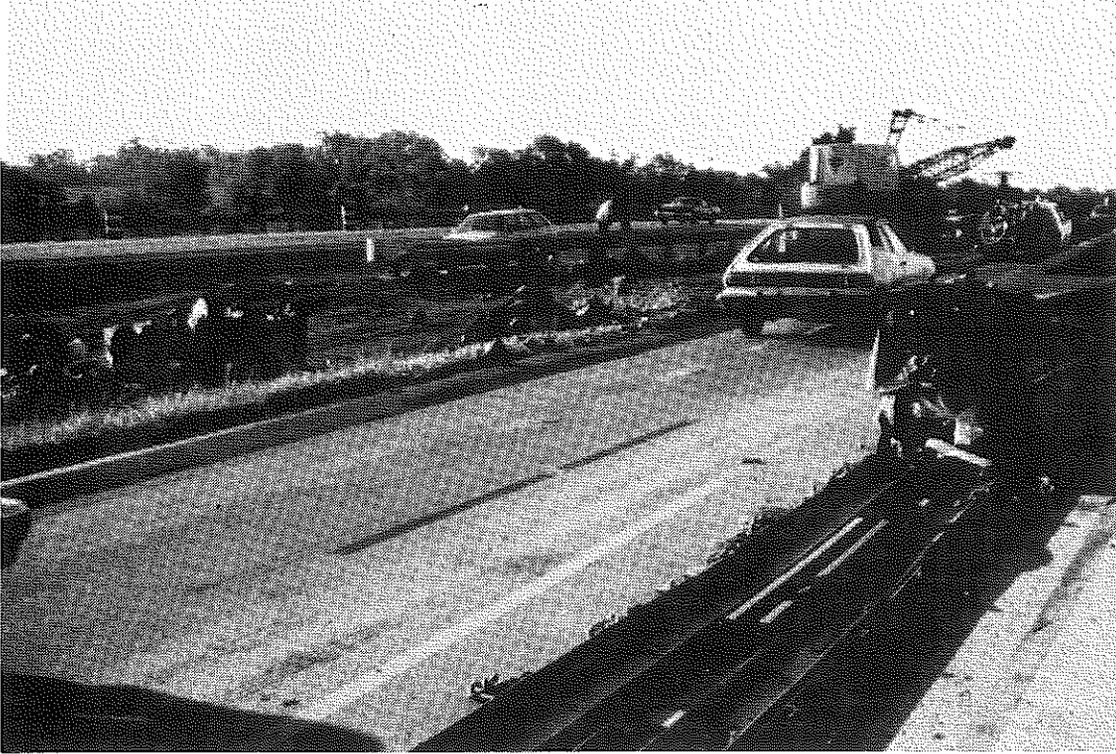
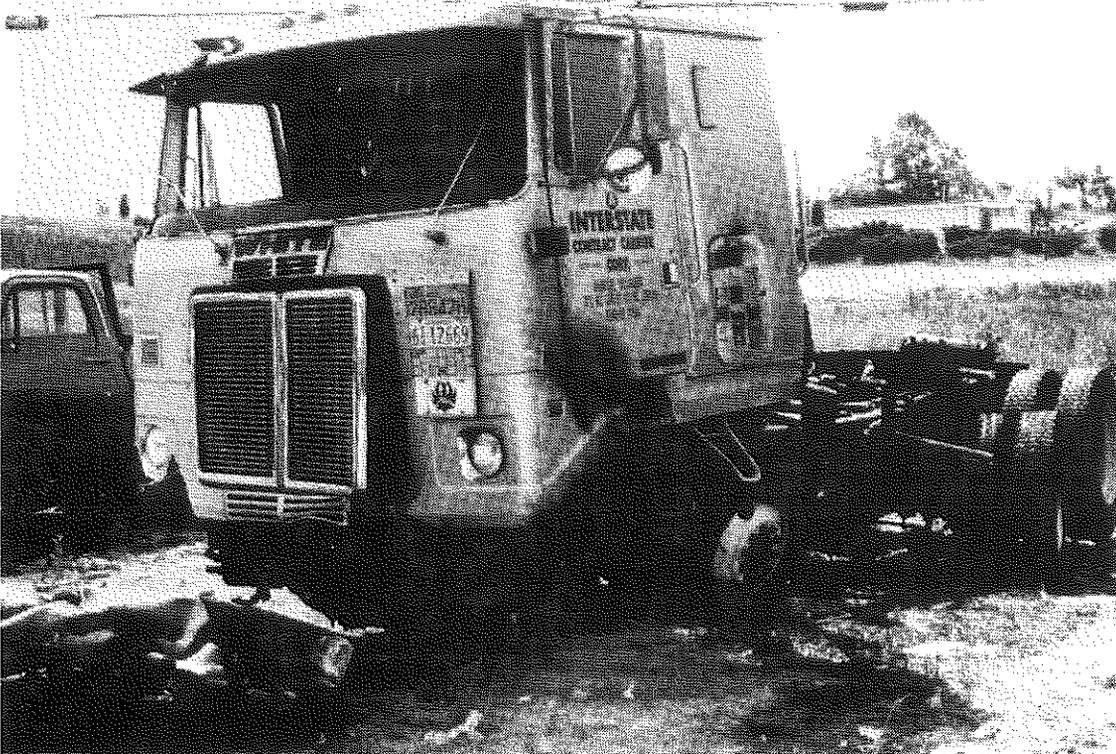
Figure C15. Accident Number 125, Scott County, I 75, MP 128.3

COMMENTS: The driver of a 1983 White tractor and semi-trailer apparently fell asleep as he approached the construction site and struck the crash cushion head-on. The vehicle then rode on top of the temporary concrete median barrier behind the crash cushion a distance of 138 feet, where it contacted a flashing arrow located between the double barrier walls. It then travelled another 47 feet before coming to rest. The vehicle was disabled and extensive damage was done to the crash cushion. The driver, who was not wearing a safety belt, suffered possible injuries.

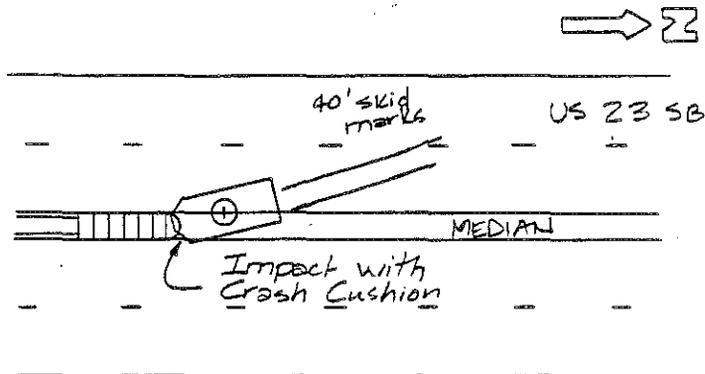
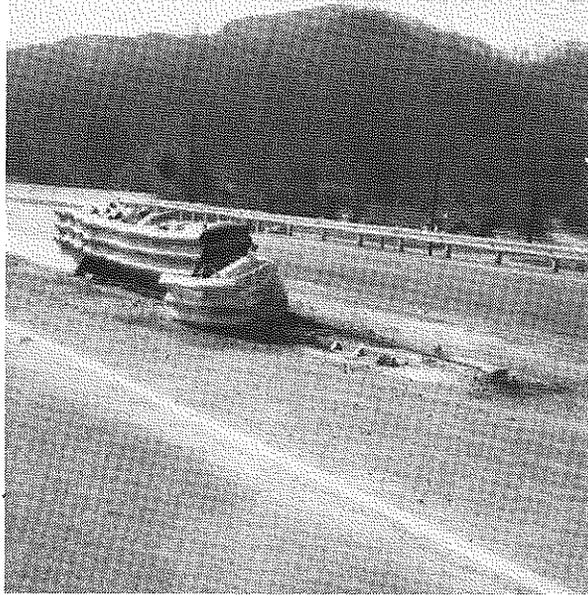
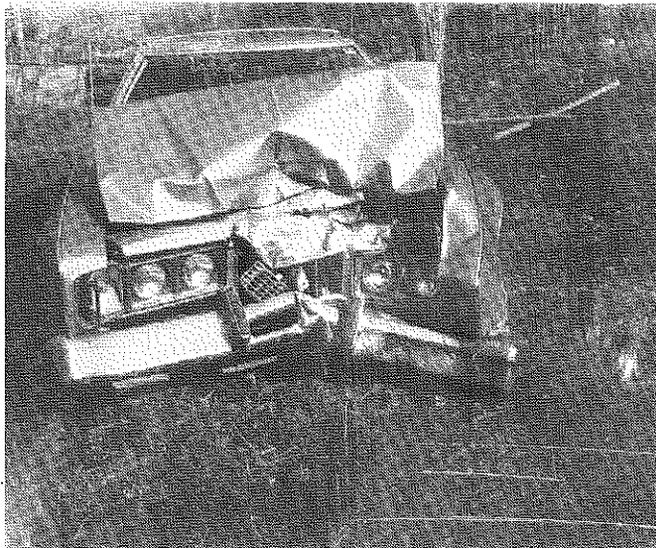
Figure C16. Accident Number 127, Pike County, US 23
at New Bole's Addition Overpass

COMMENTS: The driver of a 1976 Mercury Montego stated that he was travelling at a high rate of speed when he saw a police car turn on its blue lights. As he glanced into the rear view mirror, the car swerved into the median. The driver braked, leaving 40 feet of skid marks, and slid into the crash cushion terminating a concrete median barrier. The front end of the car was damaged heavily. The driver was not injured; he was not wearing a safety belt.
