Research Report
UKTRP-83-14

GEOTECHNICAL, HYDROLOGIC, AND HYDRAULIC
INVESTIGATION OF MILL CREEK DAM -- PHASE II

July 1983

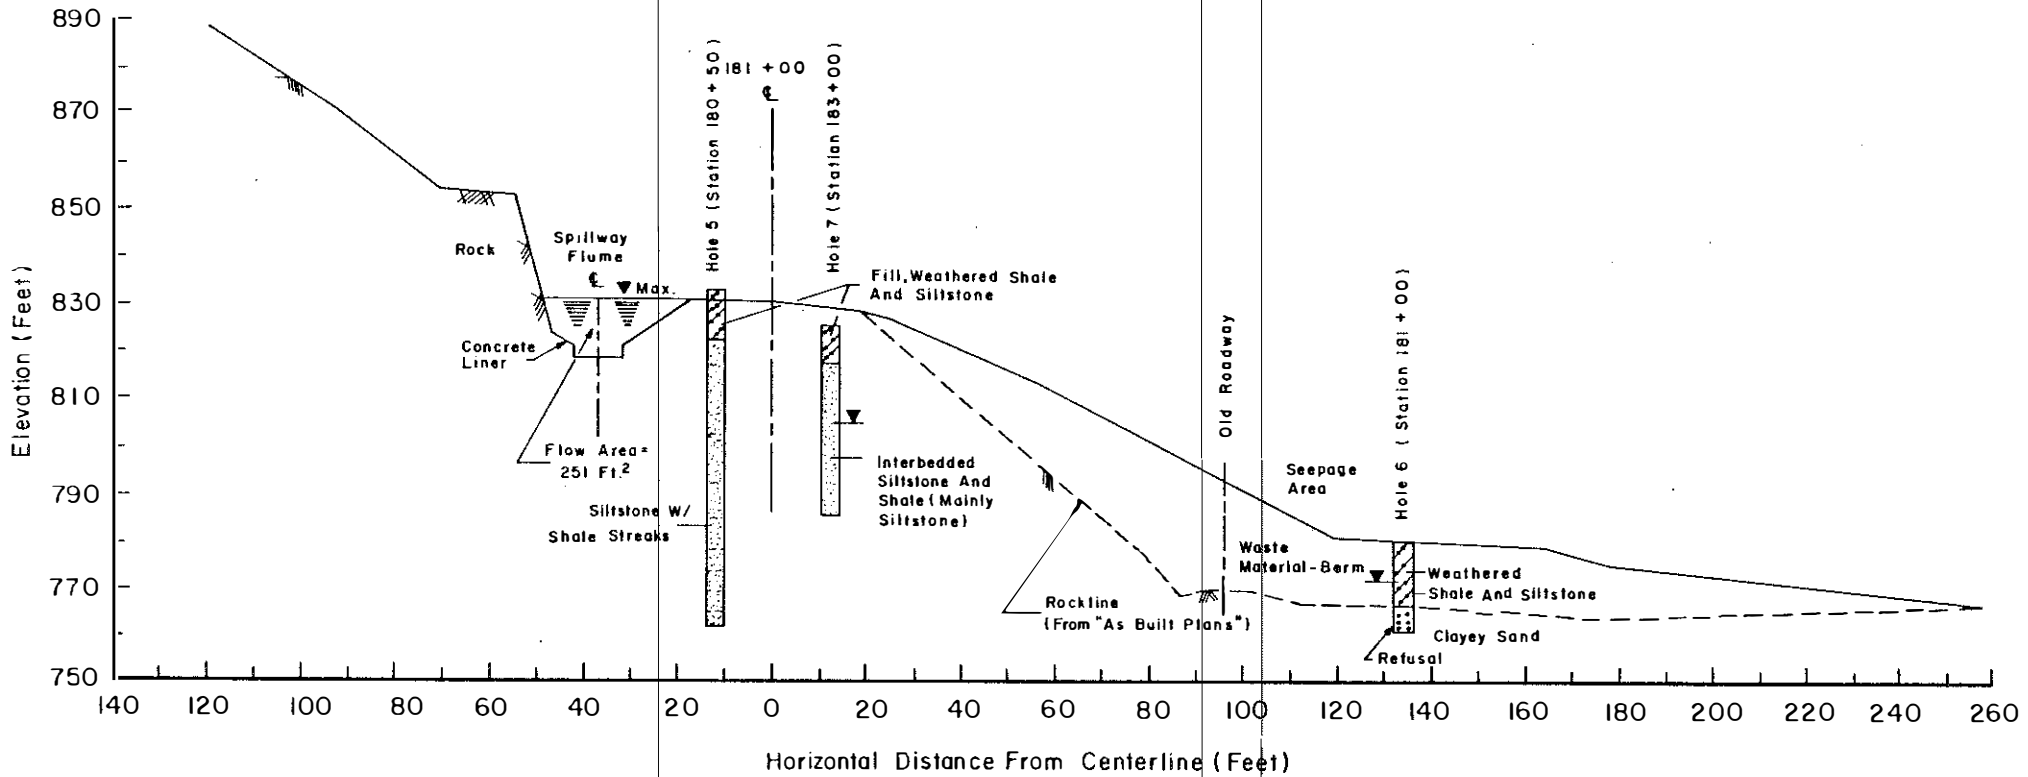
Figure 8. Typical Cross Section of the Service Spillway Flume at Station 181+00.

A typical cross section of the spillway flume at Station 181+00 is shown in Figure 8. Depth of the flume is about 12 feet. Width of the spillway ranges from 32 feet at the top to 10 feet at the bottom. Approximate area of the spillway is 230 square feet. The area of the box culvert opening is 96 square feet (12 feet x 8 feet).

respectively. The location of the phreatic line, based on groundwater elevations in Holes 2, 3, and 4, is shown in Figure 6, a typical cross section of the dam at Station 178+00. A sketch of the phreatic surface along centerline axis of the dam is shown in Figure 7. Groundwater elevations at Station 181+00 (sidehill portion of the embankment) are shown in Figure 8.

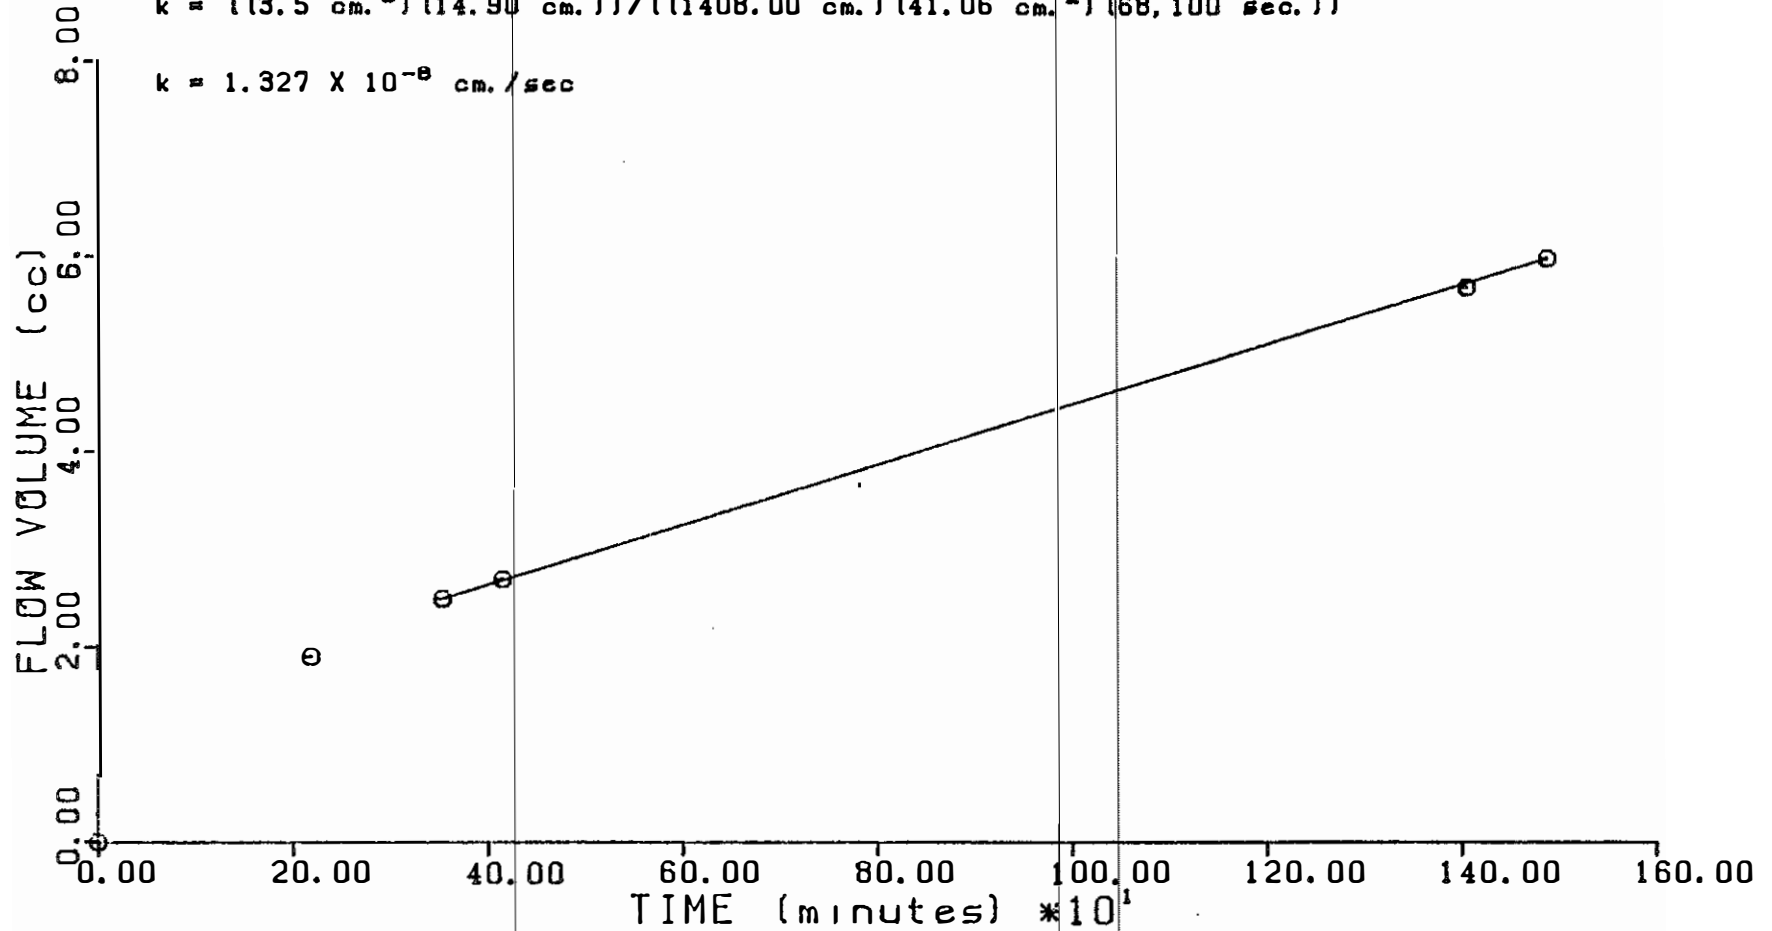
Figure 14. Volume Flow-Time Curve (Hole 2A, Specimen S-1B).

The coefficient of permeability, measured in a vertical direction, of soils in the shell zone based on one test (Specimen S-1B from Hole 2A) was 1.33×10^{-8} centimeter per second (Figure 14).

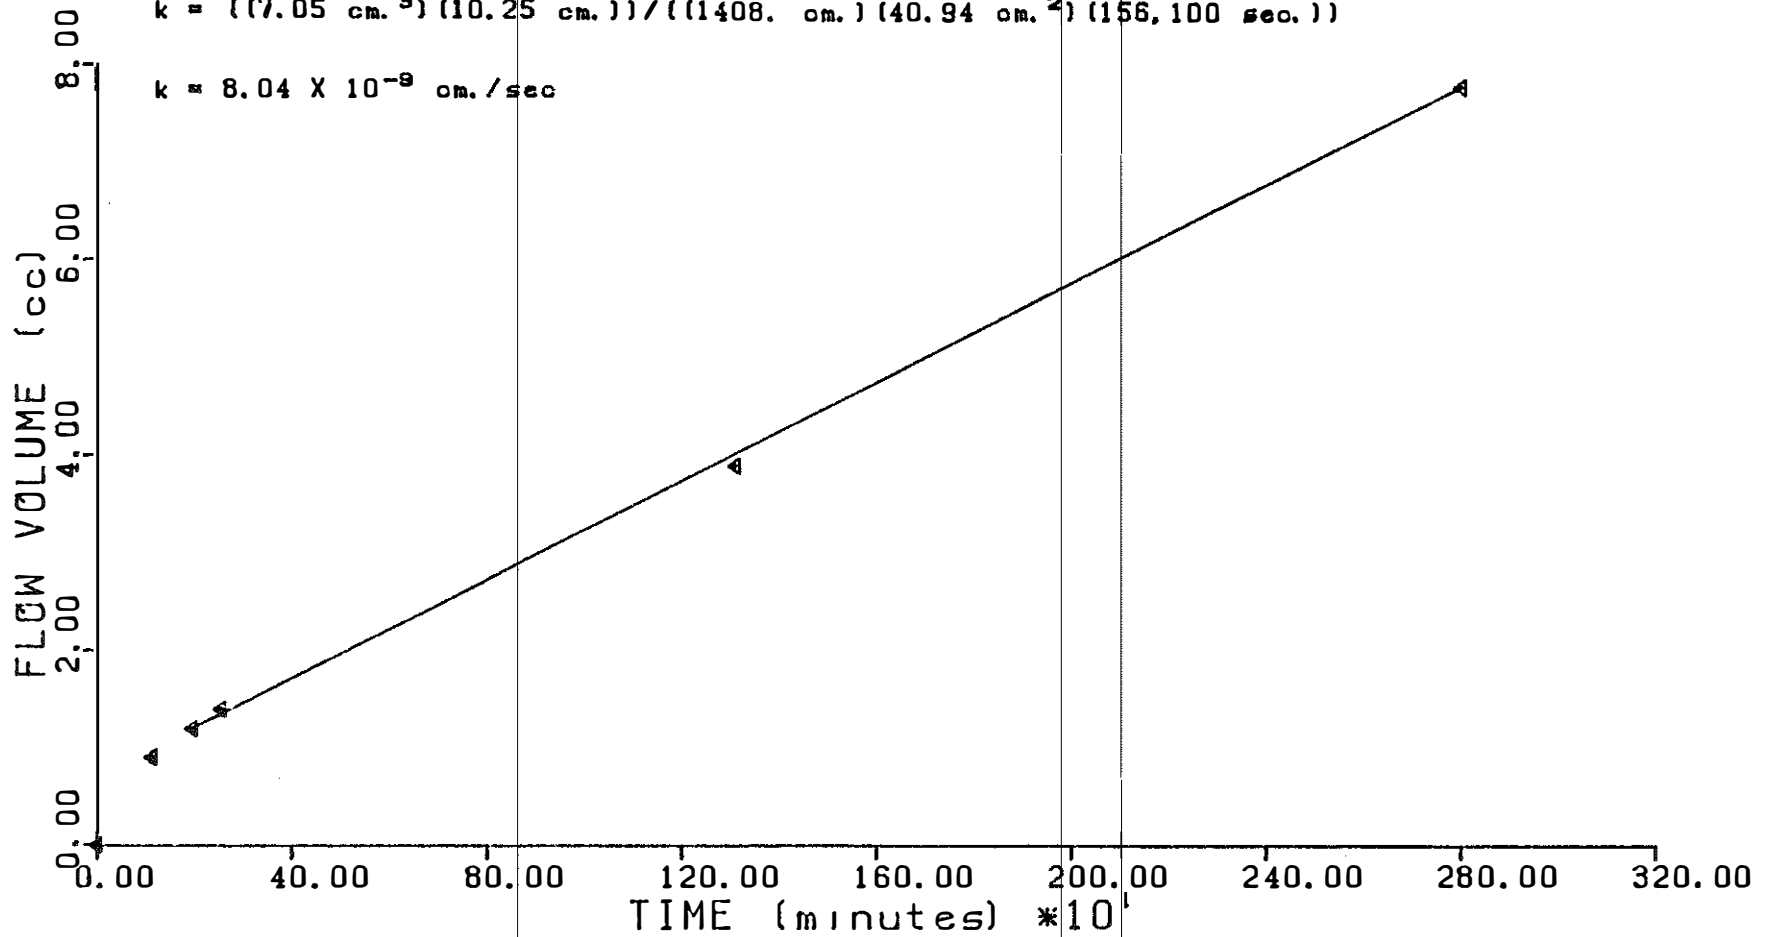
Figure 15. Volume Flow-Time Curve (Hole 2, Specimen S-3A).

The coefficient of permeability or hydraulic conductivity of the clay core, Figure 15, based on one test (Specimen S-3A from Hole 2) and measured in a vertical direction was 8.04×10^{-9} centimeter per second. Effective stress angle of internal friction and effective cohesion of the soils in the clay core zone were 25.9 degrees and 305 pounds per square foot.

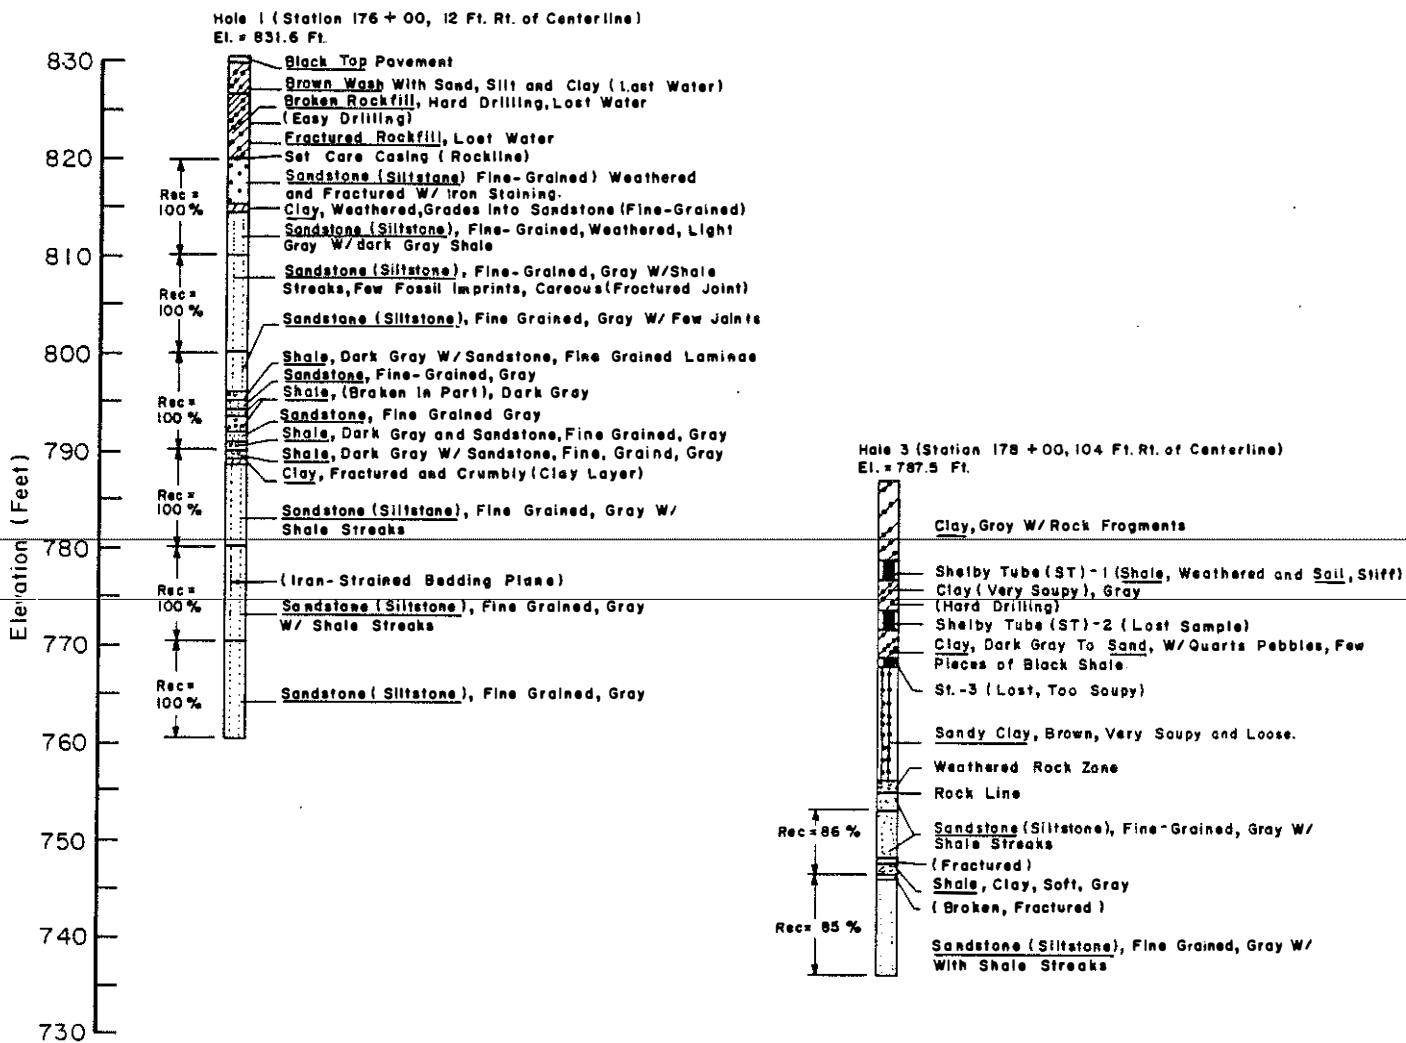
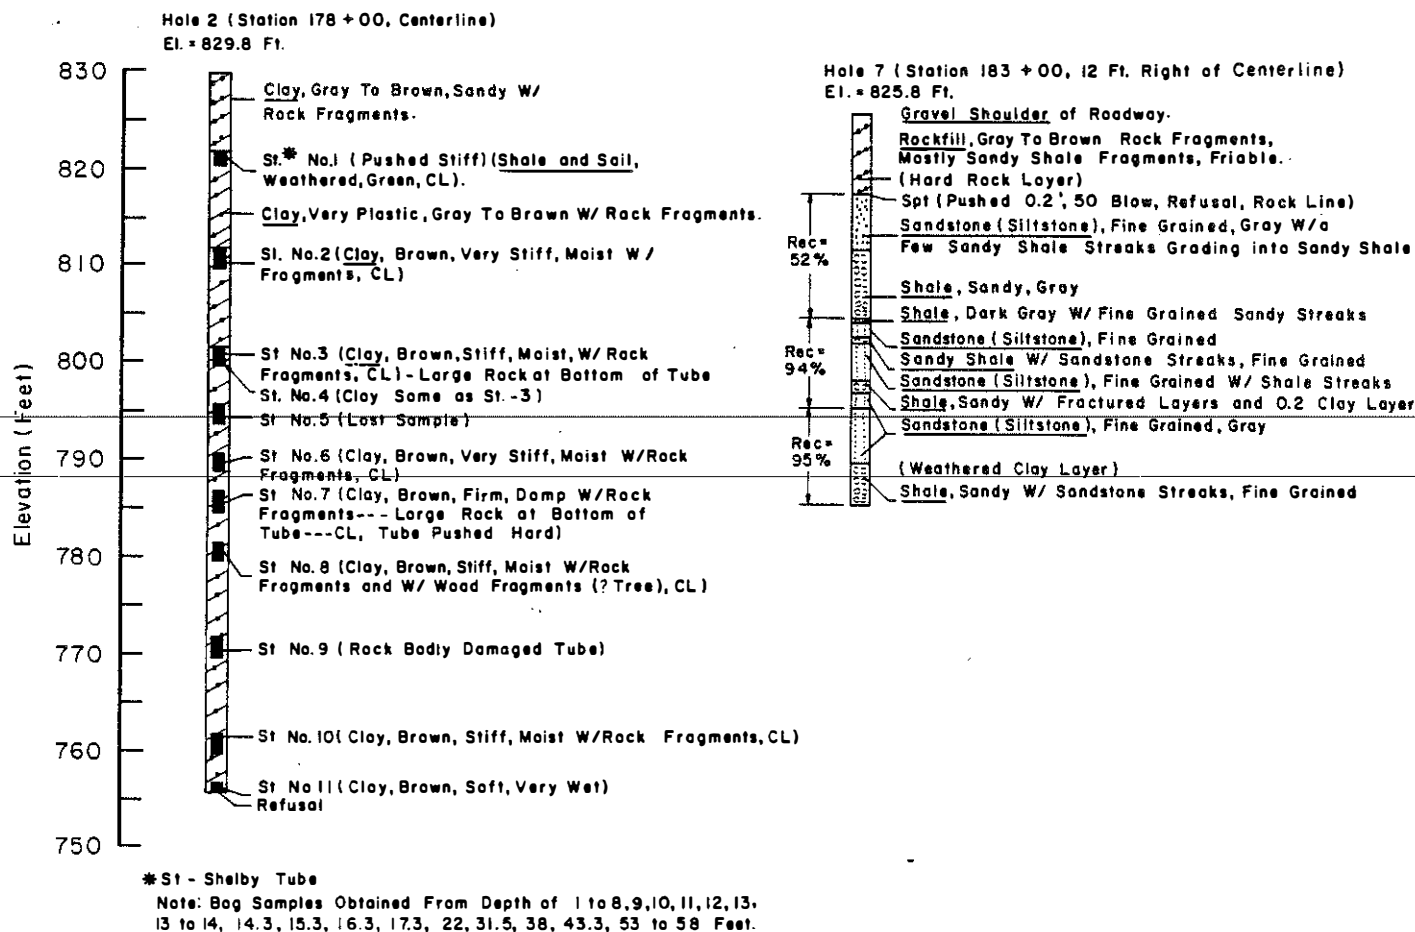
Materials in the rock abutments and foundation rock strata consisted mainly of siltstone, or very fine-grained sandstone, as shown in Figures 5, 6, A.1, and A.2. The siltstones contained shale streaks interbedded throughout the rock abutments and foundation. Based on detailed coring logs in APPENDIX A, the rock abutments and foundation appeared to be tight with regard to seepage; that is, they were relatively free of joints, cracks, or crevices. Estimated coefficient of permeability of the siltstones is low, perhaps on the order of 1×10^{-6} centimeter per second.

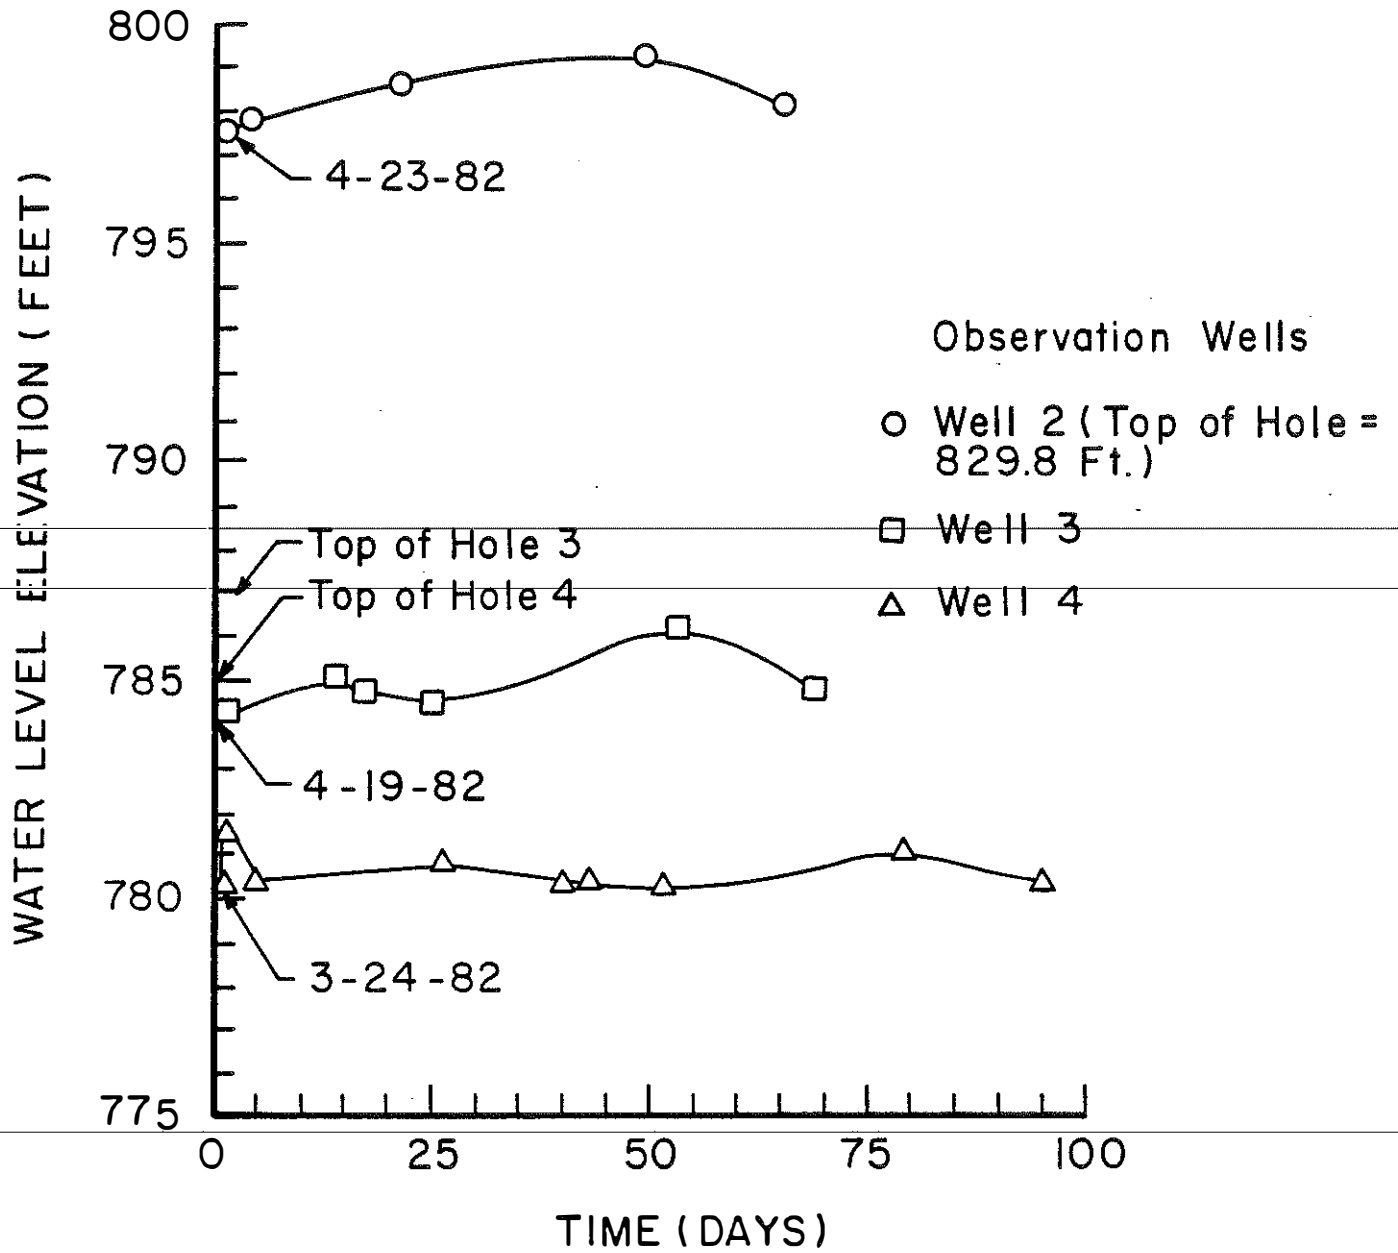
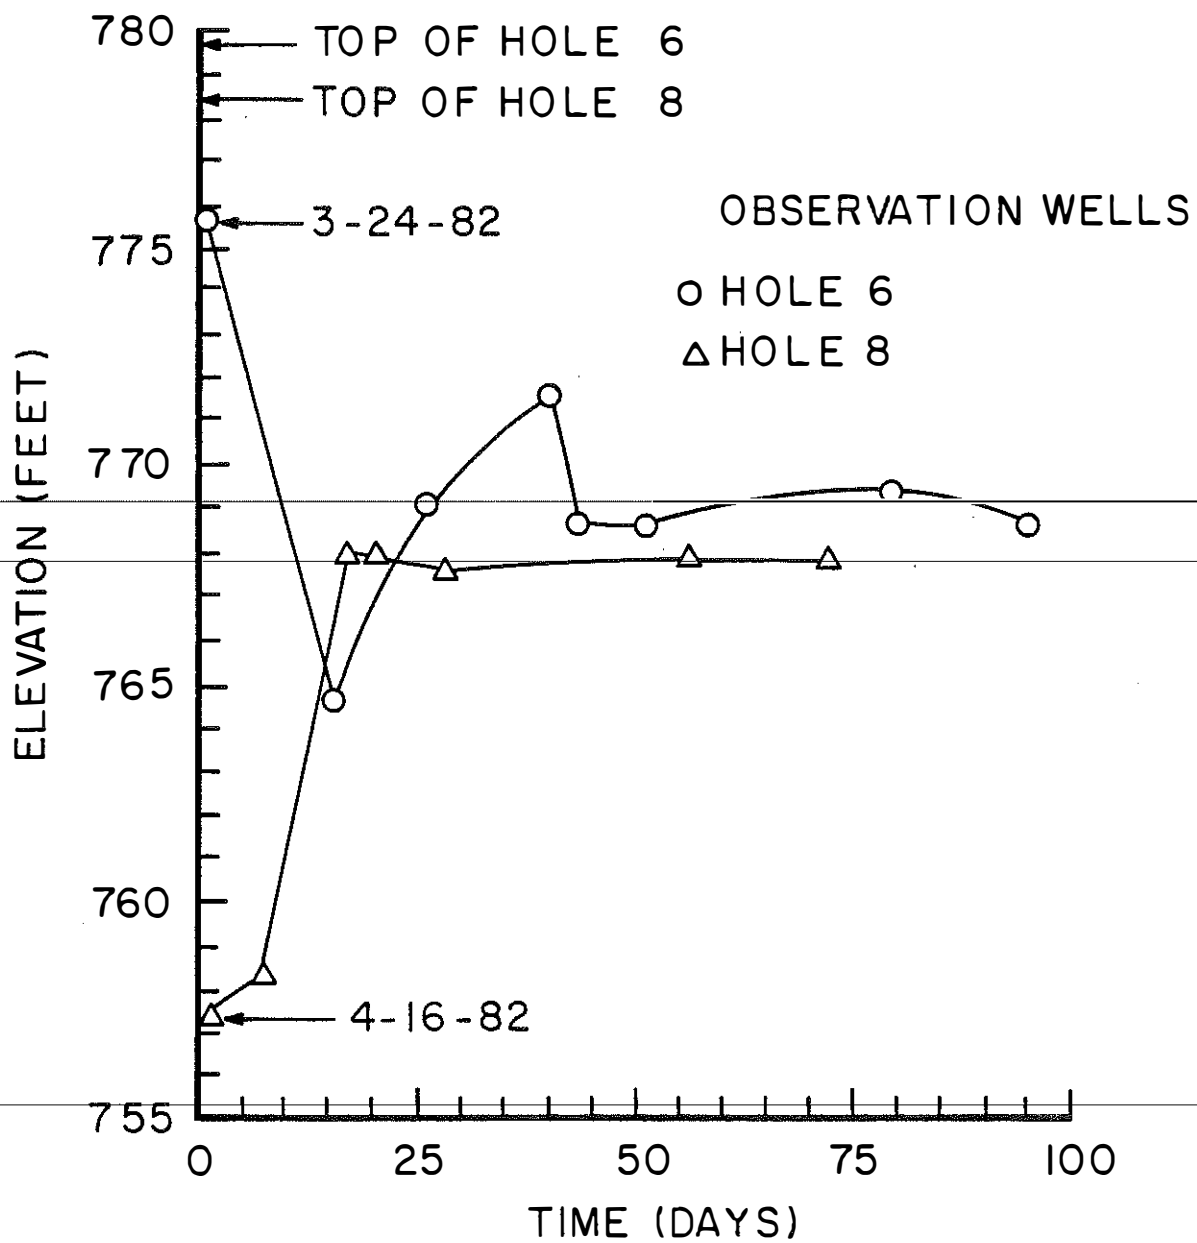
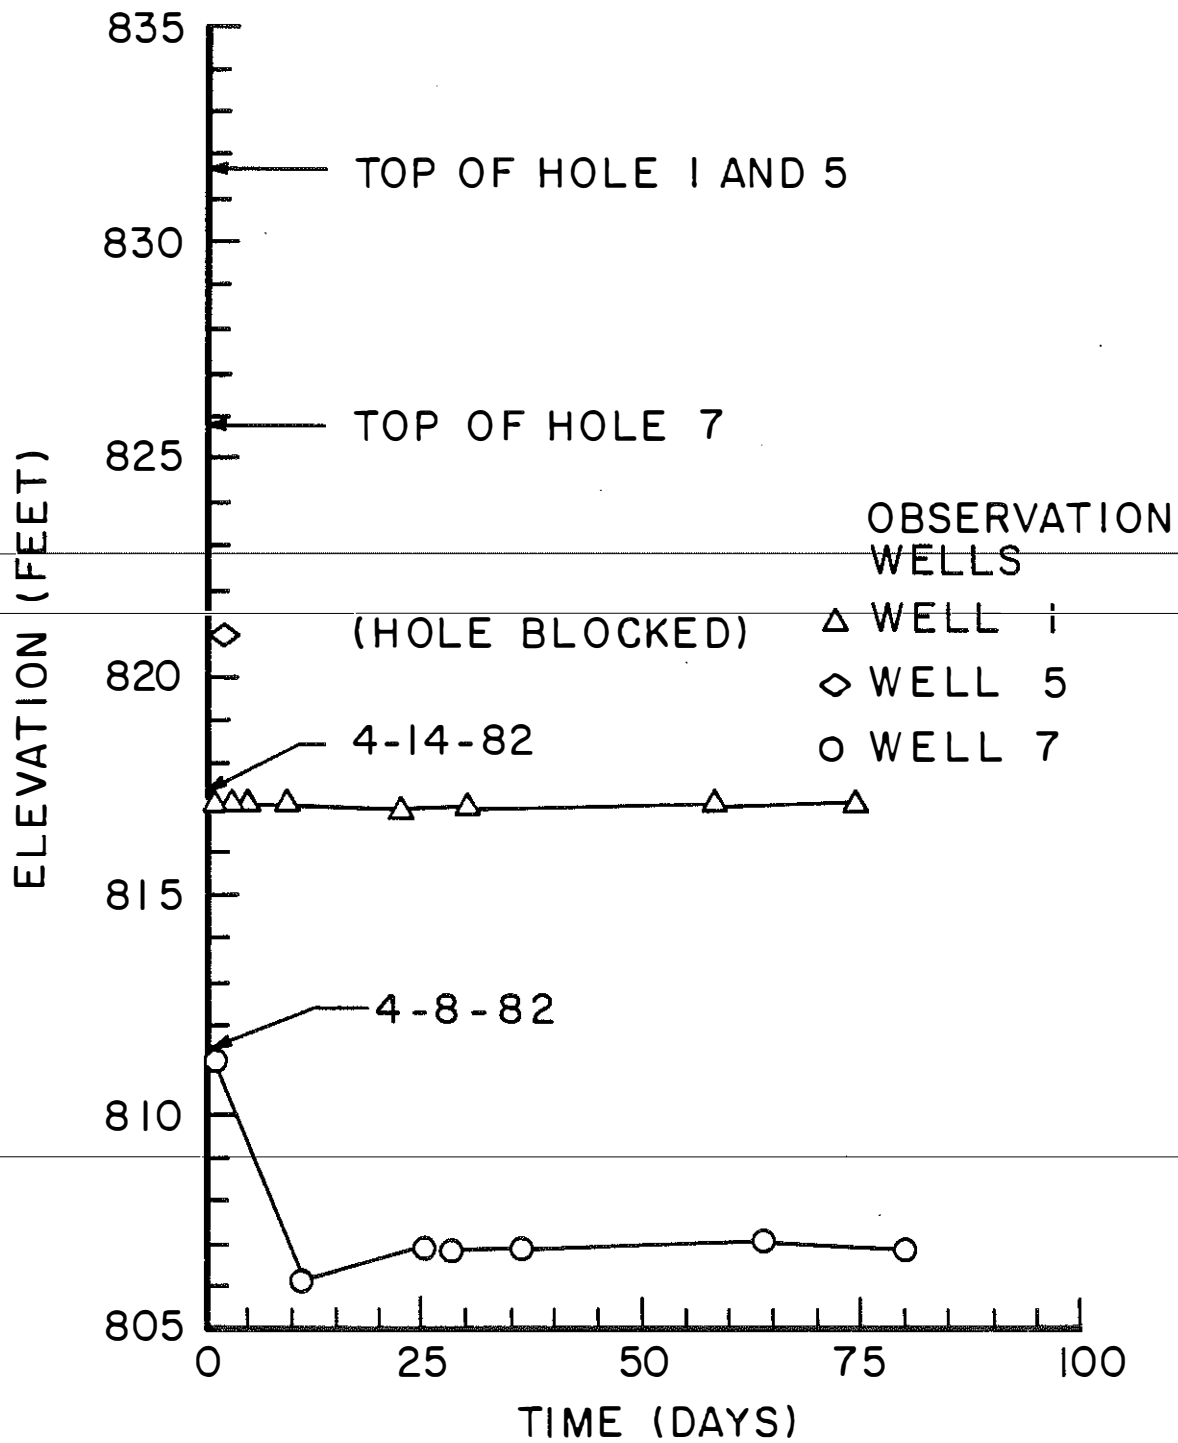
Groundwater elevations observed in cased bore holes are presented in APPENDIX B. Groundwater elevation-time curves for Bore holes 2, 3, and 4; 6 and 8; and 1, 5, and 7 are shown in Figures B.1, B.2, and B.3,
