Research Report
UKTRP-81-6

Ohio River Suspension Bridges: An Inspection Report

Theodore Hopwood II
Research Engineer Principal

June 1981

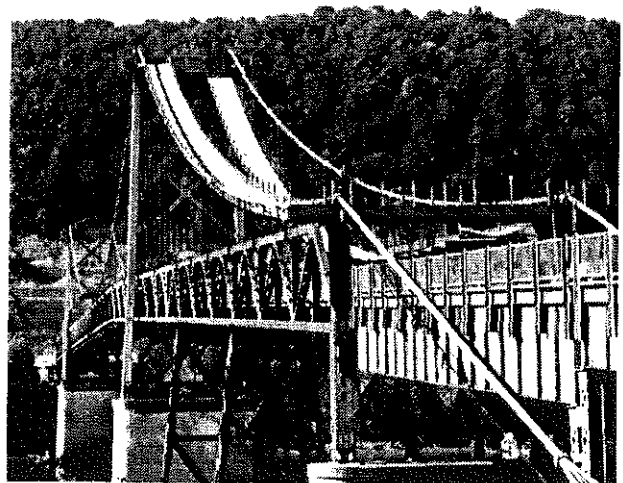
From May 9, 1979, to completion in December 1979, Research Program personnel monitored recabling of the Portsmouth Bridge (Figure 1). The work was performed by the American Bridge Division of U.S. Steel Corporation. Modjeski and Masters were the consultants, and M. Baum was the resident engineer for the Ohio Department of Transportation.

Figure 1. The Portsmouth Bridge early in the recabling operation.

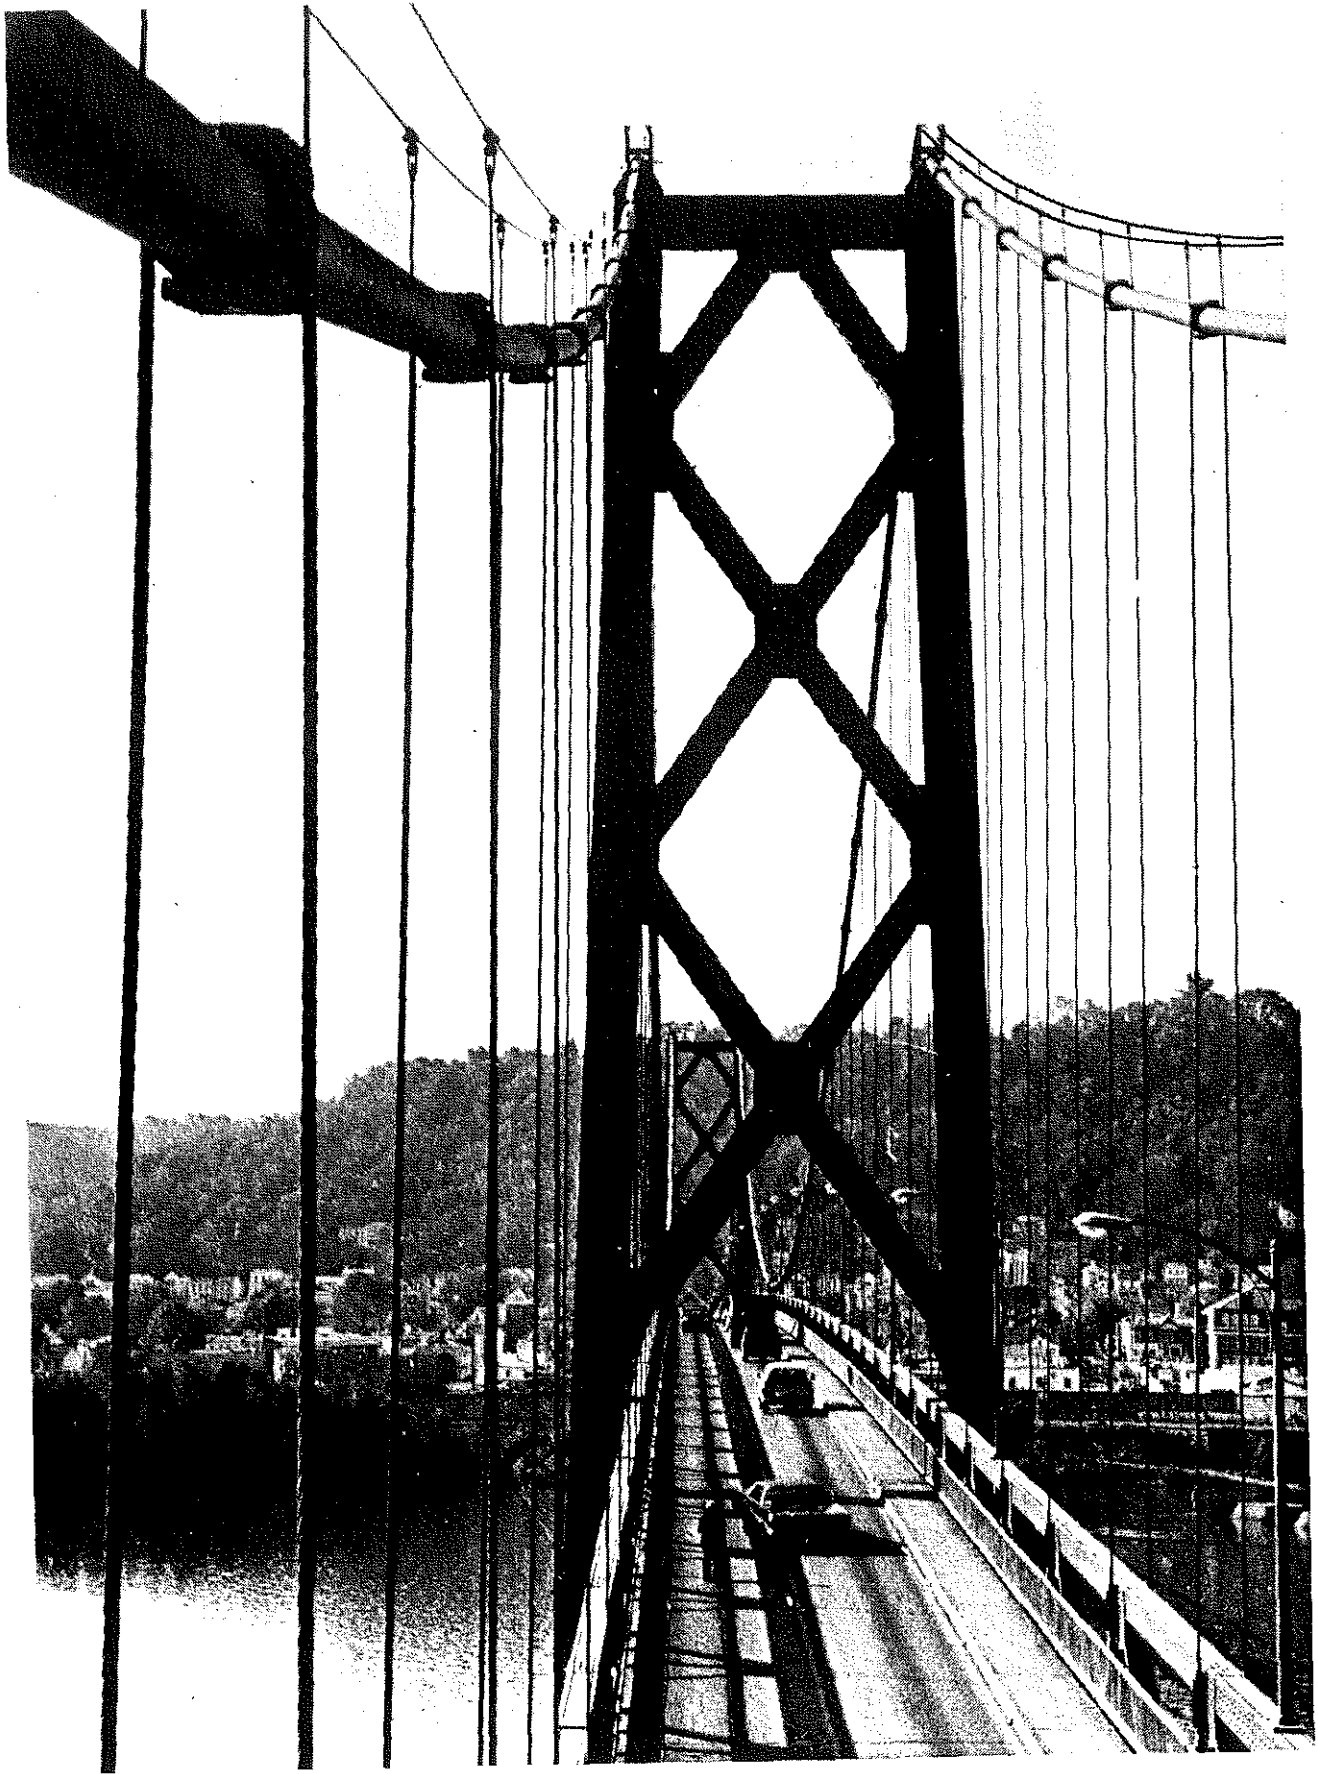
Inspection of the Maysville Bridge (Figure 6) began in June 1979. The bridge had been in continuous service for 49 years. It had no known history of corrosion problems. The first three inspections (June-August 1979) consisted of external observation of the wrapped cables and the splayed structural strands inside the bridge anchorages.

Figure 6. The Maysville Bridge.

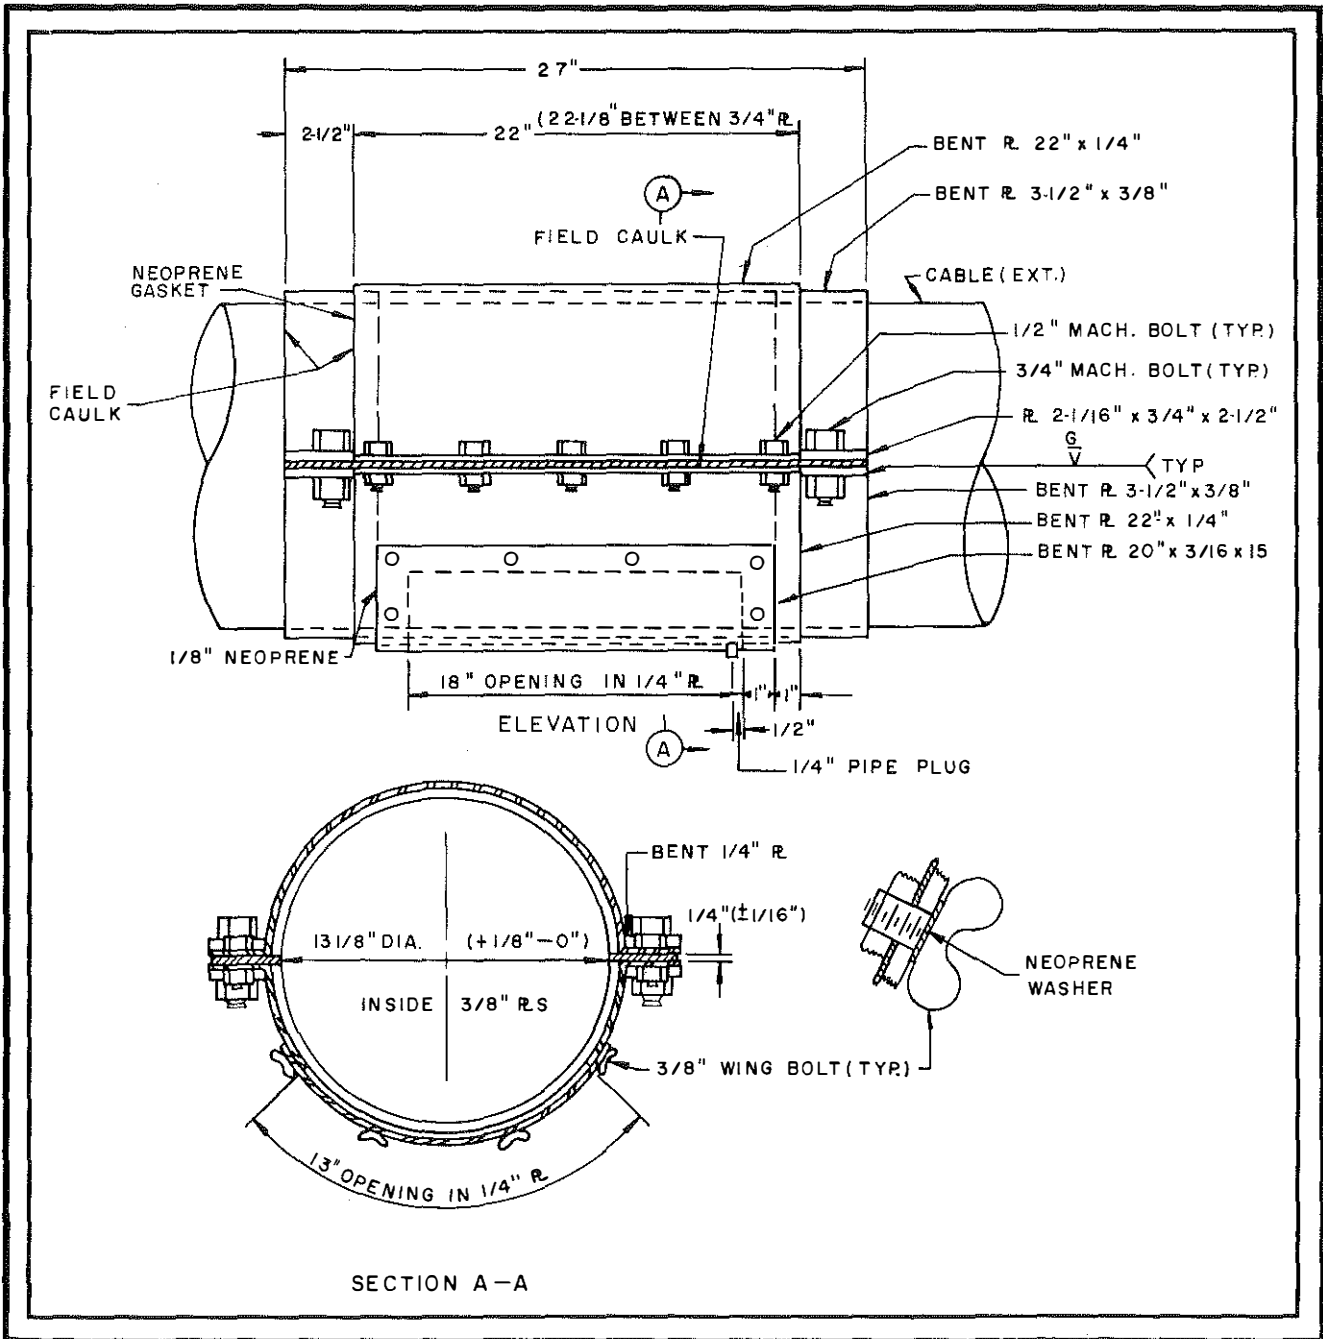
During the third week of August 1979, bridge maintenance personnel installed seven inspection ports on the Maysville Bridge (Figures 11 and 12). Those were located at Panels 0-1, 7-9, 59-61, and 69-69 on the Ohio span and the main span (Figure 13). The ports were

Figure 11. Cable inspection port used on the Maysville Bridge.

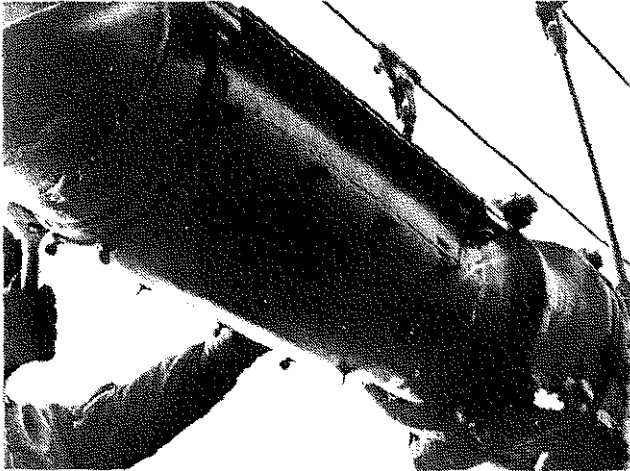
Figure 12. Installation of an inspection port on the Maysville Bridge.

installed near bands having pop-outs and on panels where the cable paint had deteriorated.

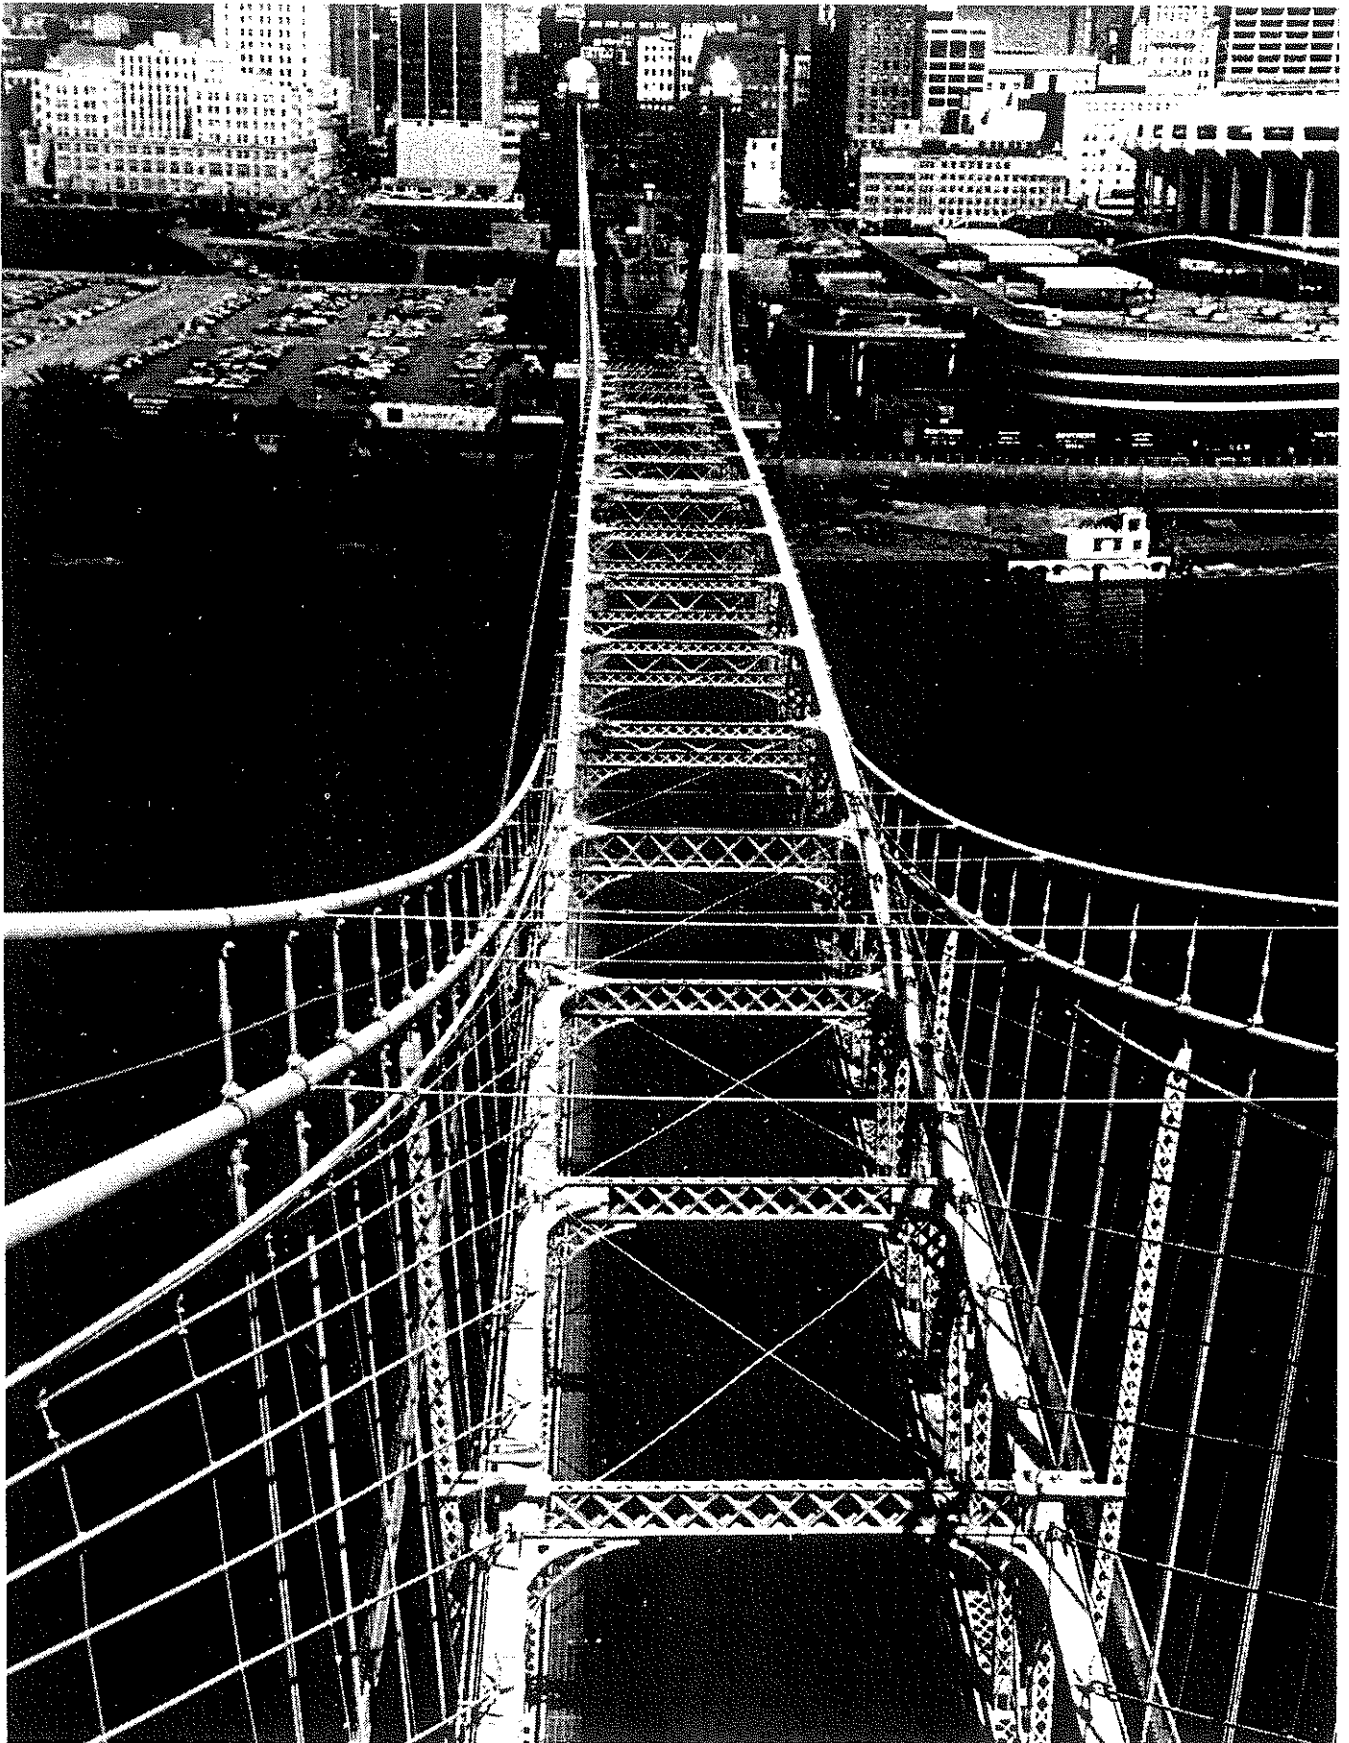
Inspections were made of the Ohio River Suspension Bridge at Covington in June and September of 1979 (Figure 15). The scope of work was similar to the examination of the Maysville Bridge; however, inspection ports were not installed into any of the cables.

Figure 15. The Covington Bridge.
