Research Report UKTRP-84-16

ANALYSIS OF ACCIDENTS INVOLVING
BREAKAWAY-CABLE-TERMINAL END TREATMENTS

Kentucky Transportation Research Program
College of Engineering
University of Kentucky
Lexington, Kentucky

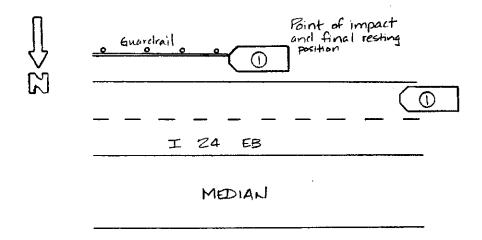
The vehicle, a 1979 2-door Ford sedan, struck the guardrail end head-on and stopped. The vehicle remained in service, so it can be assumed that damage to the vehicle was minor. The driver was not wearing a safety belt and received a non-incapacitating injury to the head. Damage to the end treatment was unknown.

It is assumed that the speed of the vehicle just prior to impact was low, since the injury to the driver was not serious and the auto remained in service.

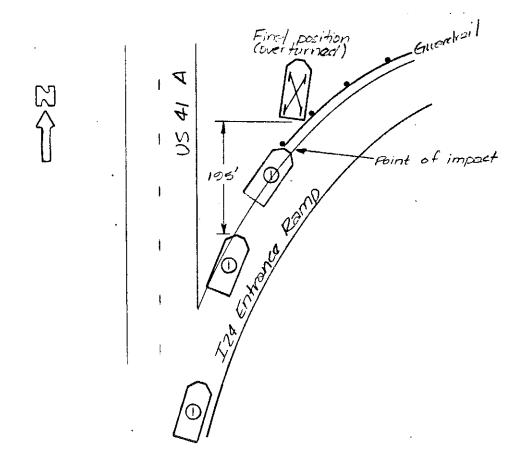
The vehicle, a 1978 GMC pickup truck, overturned after striking the end treatment head-on. All four occupants suffered incapacitating, multiple injuries. None were wearing safety belts. The police report indicates that the guardrail end was impacted at a high rate of speed. Alcohol involvement was listed as a contributing factor.

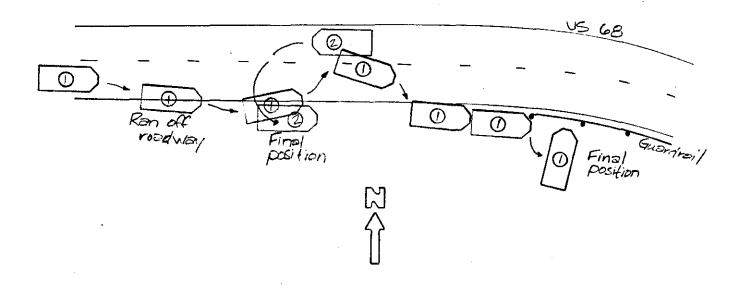
A 1976 Pontiac 2-door sedan struck a guardrail end after losing control and striking another vehicle. The car struck the guardrail at the end from a slight angle. It then spun 90 degrees counterclockwise behind the guardrail and came to rest. The car struck the guardrail end with the left front and left rear fenders. The driver, who was not wearing a safety belt, sustained a possible back injury. The car received disabling damage.

It is impossible to determine from the police diagram whether the vehicle broke through the end treatment or rotated around it. However, the repair form stated that the end treatment was replaced entirely, including concrete footings, which indicates that the posts did break.

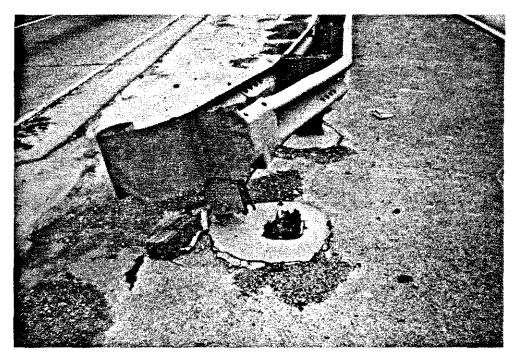
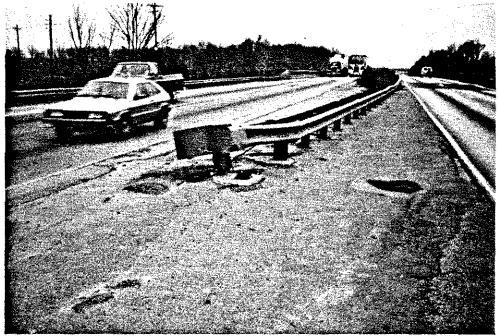
Figure B3. Accident Number 014, Bullitt County, I 65.

COMMENTS: No accident report was found. An unknown vehicle

impacted this Type 6 end treatment at a shallow angle, breaking the first post. Vehicular action after impact is

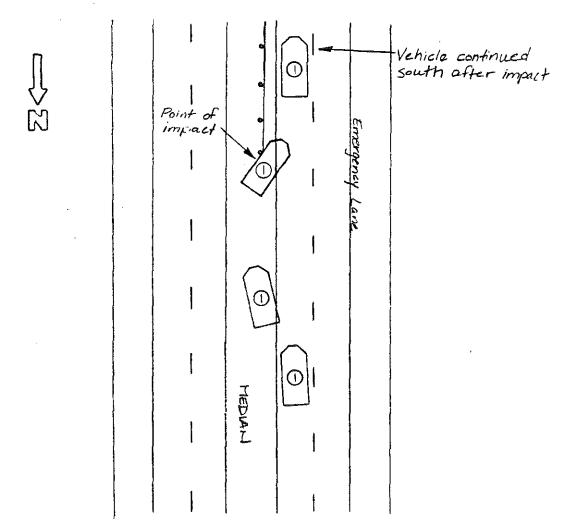
A 1977 Pontiac Grand Prix struck a guardrail end on the shoulder of the median. The vehicle had run off into the median when the driver fell asleep and was recovering back onto the roadway when it struck the end treatment with the driver's-side door. The driver, who was not wearing a safety belt, sustained a possible head injury. After impact, the vehicle was driven to the next interstate service area.

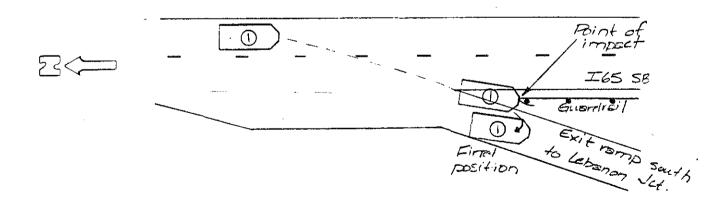
The vehicle, a 1962 2-door Volvo, struck a guardrail at a gore area head-on, bent the end treatment back (breaking both wooden posts), and stopped. The vehicle was heavily damaged in the front end, completely disabling it. The driver, who was not wearing a safety belt, sustained an incapacitating head injury.

The police report suggests that the Volvo struck the guardrail end almost straight-on, destroying 20 feet of rail and posts. There was damage to the end treatment past the wooden posts. It appears that the guardrail end did not penetrate the front end of the vehicle but was bent back as the Volvo slid off to the right after impact.

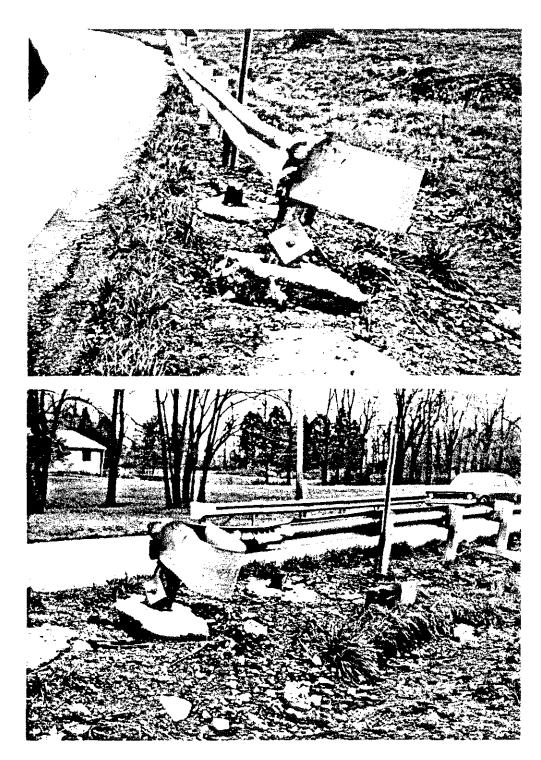
Figure B8. Accident Number 024, Jefferson County, US 31E, MP 1.9.

Photos show that both wooden posts were completely broken off at ground level. It also appears that one or two of the steel posts were either broken or knocked over. The angle of impact appears to be shallow, with extensive damage to the guardrail. The extent of vehicle occupant injury and vehicle damage are unknown. However, damage to the guardrail indicates a severe

impact.

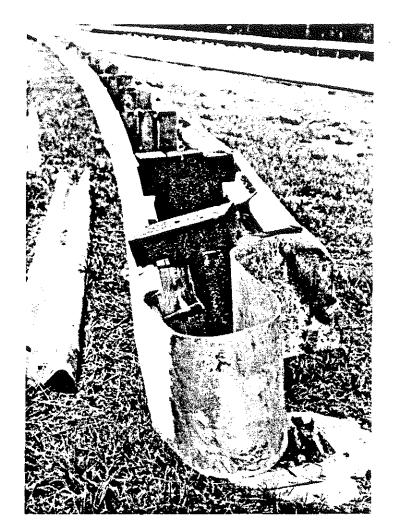
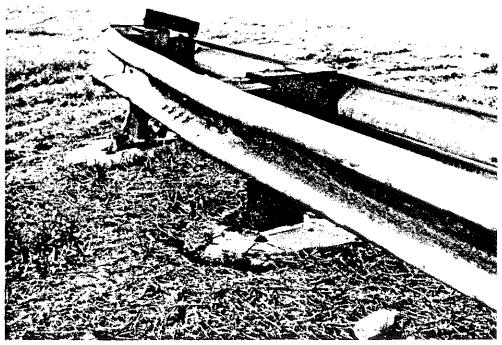
Figure B10. Accident Number 026, Shelby County, I 64, MP 29.

COMMENTS: Only slight damage was done. The second wooden post was cracked and the concrete anchor moved. No accident report could be found. Initial site investigation revealed tire marks indicating that the vehicle had run off the road and was re-entering the roadway when it struck the end treatment. Rubber deposits along the guardrail suggest that the vehicle sideswiped the end treatment, probably contacting with rubber on the bumper or fender. The vehicle probably continued on

and no accident report was filed.

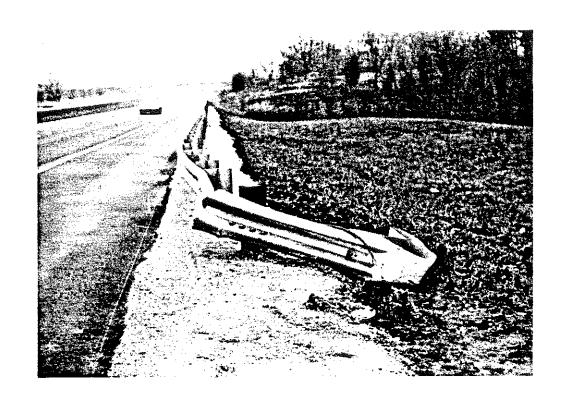
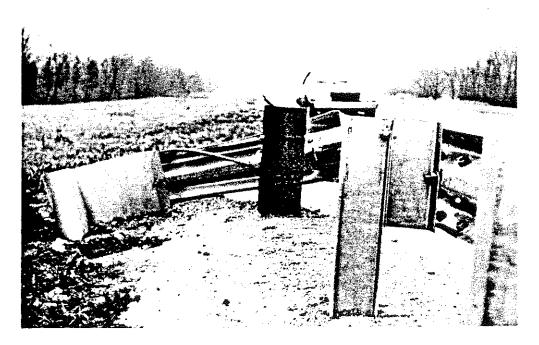
Figure B12. Accident Number 028, Shelby County, I 64, MP 33.980.

The vehicle, a 1982 4-door Chevrolet Caprice, left the roadway on the left-hand side of the exit ramp from I-75, impacted the guardrail end head-on and stopped. The first post was broken while the second was cracked but not broken. The car came to rest at the second post.

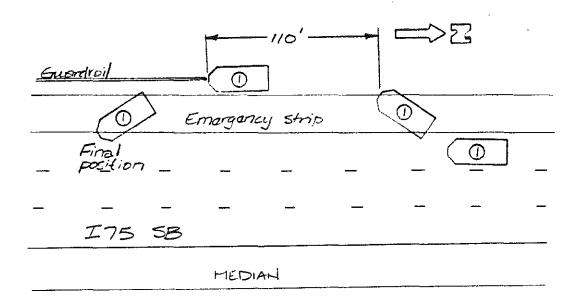
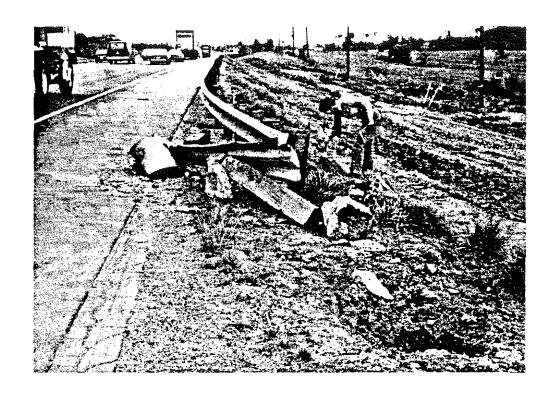
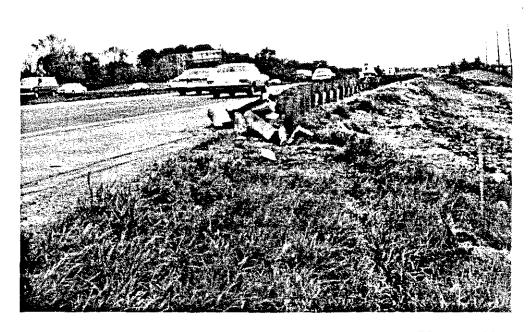
Figure B14. Accident Number 031, Boone County, I 75, MP 181.400.

The guardrail bent outward toward the roadway between the second wooden post and first steel post. The first wooden post was partially broken while the second wooden post did not break. The concrete footing failed.

Investigation of the site showed tire marks leading into the guardrail end from behind the guardrail, suggesting that the vehicle had run off the road and was in the process of recovering before the impact. This is supported as the photographs show the end bent back toward the roadway. The driver was injured slightly. He was not wearing a safety belt. The vehicle was a 1980 Chevrolet Monza.

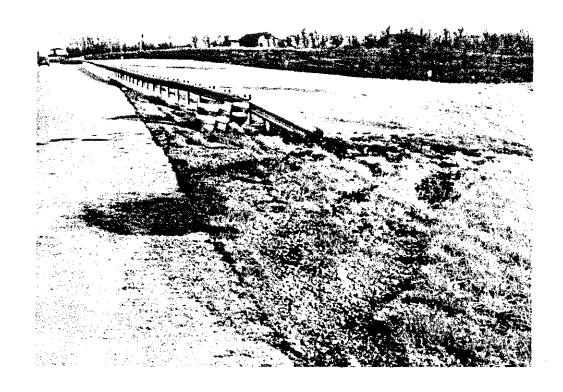
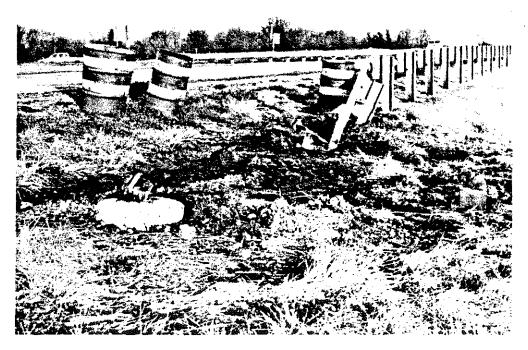
Figure B15. Accident Number 036, Boone County, I 275, MP 10.600.

The driver of a 1983 International tractor and semitrailer lost control of his truck on ice. The trailer jackknifed, causing the vehicle to leave the roadway on the right-hand side and strike the guardrail end with the trailer. The trailer then rode up onto the guardrail before the truck came to a halt. Both wooden posts were broken and the first two metal posts were bent substantially. About 30 feet of guardrail was damaged as the truck flattened the guardrail after breaking through the wooden posts. The truck was disabled. The driver suffered possible leg injuries. He was not wearing a safety belt.

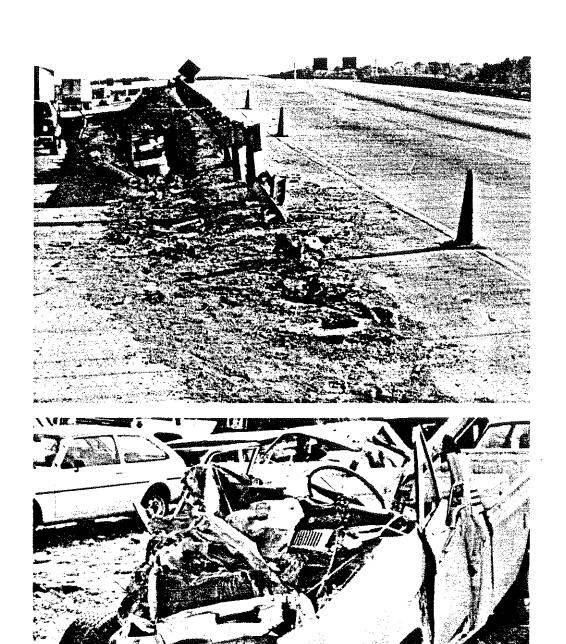
Figure B19. Accident Number 040, Kenton County, I 75, MP 184.5, I 275 WB Exit Ramp.

The guardrail penetrated the passenger compartment of this small pickup truck (a 1979 Chevrolet Luv) entering from the front windshield and extending through the rear window. It appears that the truck struck the end treatment head-on, with no inication of skid marks prior to impact. The wooden posts apparently broke away, but instead of being crushed by the front end of the truck, the guardrail end rode over the front end of the truck (truck underrun) and penetrated through passenger compartment. There was alcohol involvement for both the driver and the passenger. The passenger sustained fatal head injuries, while the driver received incapacitating head injuries. Neither occupant was wearing a safety belt although the penetration of the guardrail into the passenger compartment would have negated the effectiveness of safety belts.

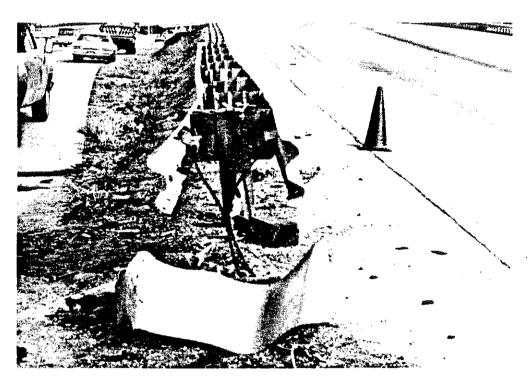
Figure B20. Accident Number 041, Kenton County, I 75, MP 184.5, I 275 Exit Ramp.

The vehicle, a 1973 Volkswagen Beetle, hit the Type 6 end treatment head-on. There was no evidence of skid marks leading up to the end treatment. The police report indicated that the driver apparently fell asleep and chemical tests show alcohol involvement. Only the first wooden post was broken and the guardrail penetrated the vehicle. The impact angle would approach zero degrees. The driver sustained fatal injuries to the head and chest. He was not wearing a safety belt.

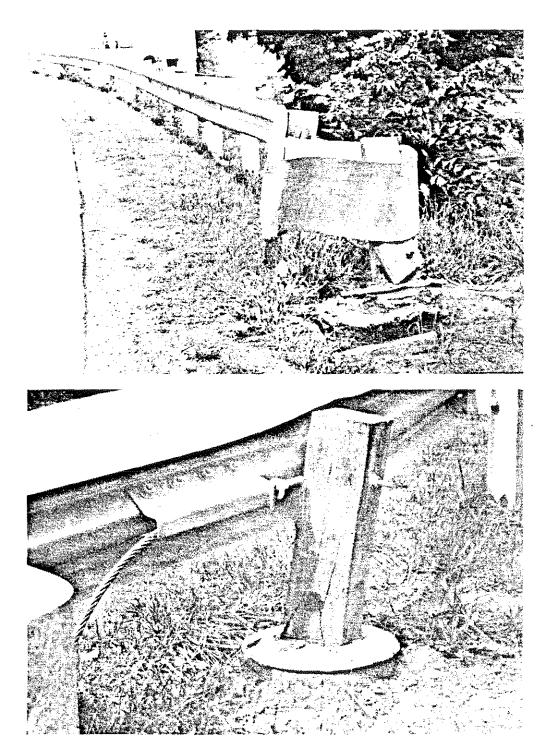
Figure B23. Accident Number 048, Kenton County, KY 1501, MP 2.4.

No accident report was found. The first wood post splintered down the middle; half of the post remained intact and the concrete footing was displaced. The second wood post cracked longitudinally near the bottom, but did not break. The rail buckled between the first and second wood posts. The

vehicle rebounded after impact.

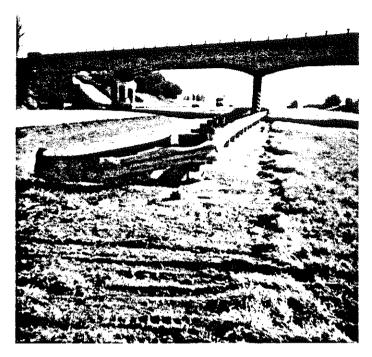
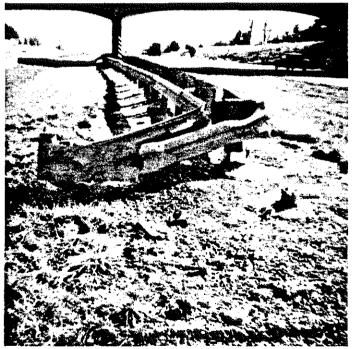
Figure B25. Accident Number 051, Fayette County, I 75, MP 106.287, KY 1927 Underpass.

No accident report could be found for this location. It appears from the photographs that a vehicle impacted the end treatment at a moderate angle and broke through causing the first post to break away at the base and the rails to be deflected approximately 45 degrees. Damage to the end treatment was moderate. Occupant injury severity

and degree of vehicle damage are unknown.

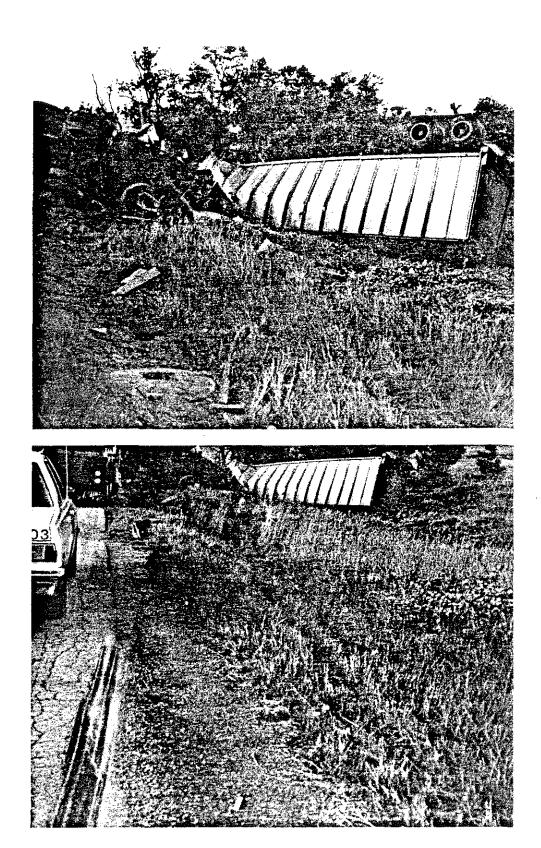
Figure B26. Accident Number 055, Fayette County, I 75, MP 105.800.

The driver of a 1979 tractor and semi-trailer stated that he was forced off the right shoulder of the road after being bumped by an unidentified vehicle. The truck impacted the guardrail end at an angle with its front end and proceeded through the guardrail, where it then overturned. Eighty feet of guardrail were damaged by the truck. The end treatment was broken away. The driver received incapacitating leg injuries. He was not wearing a safety belt. The vehicle suffered frontend damage from overturning.

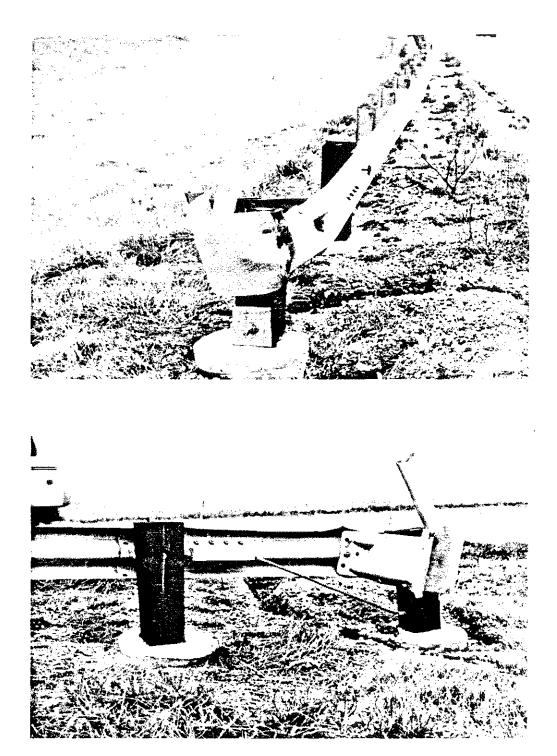
Figure B27. Accident Number 058, Madison County, I 75, MP 90.

No accident report was found, which was probably due to the minor nature of the impact. The guardrail on the median shoulder sustained damage to the buffered end. The first wood post was not damaged, but the second wood post had split longitudinally. However, it did not break at the concrete footing and remained intact with the guardrail. The extent

of vehicle damage and occupant injury is unknown.

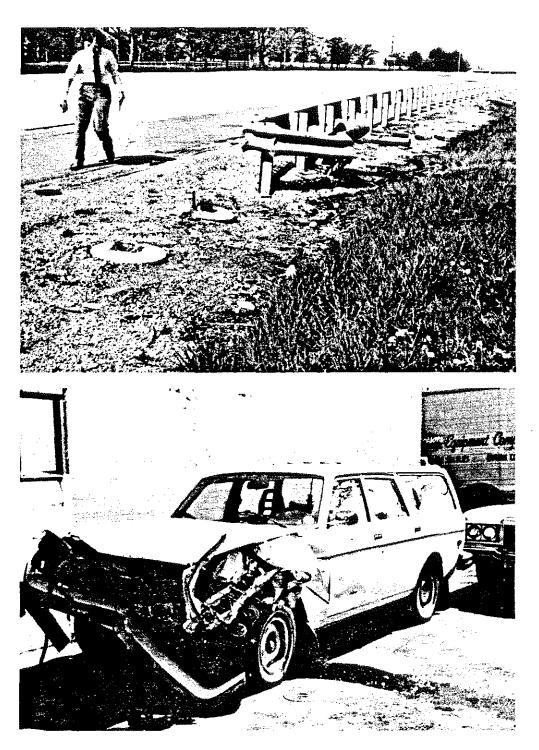
Figure B28. Accident Number 059, Woodford County, US 60, MP 11.7.

The driver of a 1976 Volvo 265 DL station wagon stated that he fell asleep at the wheel and ran off the right side of the roadway, striking the end of the guardrail head-on. The car broke through both wooden posts and stopped just behind the guardrail. Disabling damage was done to the front of the vehicle. Neither the driver nor the front passenger were injured (both were wearing safety belts). Heavy damage was done to the guardrail end as both posts were completely broken away (the first post was shattered). Vehicle speed at impact was estimated to be approximately 40 mph.

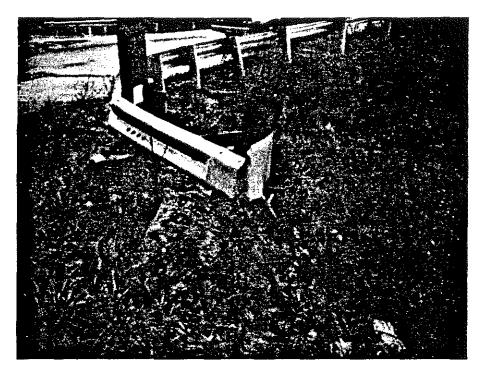
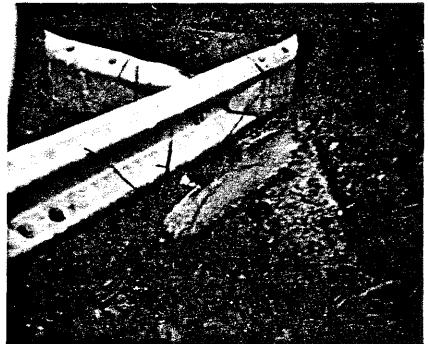
Figure B29. Accident Number 060, McCreary County, KY 92, MP 17.578.

COMMENTS: Photographs show that the first concrete footing was pulled out of the ground while the wooden post remained unbroken and firmly implanted in the footing. The second post was leaning slightly but was also not broken. No accident report was found which was probably related to the

relatively minor nature of the accident.
