CORRECTIVE MEASURES FOR UNSTABLE BRIDGE-APPROACH EMBANKMENT

US 68, LICKING RIVER, BLUE LICKS

KYP-72-38, HPR-PL-1(15), Part III B

November 1979

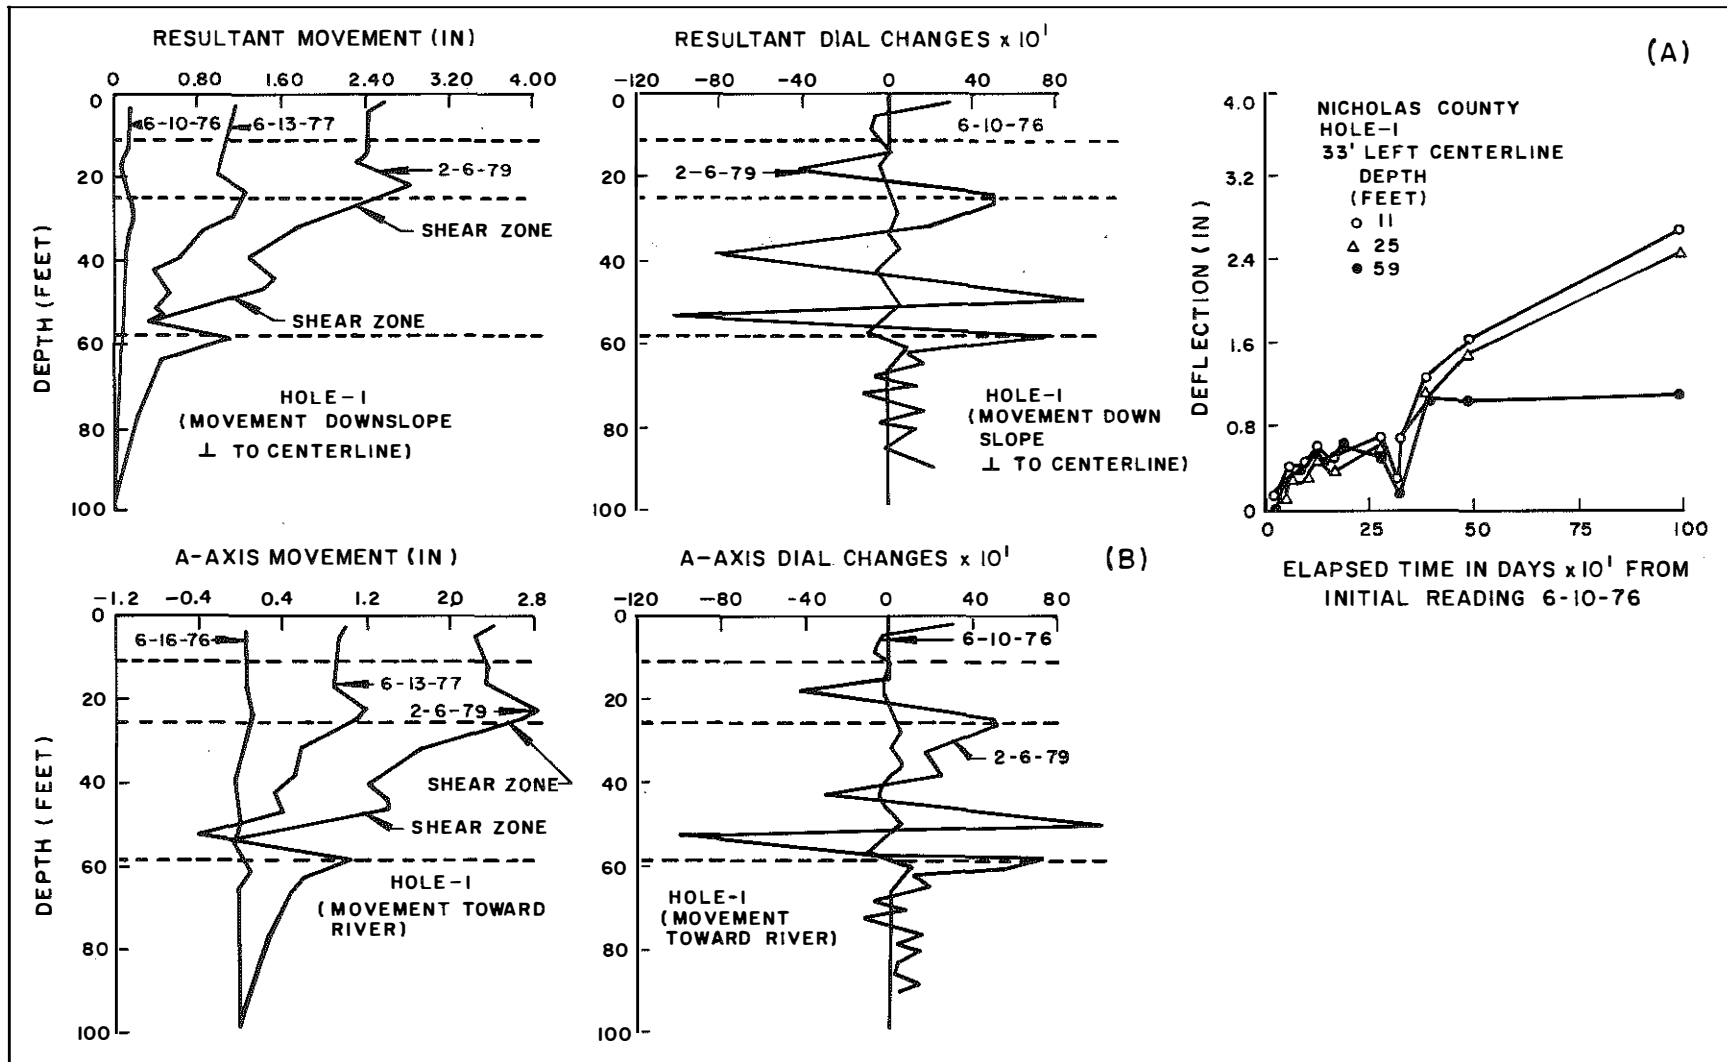
Figure 13. Slope Inclinerometer Results: Hole 1; a) Resultant Movement and b) A-Axis.

Slope inclinometer results for the four holes are shown in Figures 13, 14, 15, and 16. Resultant horizontal movements and dial changes are plotted as a function of depth. Horizontal movement parallel to centerline and toward the Licking River is shown in Figure 13B. Movement-time curves are given for all four holes in Figures 13

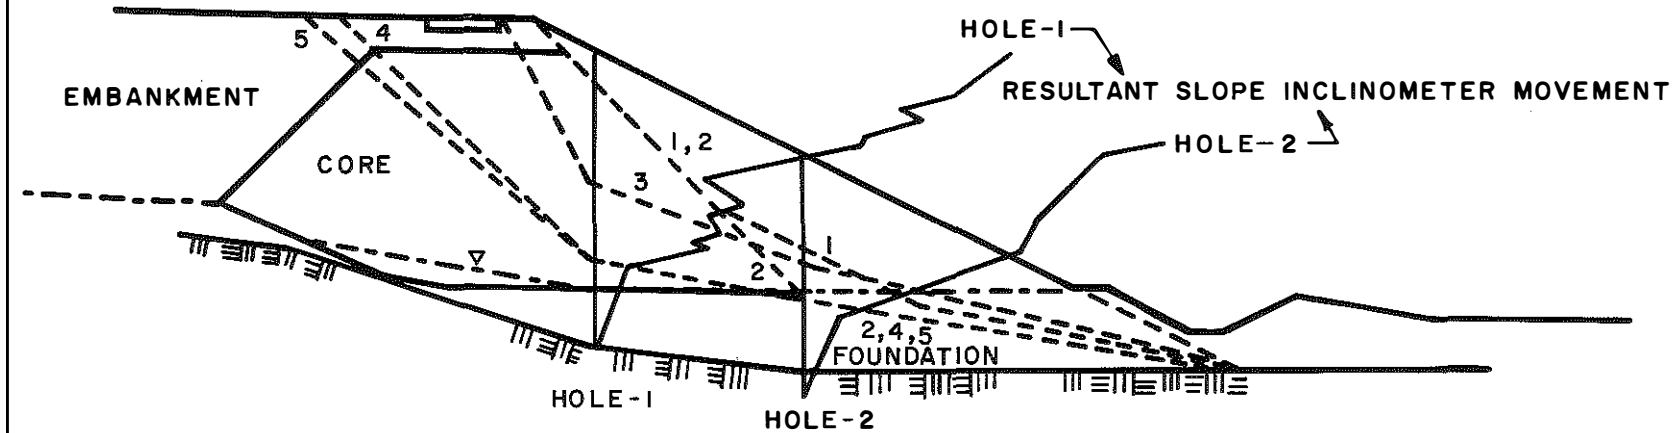
Figure 26. Left-of-Centerline Cross Section, Critical
Wedges.

Over 70 wedge configurations were analyzed searching for the critical configurations for the three cross sections shown in Figures 26, 27, and 28. The effective angles of friction along the failure surfaces were 23 and 16 degrees. The angle of friction within each wedge was assumed to be 23 degrees. Backed-in values of ϕ^0 were calculated from these results and are tabulated on Figures 26, 27, and 28. For simplicity, the embankment soils were assumed to have uniform unit weights of 125 pounds per cubic foot (2,002 kg/m³). Each cross section was assumed to be infinitely wide. Because this last assumption is not valid, especially in the case of the skewed section shown in Figure 28, the critical wedge was not selected on the basis of the lowest factor of safety but according to the failure surface which

The skewed cross section in Figure 28 lies on the intersecting edge of the cross sections in Figures 26 and 27. The section properties change significantly in the direction perpendicular to the plane of Figure 28. consequently, too much error results in the assumption of a plane-strain situation. Instead of assuming plane-strain, weights of the sliding block above each failure plane were used. In addition, because the use of berms to increase stability was limited by the proximity of the Licking River, a design using a lightweight fill was investigated.

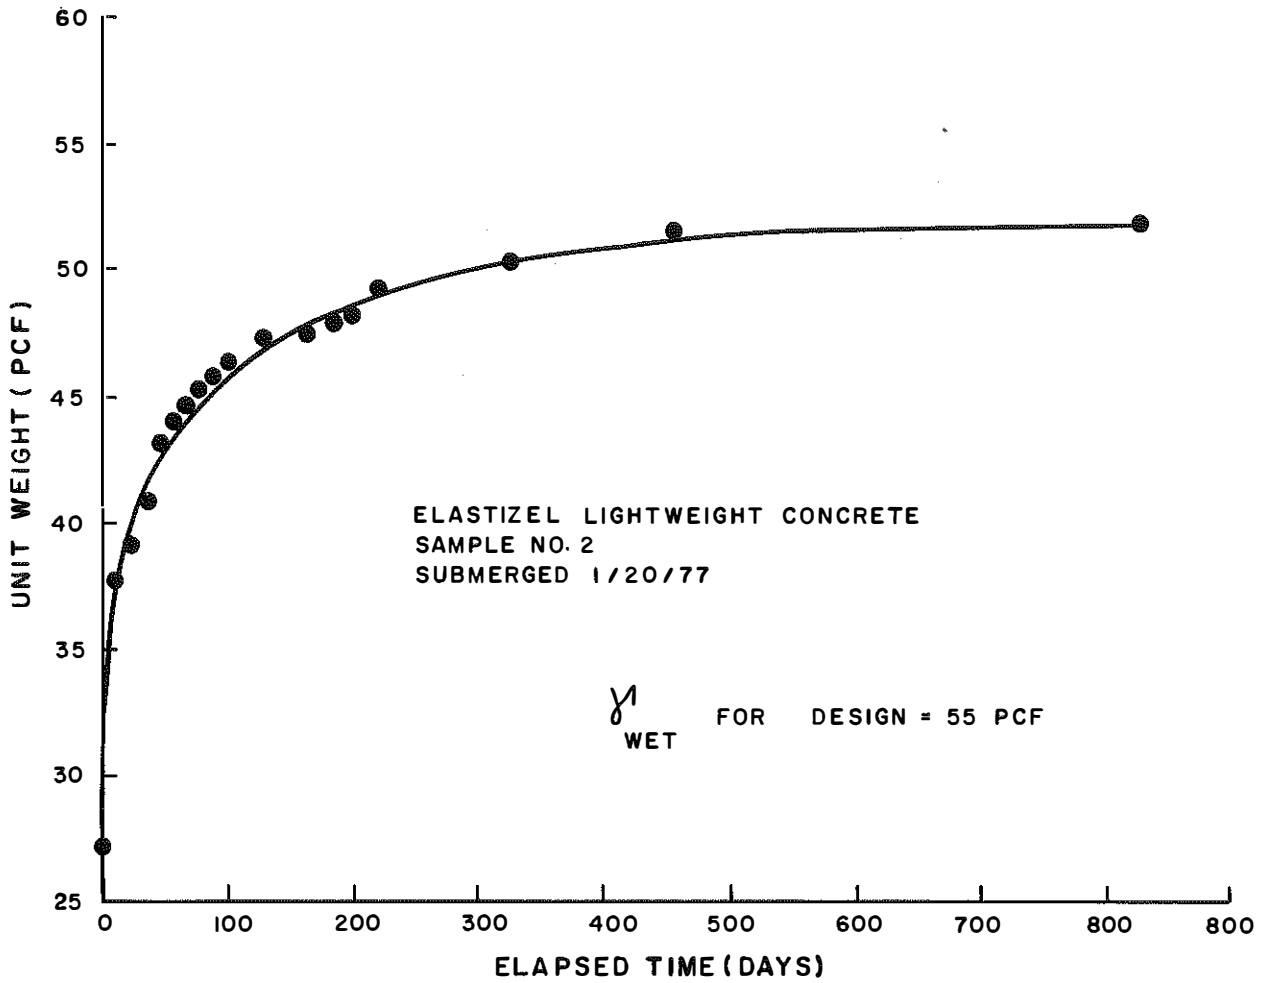
Figure 29. Effect of Submergence on Density of Elastizell Lightweight Concrete, Sample No. 2.

The lightweight material is produced commercially by the Elastizell Lightweight Concrete Corporation of Dayton, Ohio. Two tests were made by Division of Research to determine the long-term wet density of this material (55 pounds per cubic foot (880 kg/m^3) (Test 2 in Figure 29)). Elastizell Corporation has reported that the lightweight material having this wet density would have a compressive strength of between 260 and 400 pounds per square inch (1.79 and 2.76 MPa). A compressive strength of 200 pounds per square inch (1.38 MPa) was selected for design. Assuming a ϕ -equal-zero analysis, half of this compressive strength would be equivalent to an undrained cohesion, c_u , of 100 pounds per square inch (0.69 MPa).

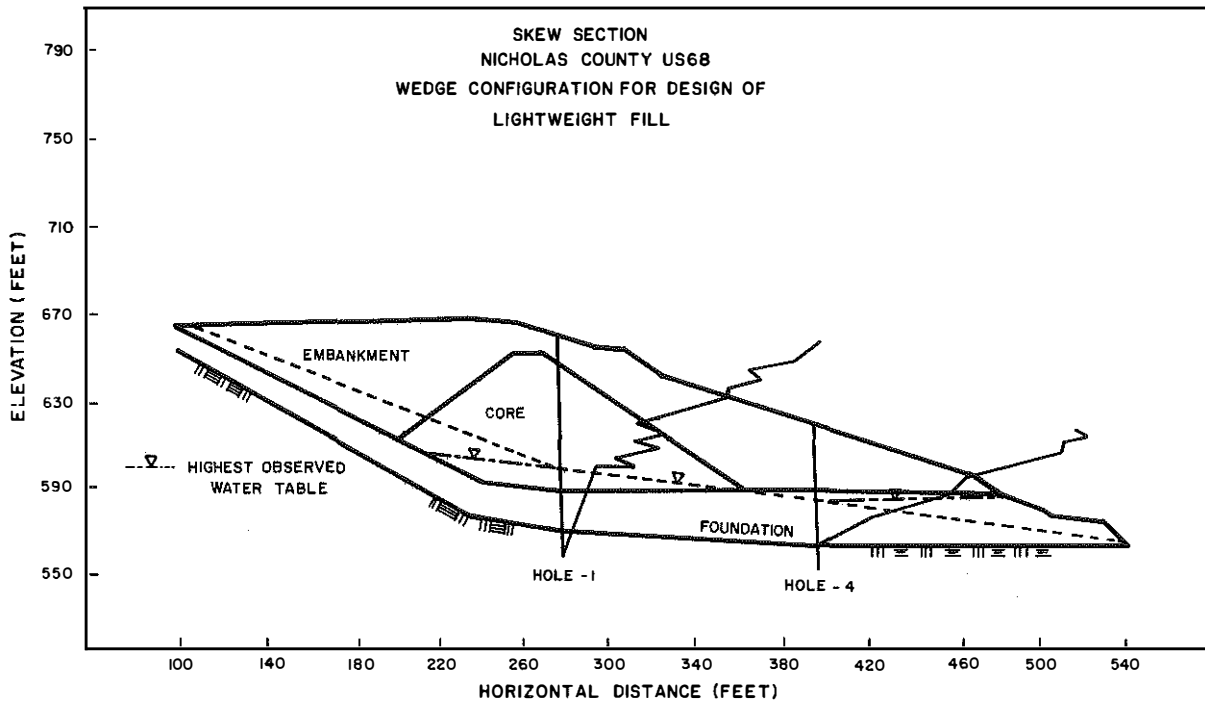
Figure 30. Wedge Configuration Used in Design of Lightweight Fill.

The wedge configuration shown in Figure 30 was used to analyze two conditions: 1) zero cohesion and 2) cohesion of 100 pounds per square inch (0.69 MPa). The driving wedge (upper block) was estimated to weigh 24,902 kips (110 MN) and act over a distance of 184.7 feet (56.3 m). The resisting wedge was estimated to weigh 79,260 kips (353 MN) and act over a distance of 265 feet (81 m). The value of internal friction along the failure surface was assumed to be 16 degrees. Any increase in the overall value of internal friction due to the addition of the lightweight fill was ignored. A uniform density of 125 pounds per cubic foot ($2,002 \text{ kg/m}^3$) was assumed for the embankment in the calculation of these block weights. Replacements of portions of the driving wedge with varying lifts of
